32. Diamond drilling at building site, 144-148 Macquarie Street, Hobart.

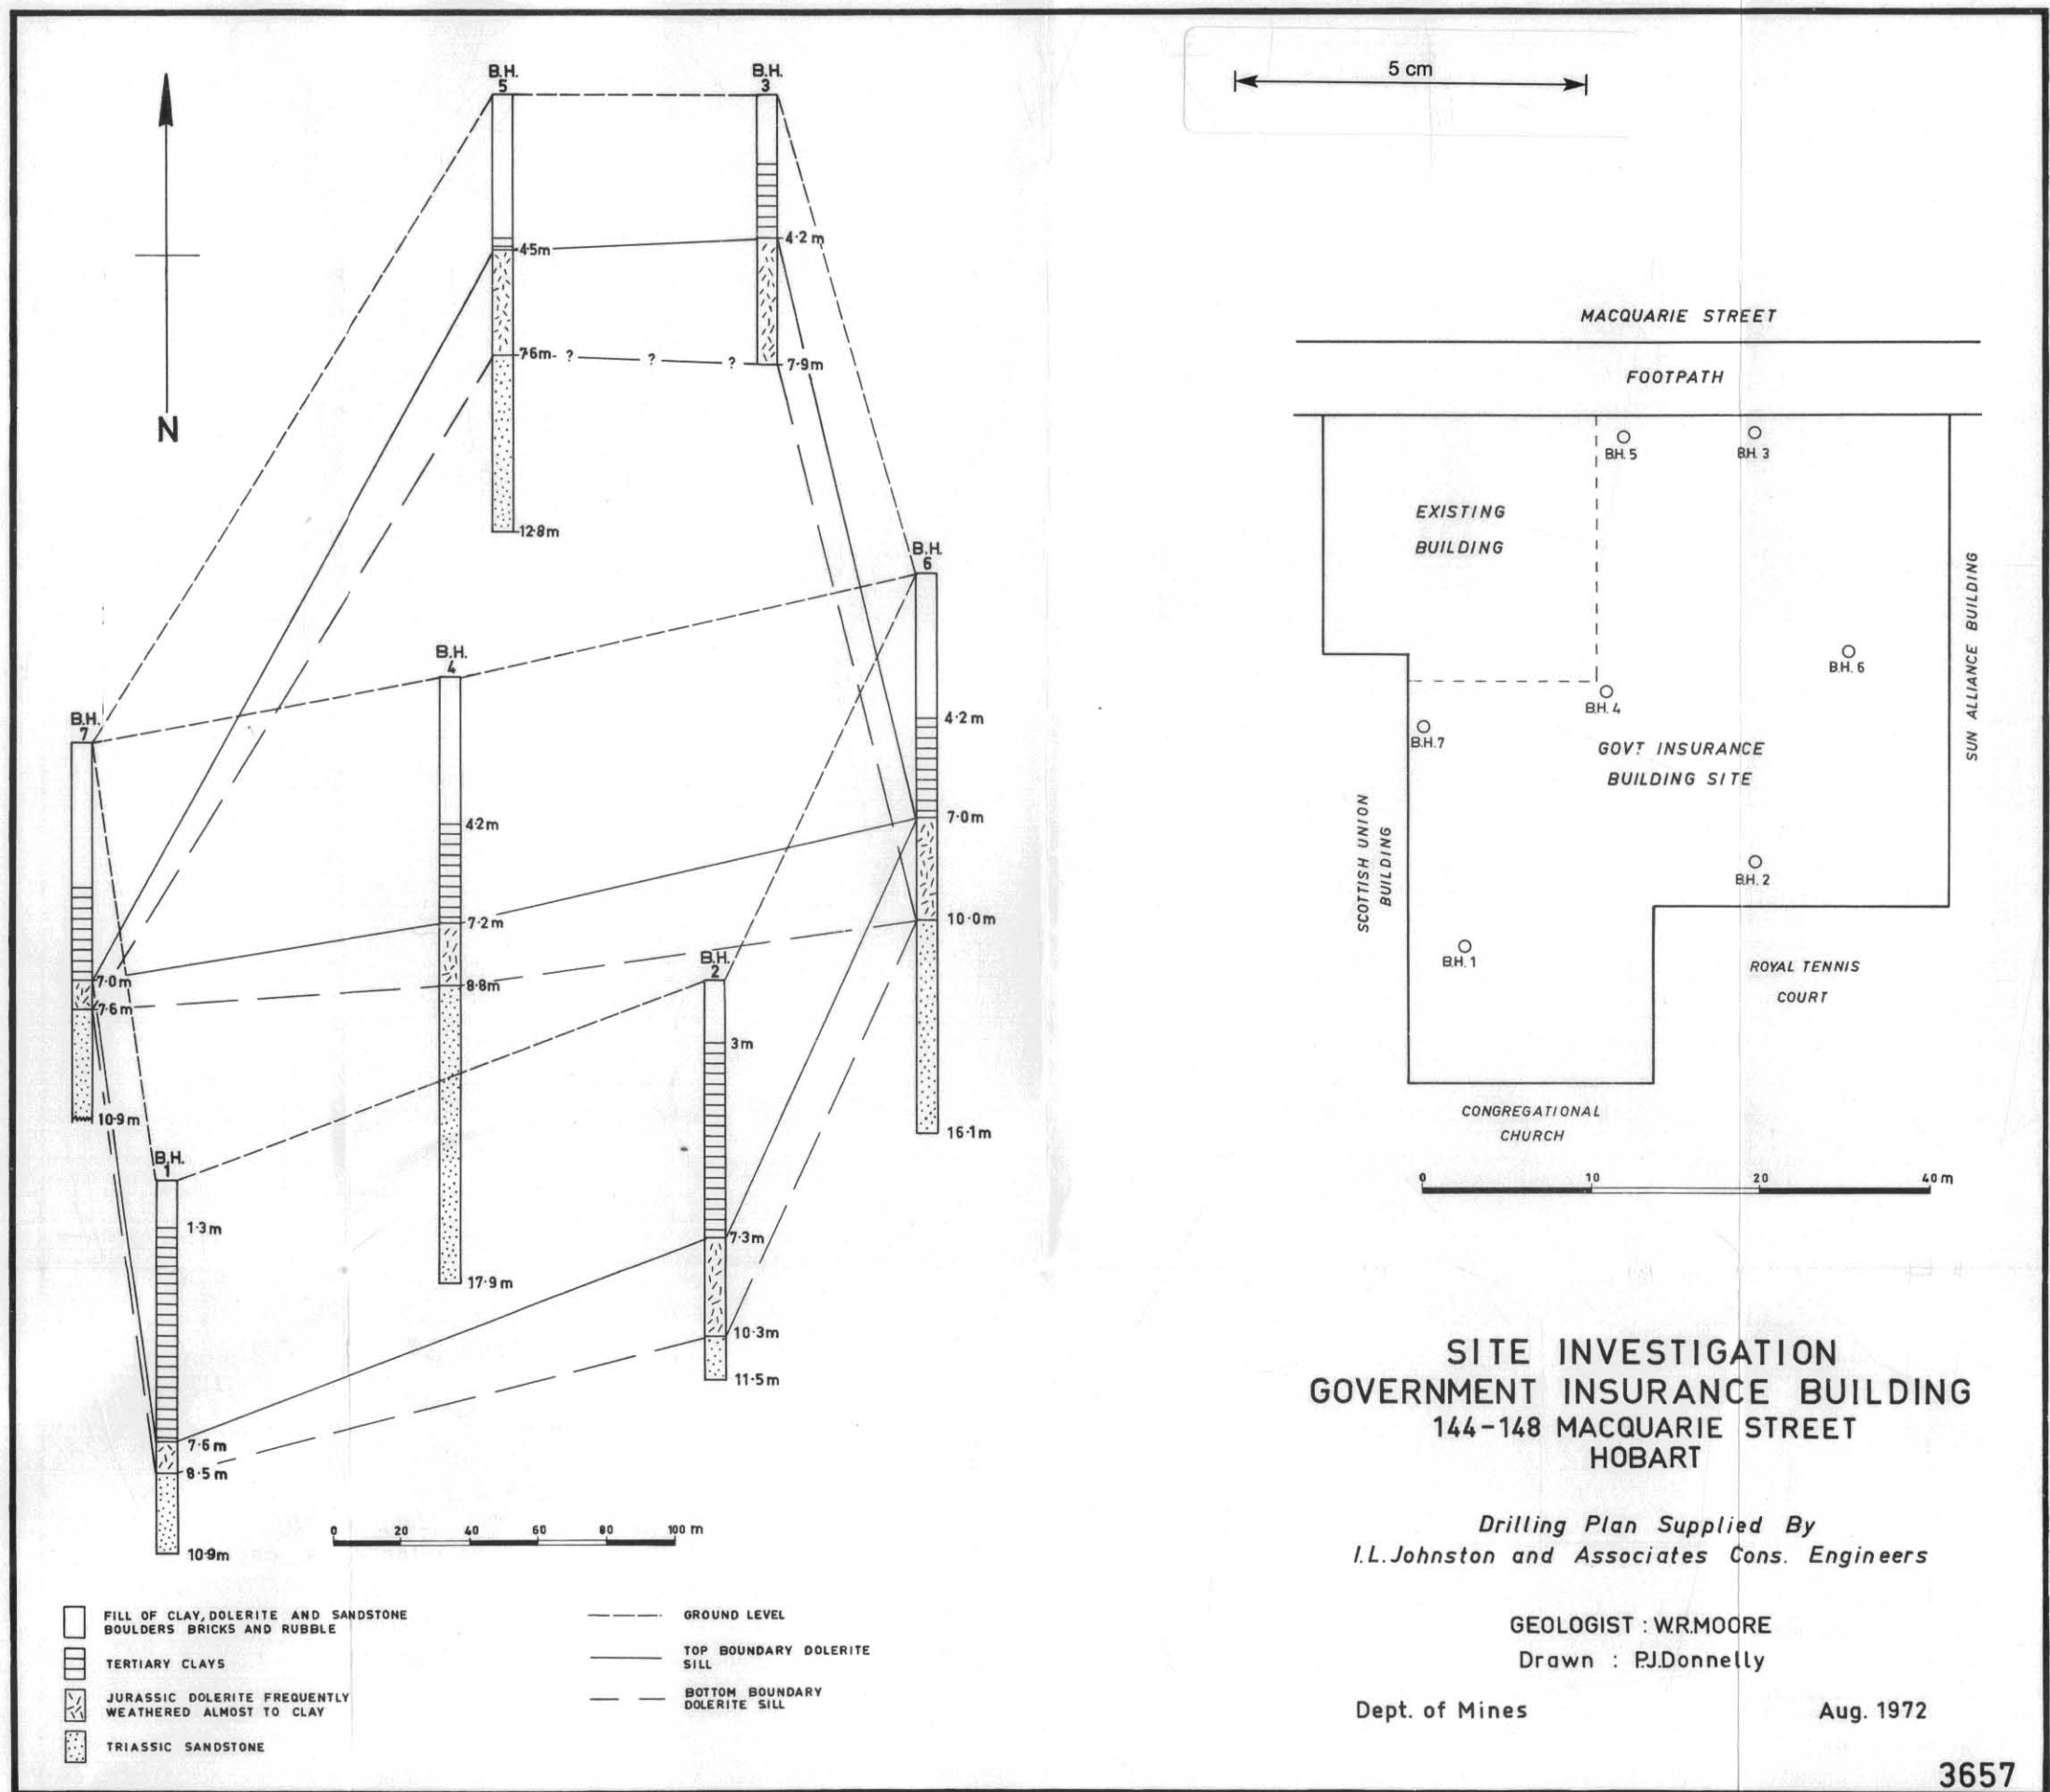
In October 1971 the Department of Mines drilled three bore holes (BH 1, 2 and 3) at the Macquarie Street building site at the locations shown in Figure 35. In each of the bore holes a thin dolerite sill was encountered beneath Tertiary clay at depths of 4.5-7.5 m below ground surface. The sill appears to dip to the south and overlies Triassic sandstone and mudstone. The Tertiary clays and the dolerite sill are previously unknown at this locality, but the Triassic rock has been encountered by drilling in nearby localities.

In all the holes drilled dolerite was encountered, the dolerite sill having a slope to the south and an increased thickness to the east as indicated in the following table and Figure 35. The dolerite has a minimum thickness of one metre in BH 1 and a maximum thickness of 3.5 m in BH 3.
