31. Groundwater investigations, Flinders Island.

W.L. Matthews

GROUNDWATER INVESTIGATIONS FLINDERS ISLAND - WHITEMARK AREA

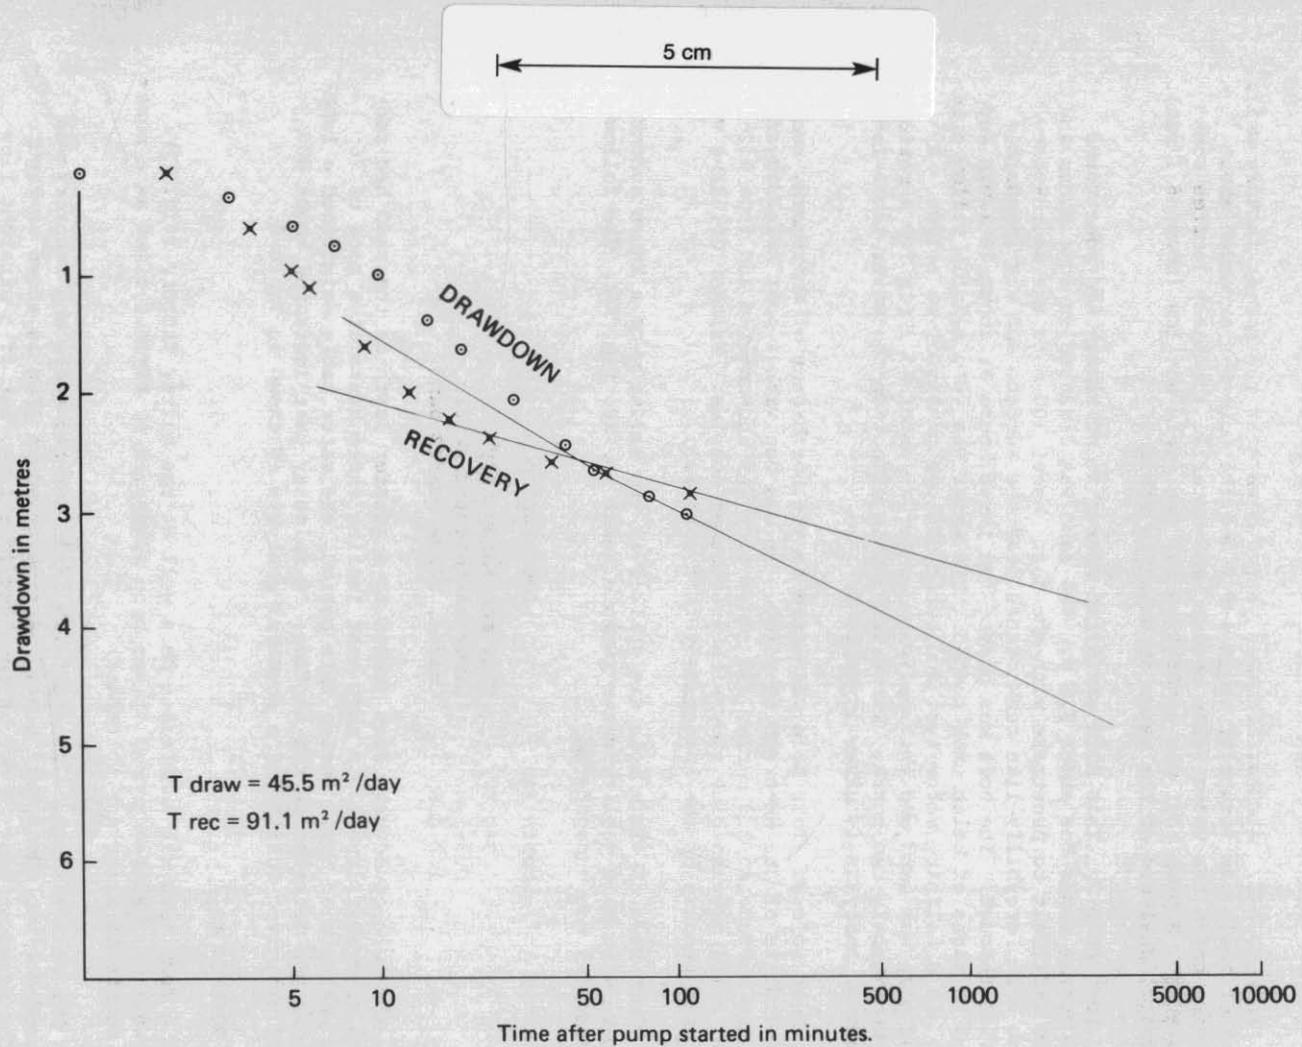
The positions of the test holes are shown on Figure 93. The first two areas investigated were both in the vicinity of the butter factory.

Test Hole 5. This hole was drilled in the vicinity of a known successful bore with good quality water (Sample Point No. 30, fig. 93). The following material was encountered.

A pump test was undertaken on a well at the butter factory (fig. 93). This well or the area around it has been suggested at various times as a possible source of water for Whitemark.

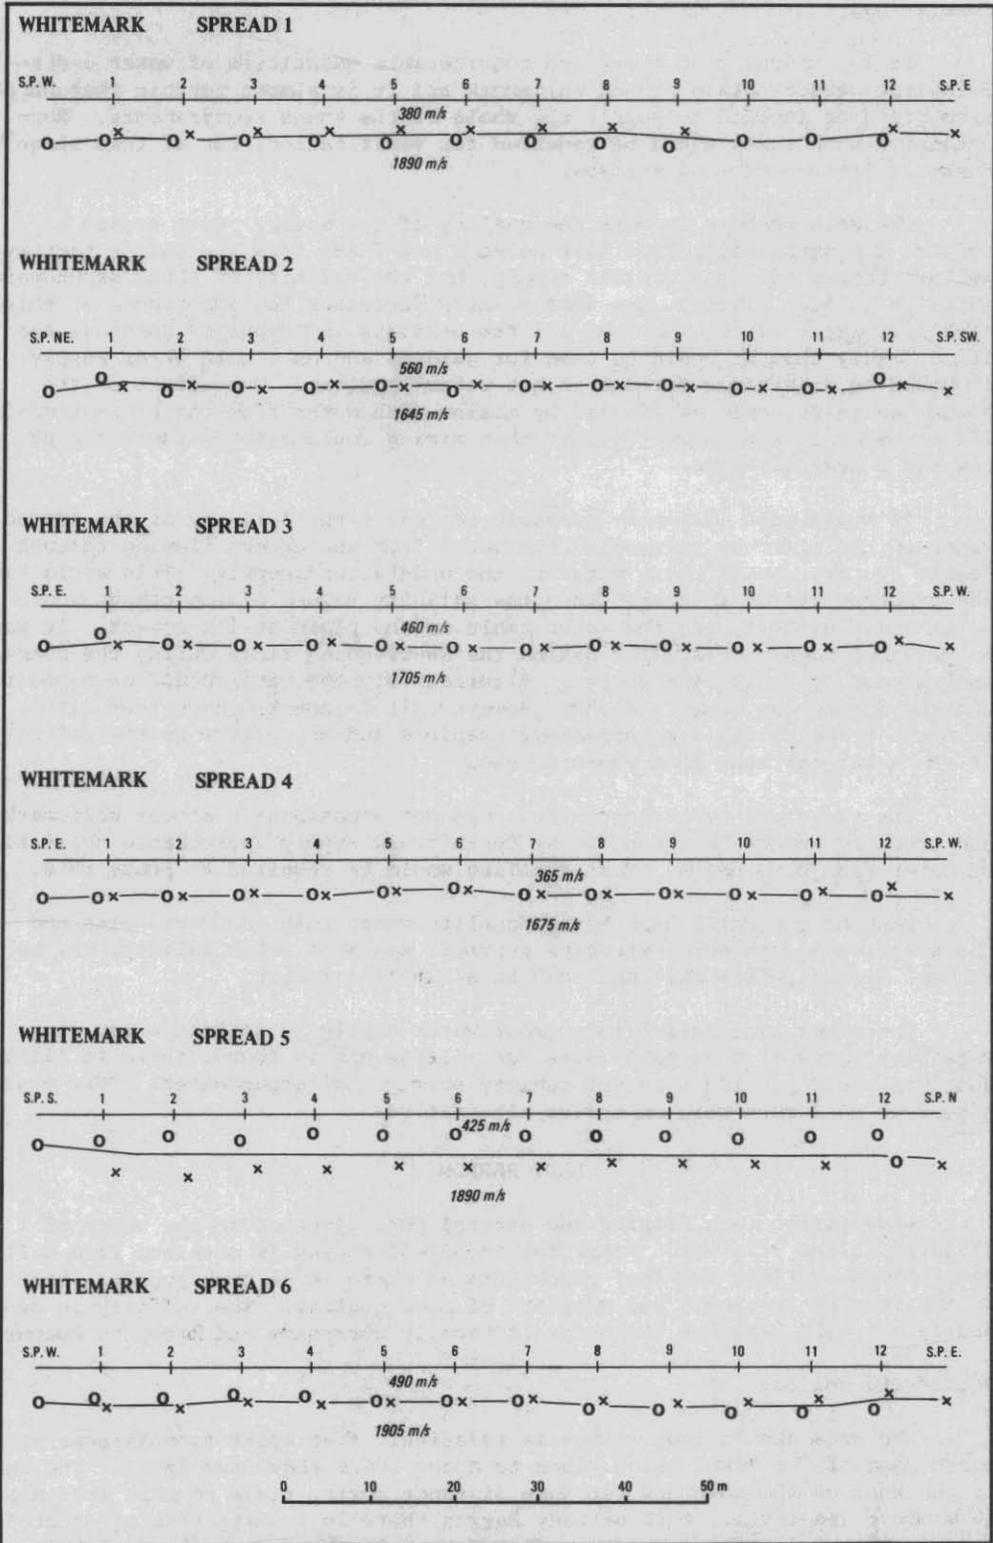
Figure 95. Seismic sections, Whitemark.

Six seismic spreads were fired in the positions shown on Figure 95. Each had a geophone spacing of 7.6 m and was fired on each end at a similar distance from the first geophone. An extension shot was fired on the end of Spread 1. The seismic work was undertaken to determine the depths of unconsolidated material under the plain. Most, and perhaps all of the spreads failed to probe deep enough to reach basement rock.

The results of the seismic spreads are summarised on Table 3 and interpreted sections are shown on Figure 95. The lower velocities of 365-560 m/s probably represent soil and fairly uncompacted and unsaturated material. The material with a velocity of about 1650-1900 m/s is probably saturated sediments with some areas of consolidation or it may be 'coffee rock'. Another possibility is that it is weathered basement rock which may also exhibit seismic velocities in this range. It is not unweathered basement rock as unweathered slate and quartzite would be expected to exhibit velocities at least as high as 3050 m/s and granite probably at least 4500 m/s. Using this information, it can be calculated that unweathered basement rocks are not likely to occur at depths of less than about 30 m below the surface.

The extension shot on Spread 1 with the first geophone at an interval of 53 m exhibited the same velocity as the shorter spread. Using a similar calculation as above, it is unlikely that unweathered basement occurs at shallower depths than about 40 m in the vicinity of Spread 1. The last two geophones on the extension shot suggested a slightly greater velocity (2590 m/s) which if reliable would almost certainly represent basement that was slightly weathered. It is unwise to place too much emphasis on a velocity indicated by only two geophones on the end of the spread however, as near surface irregularities could produce the same effect.

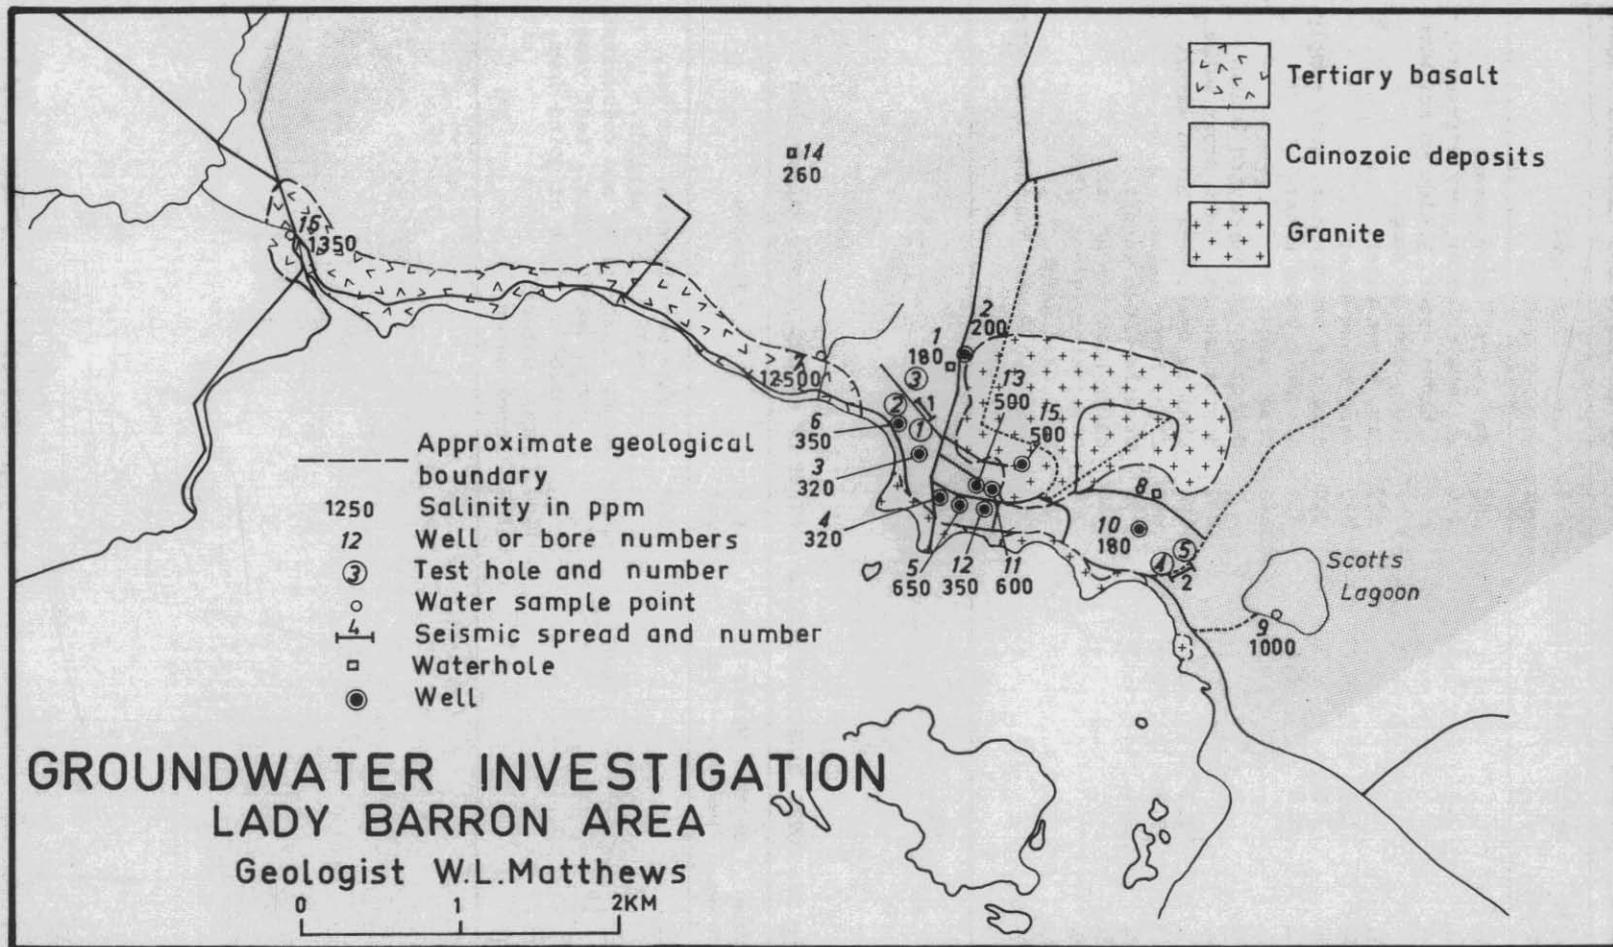
Lady Barron is a fishing and general port situated in the south of Flinders Island (fig.96). Water for the 20-30 houses is obtained from wells, water holes, springs and roof catchments as there is no town supply. Most of the sources are small and many are of poor quality. The salinity is generally not very high but the water is usually corrosive and brown in colour.

Two spreads were fired (fig.97) to determine the thickness of the Cainozoic sediments underlying the flat areas at the positions shown on Figure 96. Each spread had a geophone spacing of 7.6 m. Spread 1 revealed about 4.3-5.5 m of soil and fairly unconsolidated material ($V_0 = 335$ m/s) occurring at the surface underlain by material with a seismic velocity of 1630 m/s. This probably represents saturated and perhaps slightly consolidated Cainozoic sediments ('coffee rock') or possibly weathered basalt. Unweathered granite or basalt is unlikely to occur any closer than about 40 m from the surface. Under Spread 2, 2.4-4 m of soil and generally unconsolidated material ($V_0 = 535$ m/s) was indicated at the surface. This is underlain by material with a seismic velocity of 2010 m/s which is also probably compacted sediments or possibly weathered granite. Unweathered granite is not expected to occur at depths shallower than about 40-45 m.

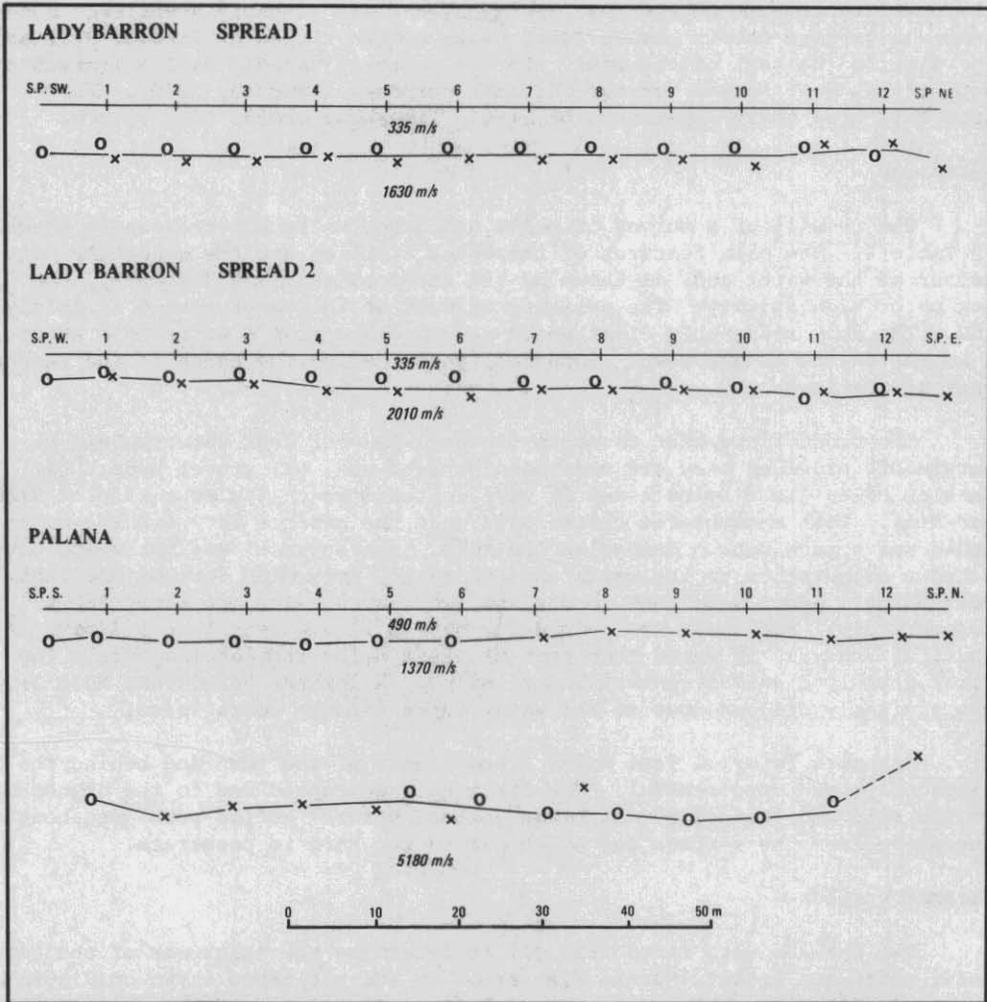
Figure 97. Seismic sections, Lady Barron and Palana.

It is apparent from the seismic spreads that a considerable thickness of Cainozoic sediments (or weathered rock) occurs to the east of, and west of Vinegar Hill. There is a good chance of obtaining water supplies from

these sediments, but test drilling would be required for confirmation.

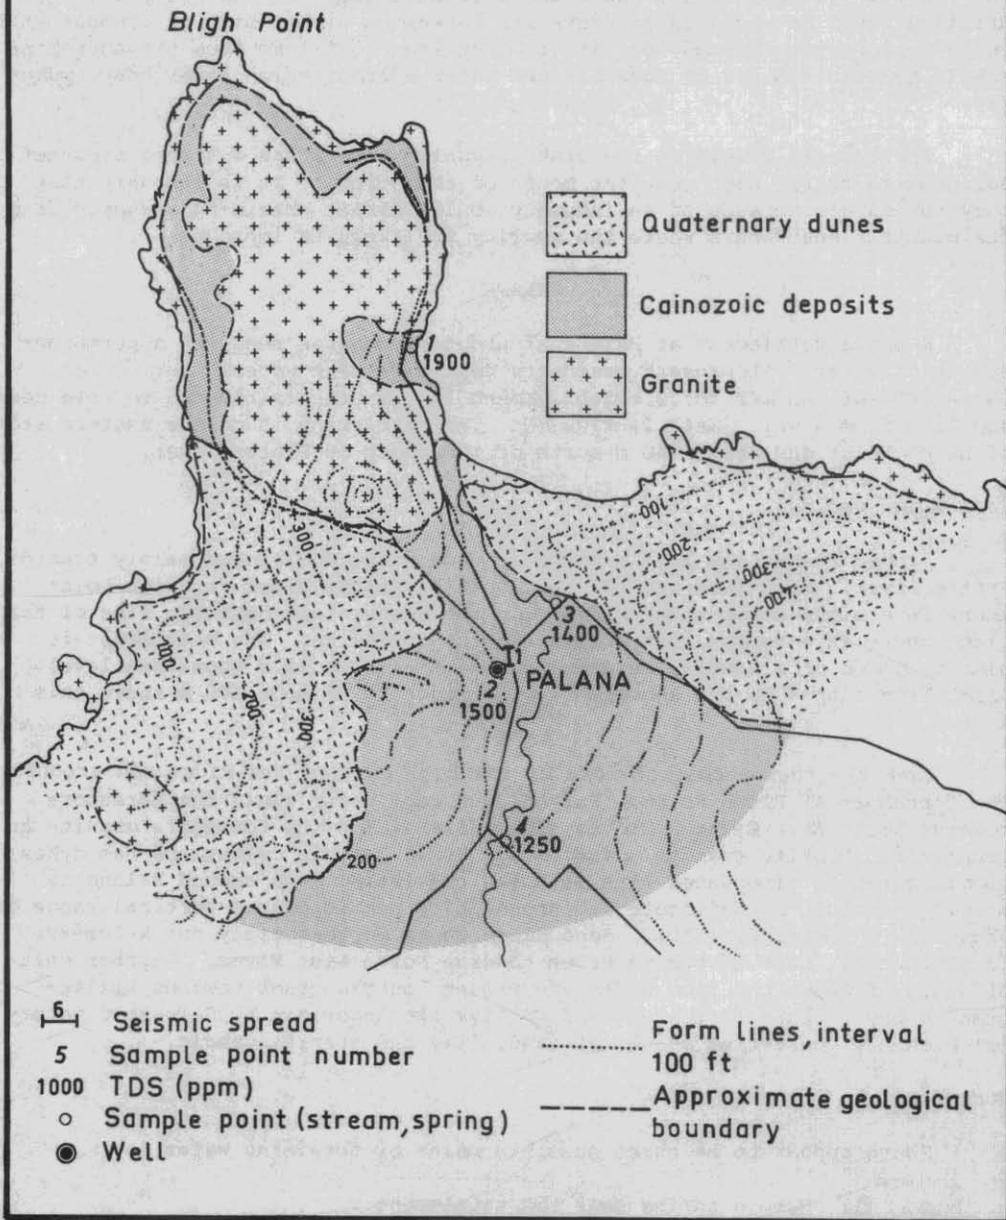
Figure 98.

The spring on the shoreline just below the settlement (Sample Point 1, fig.98) is the nearest source. The spring is situated at the base of a steep shallow valley extending towards the top of the ridge. The valley is underlain by superficial material probably mainly made up of sand and granite debris with a steep seaward sloping contact with the underlying granite. Most of the water supplying the spring is likely to be stored in this superficial material. There is a fairly small catchment and storage area behind the spring and due to the steepness of the country, it is expected that this would drain after extended dry periods, which is in fact reported to happen by local residents. There is another such valley in the northern area of Bligh Point but the same situation is likely to be present. A sample of water from the spring near the settlement had a total dissolved solids content of 1900 ppm which is too high for domestic use for extended periods, but may be useful as a source for emergency supplies.

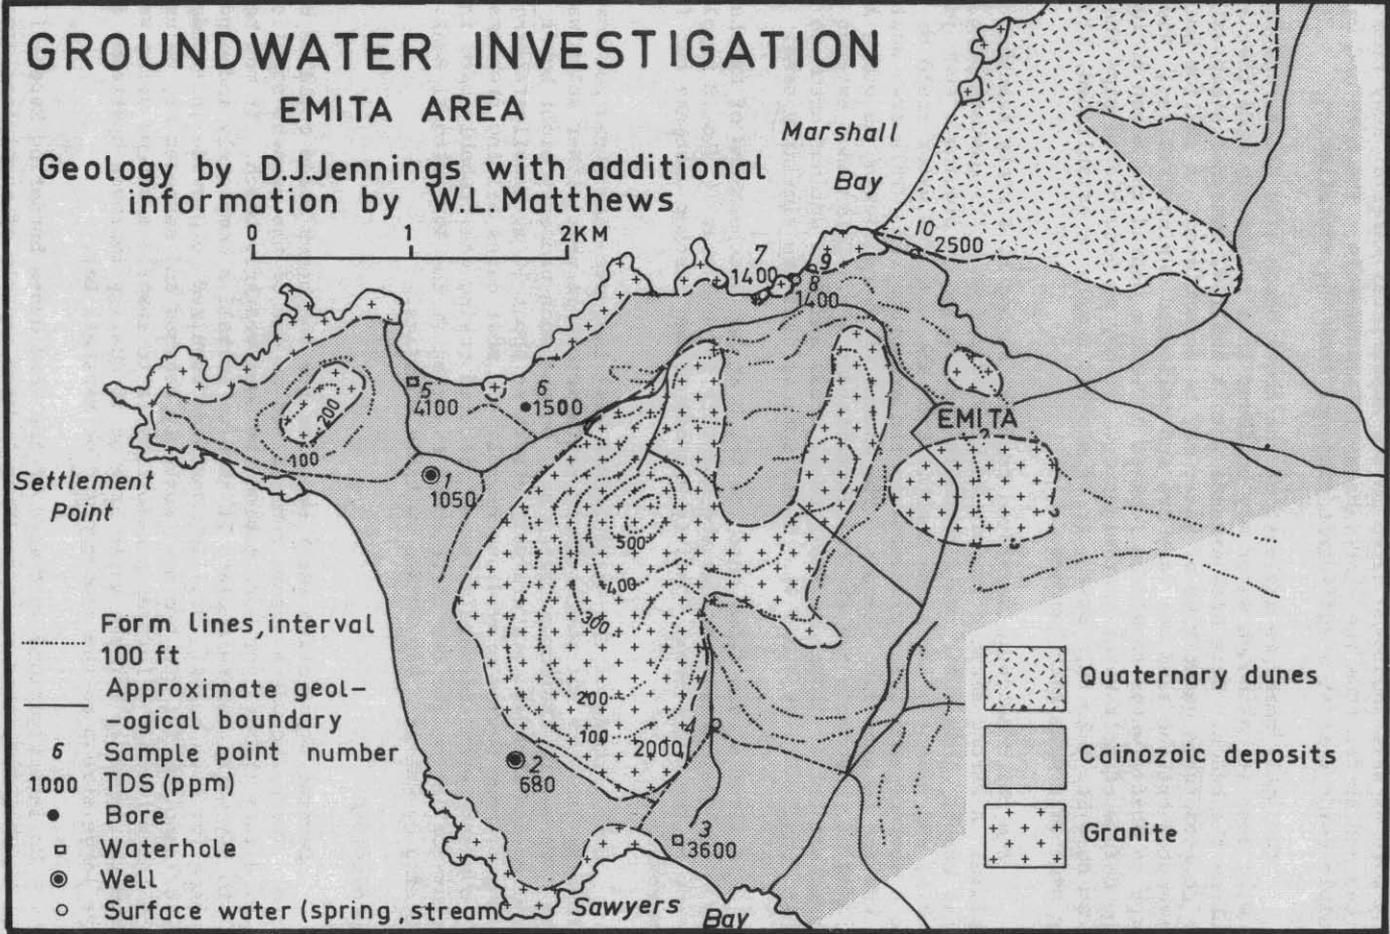
A survey of wells and other water supplies is shown in Table 6 and the points where samples were collected are indicated on Figure 99. Salinity in most of the samples tested was high and unsuitable for long term domestic use. The two best supplies are from a well (Well 1, fig.99) and a bore (Bore 6, fig.99). The well was reported to yield 40 l/min. The bore, drilled near a successful well not far from the shoreline, was extended too deep and when pumped the fresh water/salt water interface rose to contaminate the supply including the well water. However at present, the quality is reasonably good.

quantities of water from depths below sea level if the hole is sited near the shoreline. Such a precaution should avoid salt water contamination. Any bore or well should be sited in the superficial material away from granite areas and as far from the shoreline as is practicable. The bore and well at Sample Point 6 is at a sufficient distance from the shoreline.

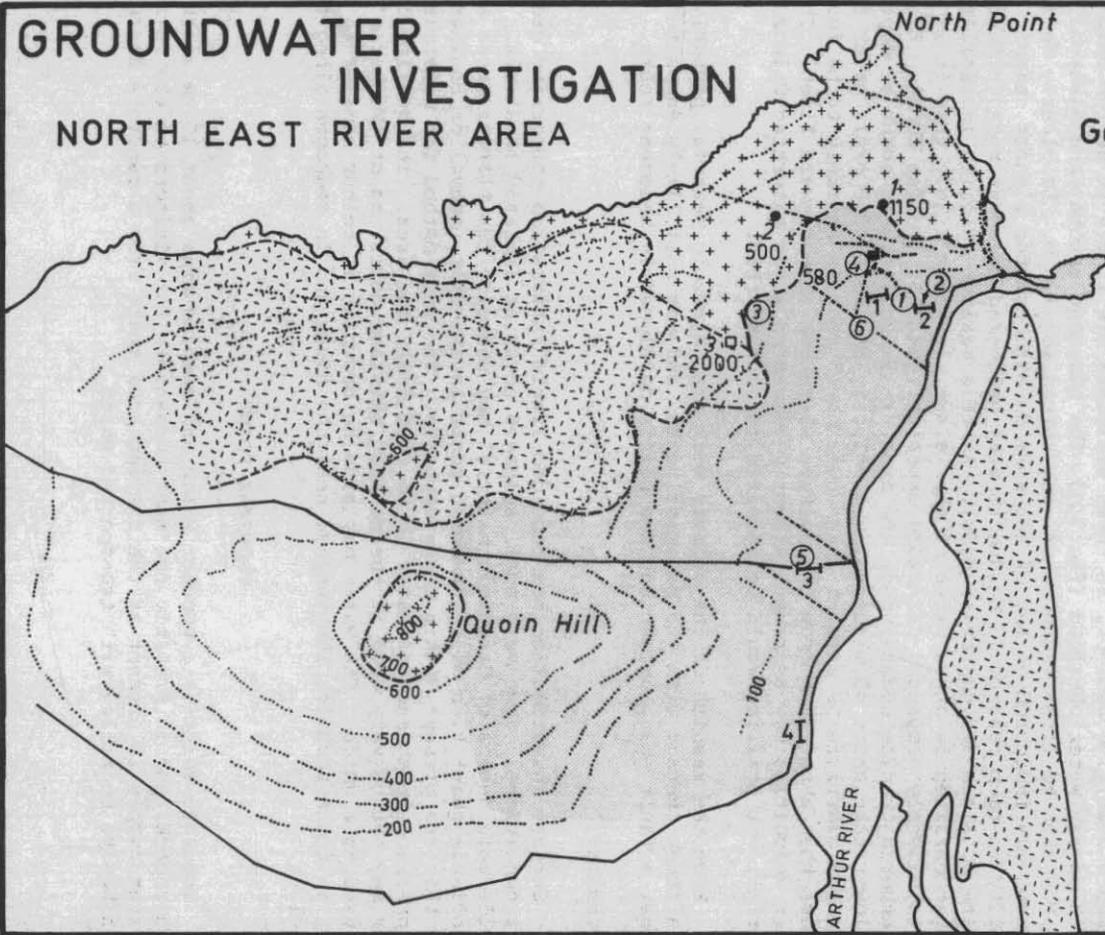
Figure 100.

The area is noted for its lack of surface water. The sole resident in the area depends, apart from tank water, on a small spring (Sample Point No. 1, fig.100 on the side of a very steep slope. During very dry years, this spring dries up, but in an average year yields about one hundred litres of water per day. Another spring (Sample Point 2) on a westward facing slope gives a similar quantity of water but gravitates towards the sea rather than towards the house. About one kilometre south-west of the house a bulldozed hole contains only a small amount of water. Approximately 100 m south-west of the house a seepage occurs which could be usefully developed. Small seepages of brown water occur along the foreshore.

Some shallow drilling was attempted at the various localities shown on Figure 100 but with little success except in the seepage just south-west of the house (Test Hole 4) where the water obtained was of quite good quality (540 ppm of dissolved solids). In Test Hole 1 plastic clay with a little dampness was struck, while in Test Hole 2 moist 'coffee rock' was struck before it became too hard to drill at a depth of 2 m. Test Hole 3 showed no moisture before hard 'coffee rock' was struck and Test Holes 5 and 6 encountered loose, dry brown sand which continued to collapse into the hole after drilling to about one metre.
