1979/50. Report on pre-feasibility geological site investigation:  
Carlton River Project

A.T. Moon

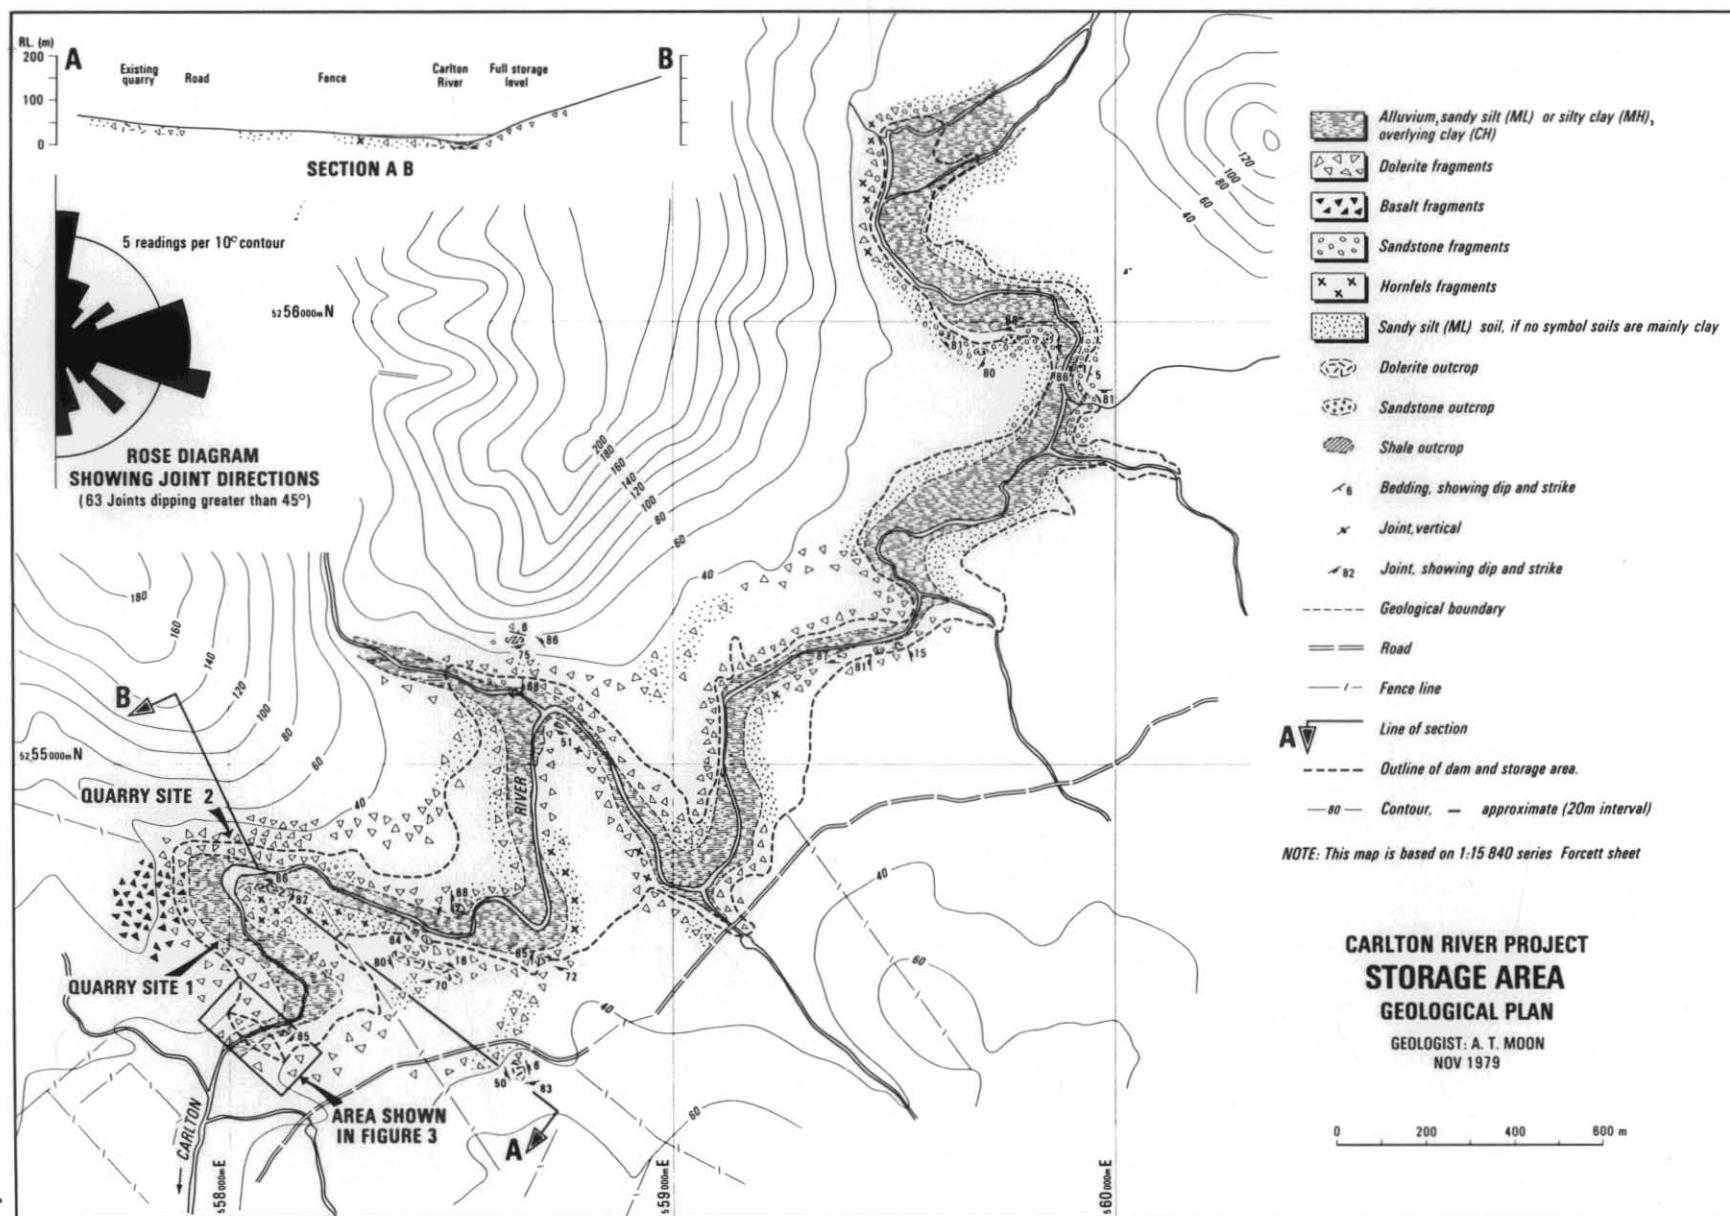
During the Tertiary period, sediment and basalt were deposited in basins between outcrops of older rocks. A cap of basalt occurs on the ridge about 200 m north-west of the dam site (fig. 2). Since the basalt eruptions, erosion and weathering have been the dominant geological processes in the area. Most of the rocks exposed on the surface are highly weathered. Residual soils have developed, high plasticity clay (CH)\* overlying dolerite, and silty sandy soils (ML and SM) overlying the sandstone. Sandy silt (ML) topsoil, which may be windblown in origin, overlies the dolerite in places. Talus, consisting of rock fragments in soil, has developed at the base of the steeper slopes. Alluvium consisting of organic clay (OH) overlying sandy silt (ML) and clay (CH) has been deposited in valley floors.

Two possible quarry sites have been indicated on Figure 2. Both occur upstream of the dam site on the right bank of Carlton River. Neither site has been examined in detail. Although no outcrops were observed, the abundant fragments at the surface indicate that dolerite is likely to occur at shallow depth.

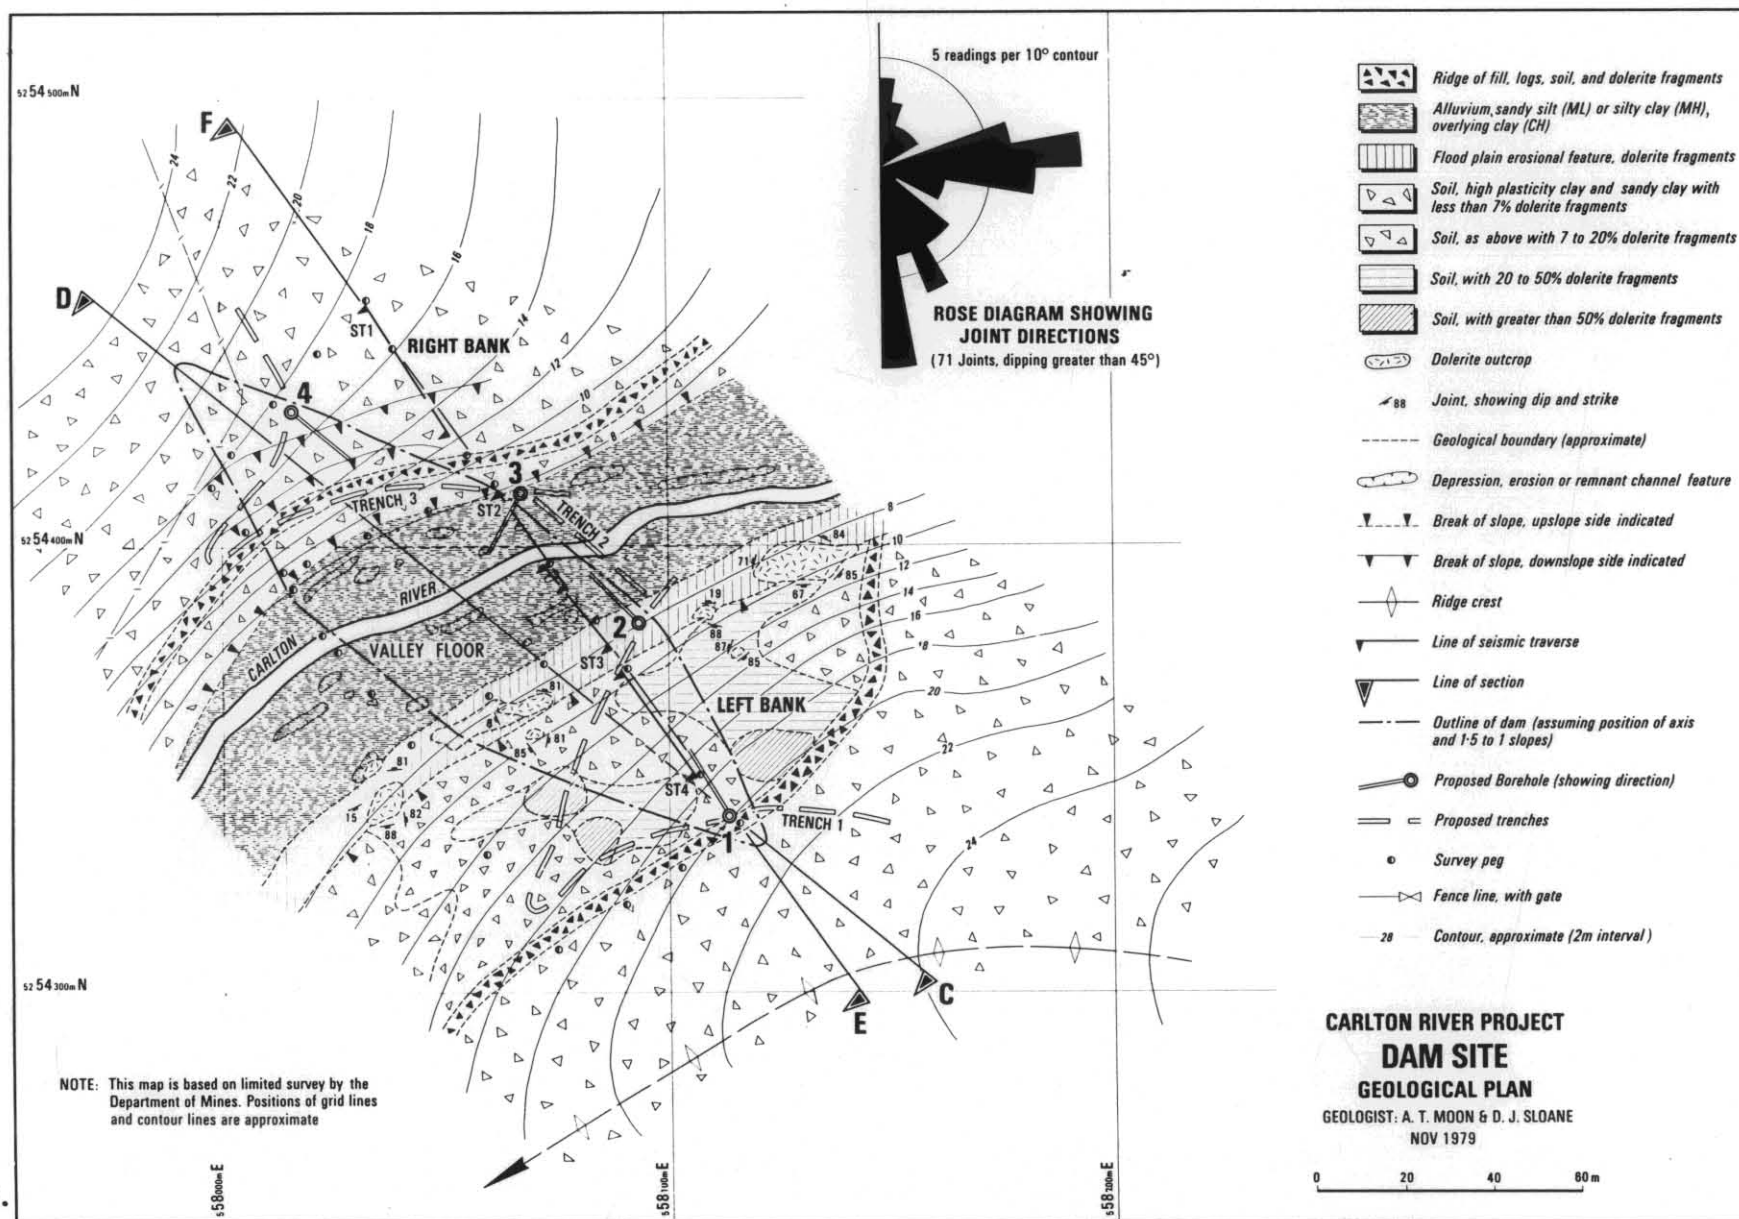
Dolerite is the only rock type exposed in the dam site area (fig. 3). Several outcrops occur on the left bank but no outcrops were observed on the right bank. The distribution of the outcrops is shown in plan on Figure 3.

A section of valley floor at the base of the left bank is not covered by alluvium; there are outcrops of dolerite, many dolerite fragments and only thin soils. It may be an erosional feature and is described as such in Figure 3.

The only defects observed in the rock mass at or near the dam site are joints (see Table 5, Appendix 1). The rose diagram (fig. 3) shows the main joint directions for the steeply dipping joints, and the poles to all the joint planes measured at the dam site are plotted on a stereographic projection in Figure 6 (Appendix 1). Although five or six joint sets occur, most joints can be grouped together into three main sets and these are described in Table 1.

- (b) excavation of about 300 m of trenches. The positions shown on Figure 3 are for a dam with an upstream impermeable face. For a core dam, the layout of the trenches (and boreholes) would be modified. Trenches 1 and 3 should be excavated with a Caterpillar D7 and ripper and cleaned up by a backhoe and sluicing. These trenches can also serve as access tracks for the drill. Trench 2 should be excavated with a backhoe. Trenching should also be carried out at the site chosen for the spillway;

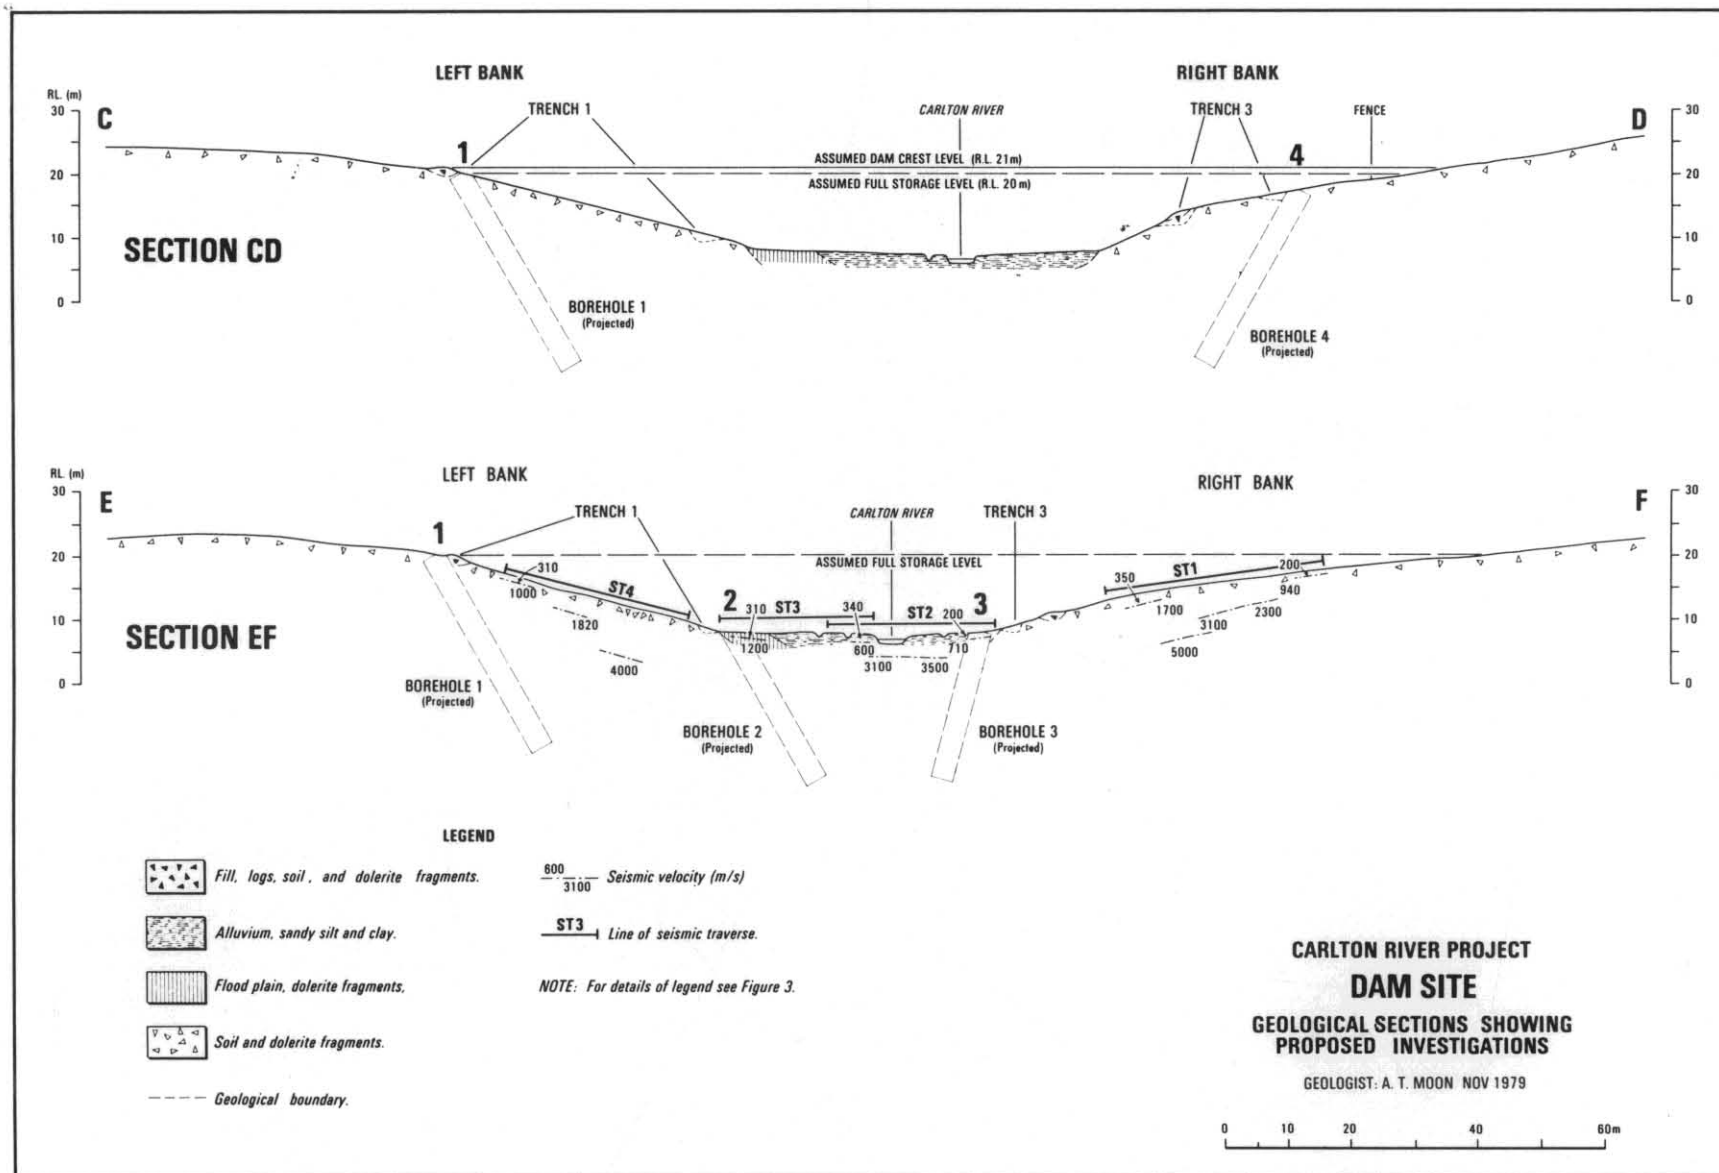
Depressions up to one metre deep occur in the valley floor (fig. 4). These depressions are elongate parallel to the river. Most are remnants of old river channels but some may be caused by erosion. Some of these depressions are floored with dolerite boulders.

Seismic refraction traverses ST1, ST2, ST3, and ST4 were carried out with a Bison hammer seismograph. The positions of the traverses are shown on Figure 3. Depth interpretations were carried out by the critical distance method and the interpretations are plotted in profile on section EF on Figure 4. The seismic velocities and interpreted materials are given in Table 6.

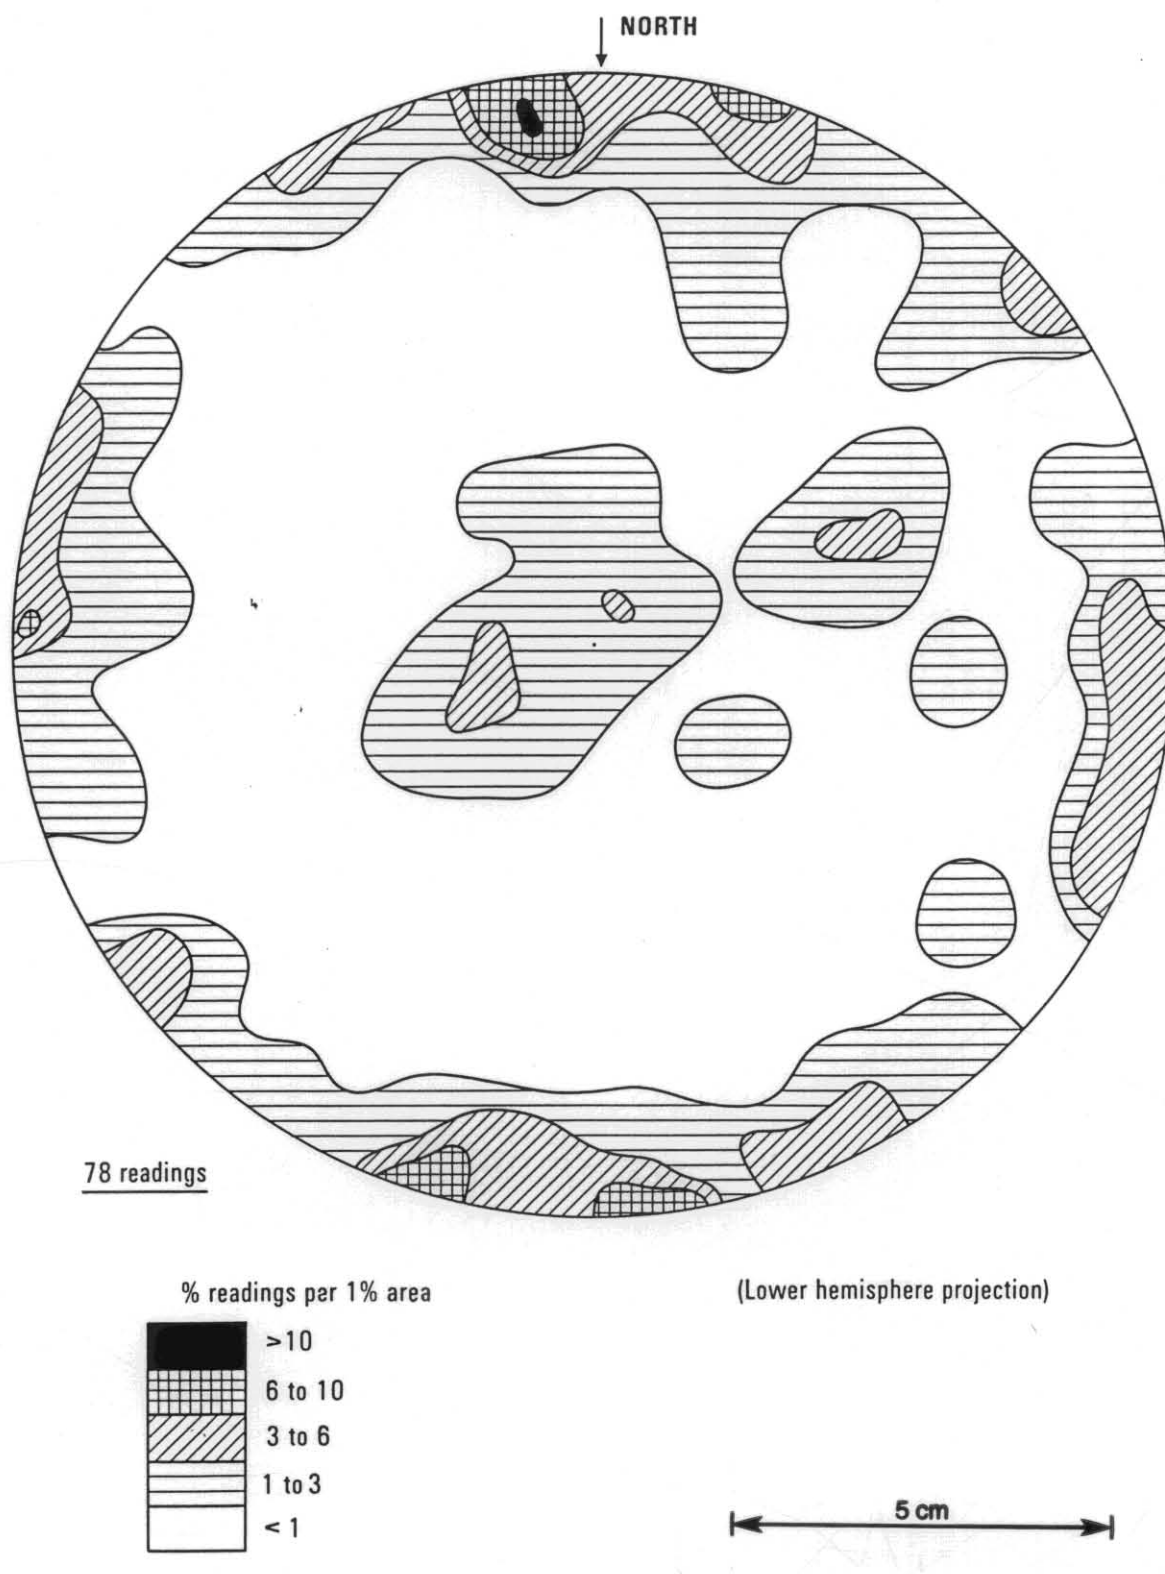
Figure 5. *Stereographic projection of poles to joint planes, Carlton River storage area*

Geological mapping of the dolerite in the storage area indicates that the main defects are similar in orientation to those at the dam site. The rose diagram (fig. 2) shows the main joint directions for the steeply dipping joints, while the poles to all the joint planes measured in the storage area are plotted on a stereographic projection in Figure 5 (Appendix 1). Joint spacing is generally 0.3 - 1 m but locally closer (100 - 300 mm).
