EL 10/93 Razorback

Final Report

**Oonah and Razorback Mining Leases Rehabilitation Plan**

CRA EXPLORATION  
OONAH AND RAZORBACK MINING  
LEASES  
REHABILITATION PLAN

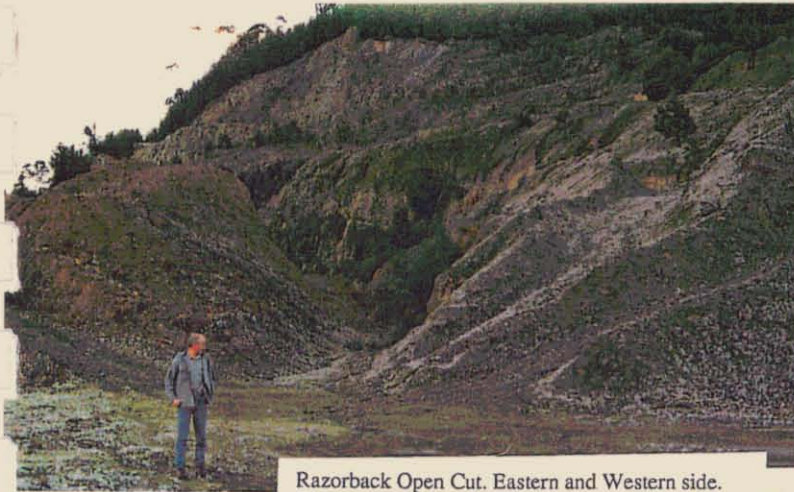
The open cut which was constructed in the early 1970's has steep slopes and high bench heights, with most of the western side now inaccessible. However, except for some local failures it is stable and the western side is revegetating naturally and successfully. This includes the the southern overburden dump. Numerous drives of the old underground workings are exposed in the open cut faces and the site itself provides diverse examples of mining history and is of some historical value.

Razorback Open Cut. Eastern and Western side.  
Eastern side to be rehabilitated

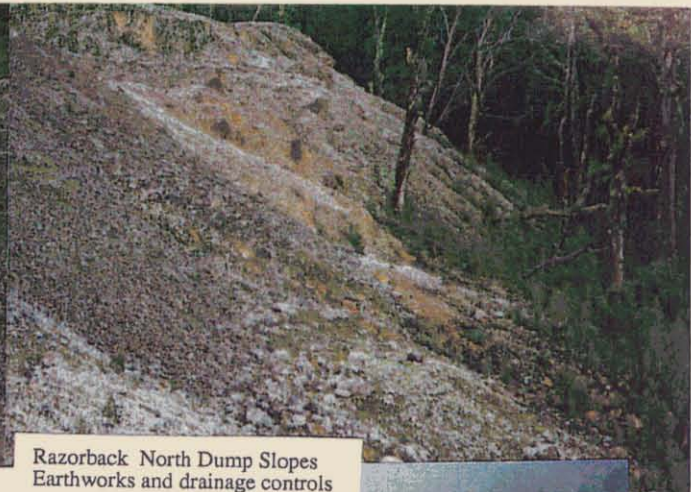
This dump contains the overburden stripped from the open cut. Overburden has been end-tipped over the hillside and has now to a large degree stabilised itself. Gully erosion is evident where uncontrolled runoff has discharged over steep areas. Revegetation is progressing slowly, due to exposure and nutrient deficiency.

Razorback North Dump Slopes  
Earthworks and drainage controls

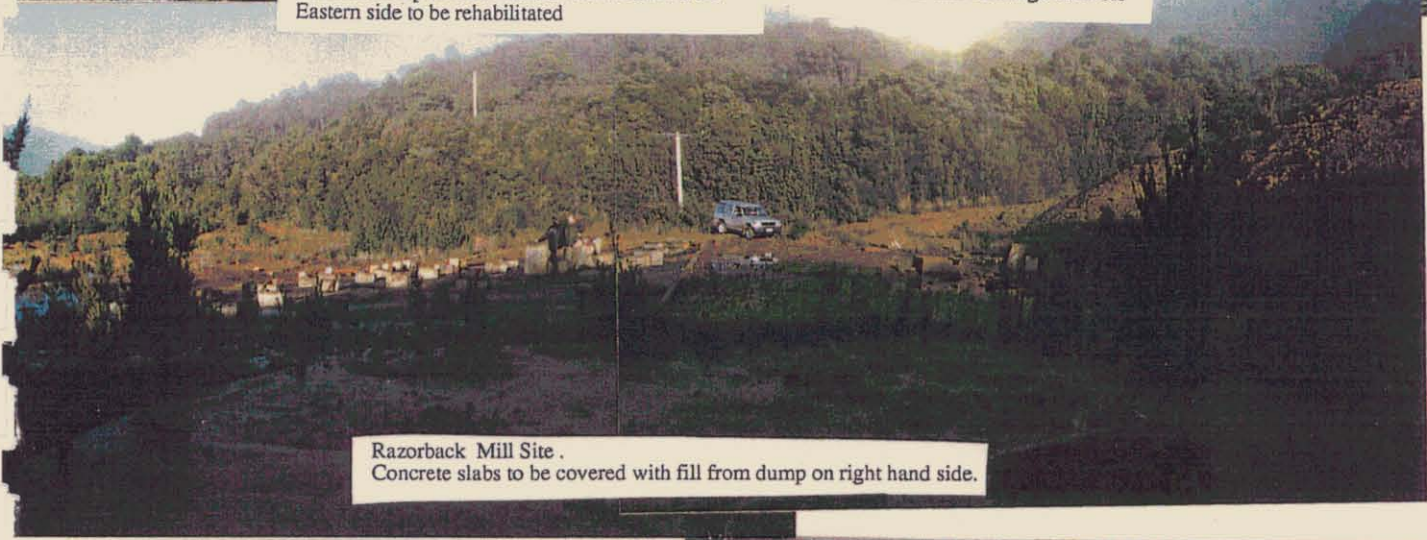
The mill site contains the concrete foundations for the mill buildings, plus associated stockpiles and overburden benches. Uncontrolled drainage from the adit also flows over the site and old steel work and general refuse also remains.

Razorback Mill Site.  
Concrete slabs to be covered with fill from dump on right hand side.

The flat exposed foundations will be covered with the fill material which exists in the batter above. This fill batter will also be benched. The inclined foundations will be broken up in selected locations if possible, and fill placed in these areas.

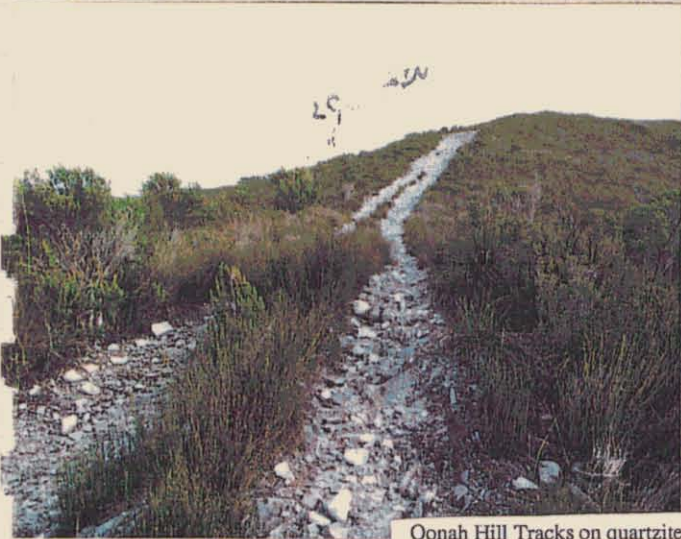
The total length of tracks is approximately 5 km of which approximately 3 km require treatment. Some of these only require drainage works, while others also require revegetation. The area for treatment has been estimated on the observed site requirements. All roads not required for long term access, will be closed. This includes access to the fire trail which is used by trail bikes and 4 wheel drives.

Oonah Hill Tracks on quartzite and in rainforest  
Tracks to be closed, ripped and gripped, soil returned from edges and revegetated.

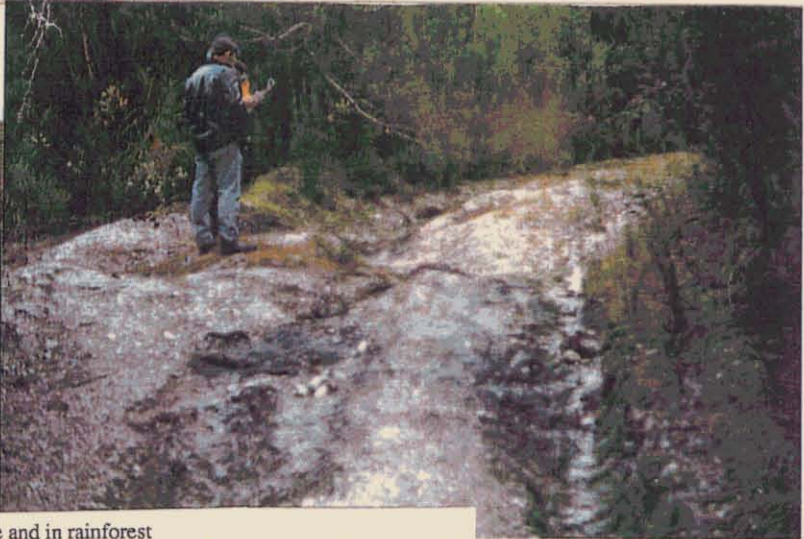
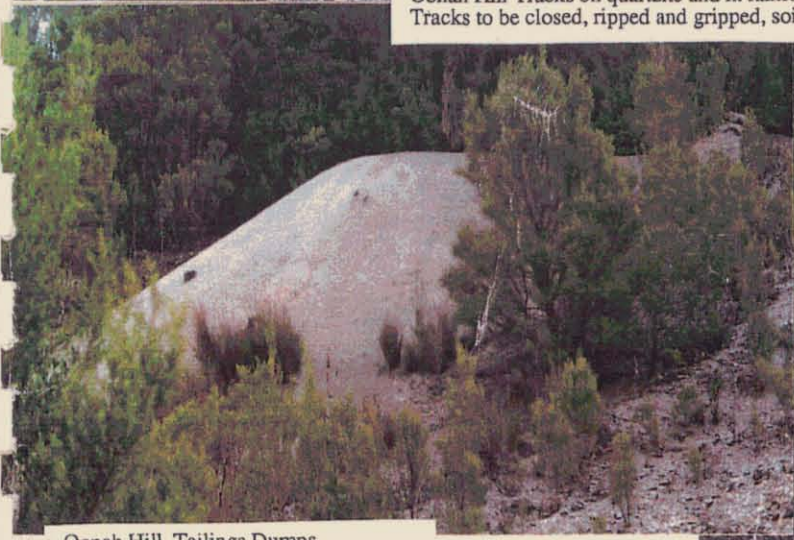
Oonah Hill Tailings Dumps.  
Revegetation with pinned Tea Tree brush

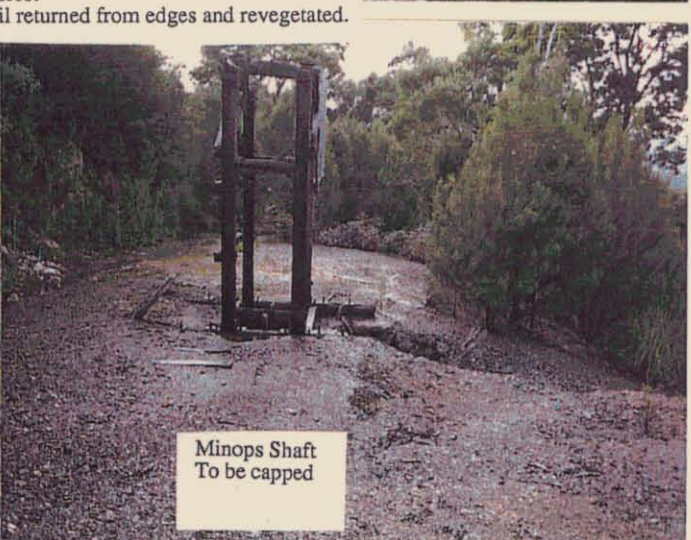
A total of four open shafts are located in the Lease area. These are the Oonah Main Shaft, near the old mill area, an unnamed shaft approximately 75 m to the north (Shaft 2), another approximately 50m north (Shaft 3), the Minops Shaft further north and the Adit near the Oonah Shaft. Only the Minops Shaft is open to any depth, with the remnants of a wooden headframe and with a concrete collar in good condition .

Minops Shaft  
To be capped
