# **Archaeological Survey Report 2002/01**

## **A brief examination of the 'Springvale' tunnel, Evandale Water Scheme**

*By Tony Webster*

August 2002

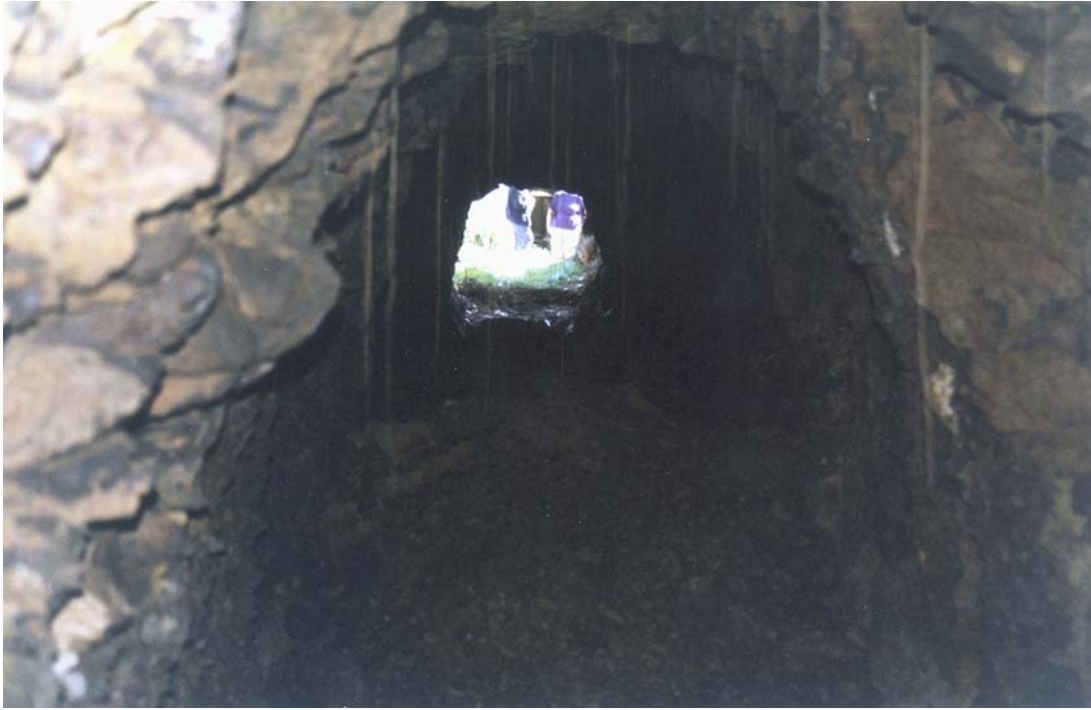
**Figure 1**

*View of portal from within tunnel. Note fine plant roots hanging from roof and the arched shape of the tunnel. This shape is due to weathered rock sloughing off over time. The fallen material is now piled on the drive floor. Artefacts may be buried beneath the material.*

The tunnel is basically square in cross section and measures approximately 1.7 metres wide by 1.5 metres high. The tunnel dimensions are significantly modified in the section closest to the entrance because the unstable weathered basalts have collapsed in places. Material that has sloughed off the roof is now piled centrally in the drive floor.

The ground conditions improve further into the tunnel, probably because of the lessening of surface weathering influences, groundwater penetration and tree/grass roots. Poor ground diminishes as weathering of the basalt diminishes. Roof collapses about 300-450 mm in zone of surface weathering influence (root line) – especially the zone in which tree and grass (?) roots can penetrate to the depth of the tunnel.

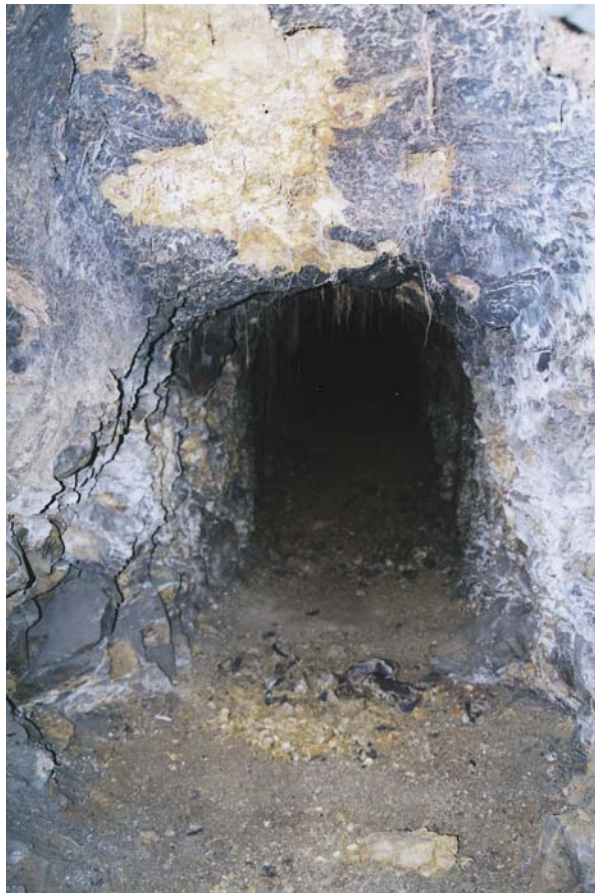
**Figure 2**

*View near tunnel mouth. Note plant roots. View shows tunnel profile caused by weathered rock sloughing off roof. Debris is piled on floor and may cover artefacts.*

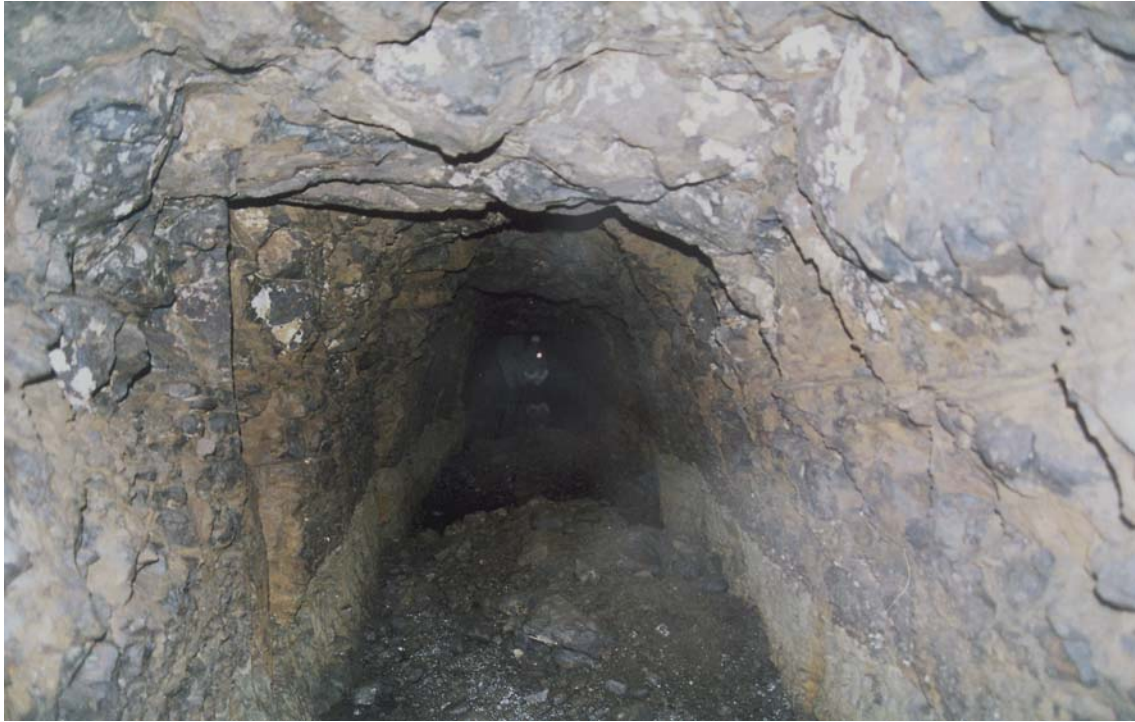
**Figure 3**

*Further into tunnel. The profile becomes more square because the basalt in the roof is less weathered and so less material is flaking from the roof. Note the pile of debris that diminishes towards the torch holder, the absence of plant roots, and the pale brown mudstone layer on either wall.*

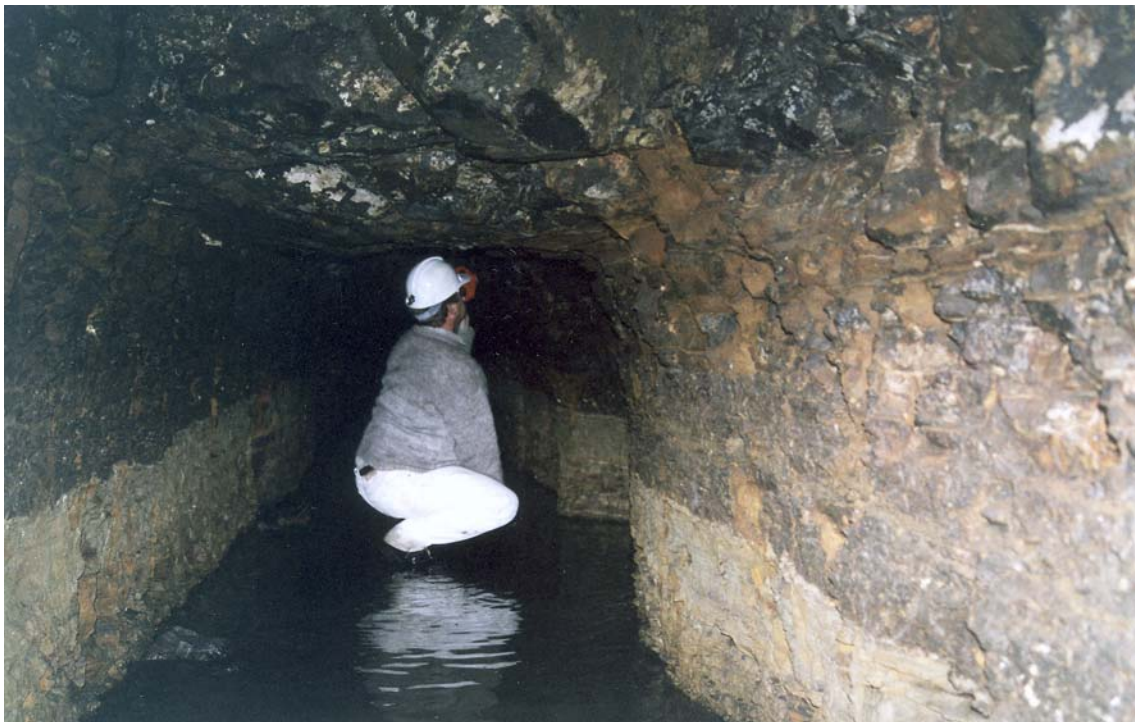
**Figure 4**

*Approximately 70 metres into tunnel. Note the intact square profile of the tunnel, which was the original shape for its entire length, prior to roof collapses. Note mudstone layer in bottom third of walls. Basalt makes up the rest. Approximately 50 mm of clear water covers floor. Note cuddy to right of person.*

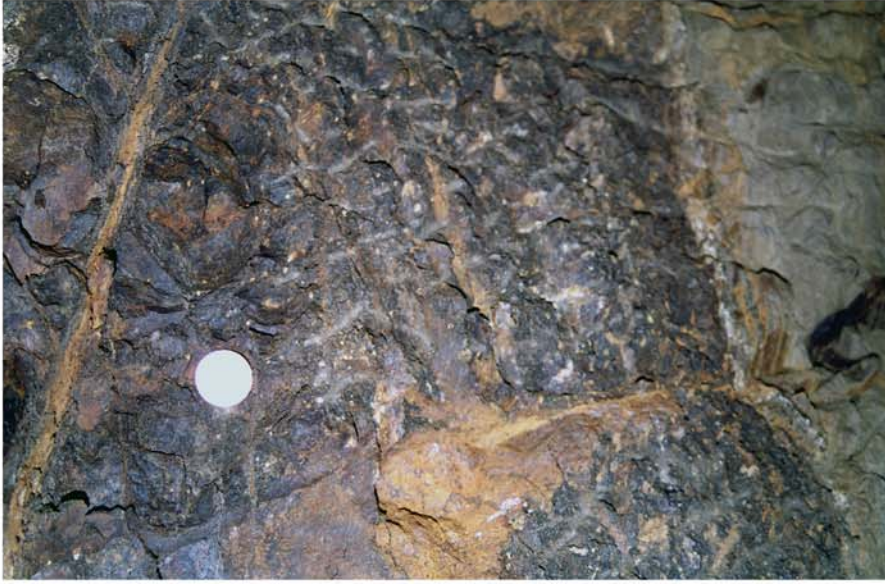
**Figure 5**

*Pick marks on the walls of drive. Such pick marks were probably made by a 'cousin jack' pick and were made while trimming the rougher edges and protuberances from the drive walls as a final 'finish', possibly in preparation*

*for brick lining. Pick marks such as these suggest professional miners, or at least workers trained or supervised by them. Note mudstone layer in base of wall.*

Large expanses of pick marks were seen on sections of the tunnel where the walls were clean and there had been little sloughing of rock. Pick marks occurred in clusters of closely spaced, triangular marks with the same orientation. Each mark represents one stroke of a pick.

I do not think that the pick marks were made during the excavation of the tunnel. They are probably the result of a systematic trimming and cleaning of the tunnel walls so that they were smooth and clean, with no projections. This clean straight surface could have been the final preparation of the tunnel for the final brick lining. It is also possible that the trimming and tidying of the drive walls by careful trimming with a pick simply shows that the miners were professionals. It is very common to find this type of careful trimming of drives and tunnels in early mines to make neat travelways and access points.

I would suggest that the tunnel was excavated by skilled miners, at least in part, and not by unskilled labour, because of the pick marks on the walls and their smoothness, regularity and cleanliness. The tunnel walls and backs have been carefully trimmed and smoothed by the careful use of 'cousin jack' picks, chipping and trimming the rougher edges from the walls. The pick marks show the care that was put into the trimming and tidying of the tunnel walls. This is generally considered to be a sure sign of professional miners. The careful finishing of the walls may also have been part of the preparation of the tunnel walls for a brick lining, that is suggested as having been planned for the tunnel walls.

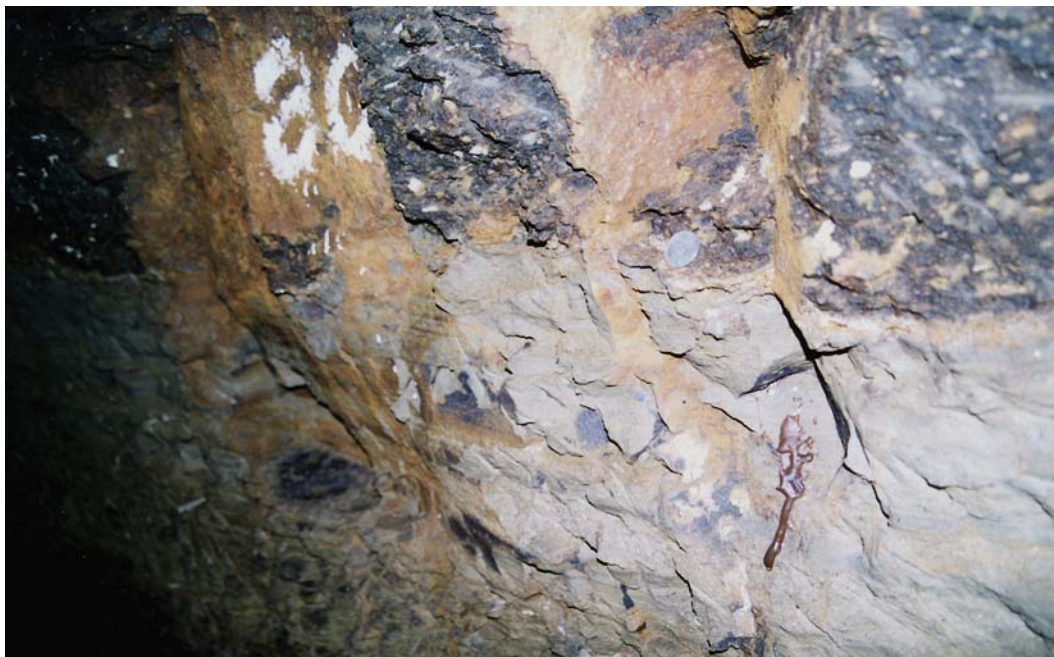
**Figure 7**

*White painted number '80' on eastern wall, presumably originating as a survey mark. White wash painted? (20 cent piece for scale). The mark represents 80 yards in from entrance. A similar mark, heavily deteriorated, was seen at 50 yards in, on the same wall. The first number was damaged due to weathered rock and dampness. The number could date from the original period of tunnel excavation in the mid 1830's. A splotch of shiny brown wax or clay, probably marking the place where a candle was placed during the theodolite survey, is seen to the lower right of the number. Note the boundary between the lower light brown mudstone and the upper dark blue-grey basalt.*

White numbers were painted in two places along the eastern (left hand) wall of the drive. The numbers were painted with white paint, possibly whitewash. The first number '50' seen was in relatively poor condition due to the weathering of the basalt. The second number '80' was in almost perfect condition and was painted with a similar white pigment. The numbers are assumed to represent the number of yards from a datum at the tunnel entrance and are considered to be survey numbers.

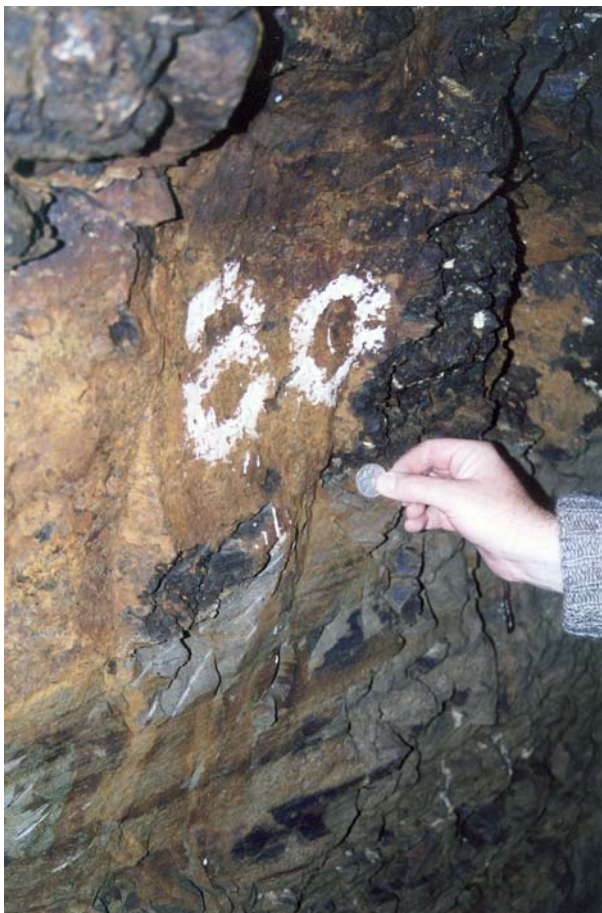
**Figure 8**

*Close up of the white number '80' on the eastern wall of the tunnel. Probably painted with white wash. Note pick marks in mudstone left and below the hand.*

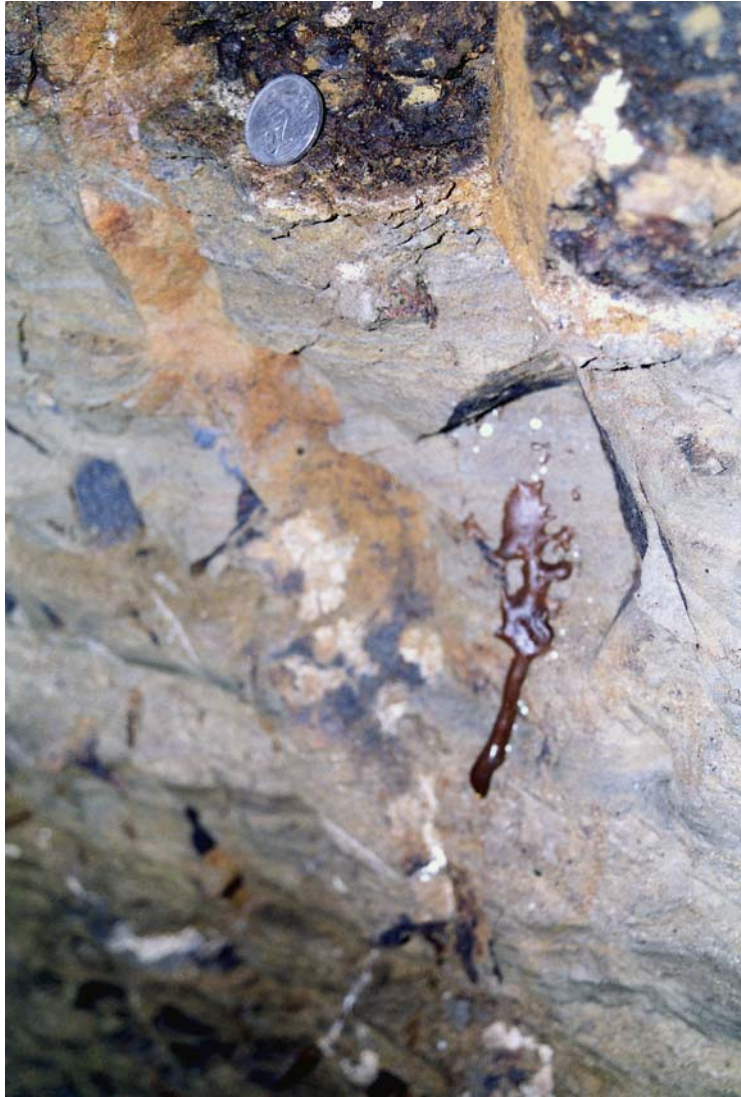
**Figure 9**

Close up of wax showing the probable position of a candle placed during the tunnel survey. A similar splotch of wax was seen below the number '50' seen closer to the entrance (this was in poor condition).

Associated with each number was a dark brown splotch of wax, clay or gum that is interpreted to represent a mounting medium and the wax drips from a candle that was used during a survey of the tunnel.
