Mineral Resources Tasmania

"The Rehabilitation of Abandoned Tin Mines in North Eastern Tasmania"

WATER QUALITY ASSESSMENT REPORT

FEBRUARY 1998

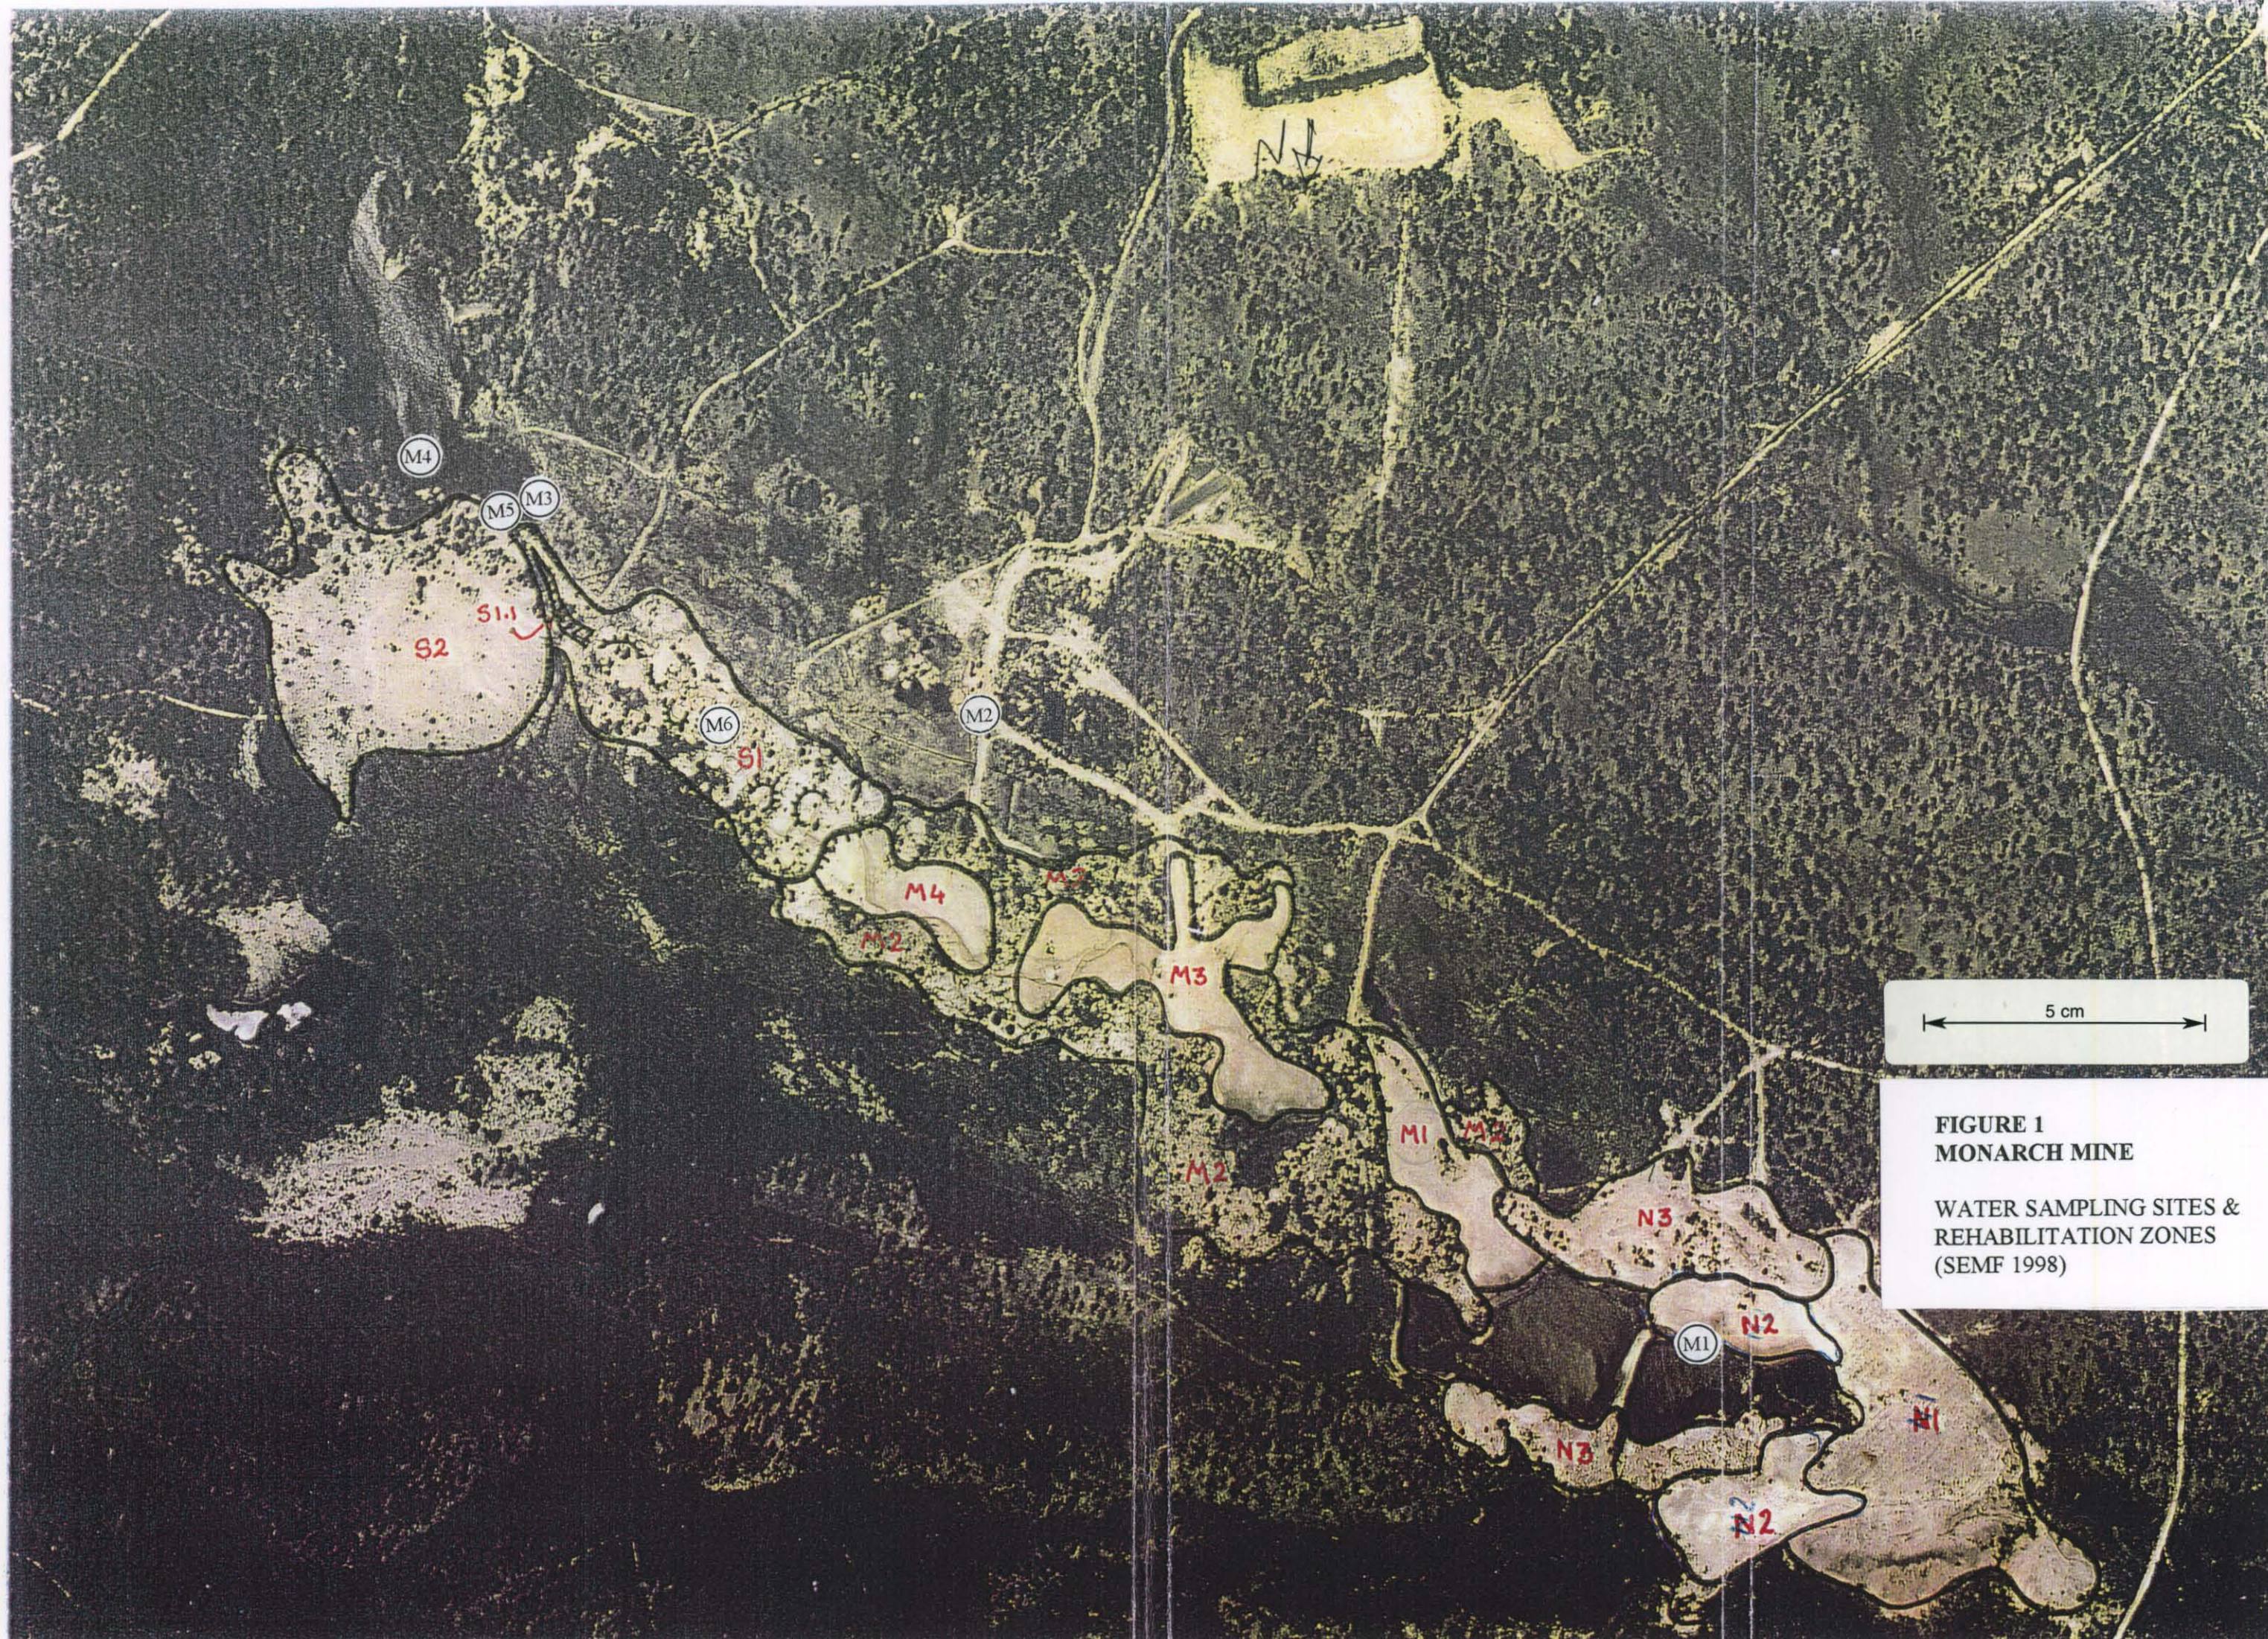
FIGURE 1
MONARCH MINE

Due to the small nature of the watercourses and lakes sampled they are not named at the 1:25,000 scale, so the location of the sampling sites at the Monarch Mine have been shown on Figure 1 (Appendix A) and the type of water body or watercourse sampled described in Table 6.1.

Monitoring Point	Location Description
M1	Outwash lagoon
M2	Background groundwater
M3	Wetland feeding into S1.1 gully
M4	Lake
M5	Start of creek
M6	Mid way along creek (old mullock heap cutting)

WATER SAMPLING SITES &
REHABILITATION ZONES
(SEMF 1998)

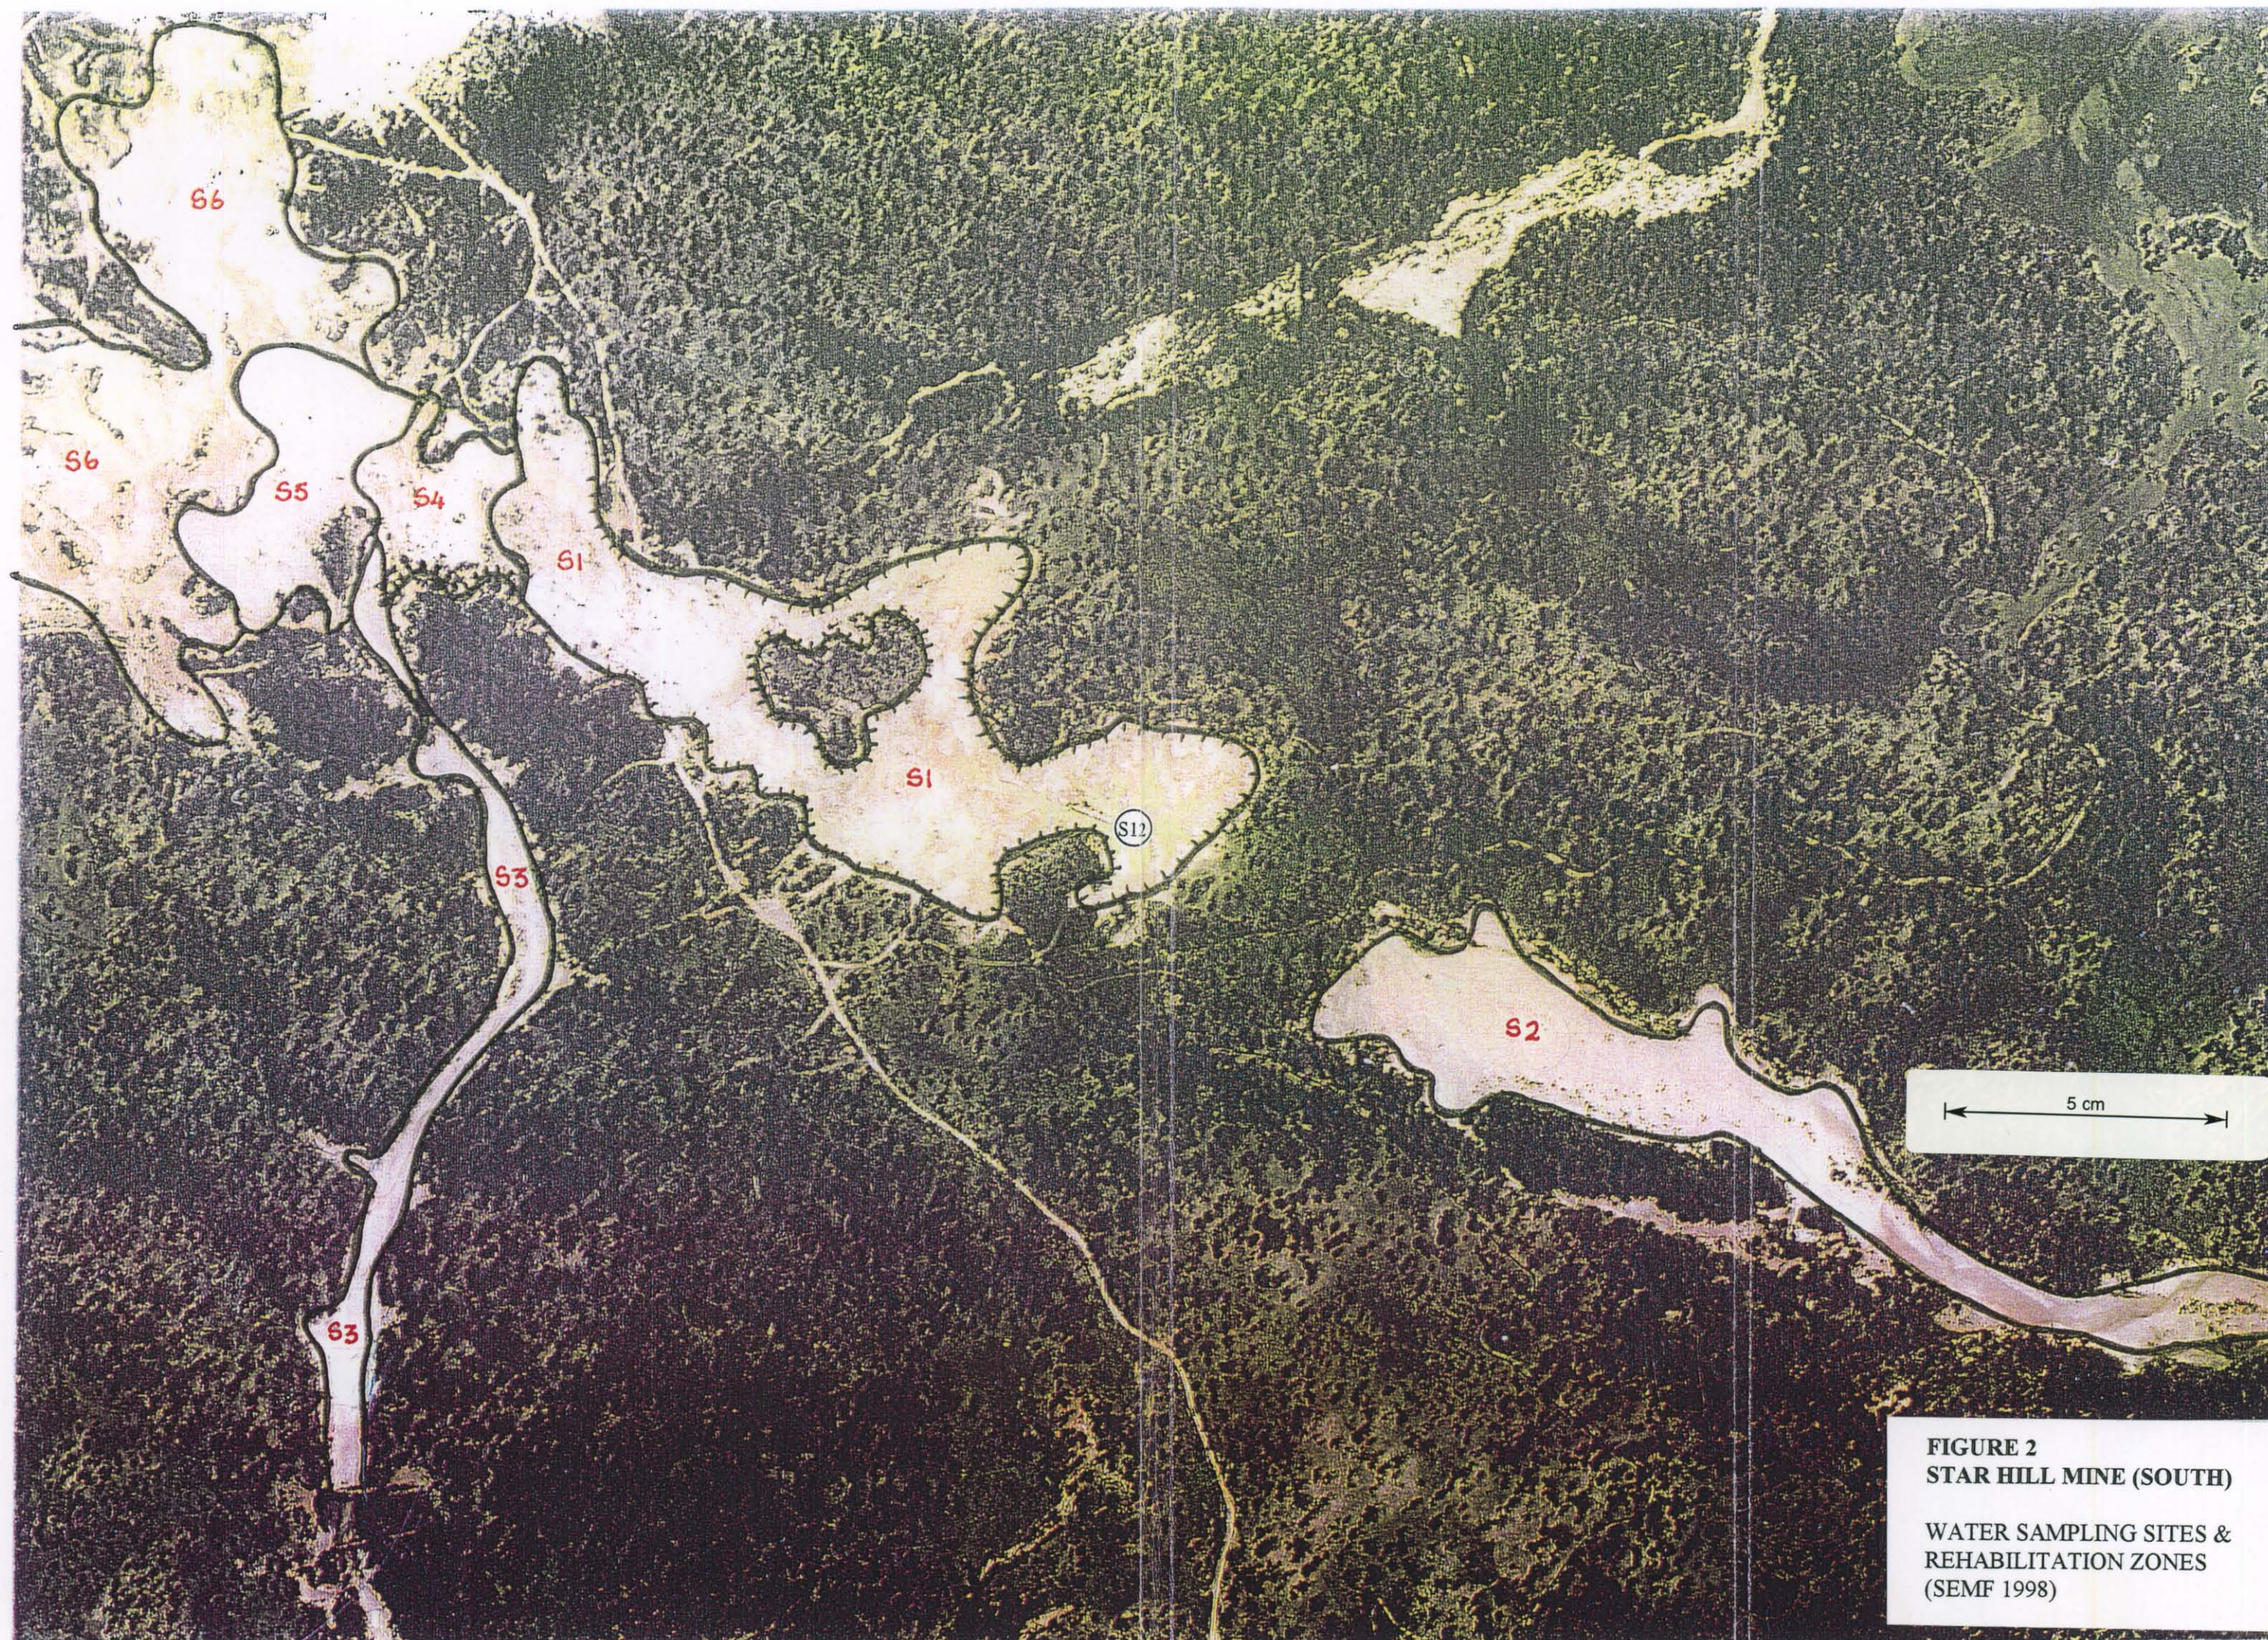
FIGURE 2
STAR HILL MINE (SOUTH)

The sampling sites at the Star Hill Mine are shown on Figures 2 and 3 (Appendix A), and the type of water body or watercourse sampled is described as in Table 6.3.

Monitoring Point	Location Description
S1	Small sediment retention dam
S2	Large sediment retention dam
S3	Dam outflow
S4	Influent creek to Ringarooma River
S5	Significant dam (wall about to breach)
S6	Remnant lake
S7	Lake
S8	Lake
S9	Lake
S10	Dam wall seepage
S11	Man-made lake
S12	Star Hill lake

WATER SAMPLING SITES &
REHABILITATION ZONES
(SEMF 1998)

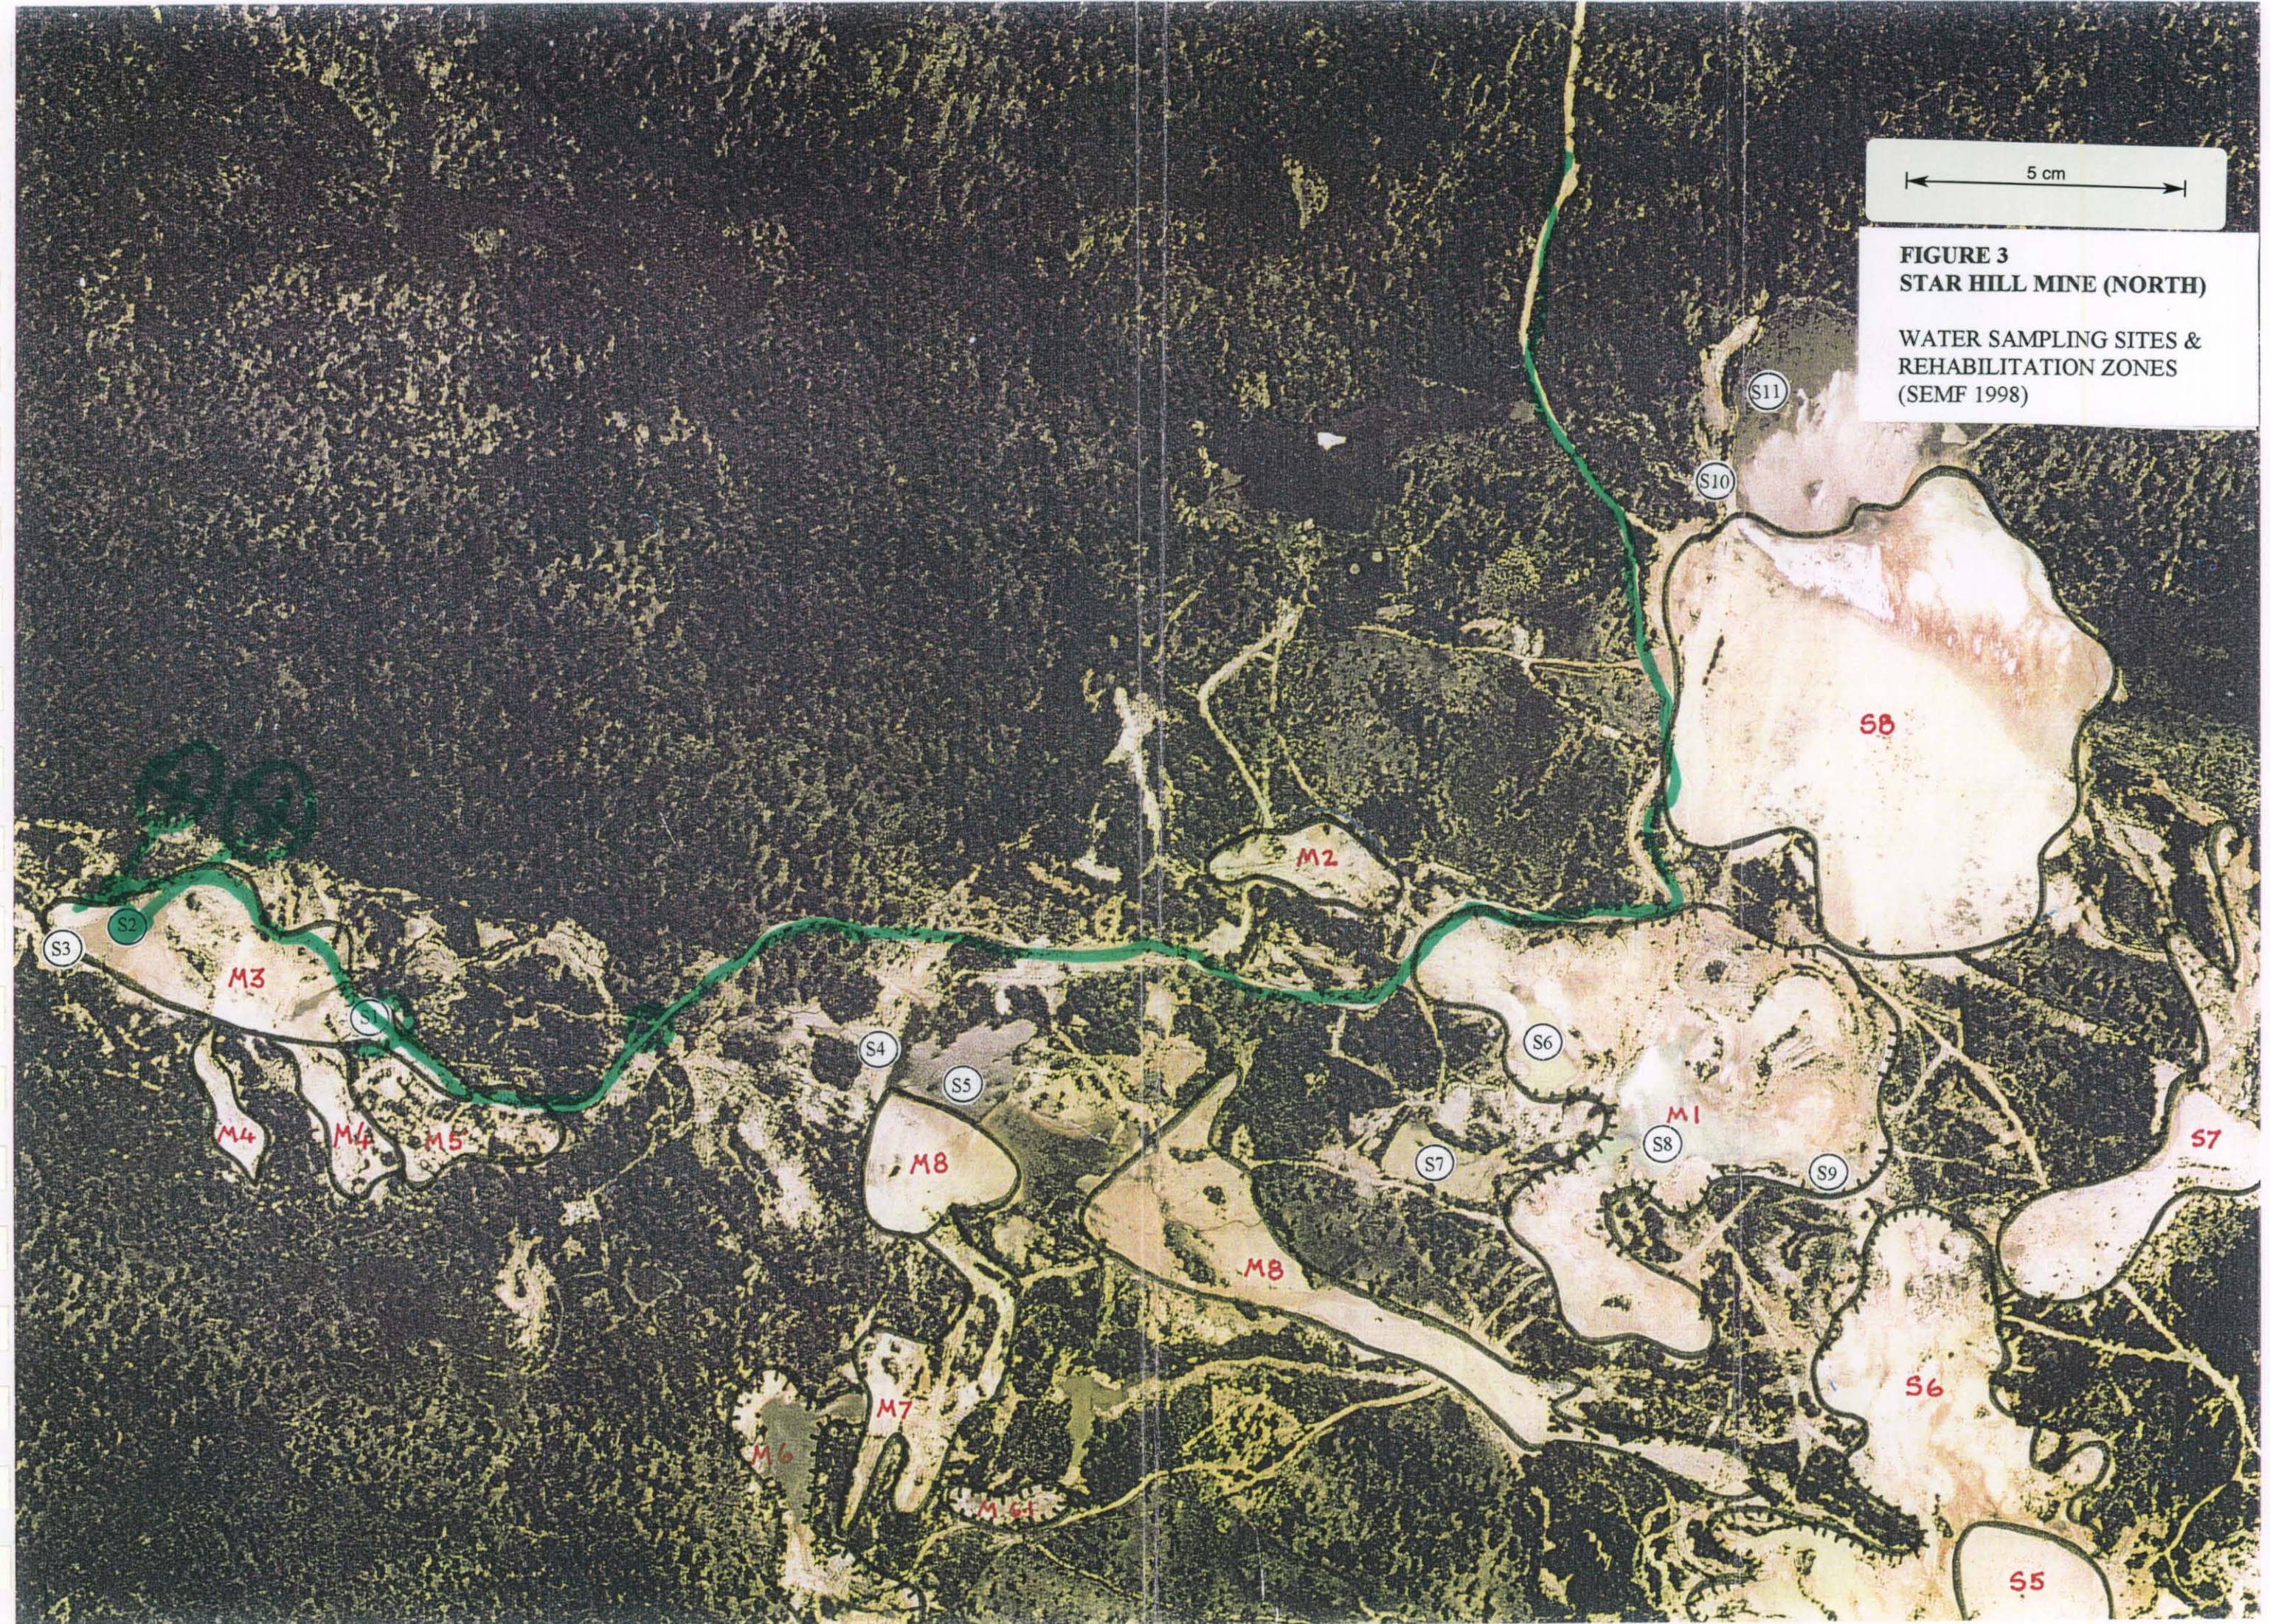
FIGURE 3
STAR HILL MINE (NORTH)

WATER SAMPLING SITES &
REHABILITATION ZONES
(SEMF 1998)
