# **The effects of waste disposal on groundwater quality in Tasmania**

## **Port Latta waste depot**

**Tasmanian Geological  
Survey Record 2002/07**

# Groundwater quality investigations at the Port Latta waste depot

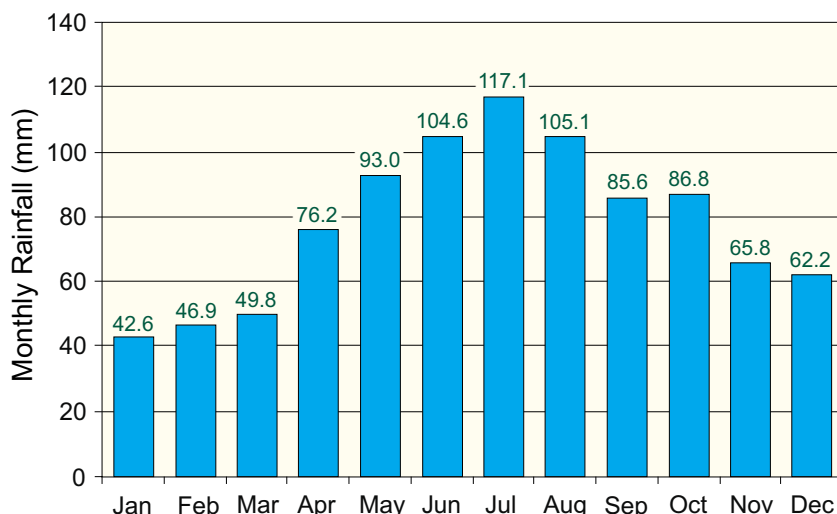
**Figure 3**  
Average monthly rainfall for Australian Bureau of Meteorology rainfall station 091094, Stanley (Post Office).

Australian Bureau of Meteorology rainfall station 091094 at Stanley (Post Office) is the closest rainfall station to the site. The rainfall chart of average monthly recorded rainfall (fig. 3) shows that the annual average rainfall for the station is 935.7 mm.

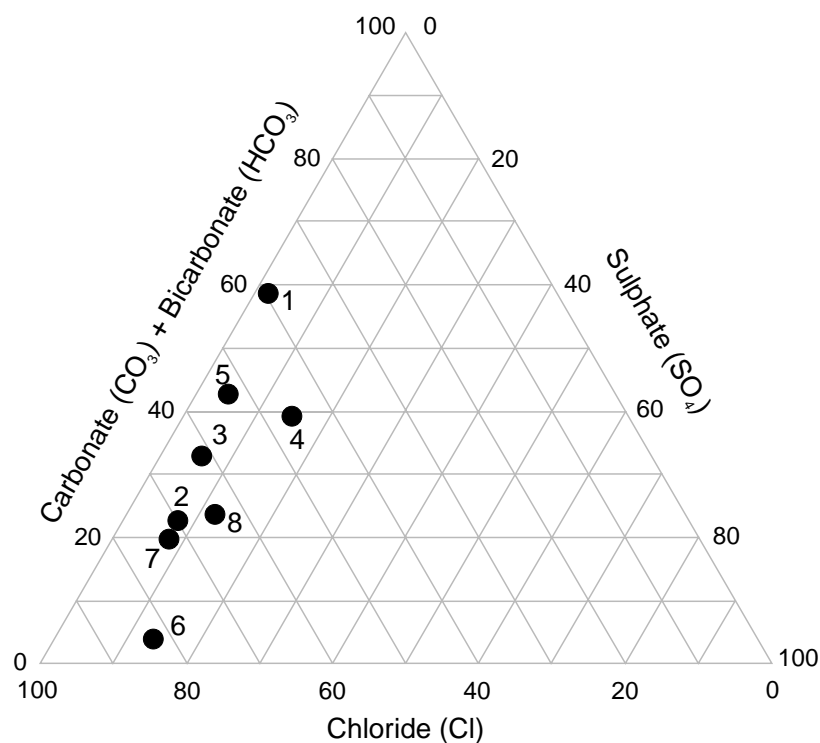
**Figure 7**

Anion Ternary plot for groundwater bores at the Port Latta waste depot. 1 – PL2000/1; 2 – PL2000/2; 3 – PL000/3; 4 – PL2000/4; 5 – PL2000/5; 6 – PL2000/6; 7 – PL2000/8; 8 – PL2000/9.

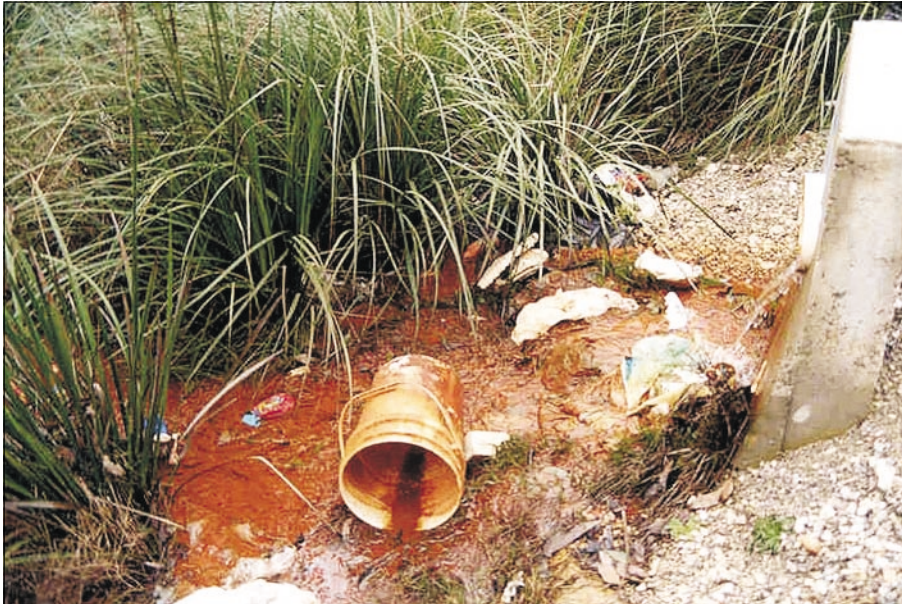
**Plate 1**

liner. Because groundwater was intercepted during various stages of development, sections of the landfill liner are underlain by a sub-liner which discharges to the surface water system. The sub-liner collection system is constructed of PVC pipe surrounded by crushed rock on weathered bedrock. Plate 1 shows a discharge point of one of these sub liners to the surface water system.

*Discharge point of one of the sub-liners to the surface water system.*

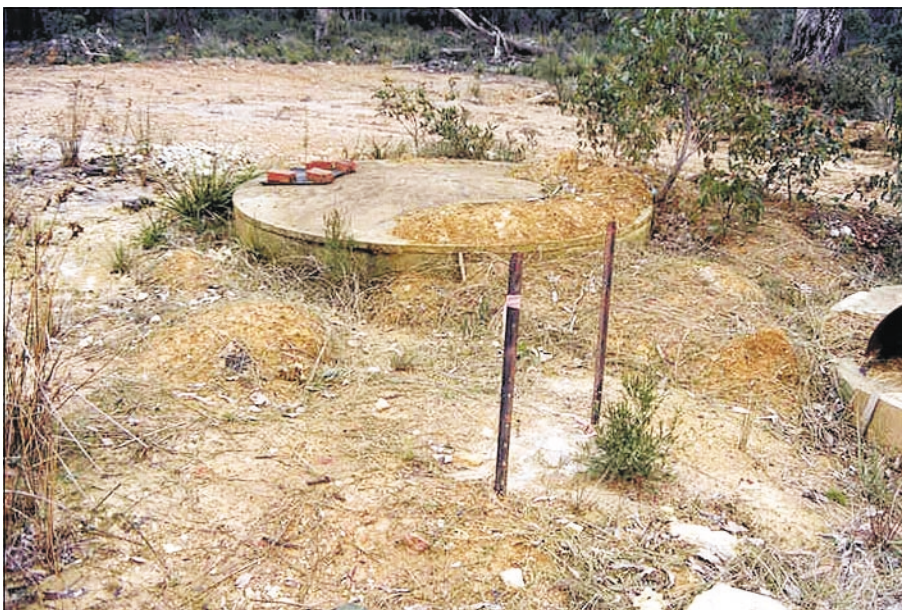
**Plate 2**

All disposal sites are located in clay deposits related to Precambrian sediments. Plate 2 shows cement tanks used to store soil contaminated by polychlorinated biphenyls (PCB's), while Plate 3 shows an active medical waste trench in clay materials typical of the site. Plate 4 shows cracking in the clays and related slumping above the most recent trenches.

*Cement tanks used to store soil contaminated by polychlorinated biphenyls (PCB's).*

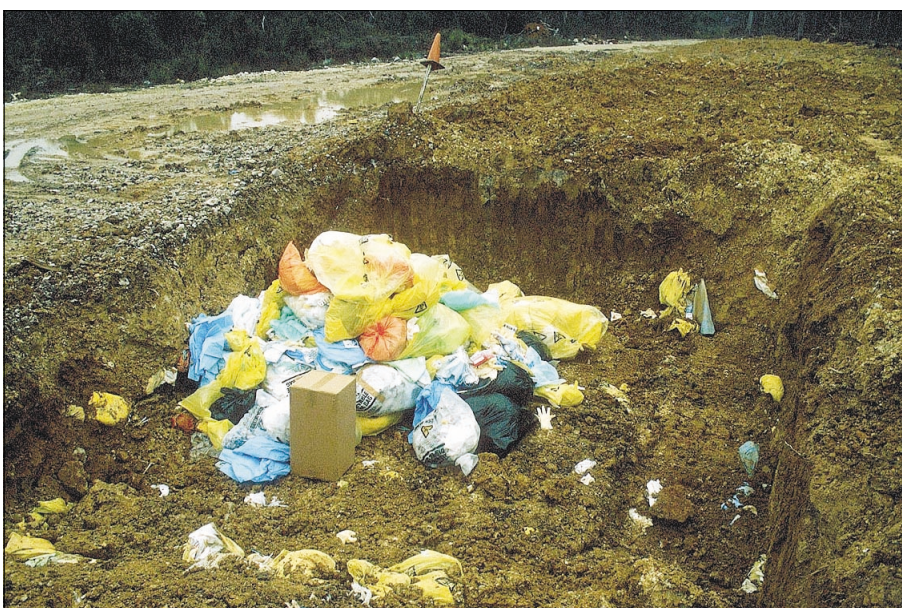
**Plate 3**

*Active medical waste trench in southern area of the site.*

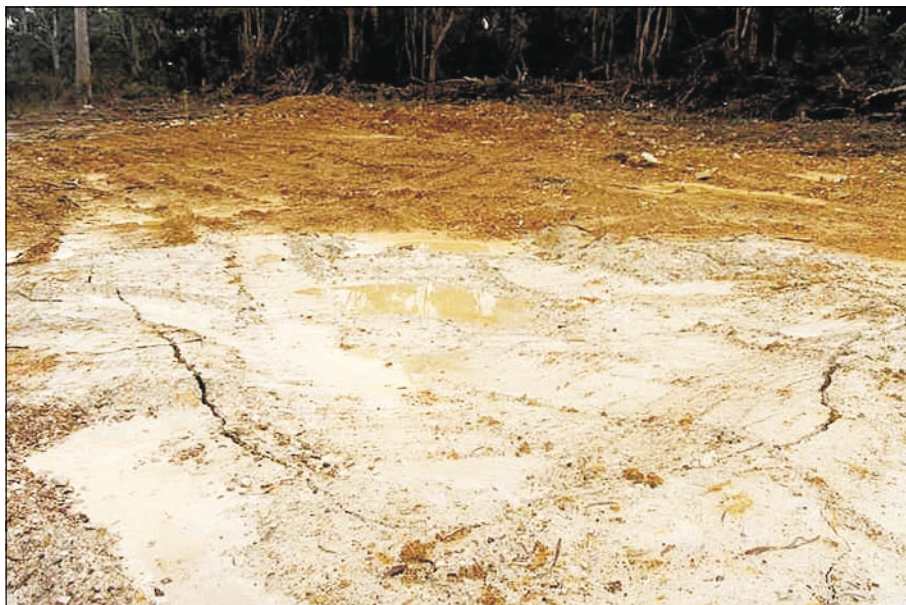
**Plate 4**

*Cracking in the clay and related slumping above a recent medical waste trench.*

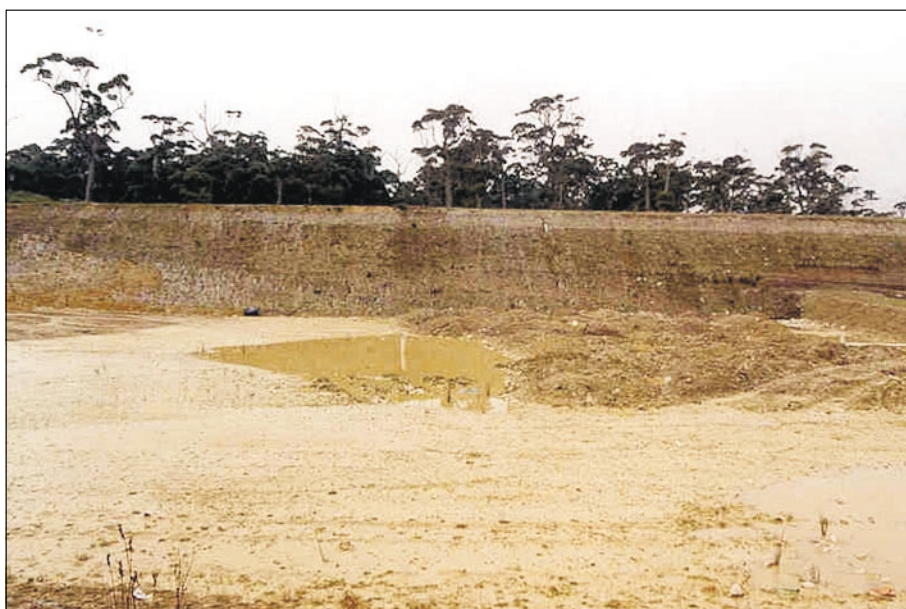
**Plate 5**

the Cowrie Siltstone, forming a regolith profile. The second material lies within a palaeochannel located within the regolith profile and the weathered Cowrie Siltstone (Plate 5). Both materials overlie the Precambrian Cowrie Siltstone with a transitional zone from the regolith profile to the bedrock. This transitional contact is exposed at the western end of the Stage 2 filling area (Plate 6).

*Palaeochannel located within the weathered Cowrie Siltstone exposed in the northern wall of the Stage 2 filling area.*

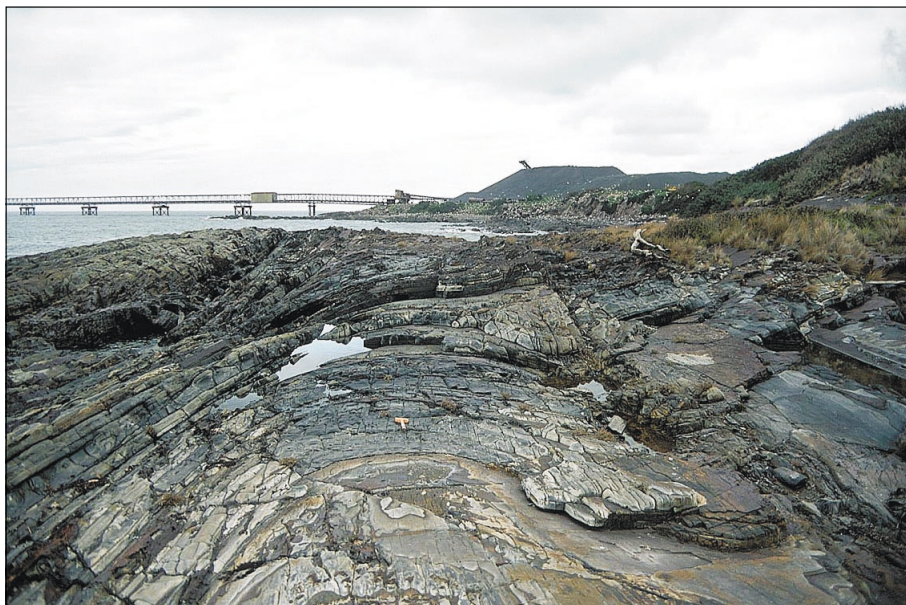
**Plate 7**

Grade II Cowrie Siltstone crops out on the coastline to the north of the landfill. Complex folding and faulting are evident within the outcrops, with fold axes ranging in length from 0.4 to over 15 metres (Plate 7) within the coastal exposures. Pyrite, as pods up to 160 mm in diameter (Plate 8) and cubes up to 3 mm, was identified in the outcrops. The Cowrie Siltstone outcrops are heavily fractured, with secondary minerals (limonite) forming on some of the joint planes (Plate 9).

*Tight axial hinge fold in the Precambrian Cowrie Siltstone coastal outcrops.*

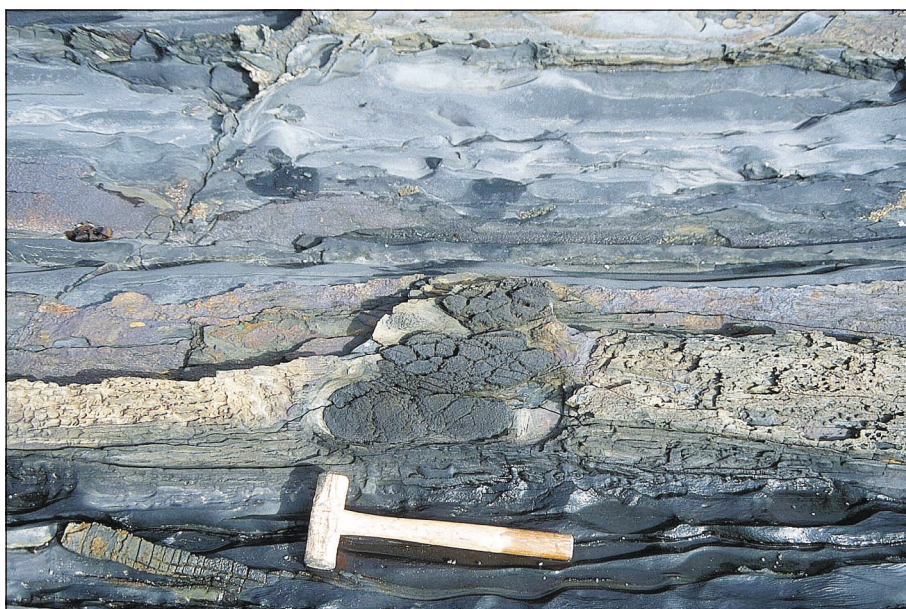
**Plate 8**

*Pyrite pods in the Precambrian Cowrie Siltstone coastal outcrops.*

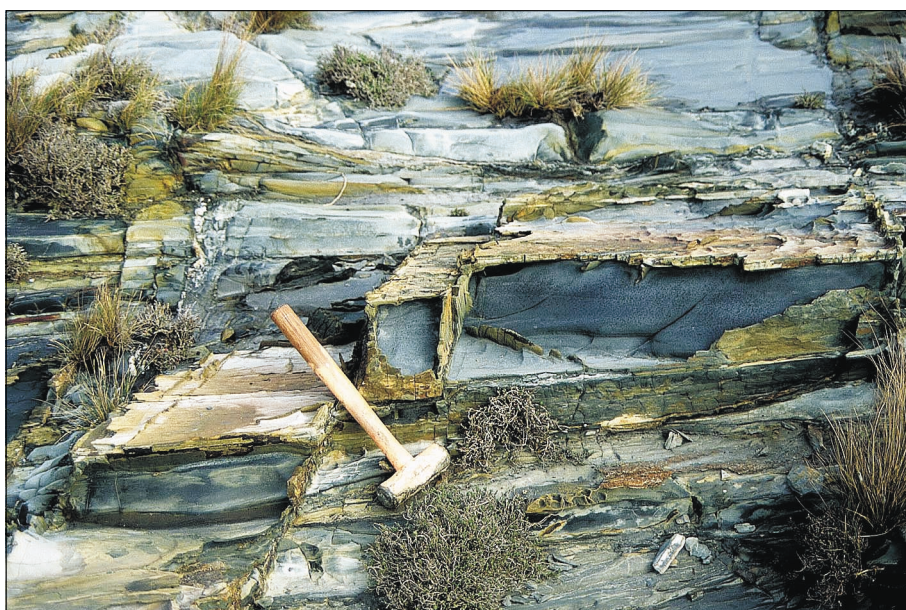
**Plate 9**

Iron and manganese are elevated in the background bore. Limonite and other secondary minerals, which occur in fractures on the coastline, imply that iron and manganese are both naturally occurring within the fractured aquifer cementation processes.

*Limonite on jointing within the heavily fractured Precambrian Cowrie Siltstone in the coastal outcrops.*

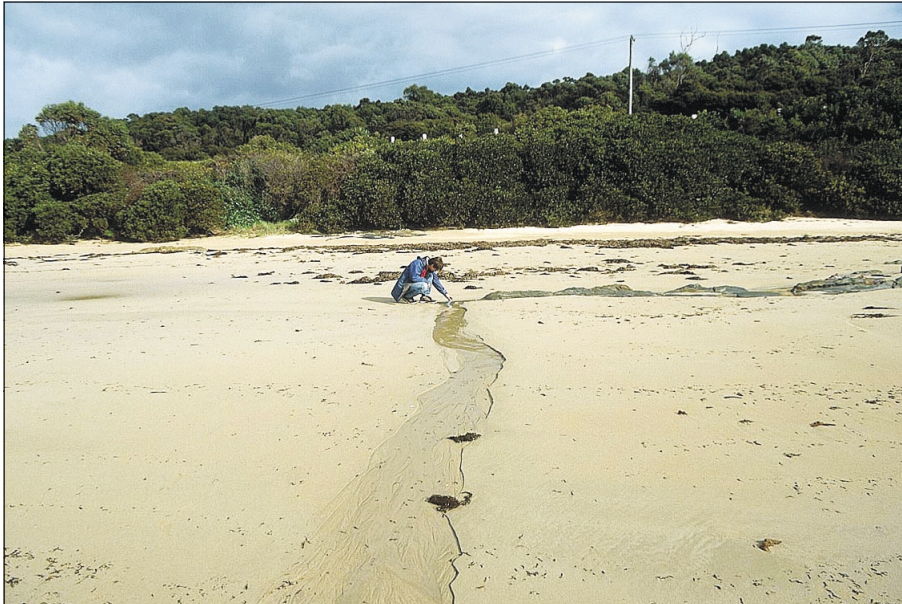
**Plate 10**

Groundwater discharges as springs on several beaches approximately one kilometre north of the landfill footprint (Plate 10). Other springs in this area discharge at the interface between bedrock and unconsolidated overburden. Some of these springs discharge discoloured water (Plate 11).

*One of many springs discharging on beaches approximately one kilometre to the north of the landfill footprint.*

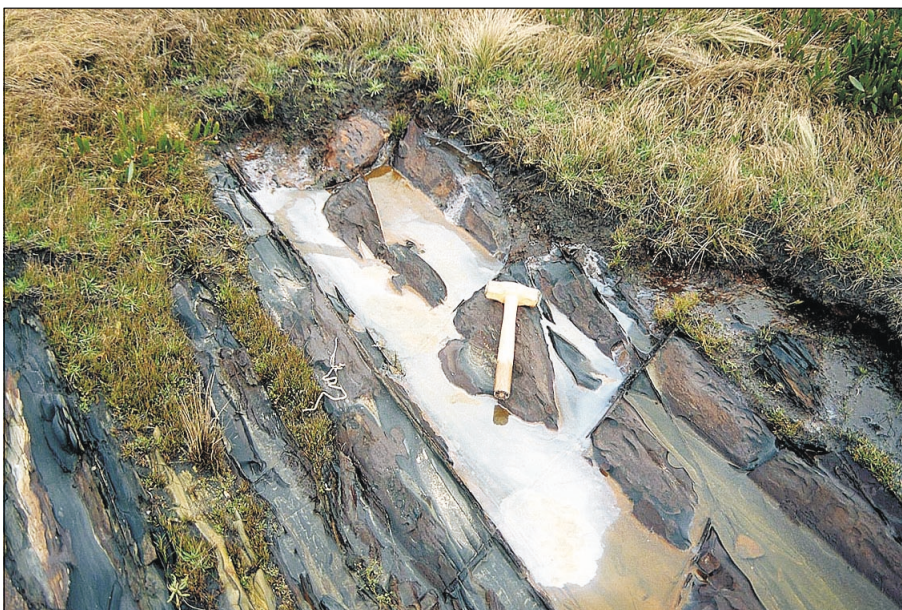
**Plate 11**

*Spring discharging at the bedrock interface with unconsolidated overburden approximately one kilometre to the north of the landfill footprint. Note discolouration of water.*

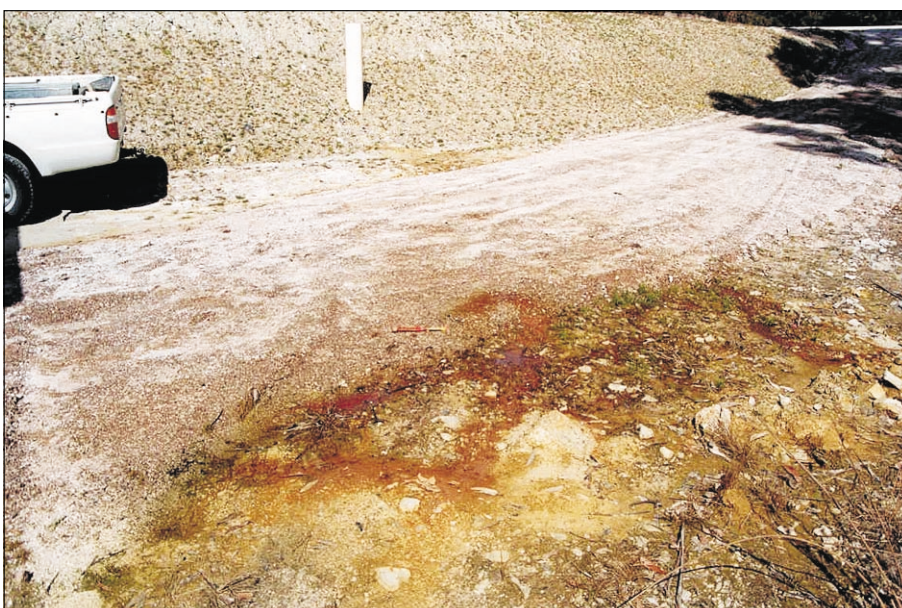
**Plate 12**

Plate 12 shows soakage observed on the north side of the leachate ponds ten metres west of borehole PL2000/5. The soakage is within ten metres of Stinking Creek, the main surface drainage outlet from the site. Other subsurface leakage from the leachate ponds could inter-react with this surface water system. Data relating to the area in close proximity to the leachate pond demonstrates that groundwater contamination has occurred at this location.

*Soakage observed on the north side of the leachate ponds 10 metres west of bore hole PL2000/5.*
