# **The effects of waste disposal on groundwater quality in Tasmania**

**Blue Ribbon  
abattoir,  
Smithton**

**Tasmanian Geological  
Survey Record 2002/06**

# Groundwater quality investigations at the Blue Ribbon abattoir, Smithton

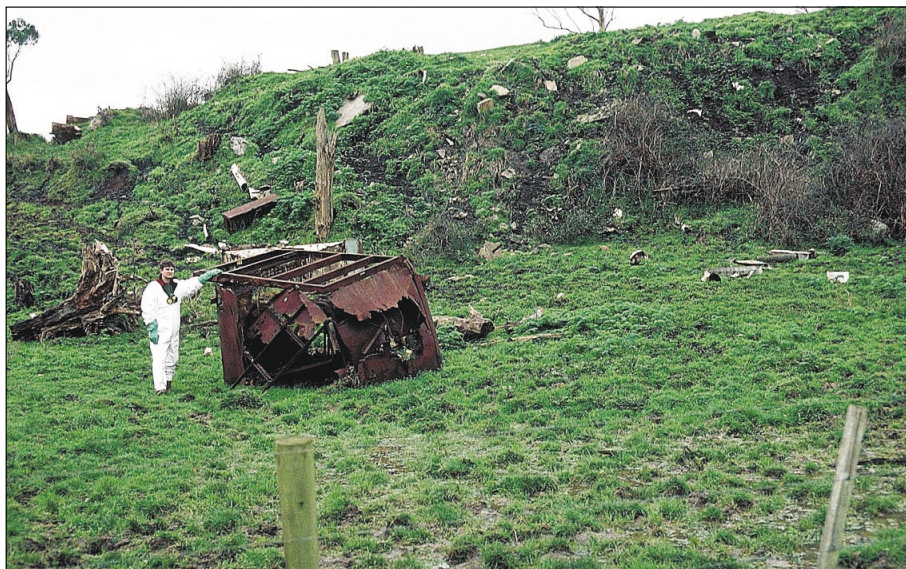
**Plate 1.** *Waste pile/landfill from the former piggery/abattoir.*

As part of the process of closing the piggery and abattoir, all waste materials were bulldozed into a waste pile to the south of the existing abattoir (Plate 1). Dehydrated Animal Fat (DAF) is buried at various locations on the site (Plate 2). Subsidence related to the

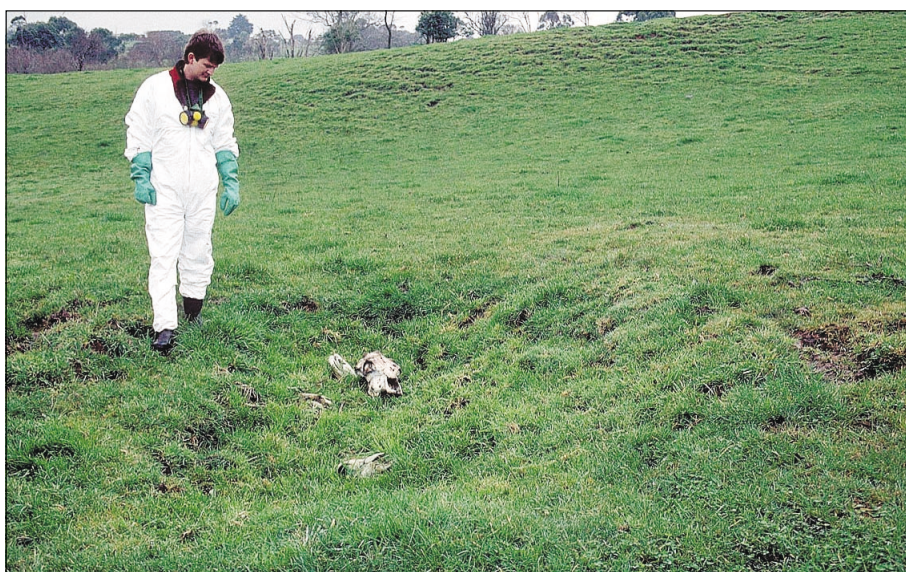
**Plate 3.** *Subsidence related to the recent DAF trenches observed in the western part of the site.*

recent DAF trenches was observed in the western area of the site (Plate 3). All disposal areas are located in sand and are covered with minimal local cover material (generally less than 200 mm in depth). No engineered filling sequence was implemented and the various aged waste materials have been placed in a random manner. General refuse, industrial machinery, organic, construction and demolition waste streams have been disposed of at the site.

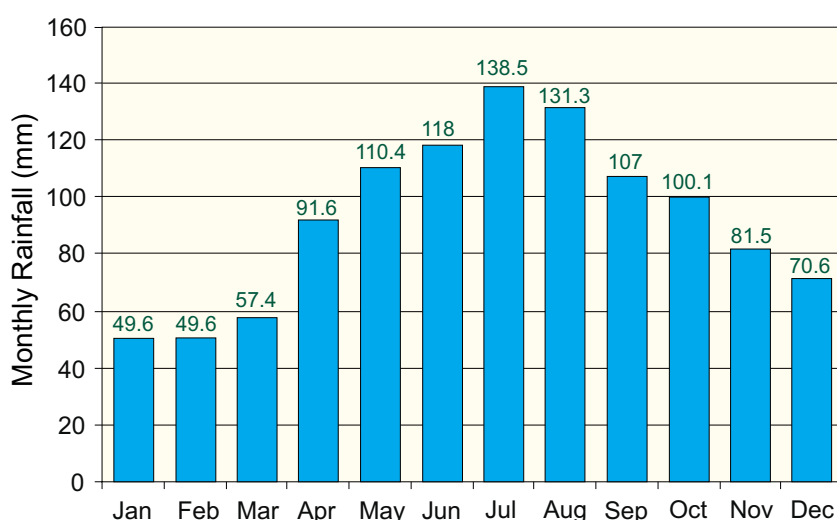
**Figure 3**

The recent DAF trenches and historical landfill are located approximately 40 m east of Coventry Creek. Australian Bureau of Meteorology rainfall station 091092 at Smithton (Grant Street) is the closest rainfall station to the site. The rainfall chart of average monthly recorded rainfall (fig. 3) shows a marked seasonality, with the highest rainfall in autumn/winter (April to October). The average annual rainfall for the station is 1105.6 millimetres.

Average monthly rainfall for Australian Bureau of Meteorology rainfall station 091092, Smithton (Grant Street).

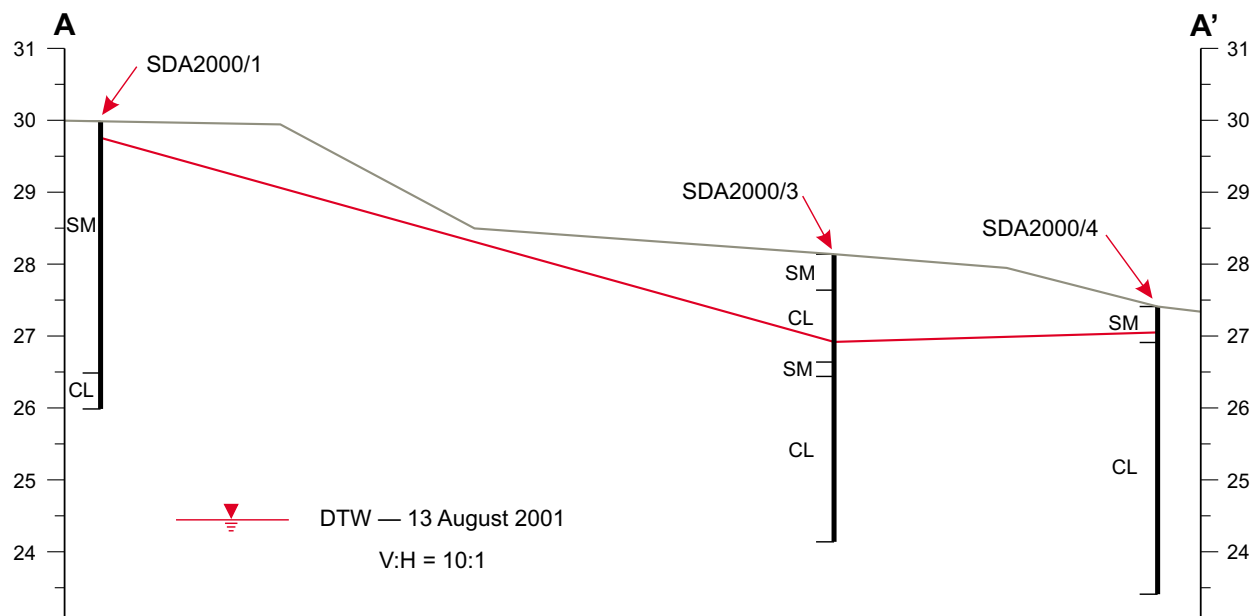
**Figure 5**

boreholes was unconfined, with yields of between 0.009 to 0.021 l/s being recorded from the bores. Figure 5 shows a cross-section and related standing water levels on 13 August 2001.

*Cross-section and related standing water levels on 13 August 2001 for bores SDA2000/1, 3 and 4 [A-A'].*

The cross section of the bores in the area of the active DAF trenches indicates that the water table along this line slopes towards the southwest. As the trenches are located in the water table, this shallow groundwater system appears to have a direct hydraulic connection to the active DAF trenches. Because of access problems associated with poor weather conditions, the drilling undertaken was not sufficient to obtain a detailed interpretation of the piezometric surface at the site.

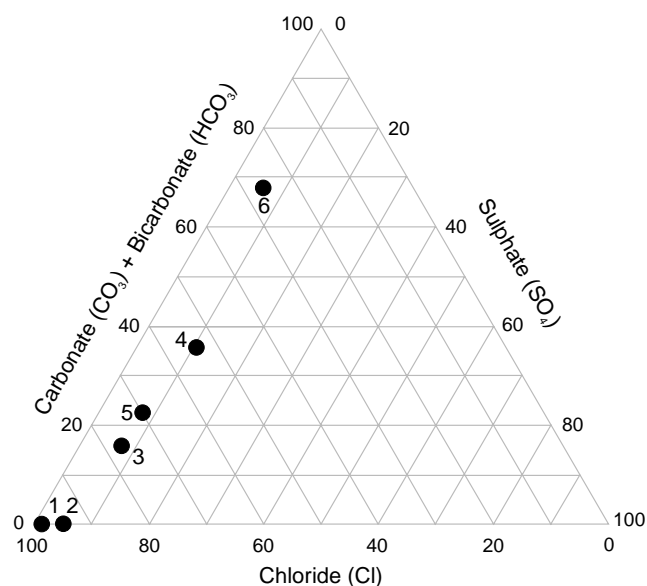
**Figure 6**

Groundwater chemistry results for bore SDA2000/2 were elevated in ammonia and ortho-phosphate. The anion Ternary plot indicates that the bores closest to the active DAF trenches contain chloride as the dominant anion. Bicarbonate levels are low due to the inland nature of the windblown sand distal from coastal beach environments to the north. Bores screened in the sand aquifer (SDA2000/1 and 2) had lower pH values than the remaining three bores screened in the clayey weathered bedrock material.

*Anion Ternary plot for groundwater bores at the Blue Ribbon Smithton abattoir disposal site.  
1 - SDA2000/1; 2 - SDA2000/2; 3 - SDA2000/3;  
4 - SDA2000/4; 5 - SDA2000/5;  
6 - average of all MRT groundwater records for Quaternary coastal sands.*

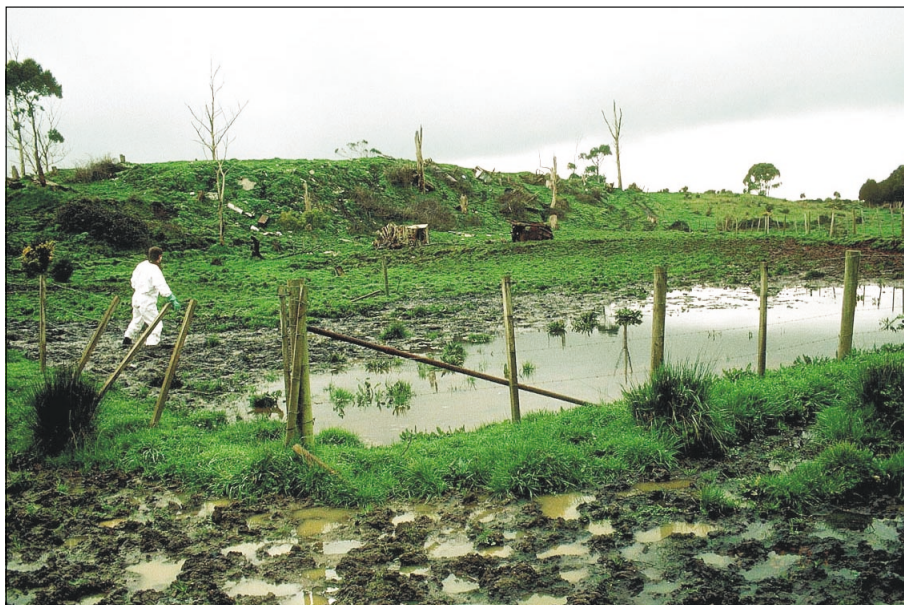
**Plate 4**

*Surface water in the area of the toe of the old landfill and Coventry Creek.*

The potential for degradation of groundwater quality, associated with leachate discharge from the old landfill material into the Quaternary sand aquifer, is considered to be significantly high. Surface discharges of leachate from the landfill and springs from the Quaternary sand aquifer are increased by rainfall events. Surface water from the site enters Coventry Creek, which is considered to be the main off-site transportation pathway for contaminants from the site. Plate 4 shows surface water in the area of the toe of the old landfill and Coventry Creek.

Contaminated groundwater is possibly contained within the Quaternary sand aquifer which flows towards Coventry Creek. Additional boreholes should be drilled to investigate groundwater quality in the area of the recent DAF trenches and the old landfill. This action is a high priority for the site. Surface water samples must be taken to gain an understanding of contamination transport pathways.
