# Rehabilitation of Mining Lands Trust Fund

2025-26 Annual Report

This annual report was developed by Mineral Resource Tasmania's Land & Tenements Branch, to detail the outcomes and progress of remediation efforts funded through the Rehabilitation of Mining Lands Trust Fund in the 2025-26 financial year.

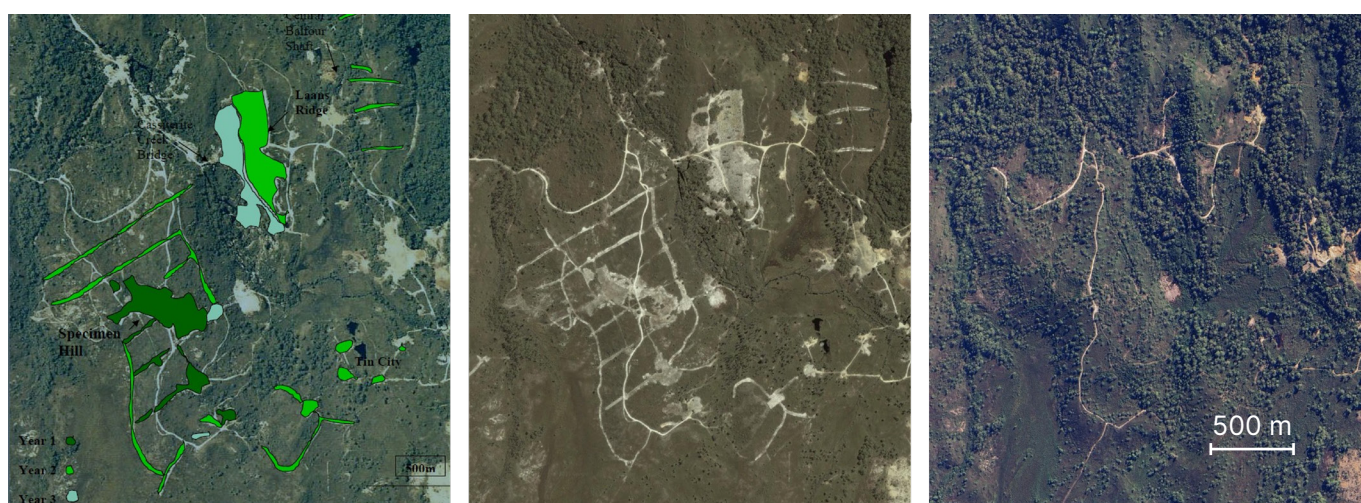
The 2025-26 financial year saw the completion of a comprehensive revegetation program that commenced in 2004, aimed at addressing soil stabilisation, revegetation and drainage impacts across multiple sites (Figure 3).

**Figure 3.** Comparative images of revegetation over Balfour Site, 2004 – 2025.

Over the last five years, management has focused on the targeted removal of the non-locally endemic species *Kunzea ambigua* (White Kunzea) and *Acacia sophorae* (Coast Wattle). In December 2025, a comprehensive ground survey of the site's rehabilitated areas was undertaken in which no incidence of these species was observed. The absence of *Kunzea ambigua* and *Acacia sophorae* concludes MRT's requirement for ongoing vegetation management at this location.

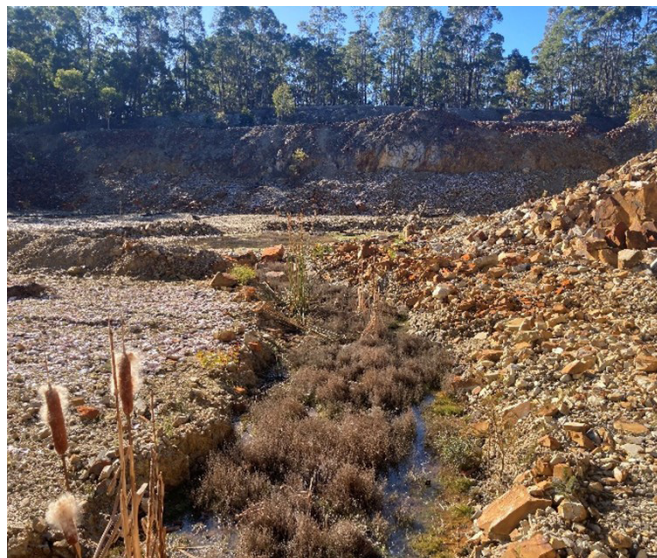
Hogans Road was inspected in August 2025 to assess its rehabilitation progress following works completed in May 2022. The quarry appears stable, with no visible erosion or evidence of unauthorised entry. Qualitative observations indicate continued improvement and an increase in vegetative recruitment since the previous inspection in October 2024, particularly across the site's upper bench (Figure 9).

**Figure 9.** Native vegetation recruitment at Hogans Rd quarry (August 2025).

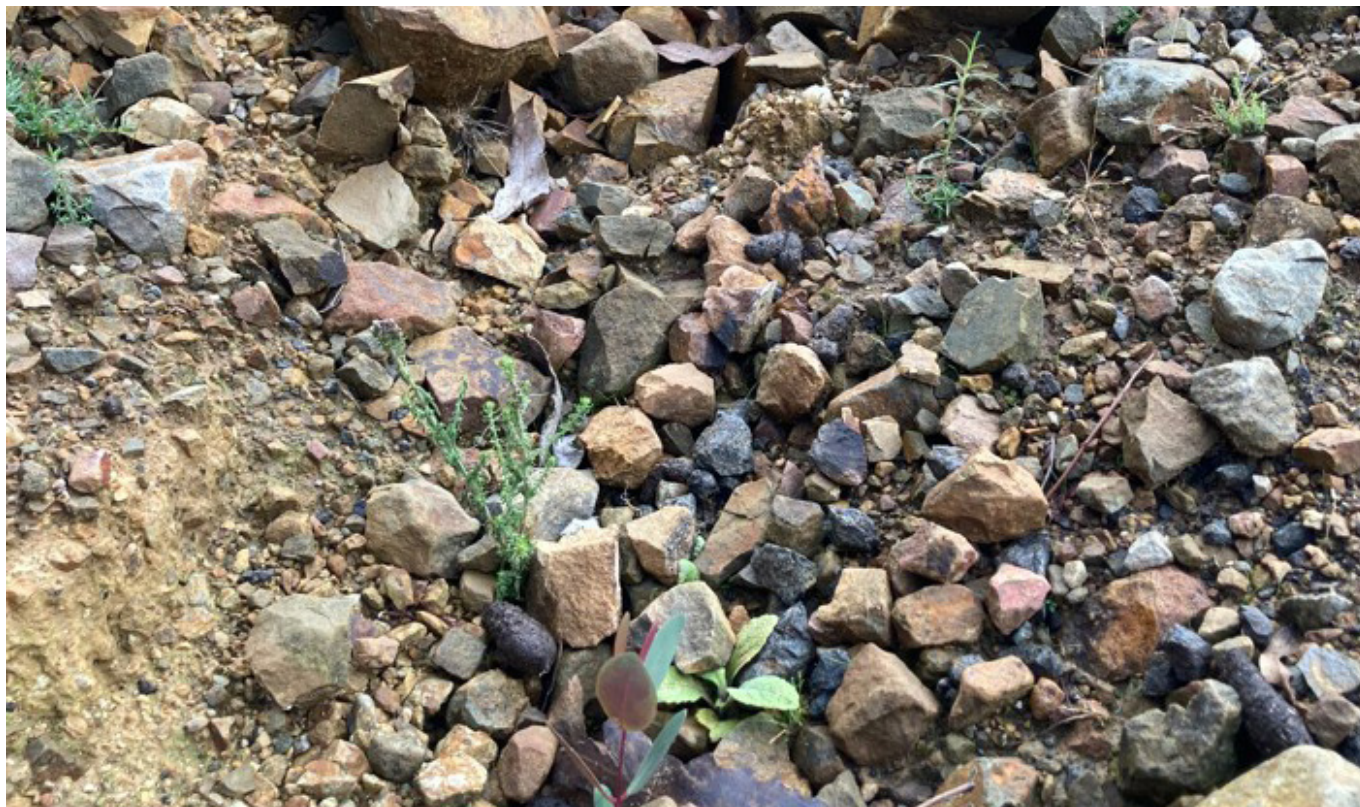
Recruitment of native species such as *Acacia dealbata* (Silver wattle), *Cassinia aculeata* (Dolly bush), *Poa labillardierei* (common tussock-grass) and *Eucalyptus* sp. were observed across the site (Figure 11).

The recently declared weed species *Digitalis* sp. (Foxglove) was identified recruiting over the quarry floor, benches and surrounding area. Given the species capacity to rapidly spread, targeted weed control will be the primary management focus at Rothalls Road in the coming financial year.

**Figure 11.** Recruiting native vegetation and Foxglove evident at Rothalls Road quarry (March 2026).

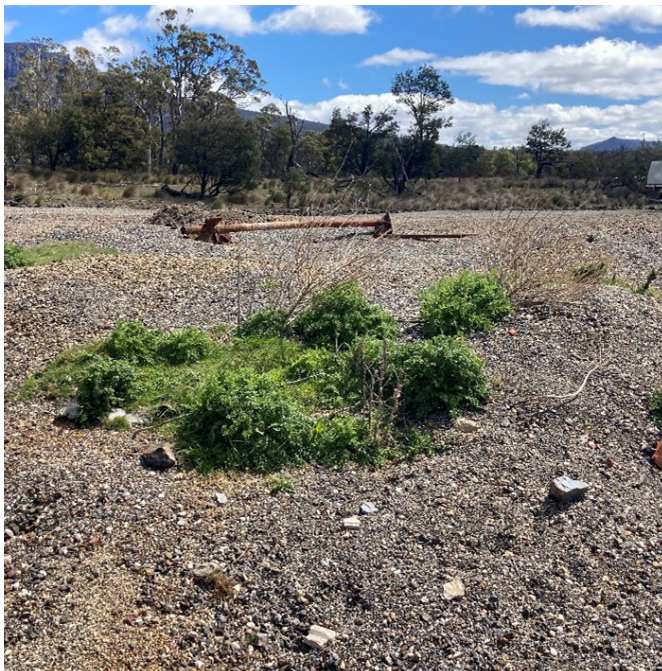
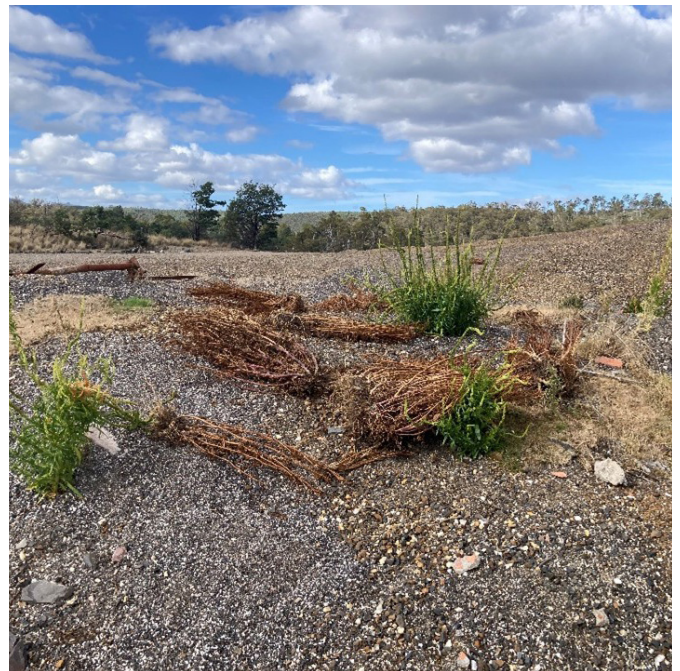
An isolated population of Ragwort identified on the Aberfoyle mine tailings during this survey was treated as part of MRT's ongoing regional Ragwort management program, completed in February 2025 (Figure 16). Further details of this program are provided in the Storys Creek section below.

**Figure 16.** Ragwort pre- (left) and post-treatment (right), Aberfoyle tailings dump.

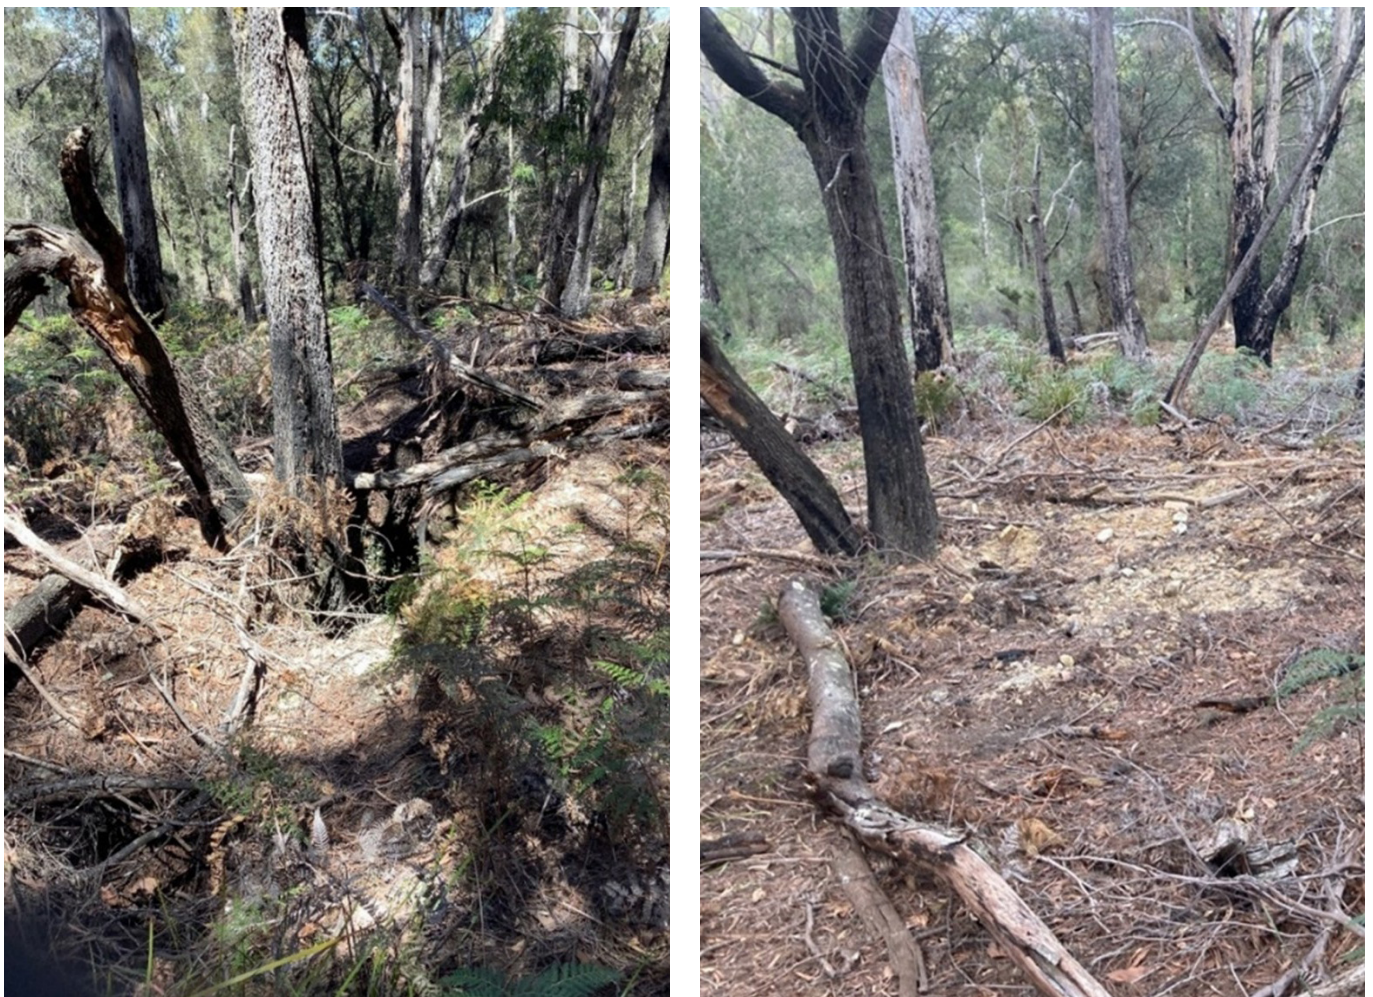
Specific works at this site involved the infill of five historical shafts using existing mullock piles, and the fabrication and installation of a heavy-duty cover over the sixth and largest opening.

**Figure 20.** Site comparison of infilled shaft site pre- (2024) and post-remediation (2026) work.

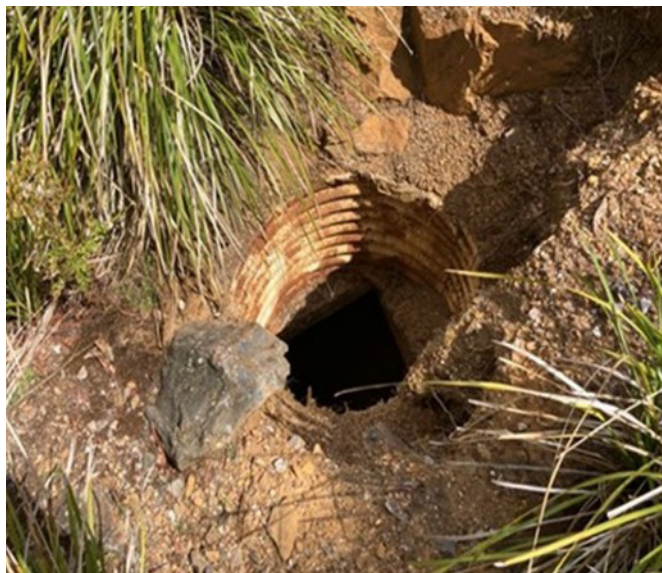
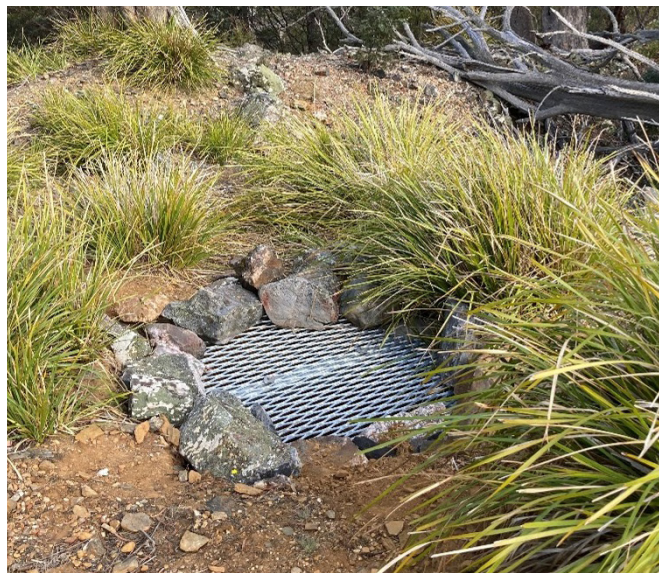
**Figure 23.** Shaft Closure completed pre (left) and post (right) work at Storys Creek (March 2026).

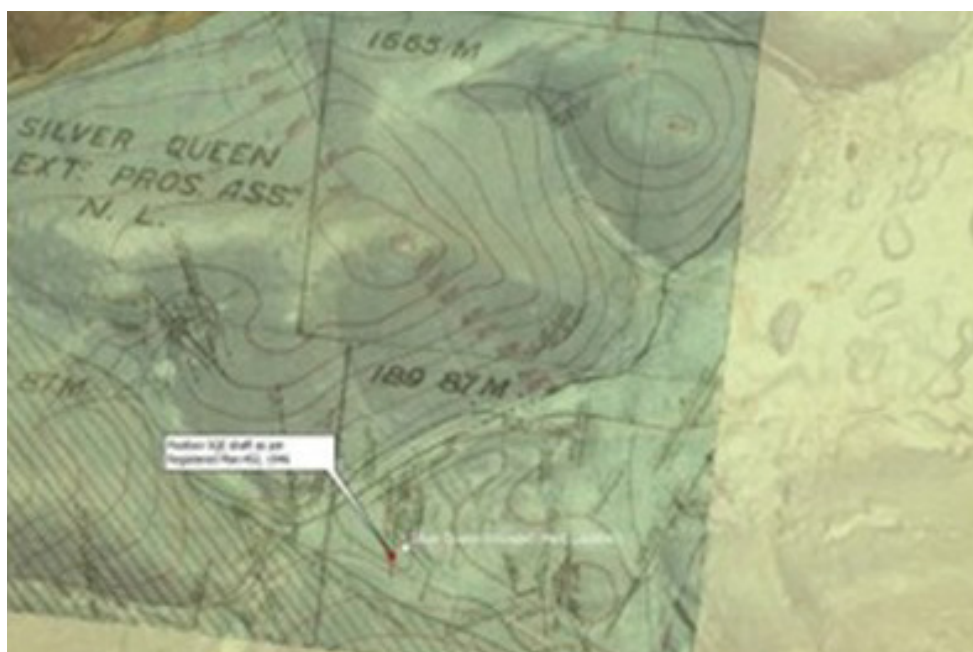
**Figure 24.** Historical mine mapping relating to Silver Queen Extended site.

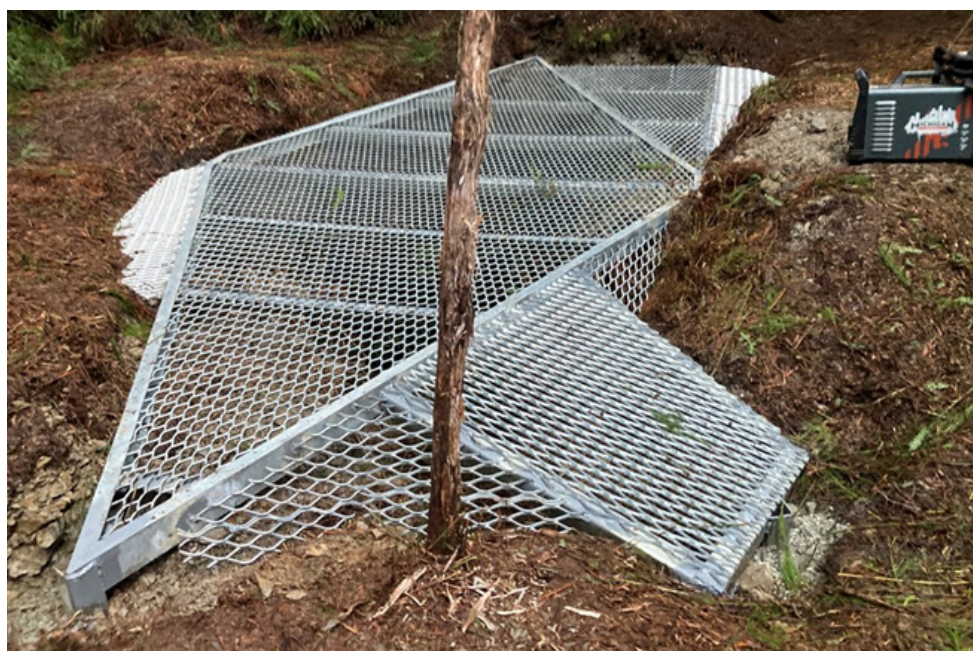
**Figure 25.** Silver Queen Extended closure cap (June 2026).

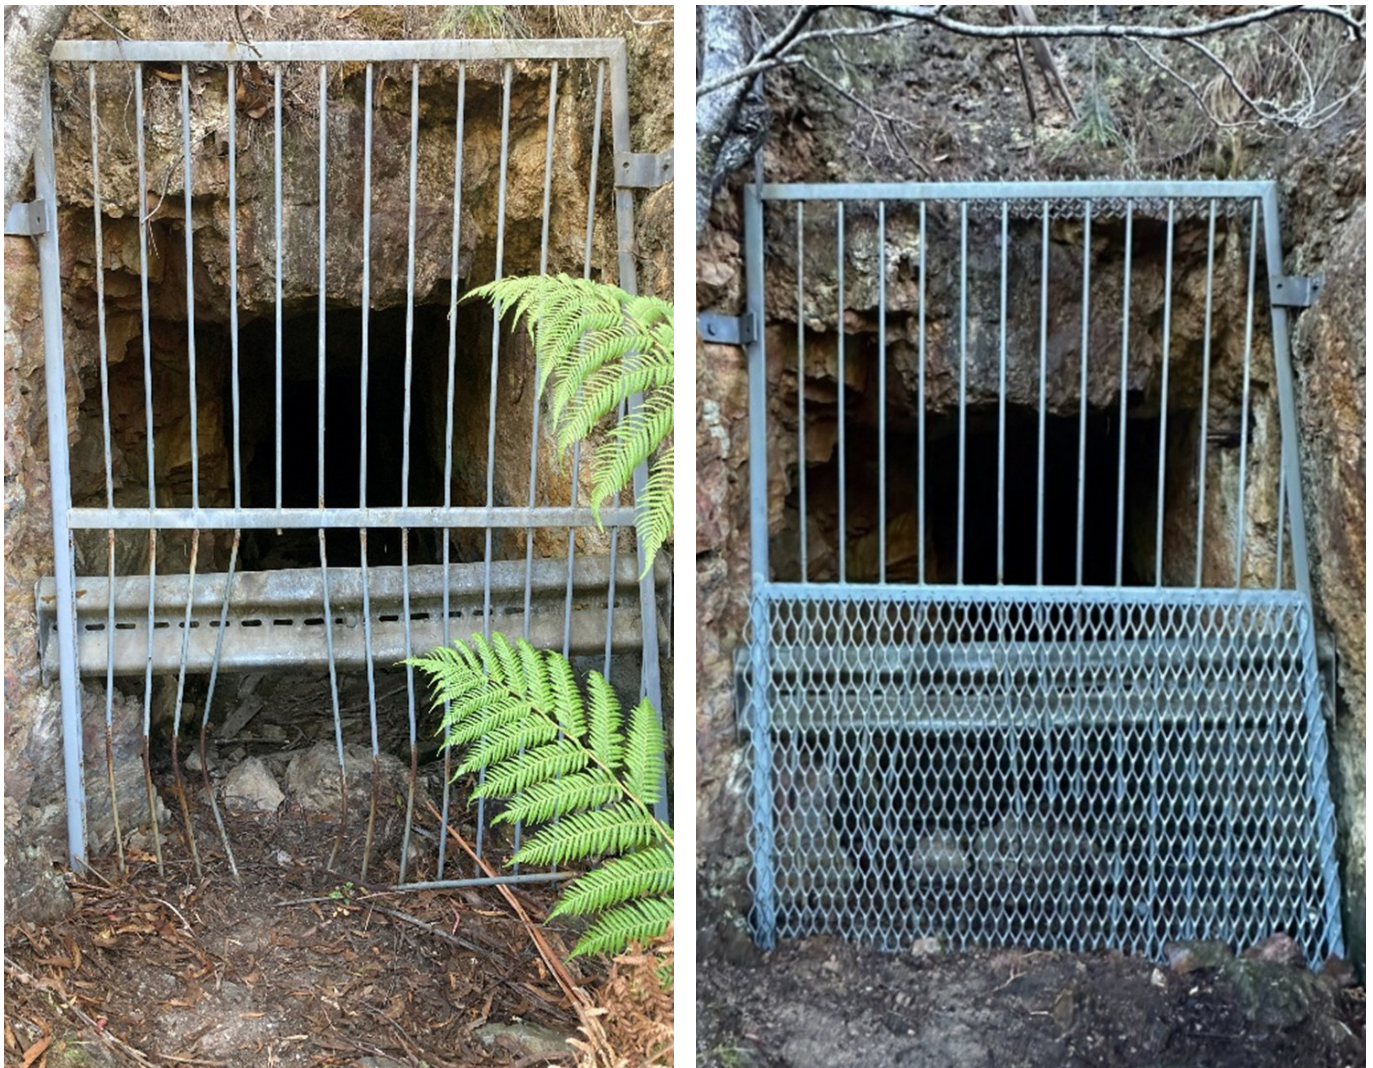
MRT received notification in January 2026, that the bars of the exclusion gate had been cut and bent, enabling unauthorised entry into the adit. Given the site's proximity to a regularly used road and the significant safety risks associated with entering historical underground workings, MRT completed maintenance works in May 2026. These works involved the installation of a galvanised expanded mesh panel to the entryway preventing future access (Figure 26).

**Figure 26.** Orieco adit site pre (January 2026) and post repair (April 2026).

MRT will continue to monitor this site and will undertake further risk assessment of legacy sites within the Upper Scamander mineral field as part of its broader feature cataloguing of Tasmania's Abandoned Mines (refer to the following section).
