# Rehabilitation of Mining Lands Trust Fund

2025-26 Annual Report

This annual report was developed by Mineral Resource Tasmania’s Land & Tenements Branch, to detail the outcomes and progress of remediation efforts funded though the Rehabilitation of Mining Lands Trust Fund in the 2025-26 financial year.

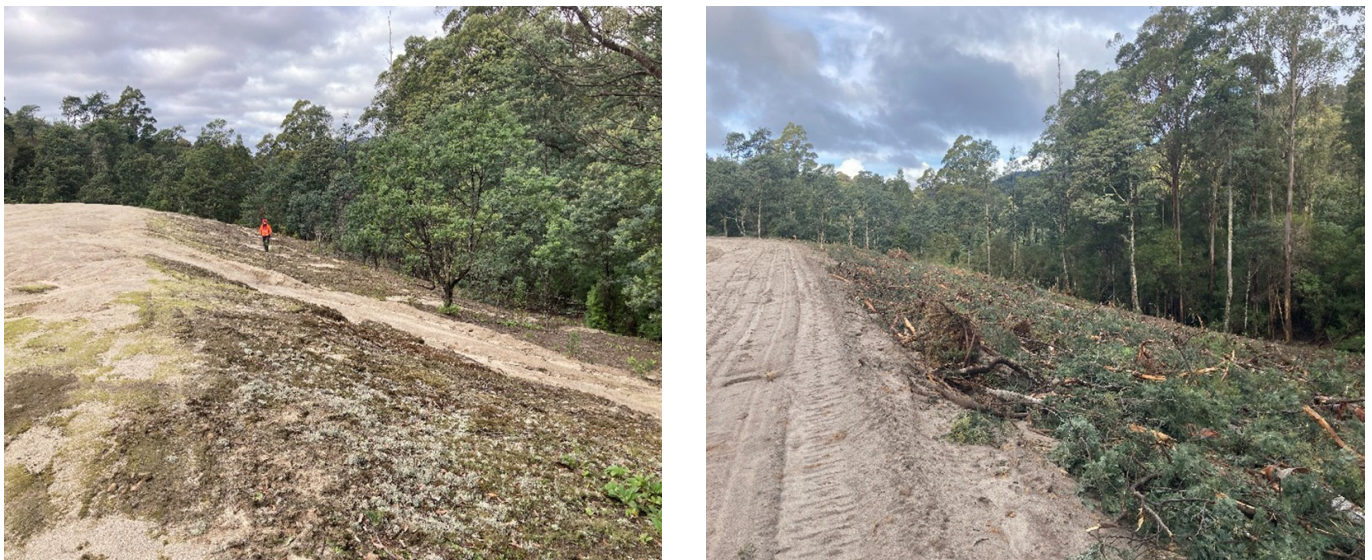
Subsequent inspections identified localised erosion along the embankment face, with sediment entering the surrounding forest and the Groom River, particularly following heavy rainfall events. Works commissioned in 2026 aimed to mitigate erosion on the embankment through water diversion, stabilisation via earthworks, installation of surface geotextile, placement of slash material and revegetation through native seeding and planting. These remediation actions were undertaken across an area of approximately 3000 m<sup>2</sup>, with all works constrained to the existing footprint of historical disturbance (Figure 2).

**Figure 2.** Comparison of Anchor embankment pre- (left) and post-remediation work (right).

MRT will continue to monitor the site to assess its rehabilitation outcomes. Ongoing evaluation will include drone-based photogrammetry and water quality monitoring, with additional weed management activities planned for the 2026–27 financial year.

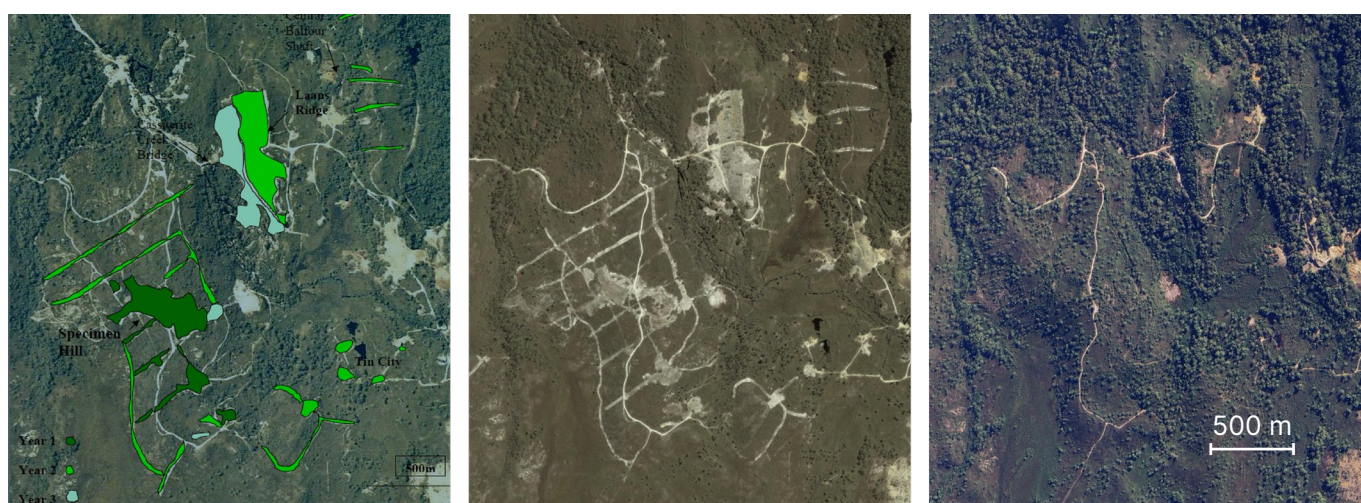
The 2025-26 financial year saw the completion of a comprehensive revegetation program that commenced in 2004, aimed at addressing soil stabilisation, revegetation and drainage impacts across multiple sites (Figure 3).

Over the last five years, management has focused on the targeted removal of the non-locally endemic species *Kunzea ambigua* (White Kunzea) and *Acacia sophorae* (Coast Wattle). In December 2025, a comprehensive ground survey of the site's rehabilitated areas was undertaken in which no incidence of these species was observed. The absence of *Kunzea ambigua* and *Acacia sophorae* concludes MRT's requirement for ongoing vegetation management at this location.

**Figure 3.** Comparative images of revegetation over Balfour Site, 2004 – 2025.

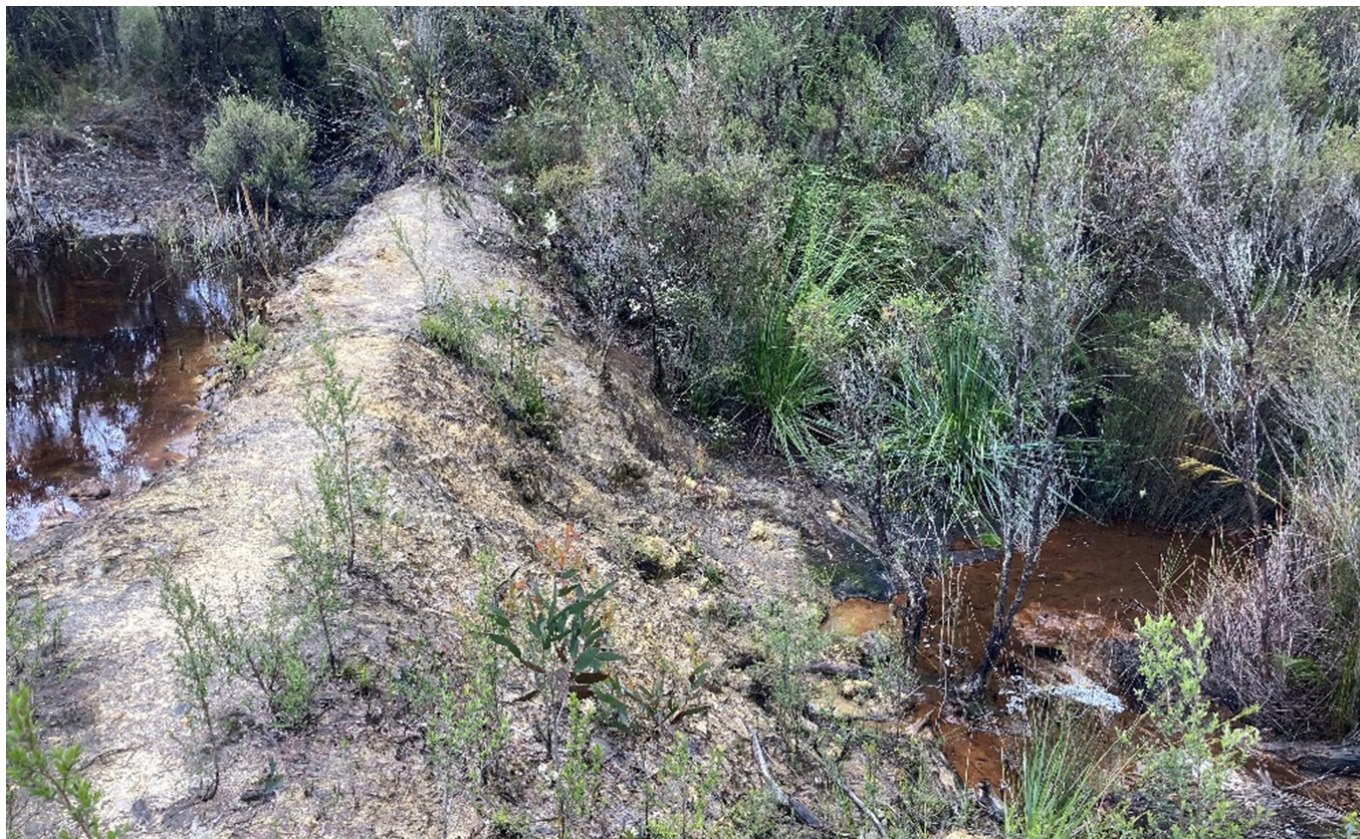
Temporary repair work on the sludge dam embankment wall below the BCS were completed in 2022 to prevent failure and the subsequent release of metalliferous sludge into the downstream Frankland and Arthur catchments. It was recommended a Consequence Category Assessment and further structural improvements be made to meet ANCOLD (2019) standards.

**Figure 4.** Current condition of Balfour Central Shaft Dam embankment (November 2025).

Proposed modifications involve raising the dam crest and downstream buttressing of the embankment (Figure 4), as well as widening and lengthening the existing spillway beyond the modified buttress (Figure 5). Both the upstream and downstream batters of the embankment and the spillway channel would be lined with geofabric and rockfill.

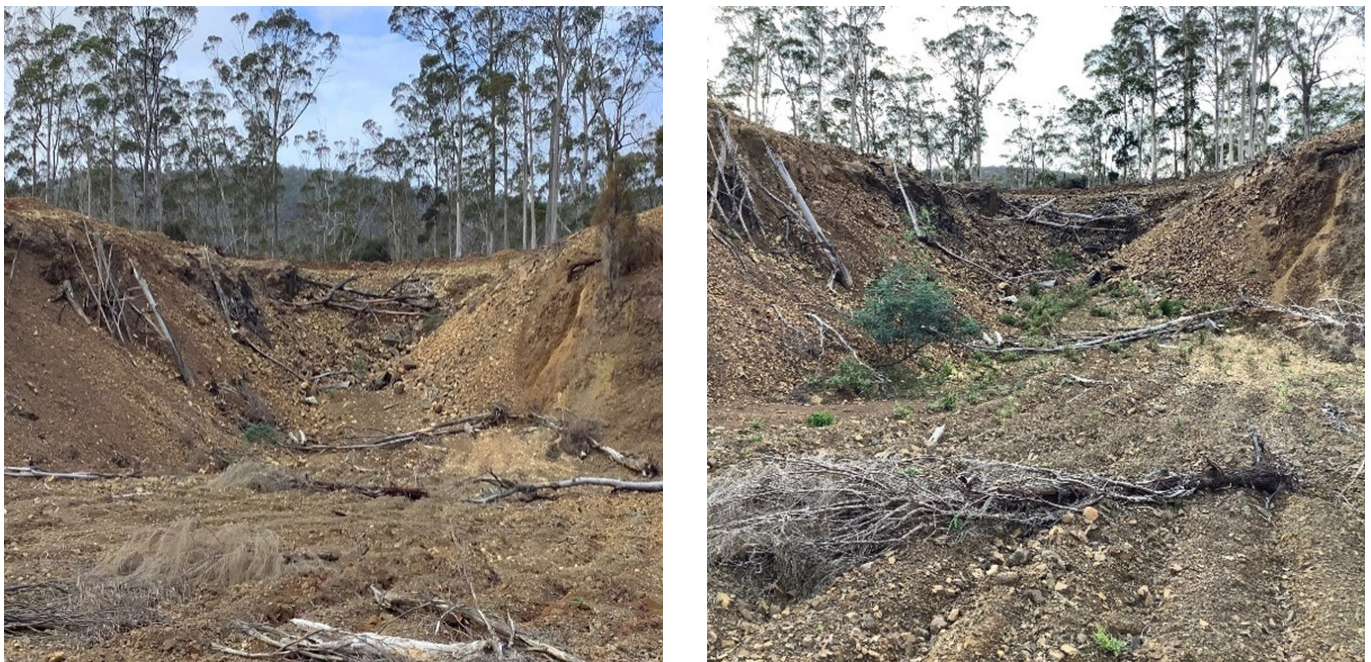
Overall, the site appears safe, stable, and non-polluting, with no visible indicators of erosion or contamination (Figure 6). While native tree, shrub and ground cover vegetation remains visually sparse, successful establishment has been observed across the entirety of the site. The presence of sufficient topsoil cover is expected to support continued natural recruitment over the next 3 – 5 years.

Weed species *Cirsium valgare* (Spear thistle), *Verbascum thapsus* (Great Mullein) and *Rumex* sp. (Dock) were observed at the site. Given the risks associated with the establishment and spread of these weed species, the site will require ongoing management.

**Figure 6.** Comparison of site post remediation (2024) and recent inspection (2025).

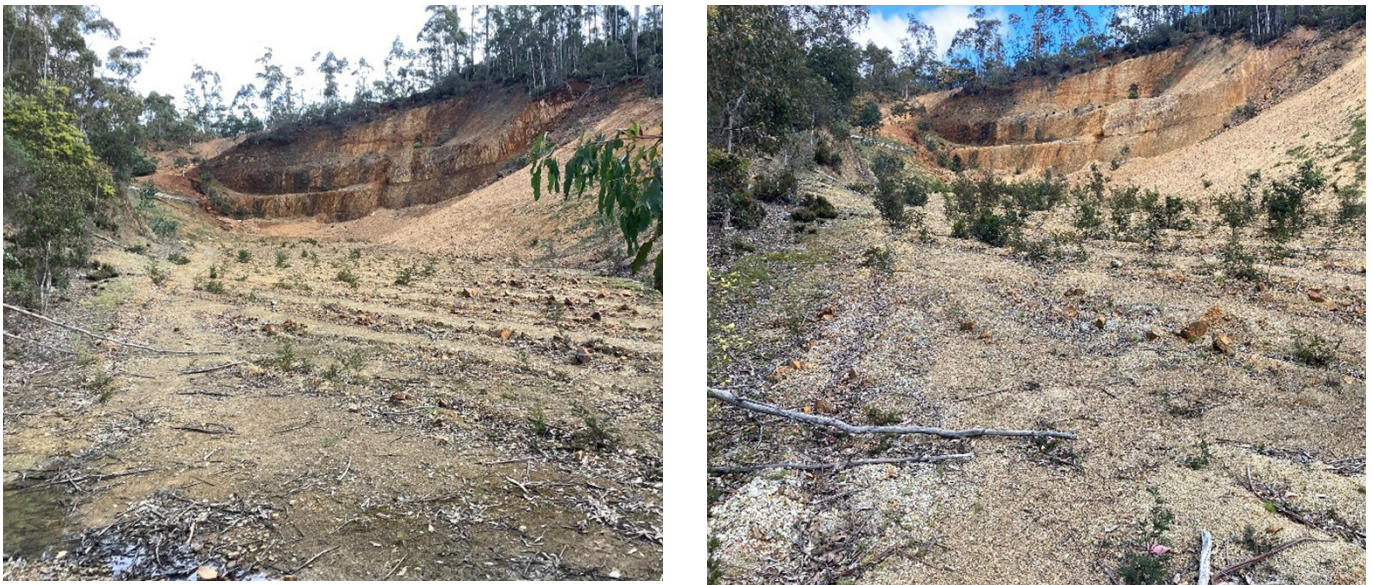
Recruitment of native species has increased, with ground cover, mid-story, and overstory species now distributed across the site. Notably, concentrations of ground cover *Aceana novae-zelandiae* (Red bidibid) were observed on the eastern batter and canopy species *Eucalyptus tasmaniensis* (Gum-topped Stringybark), *Eucalyptus amygdalina* (black peppermint) and *Acacia dealbata* (silver wattle) were established along the rip lines (Figure 8). Only a small number of isolated *Cirsium valgare* (Spear Thistle) individuals were observed.

**Figure 8.** Comparison of established vegetation 2024 (left) and 2025 (right).

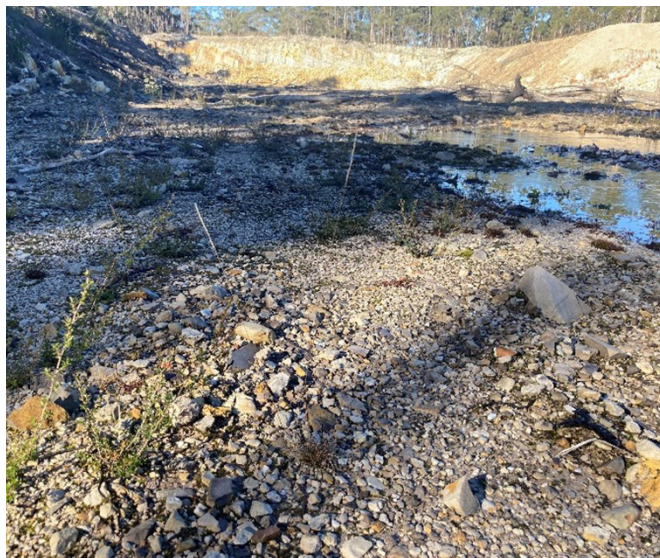
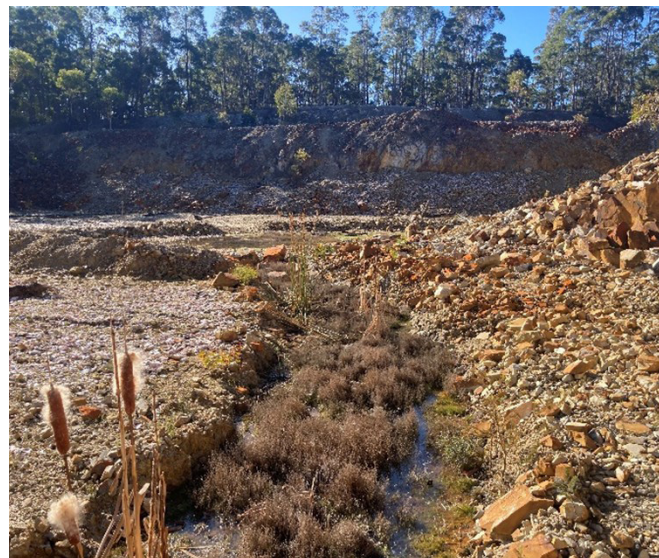
Hogans Road was inspected in August 2025 to assess its rehabilitation progress following works completed in May 2022. The quarry appears stable, with no visible erosion or evidence of unauthorised entry. Qualitative observations indicate continued improvement and an increase in vegetative recruitment since the previous inspection in October 2024, particularly across the site's upper bench (Figure 9).

**Figure 9.** Native vegetation recruitment at Hogans Rd quarry (August 2025).

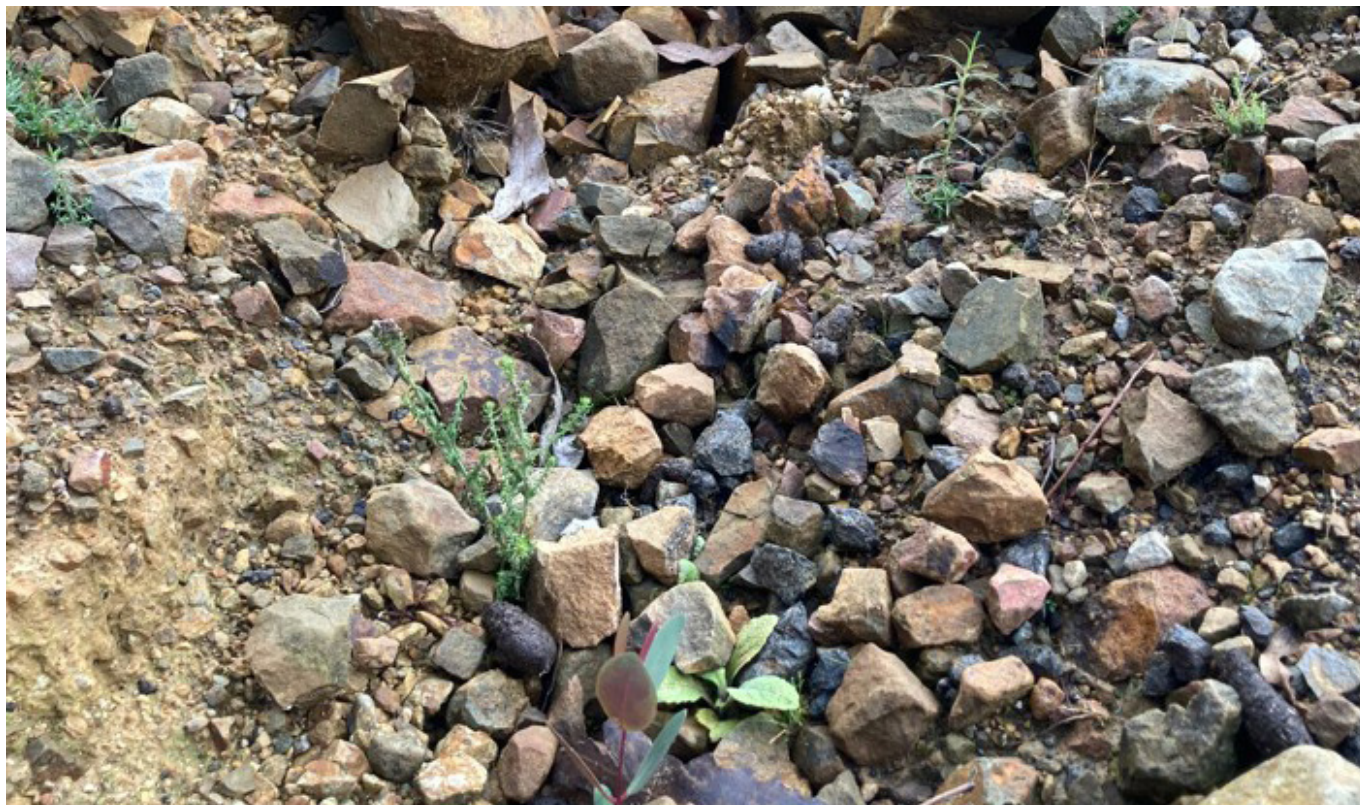
Recruitment of native species such as *Acacia dealbata* (Silver wattle), *Cassinia aculeata* (Dolly bush), *Poa labillardierei* (common tussock-grass) and *Eucalyptus* sp. were observed across the site (Figure 11).

The recently declared weed species *Digitalis* sp. (Foxglove) was identified recruiting over the quarry floor, benches and surrounding area. Given the species capacity to rapidly spread, targeted weed control will be the primary management focus at Rothalls Road in the coming financial year.

**Figure 11.** Recruiting native vegetation and Foxglove evident at Rothalls Road quarry (March 2026).

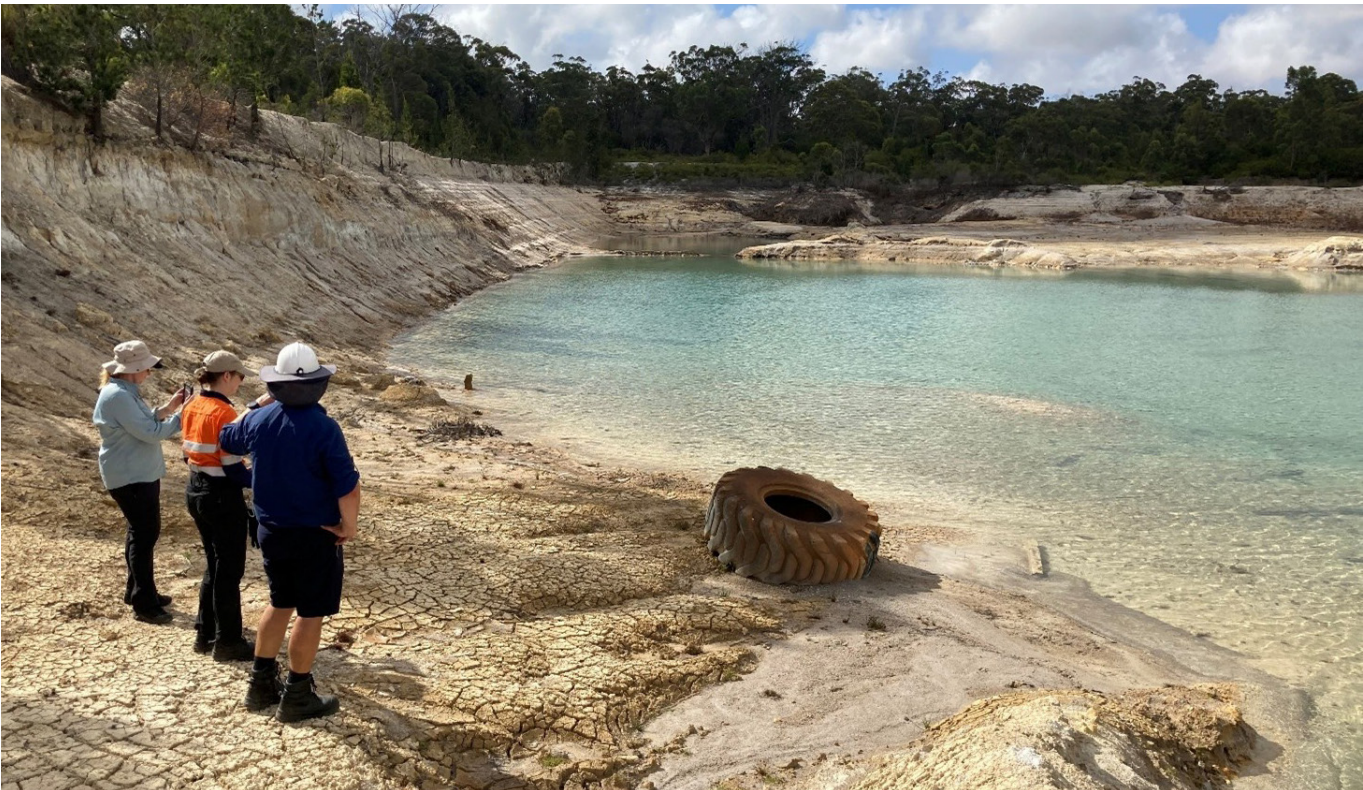
Surveillance, monitoring and maintenance of the Scotia mine site has been managed by MRT since 2014 (Figure 12). Over this period, MRT has developed a substantial dataset, providing valuable insights into the geological, geochemical, and mineralogical factors influencing water quality at the site. This information will be used to guide strategies for restoring the site to pre-mining environmental conditions.

Figure 12. Monitoring the Scotia mine site.

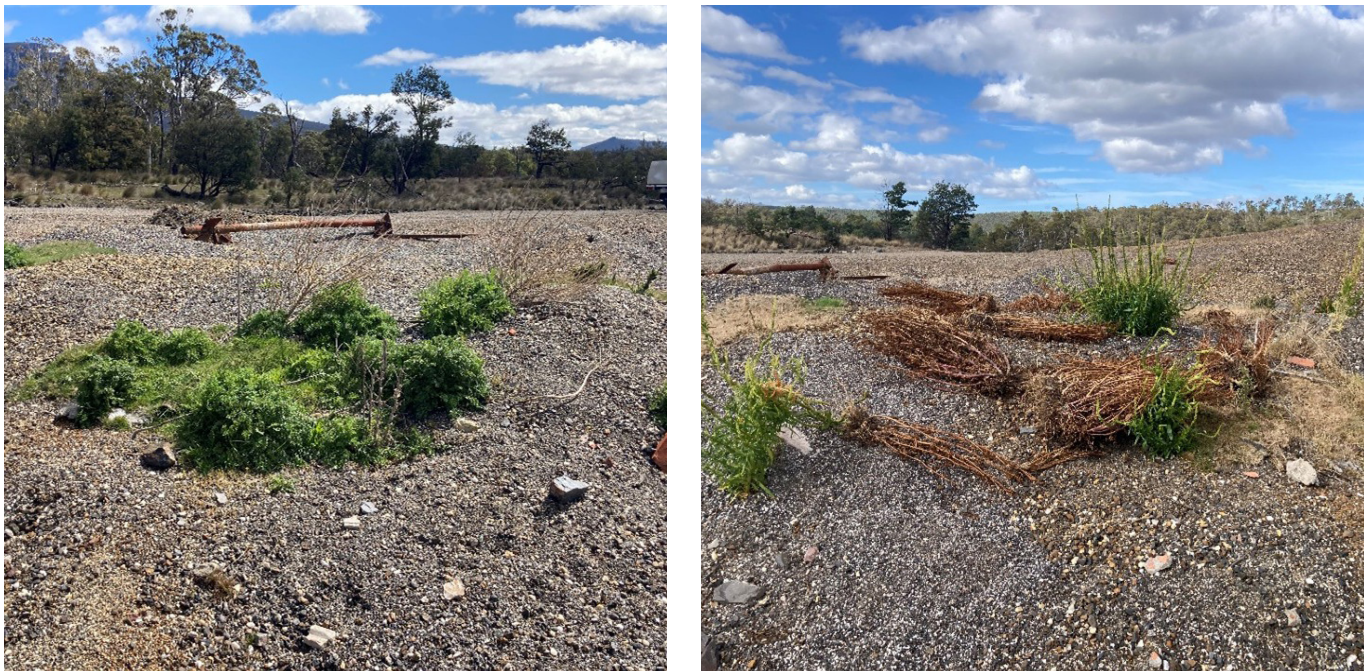
An isolated population of Ragwort identified on the Aberfoyle mine tailings during this survey was treated as part of MRT's ongoing regional Ragwort management program, completed in February 2025 (Figure 16). Further details of this program are provided in the Storys Creek section below.

**Figure 16.** Ragwort pre- (left) and post-treatment (right), Aberfoyle tailings dump.

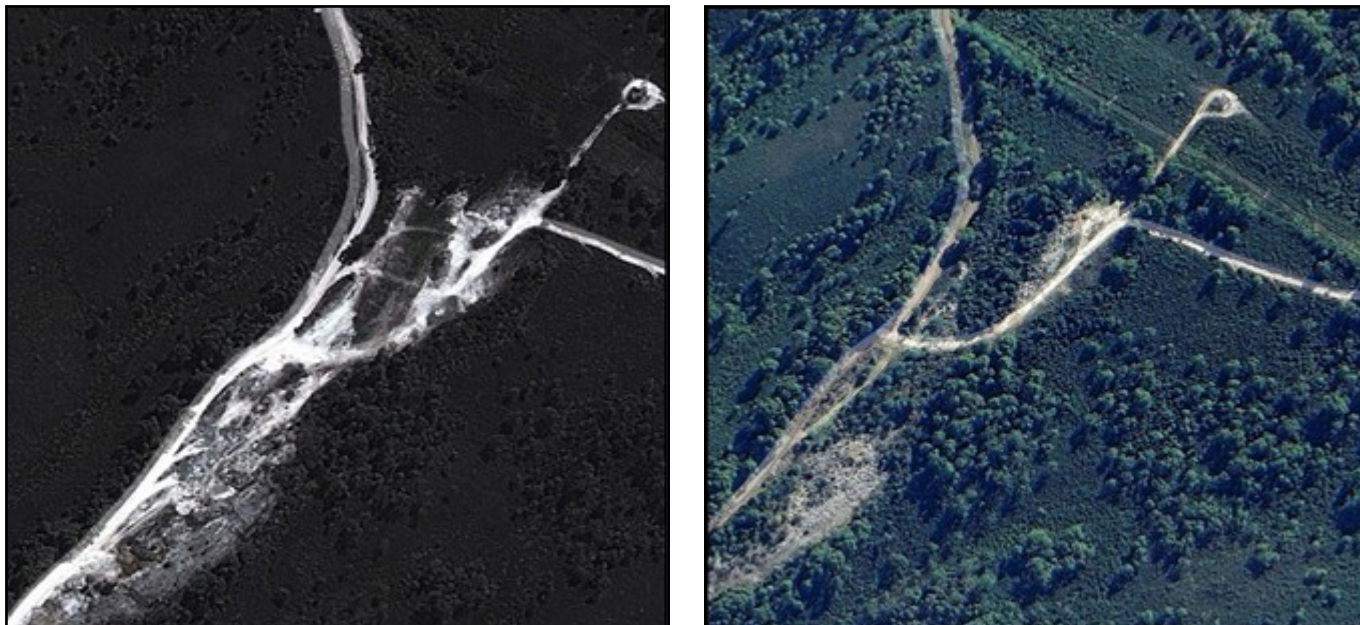
Weed management continued in October 2025, with associated monitoring indicating significant success in revegetation and weed reduction (Figure 18).

However, *Pinus radiata* (Radiata Pine) and *Cortaderia selloana* (Pampas Grass) continue to recruit and will require further ongoing management. The greatest long-term threat remains *Erica lusitanica* (Spanish Heath), which is encroaching from infestations along the Bass Highway verge.

**Figure 18.** Comparative aerial imagery of Sisters Hills Quarry Site MA1, 2009 (right) and 2024 (left).

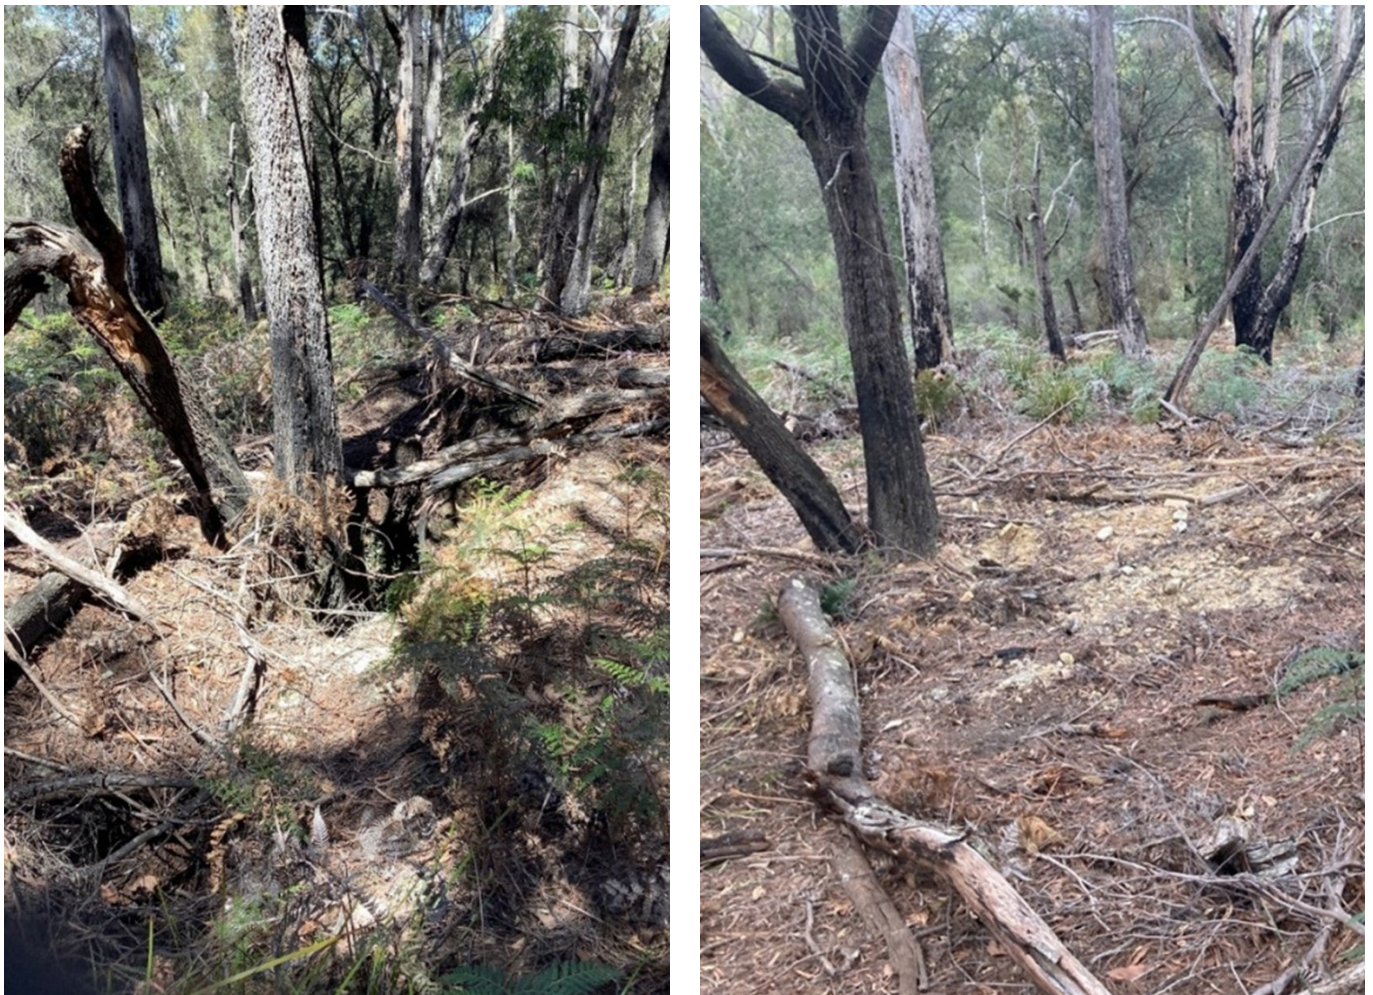
Specific works at this site involved the infill of five historical shafts using existing mullock piles, and the fabrication and installation of a heavy-duty cover over the sixth and largest opening.

**Figure 20.** Site comparison of infilled shaft site pre- (2024) and post-remediation (2026) work.

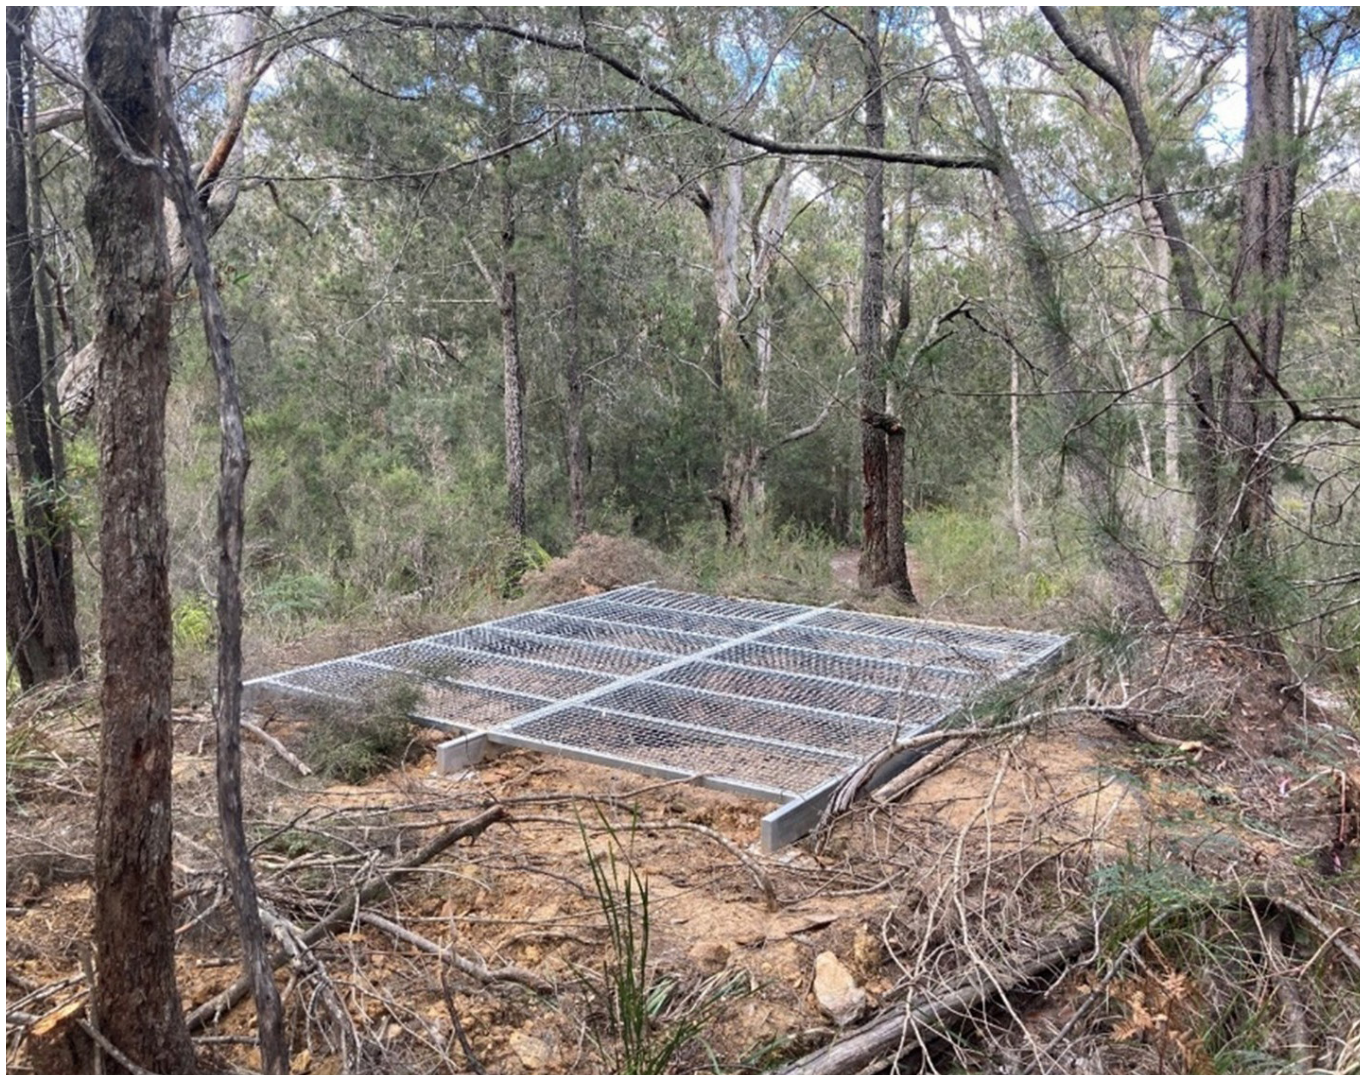
**Figure 21.** Fabricated cap installed at Equilla Site (April 2026).

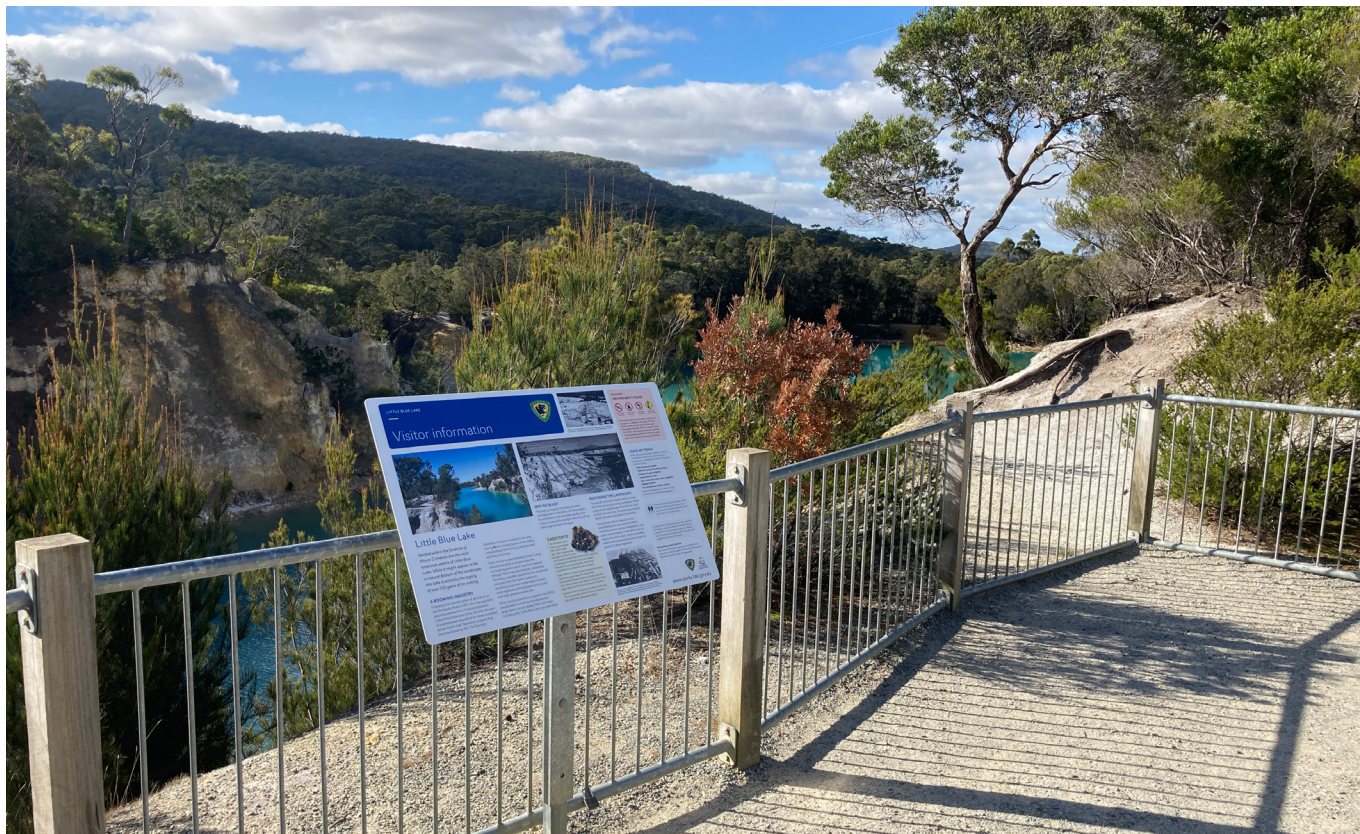
To address the need for appropriate signage, a new interpretation sign was installed at the main viewing area, providing accurate information about the site's history, environmental conditions and key safety considerations (Figure 22).

**Figure 22.** New interpretation signage installed at Little Blue Lake.

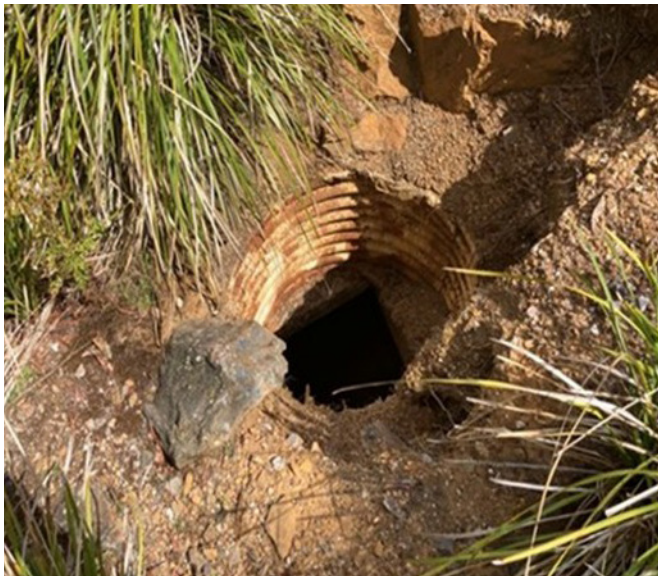
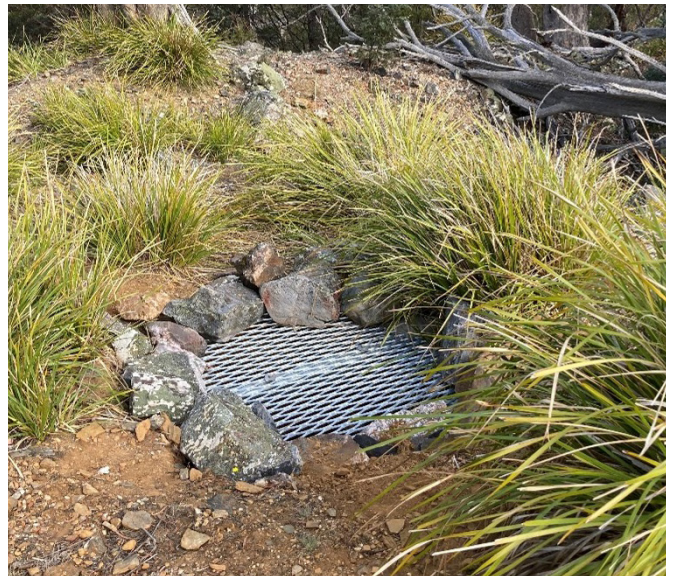
**Figure 23.** Shaft Closure completed pre (left) and post (right) work at Storys Creek (March 2026).

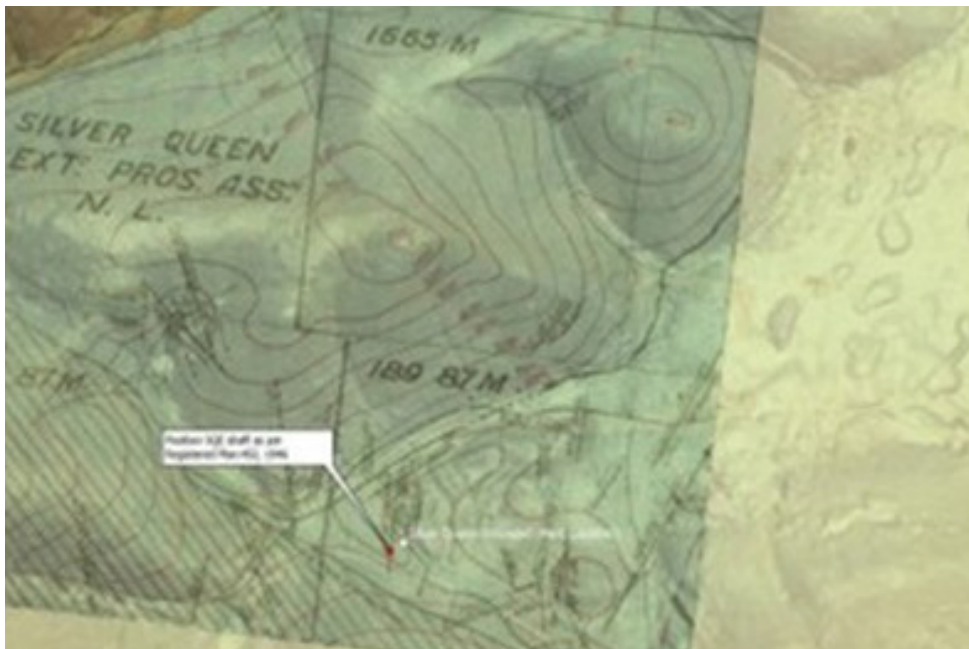
**Figure 24.** Historical mine mapping relating to Silver Queen Extended site.

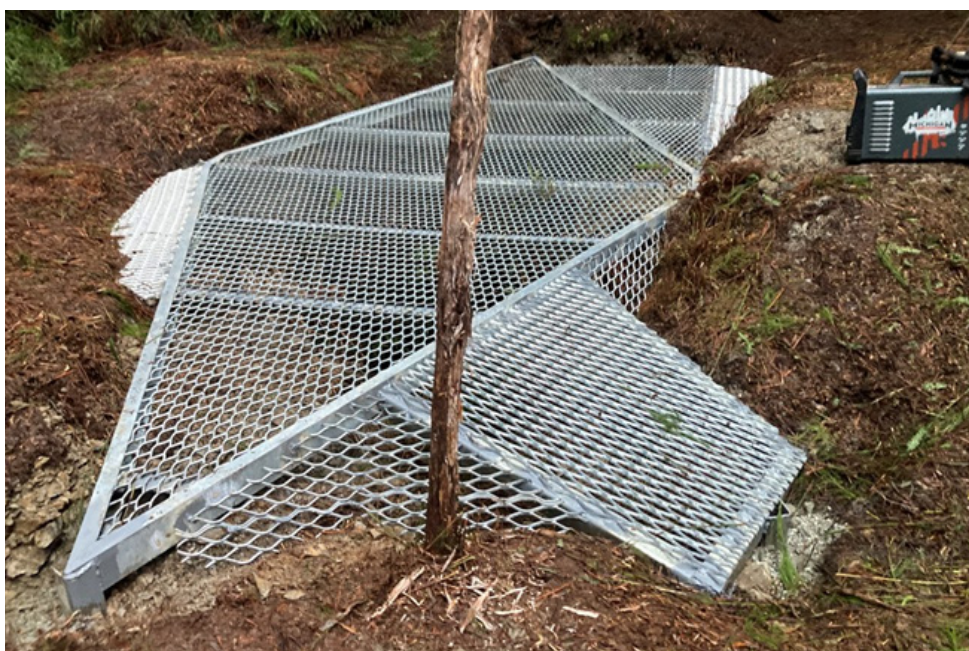
**Figure 25.** Silver Queen Extended closure cap (June 2026).

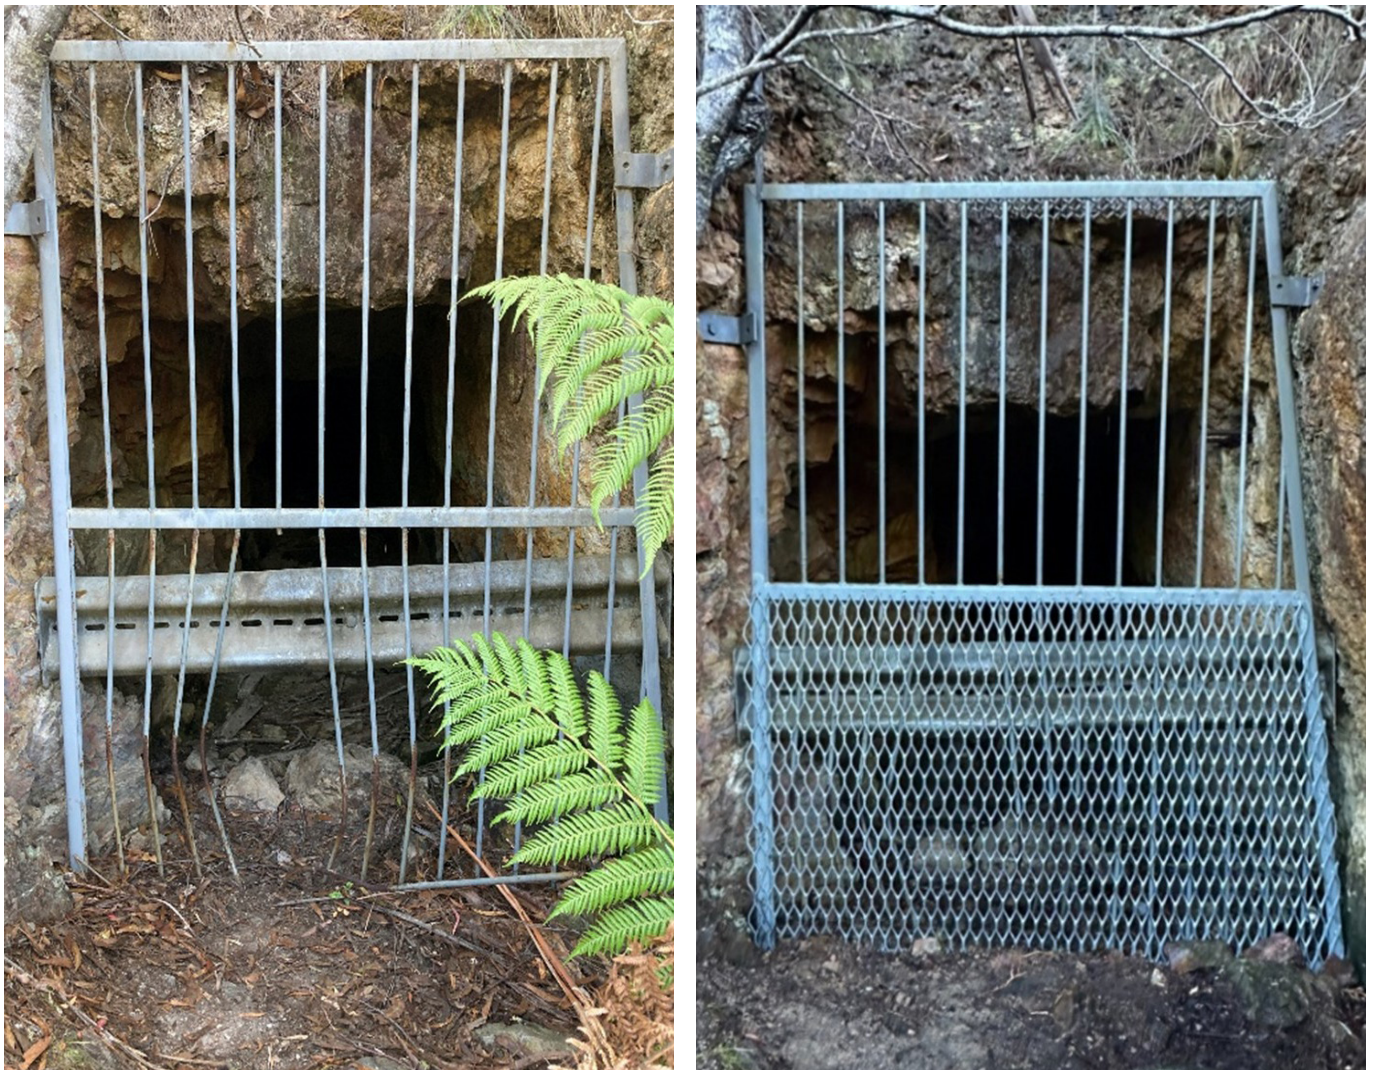
MRT received notification in January 2026, that the bars of the exclusion gate had been cut and bent, enabling unauthorised entry into the adit. Given the site's proximity to a regularly used road and the significant safety risks associated with entering historical underground workings, MRT completed maintenance works in May 2026. These works involved the installation of a galvanised expanded mesh panel to the entryway preventing future access (Figure 26).

**Figure 26.** Orieco adit site pre (January 2026) and post repair (April 2026).

MRT will continue to monitor this site and will undertake further risk assessment of legacy sites within the Upper Scamander mineral field as part of its broader feature cataloguing of Tasmania's Abandoned Mines (refer to the following section).
