The effects of waste disposal on groundwater quality in Tasmania

**McRobies Gully
waste depot,
South Hobart**

**Tasmanian Geological
Survey Record 2002/16**

Hydrogeological investigations at the McRobies Gully waste depot, South Hobart

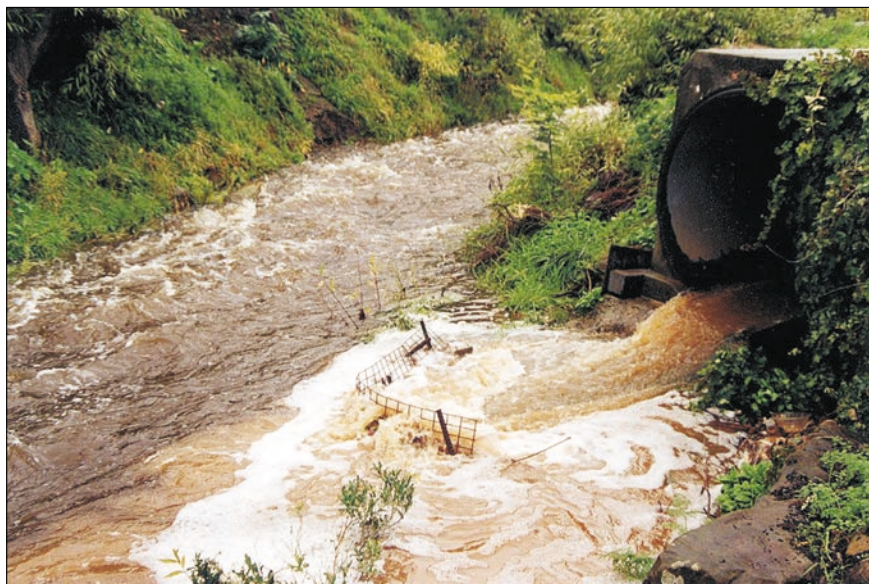
Plate 2
*Outpour into the Hobart Rivulet on
24 April 2001.*

Surface water at the site is currently difficult to control during rainfall events. Discharges to the Hobart Rivulet sometimes occur in wet periods and may vary in water quality and flow rate based on hydraulic conditions at the site. Other inputs into the stormwater pipe include run off from several local roads and houses. Plate 2 demonstrates visually the flow rate, water discolouration and foaming affects at the discharge point into the Hobart Rivulet. Increases in environmental standards now indicate that the current system is inadequate and needs to be improved to reduce the frequency and volume of discharges.

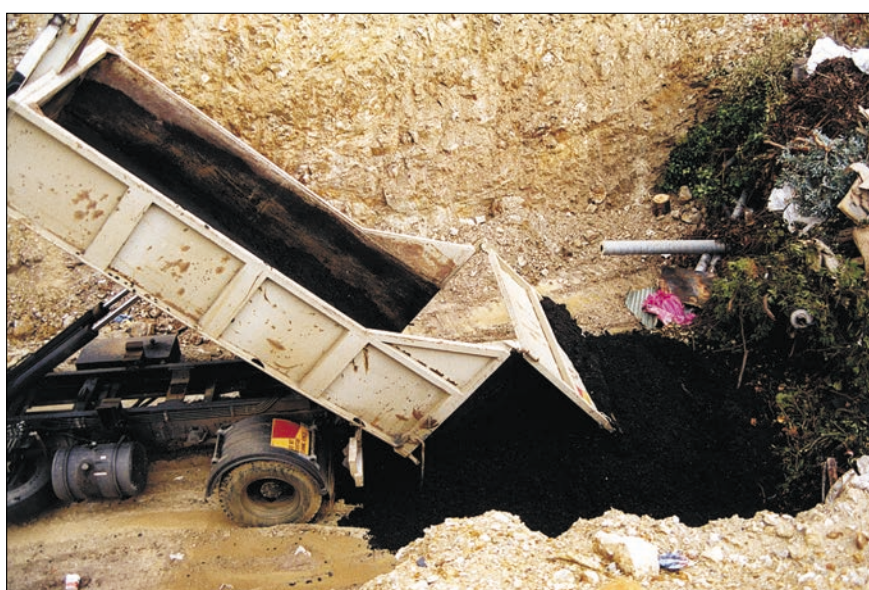
Plate 3
*Back filling the western stormwater
drain on 17 May 2001.*

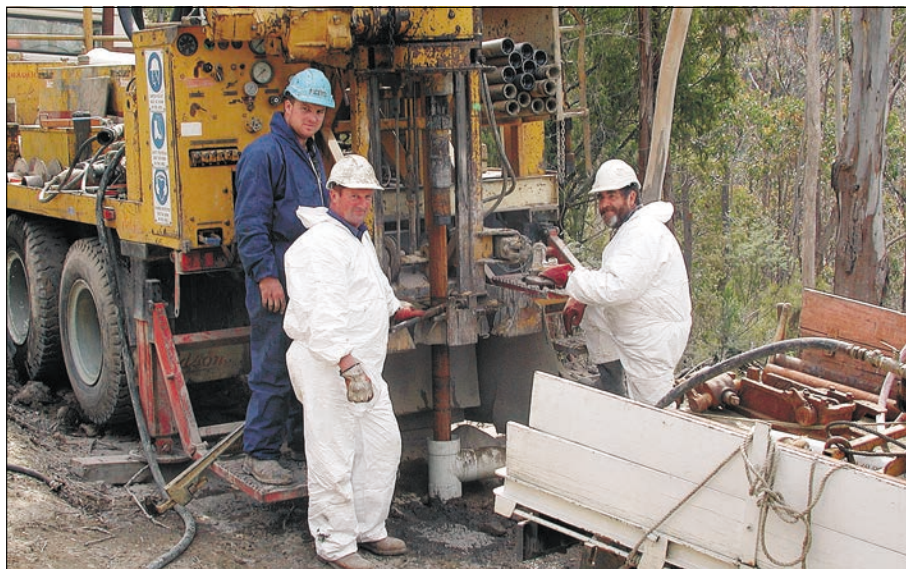
Plate 4
*Drilling borehole MG2000/2
 during October 2000.*

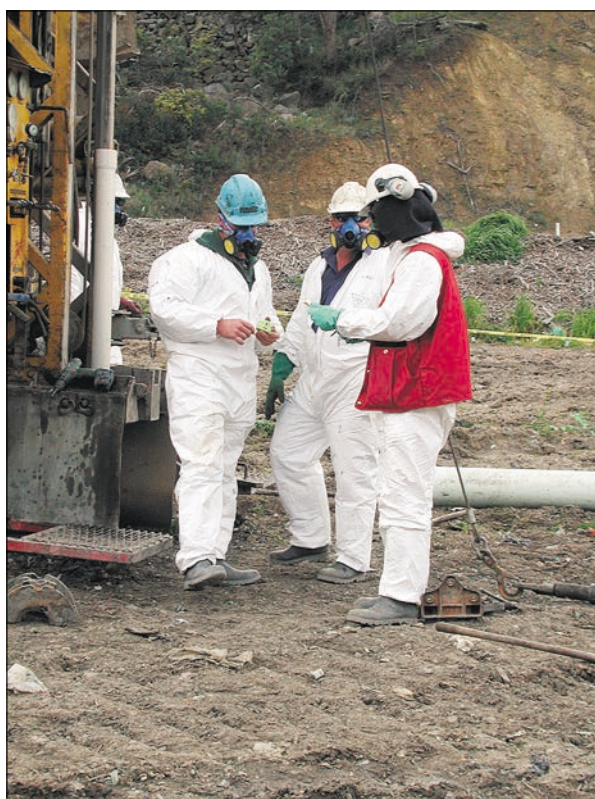
Plate 5
*Drilling borehole in waste
 fill material.*

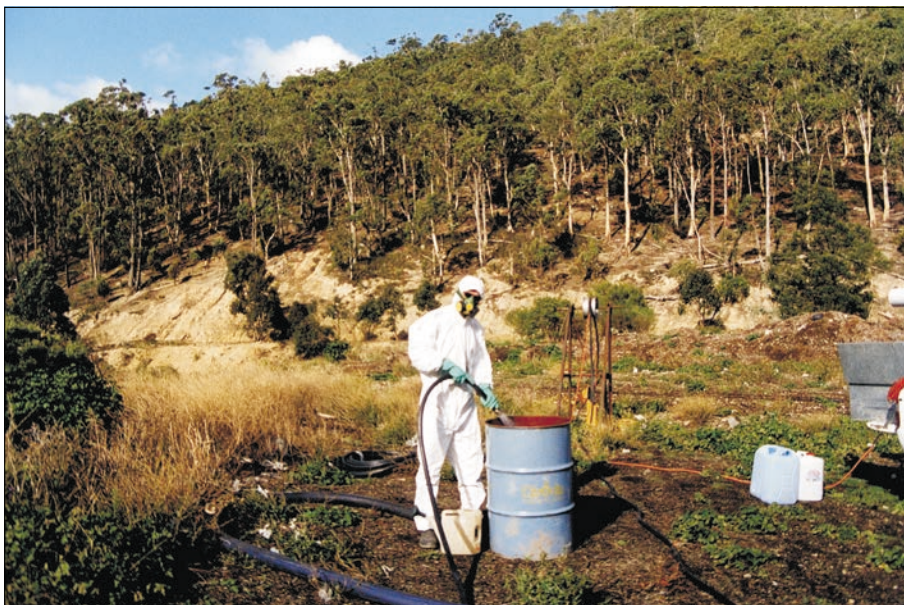
Plate 7
Sampling borehole MG2001/1.
