DEPARTMENT OF MINES — TASMANIA	
JOINT DIAGRAM — CUT OFF TRENCH RISDON BROOK DAM	
DATE	JULY 1966
GEOLOGIST	M. LONGMAN
DRAUGHTSMAN	P. NANKIVELL
REVISIONS	FILE N°
	2899

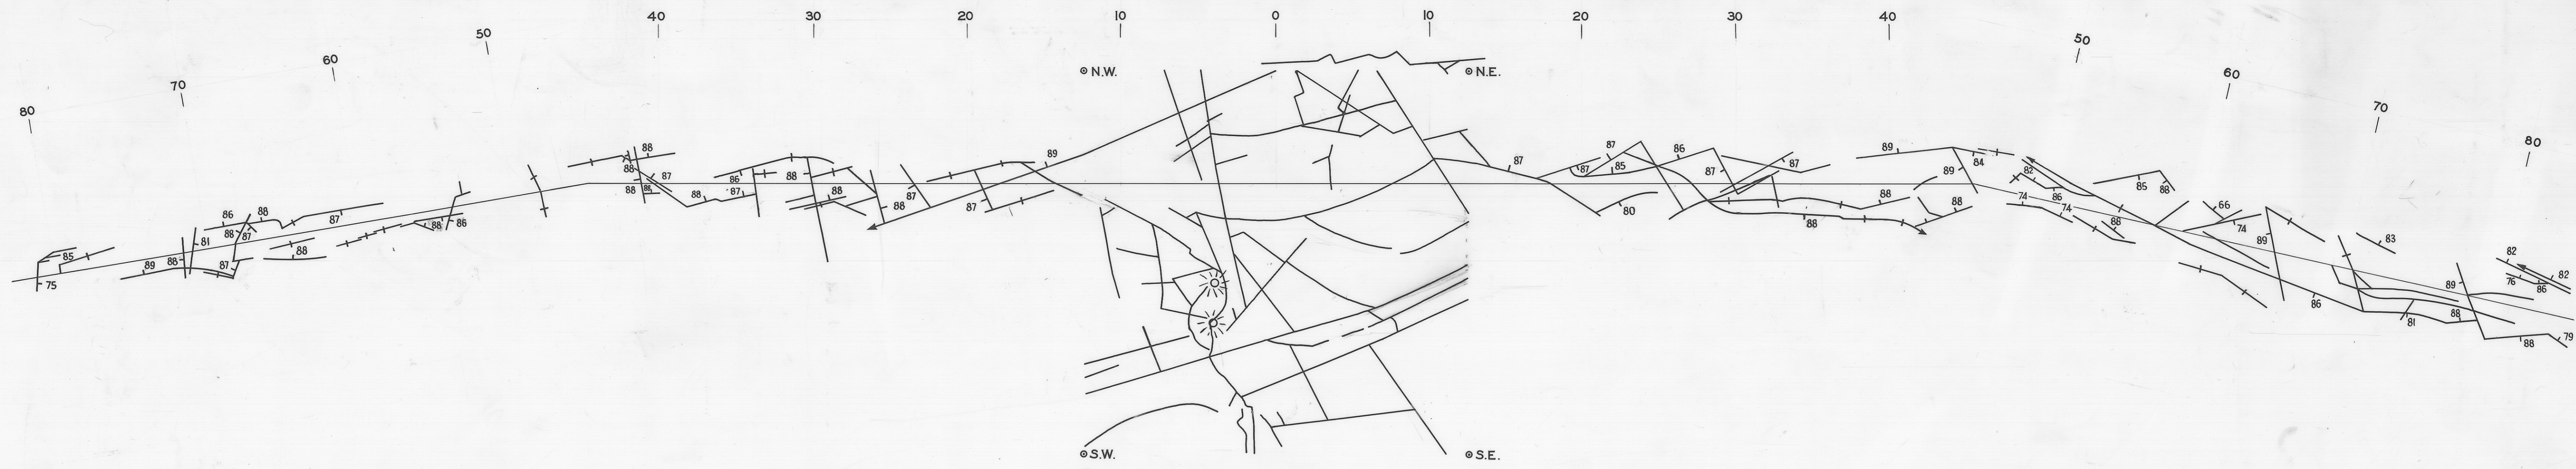
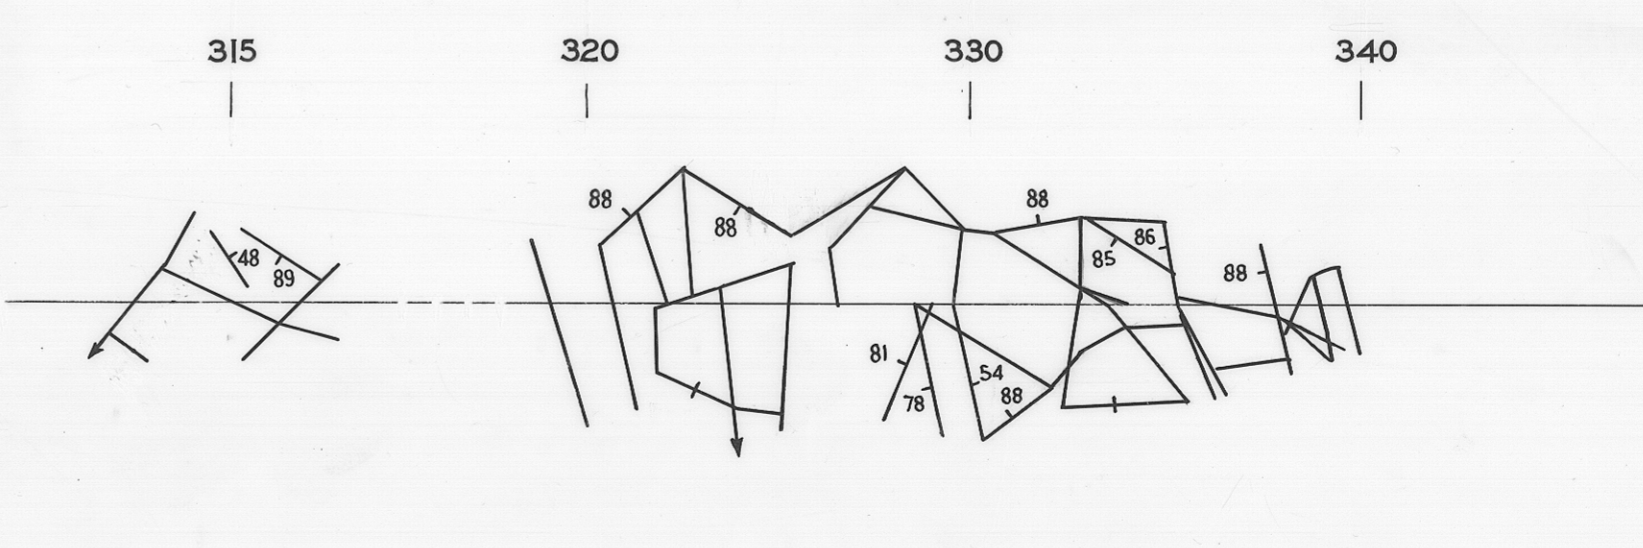
WEST SIDE

EAST SIDE

Note :- Chainages 190-230 E and 190-200 W not investigated as concrete poured before trench visited.
