RANNOCH CRESCENT PROJECT
MORPHOLOGICAL MAP

R.C. DONALDSON - JULY 1980

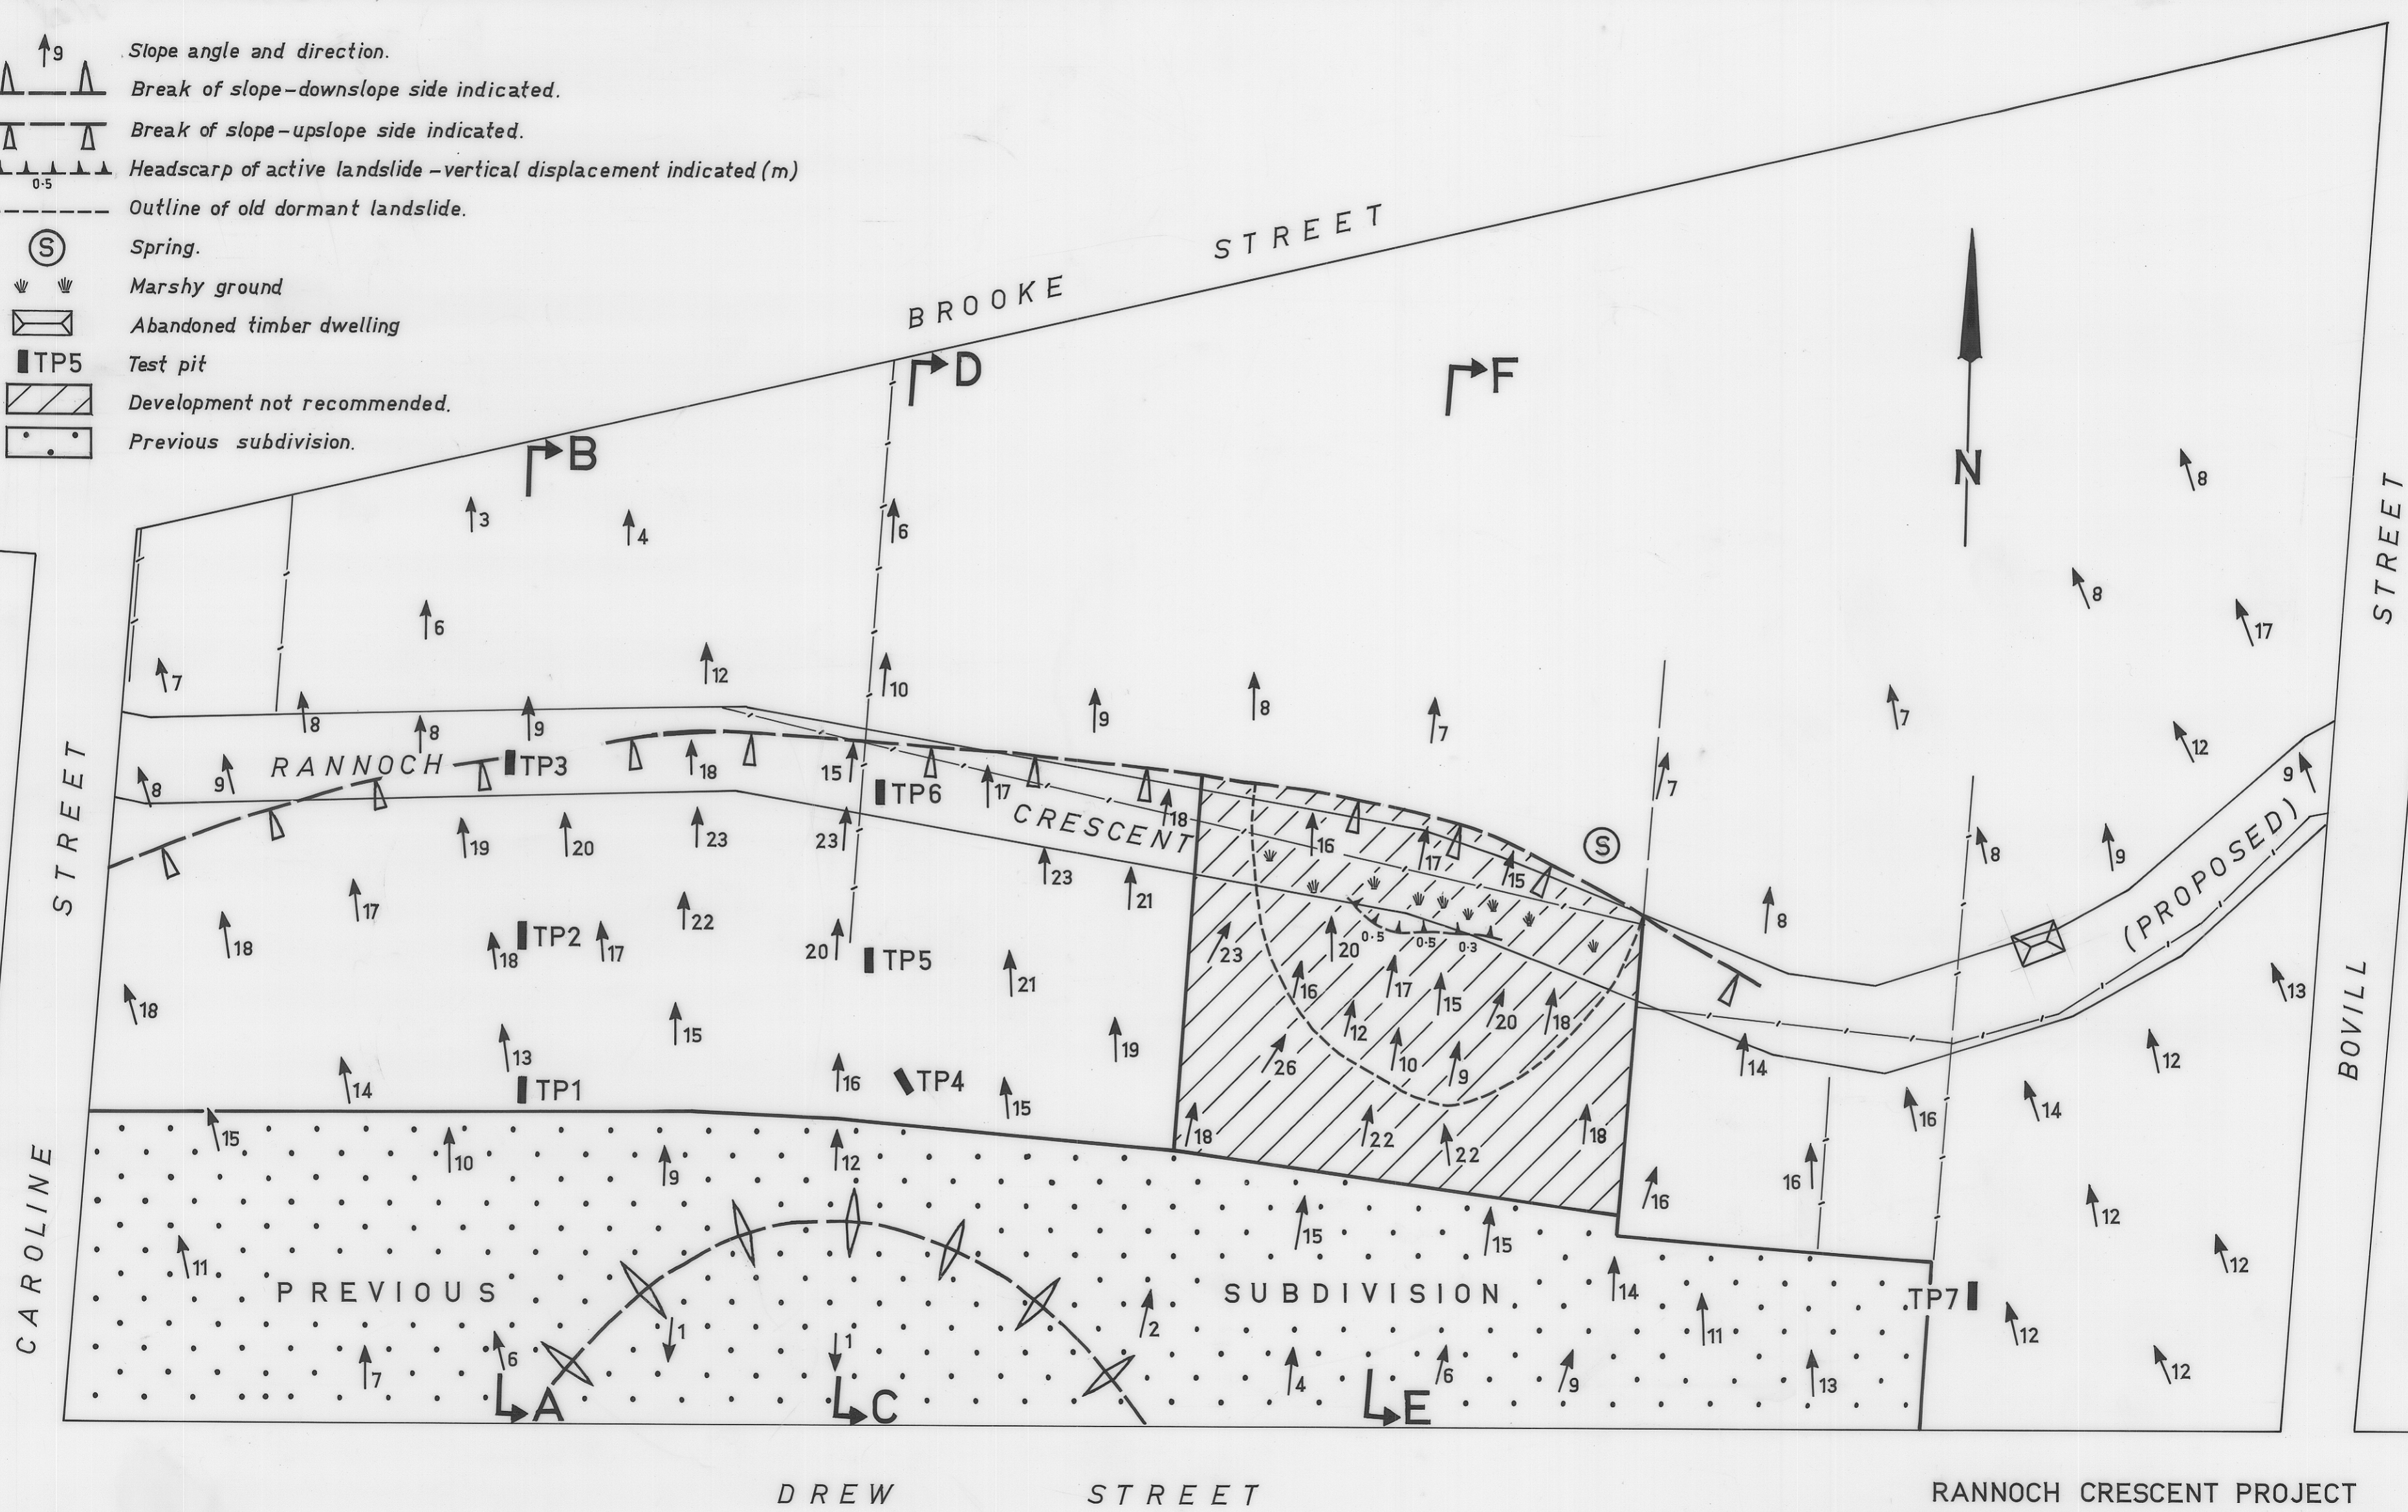
Figure 2

- Slope angle and direction.
- Break of slope-downslope side indicated.
- Break of slope-upslope side indicated.
- Headscarp of active landslide - vertical displacement indicated (m)
- Outline of old dormant landslide.
- Spring.
- Marshy ground
- Abandoned timber dwelling
- Test pit
- Development not recommended.
- Previous subdivision.
