SLOPE STABILITY ASSESSMENT

ADAMS SUBDIVISION - WINDERMERE
STABILITY ASSESSMENT

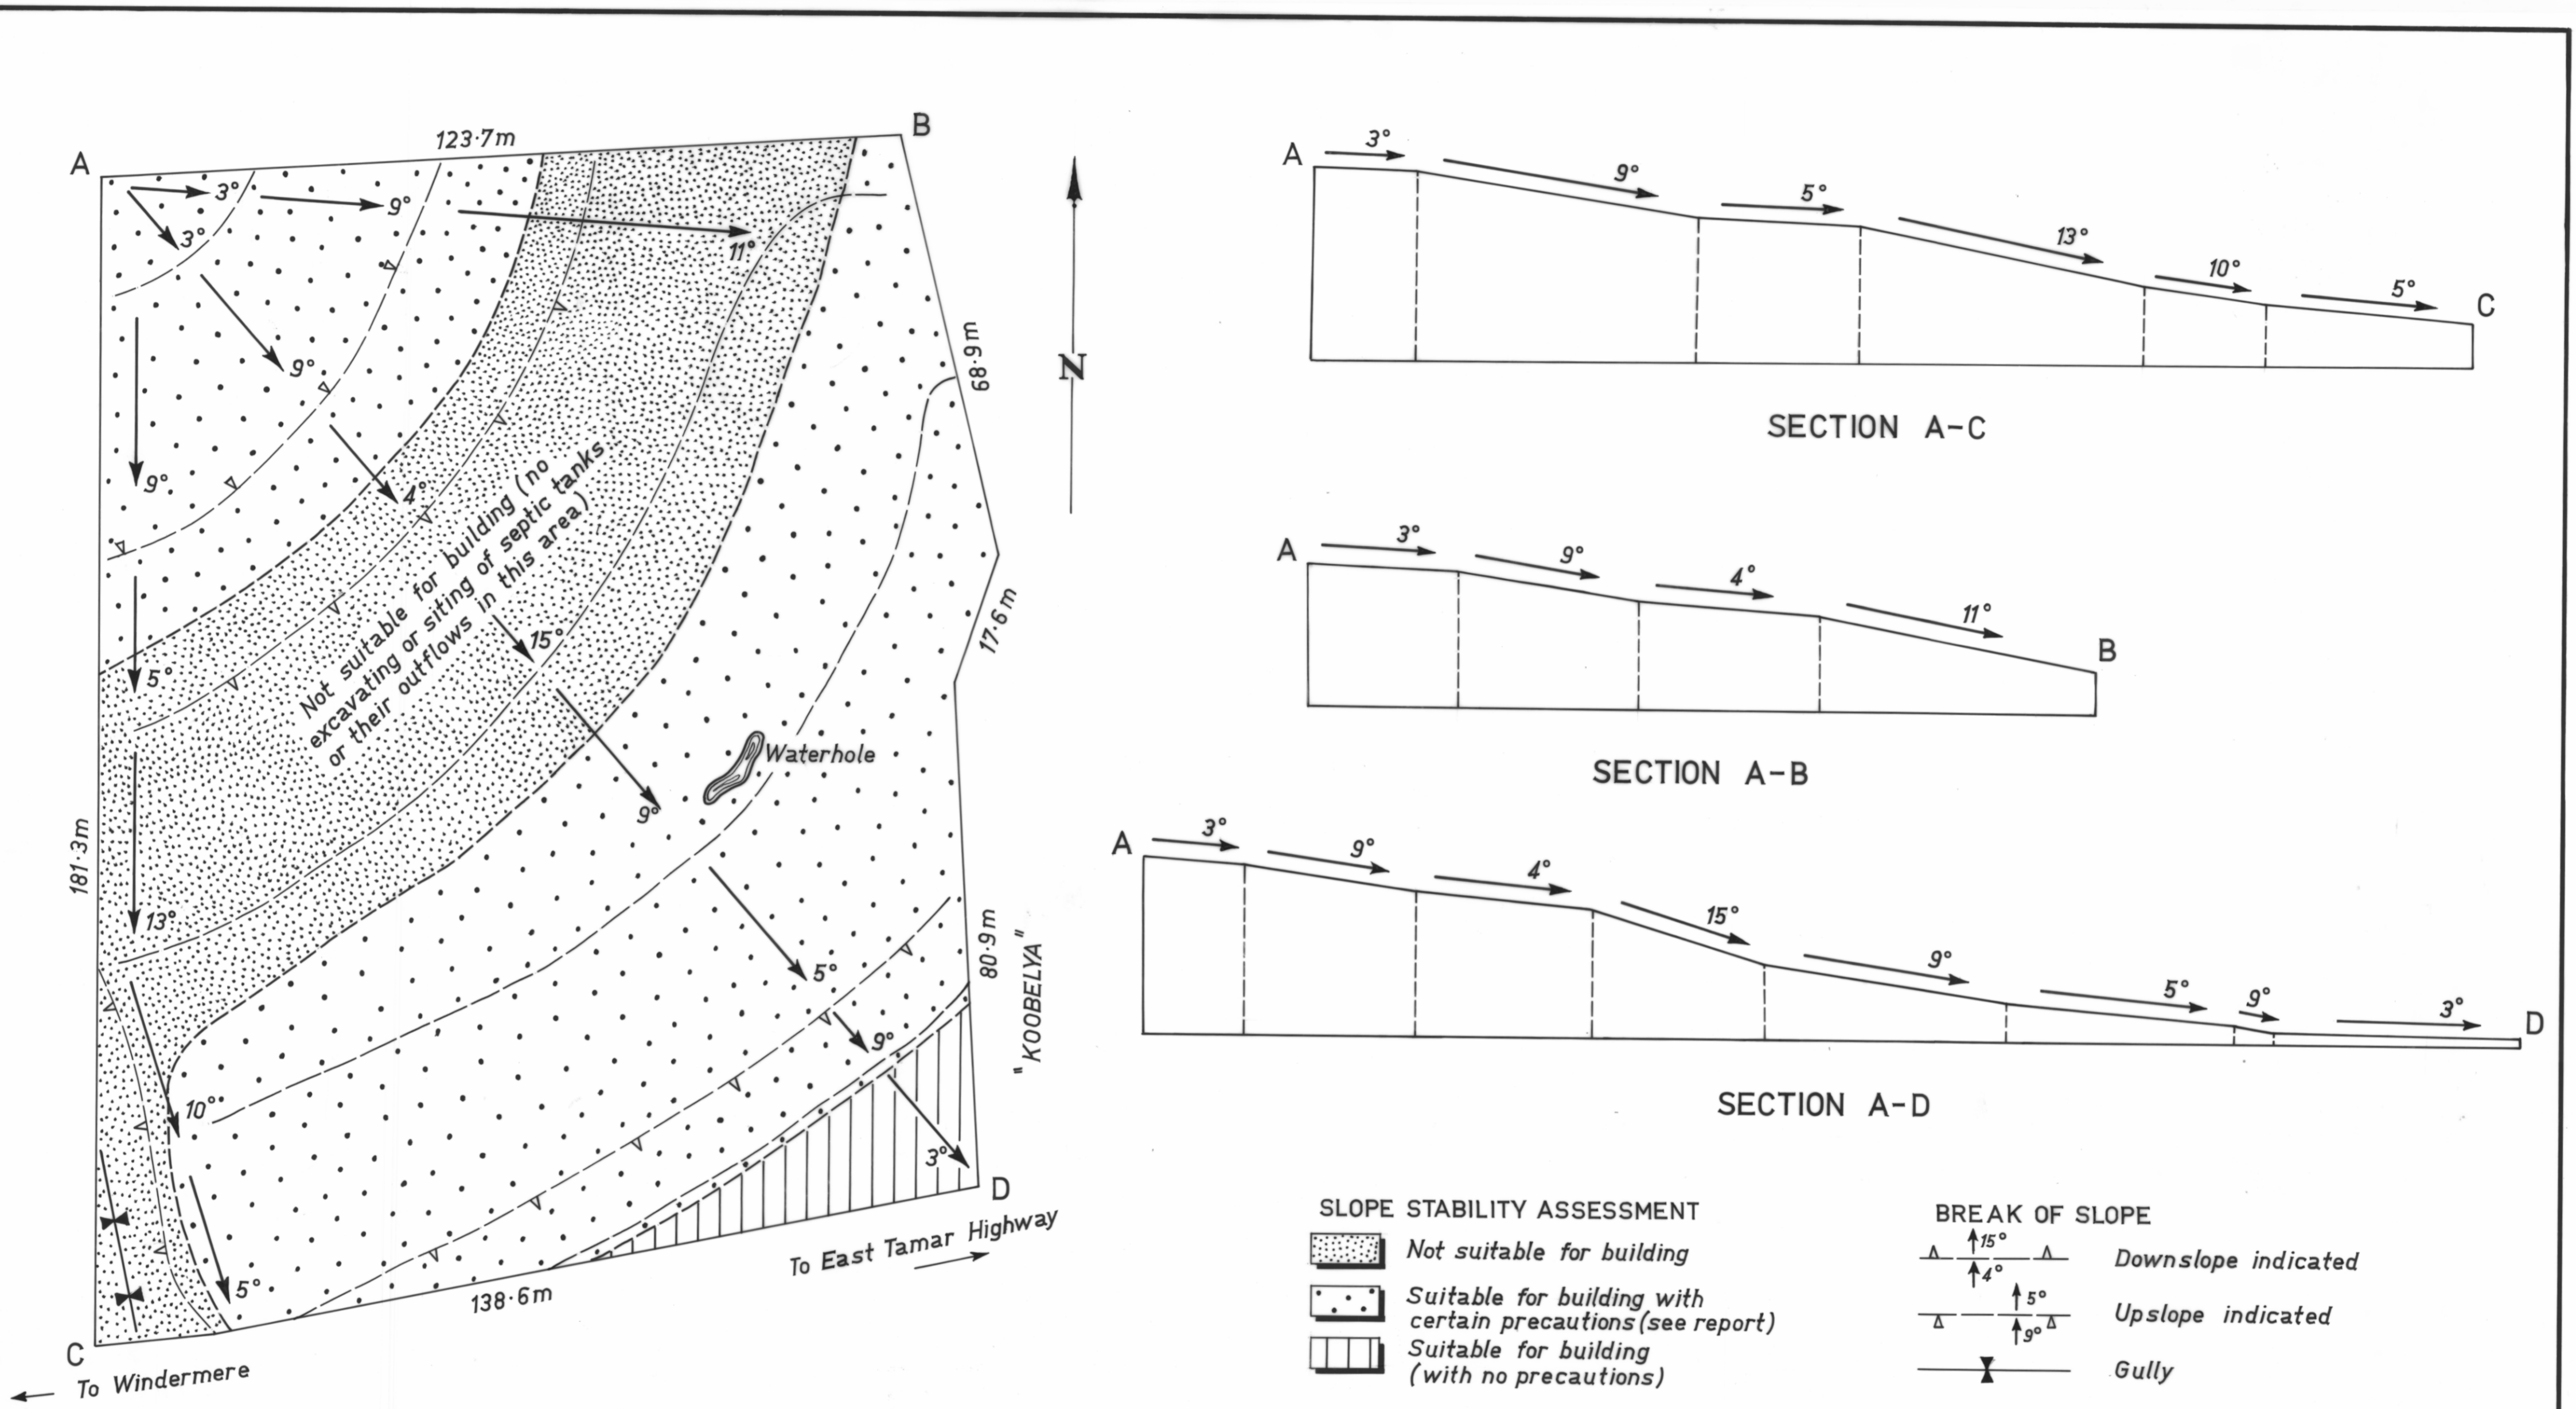
Fig.1

NOTE :- No contours on original plan
Survey by pace compass and
abney level.

Not suitable for building
-

Suitable for building with certain precautions (see report)
-

Suitable for building (with no precautions)
