DETAIL OF CRACK PROPAGATION FROM MAIN CONSTRUCTION JOINT

SOUTH WALL FOUNDATION

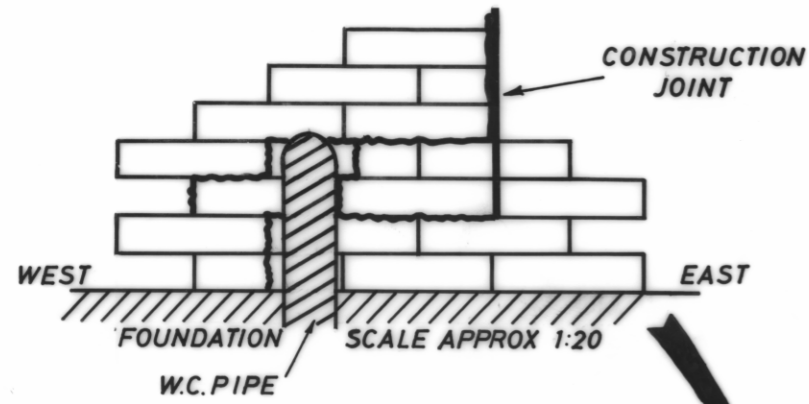
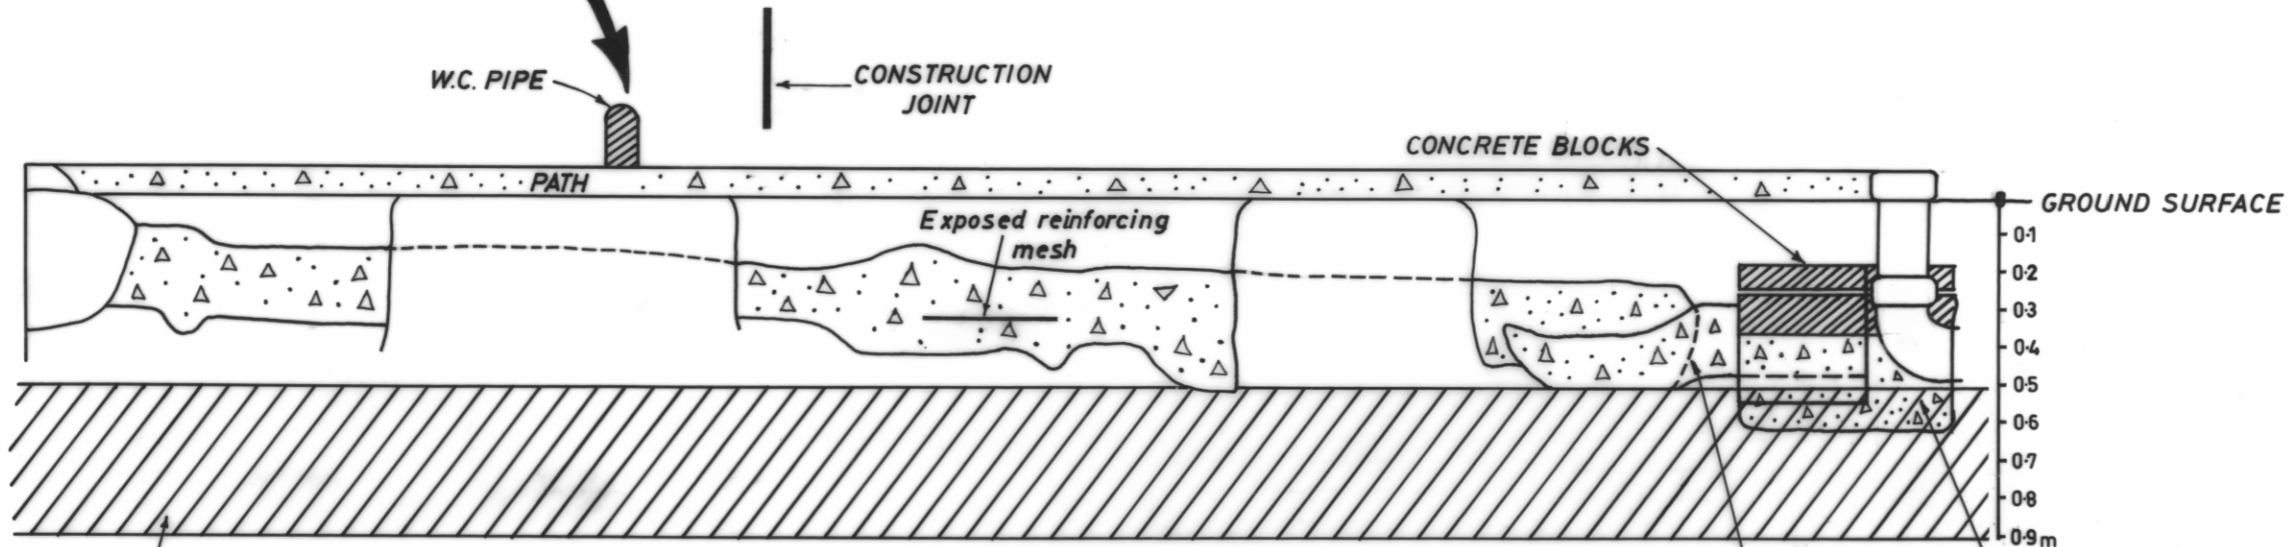
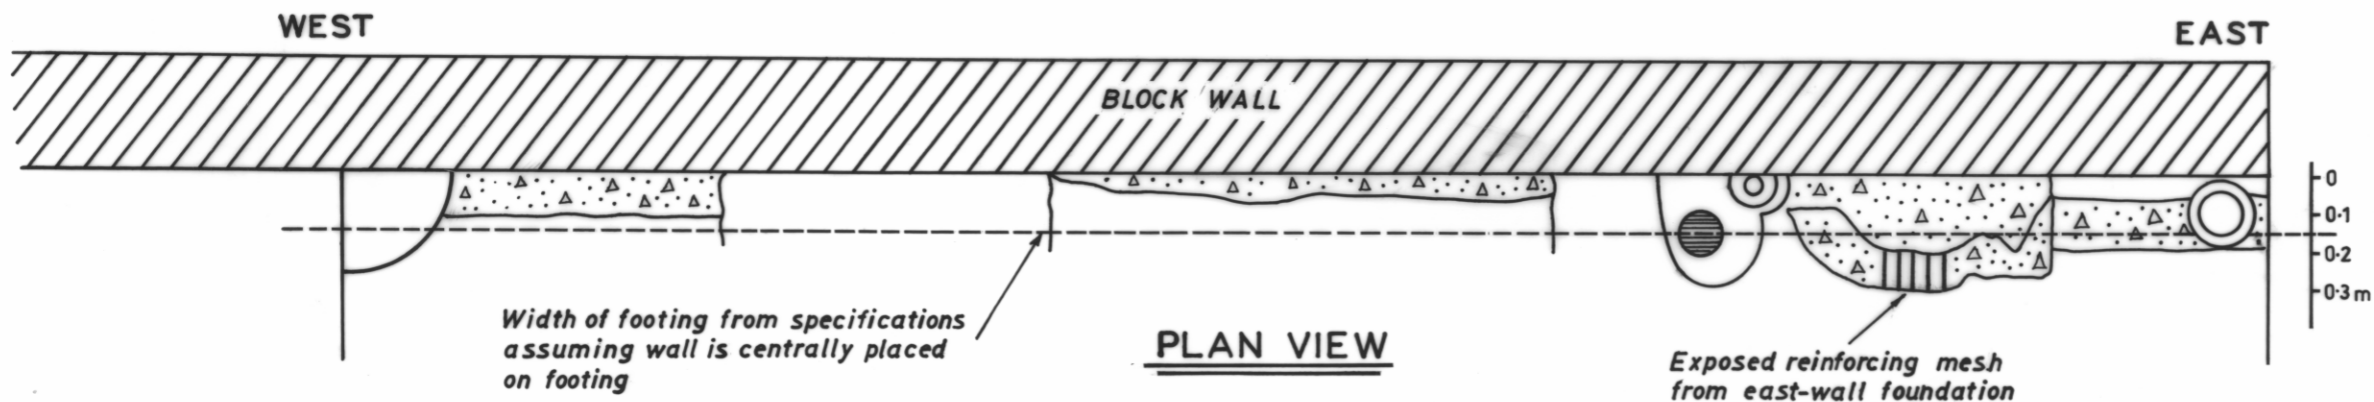
FIGURE 4.

Location of footing according to design specifications

Originally 125cm gap subsequently patched by owner

Concrete pad plus owners modification (increase in width and thickness)

Width of footing from specifications assuming wall is centrally placed on footing
