# GLADSTONE DISTRICT

## SECTIONS OF BORES

LOOKING NORTH

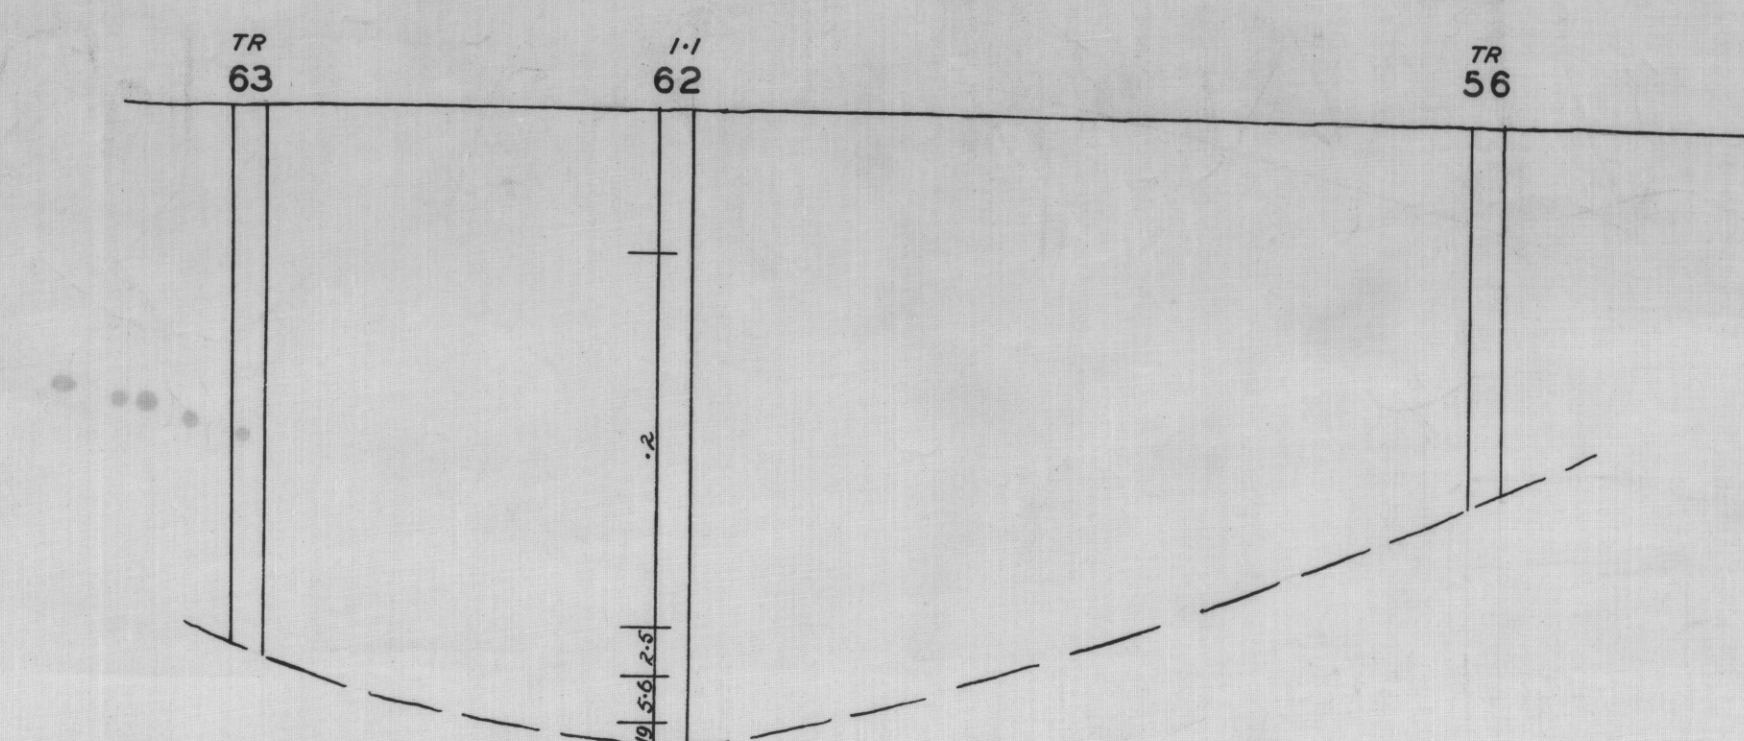
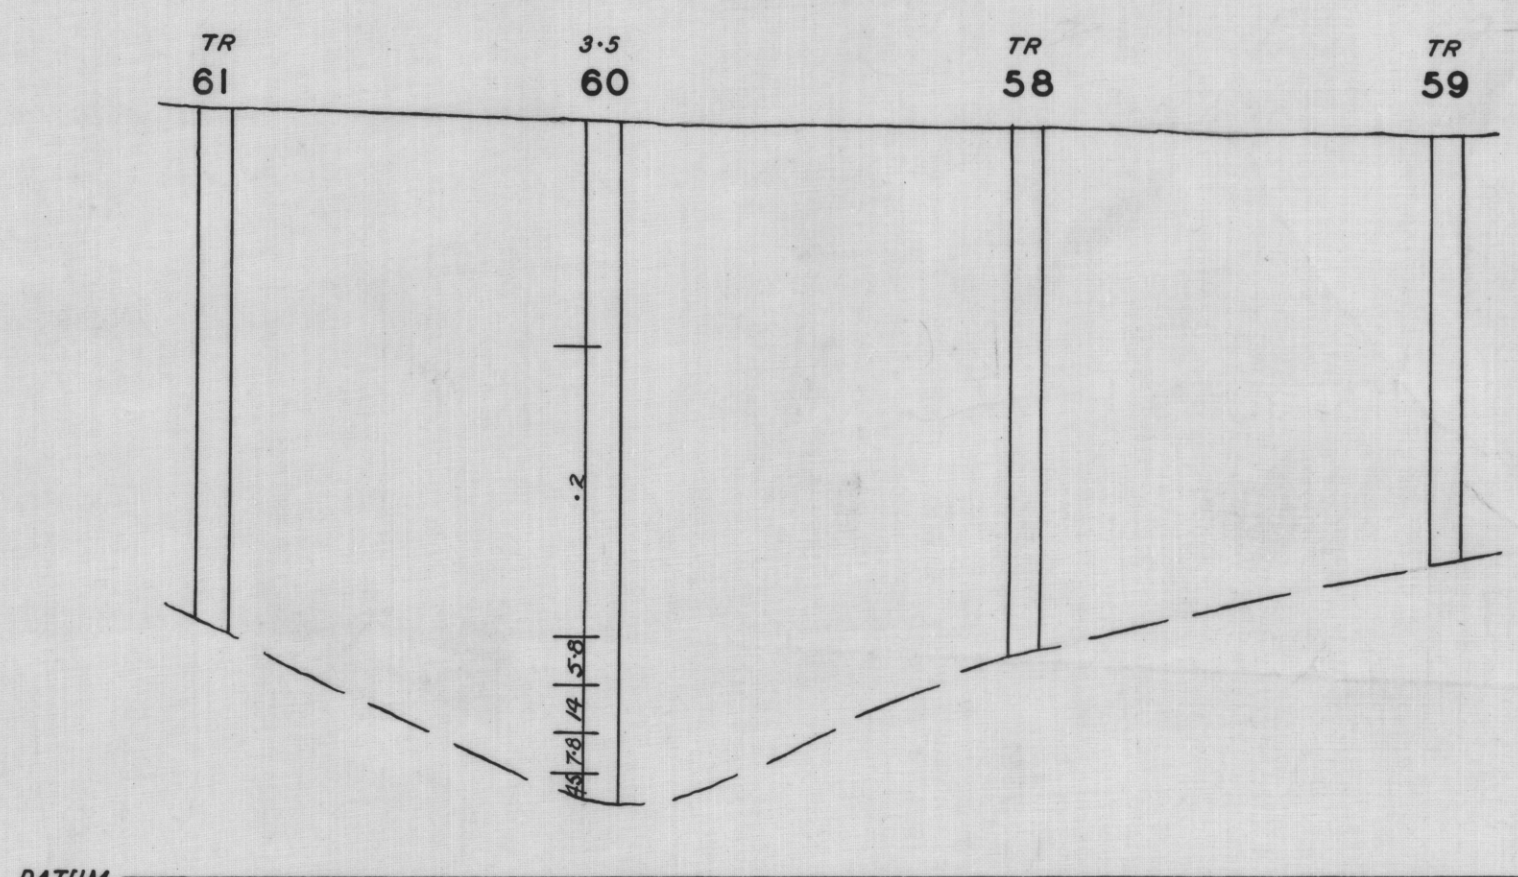
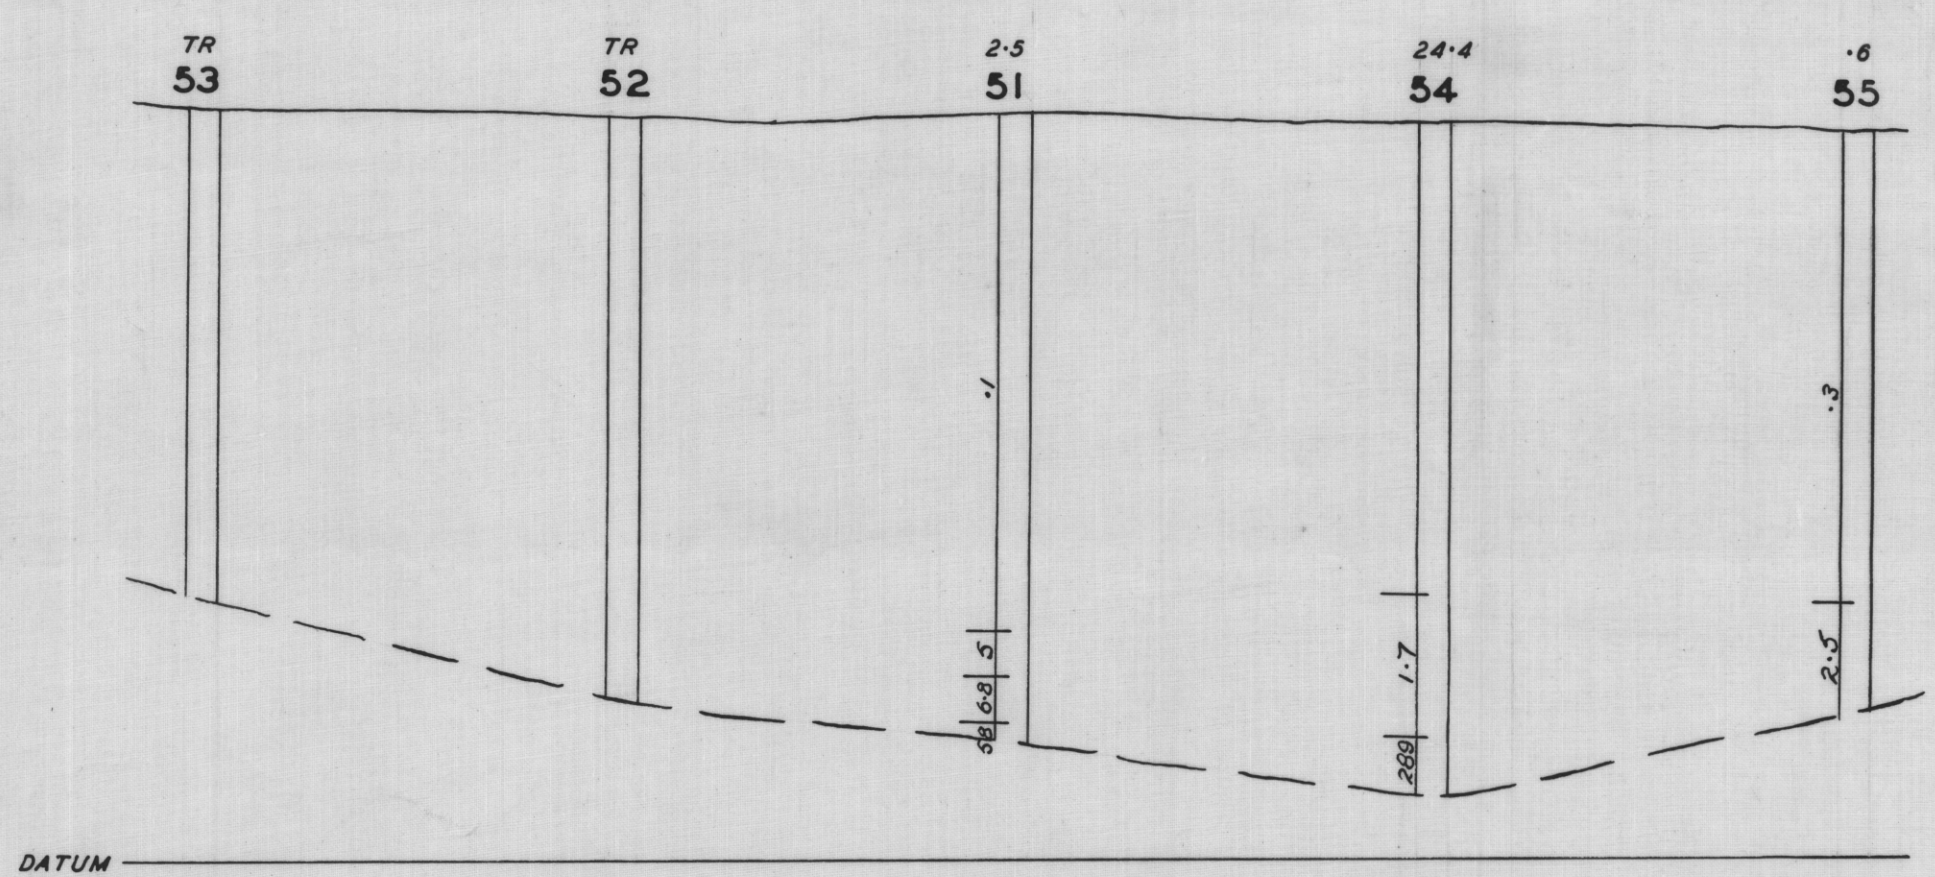
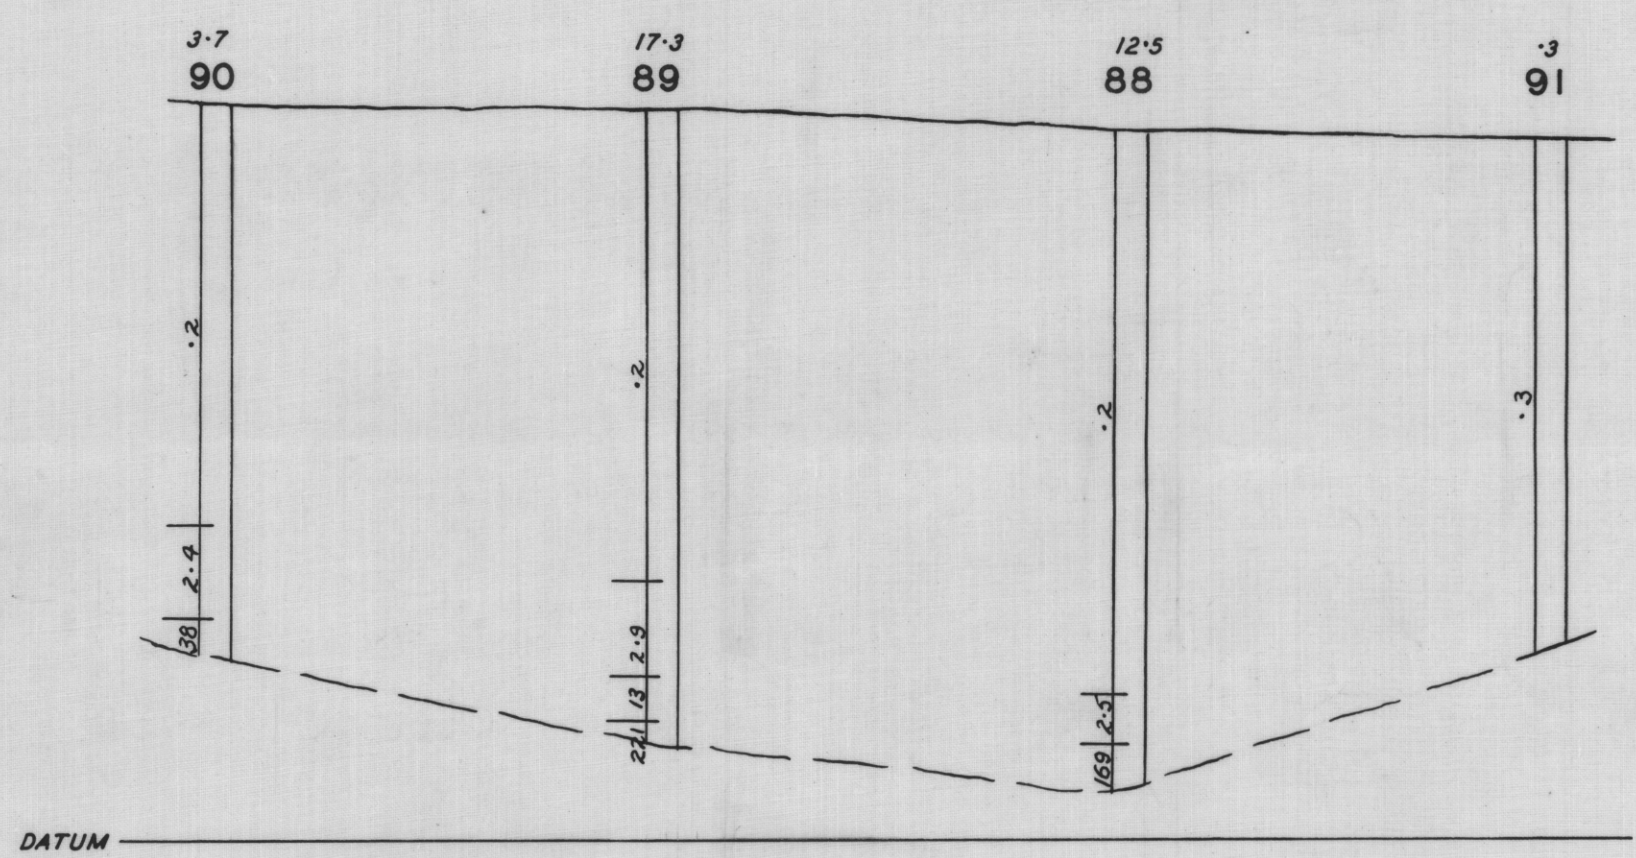
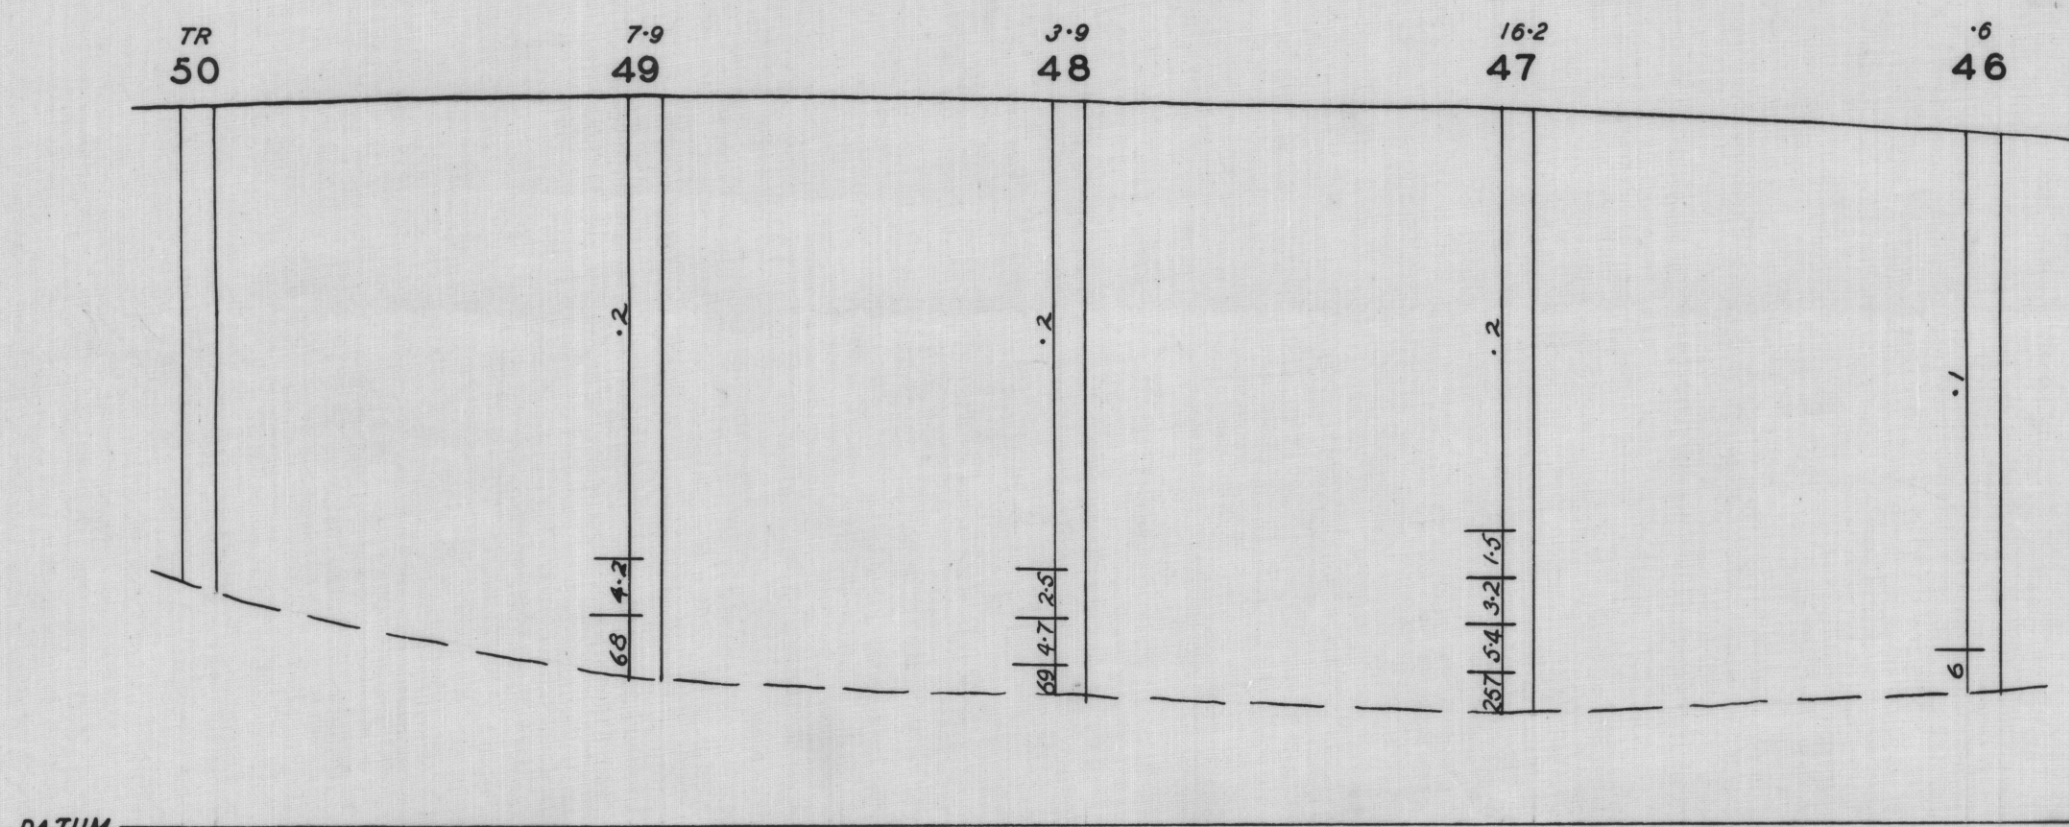
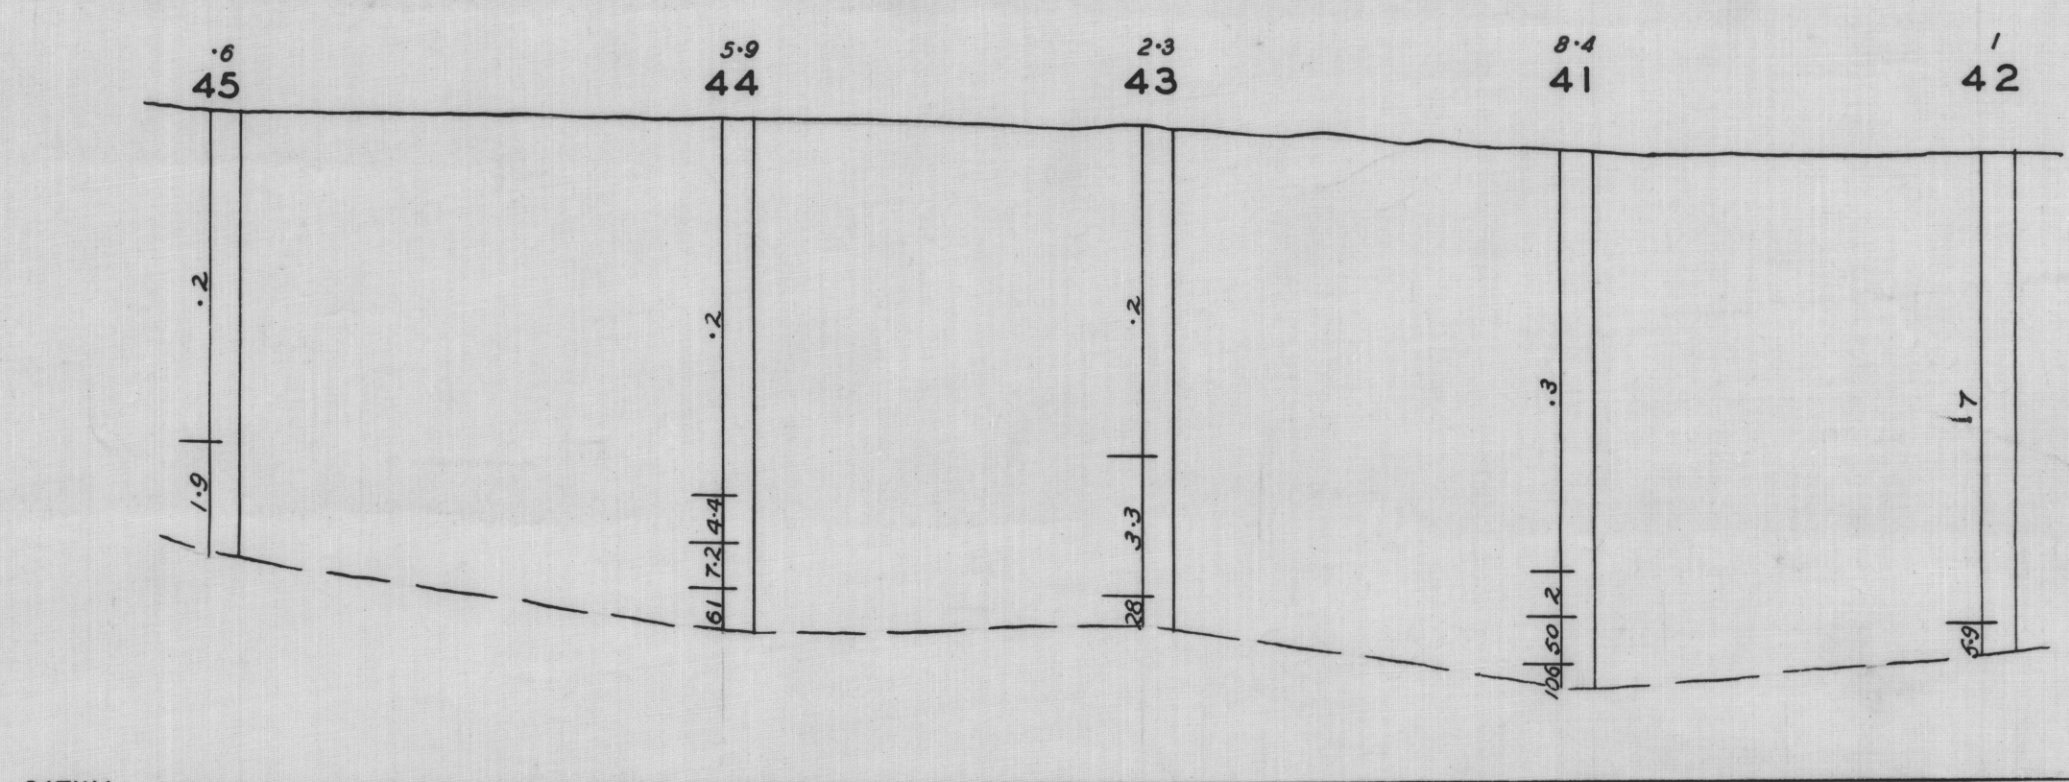
SMALL FIGURES ABOVE EACH BORE INDICATE TIN CONTENT OF ENTIRE HOLE IN OZ. PER C.YD. OF 70% CONC.

ON LEFT OF PORTIONS SHEWN DATUM

DATUM IS WATER LEVEL IN RINGAROOMA RIVER AT FOOTBRIDGE
