# An Archaeological Survey & Assessment of the Magnet Mine, Waratah Area, Northwest Tasmania

**Prepared for Mineral Resources Tasmania**

**Anne McConnell**  
[with Nic Haygarth]

**August 2013**

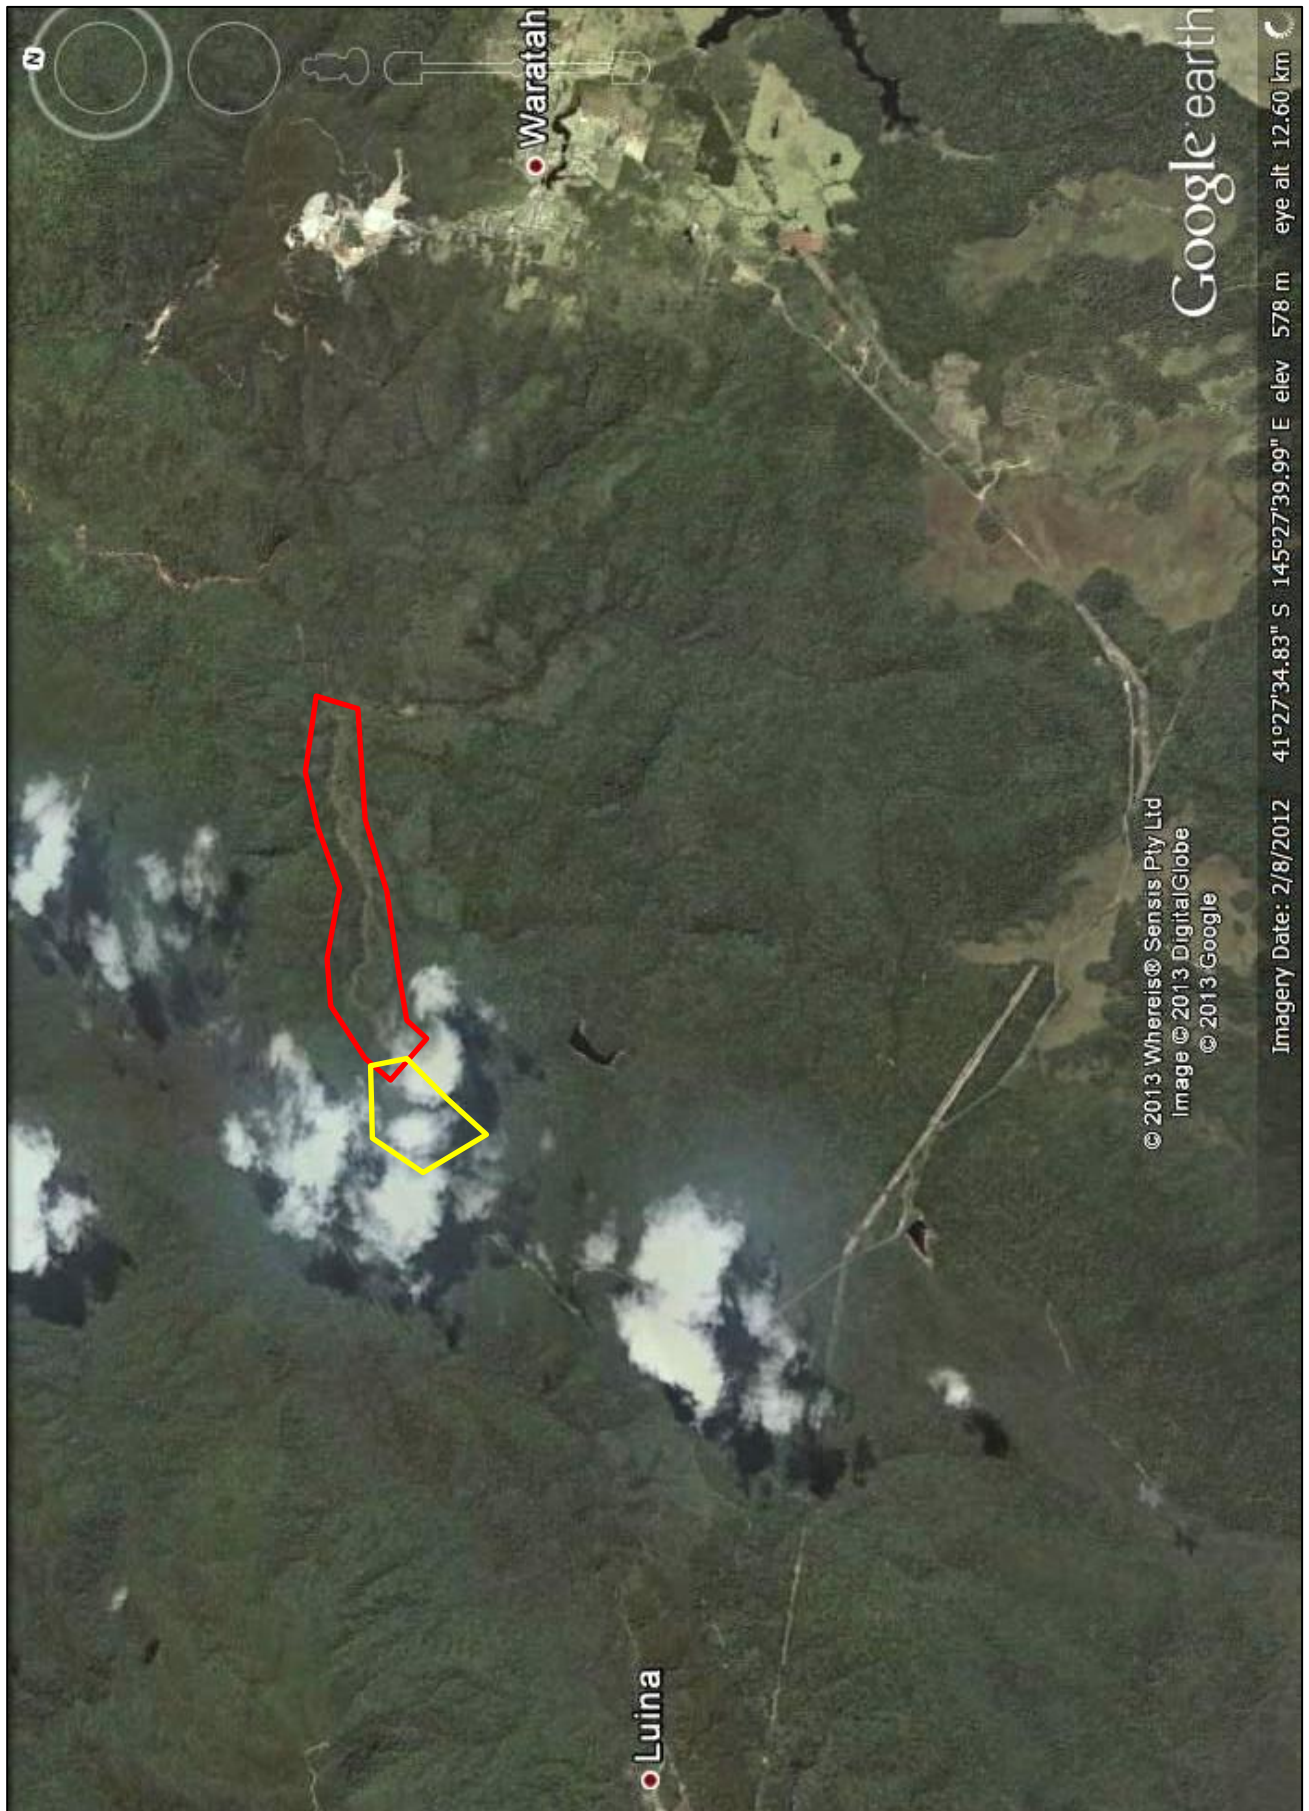
**Figure 2**

Setting of the Magnet Mine (the mine area is approximately indicated by the yellow line & the township area is approximately indicated by the red line). The mine area is largely under cloud.

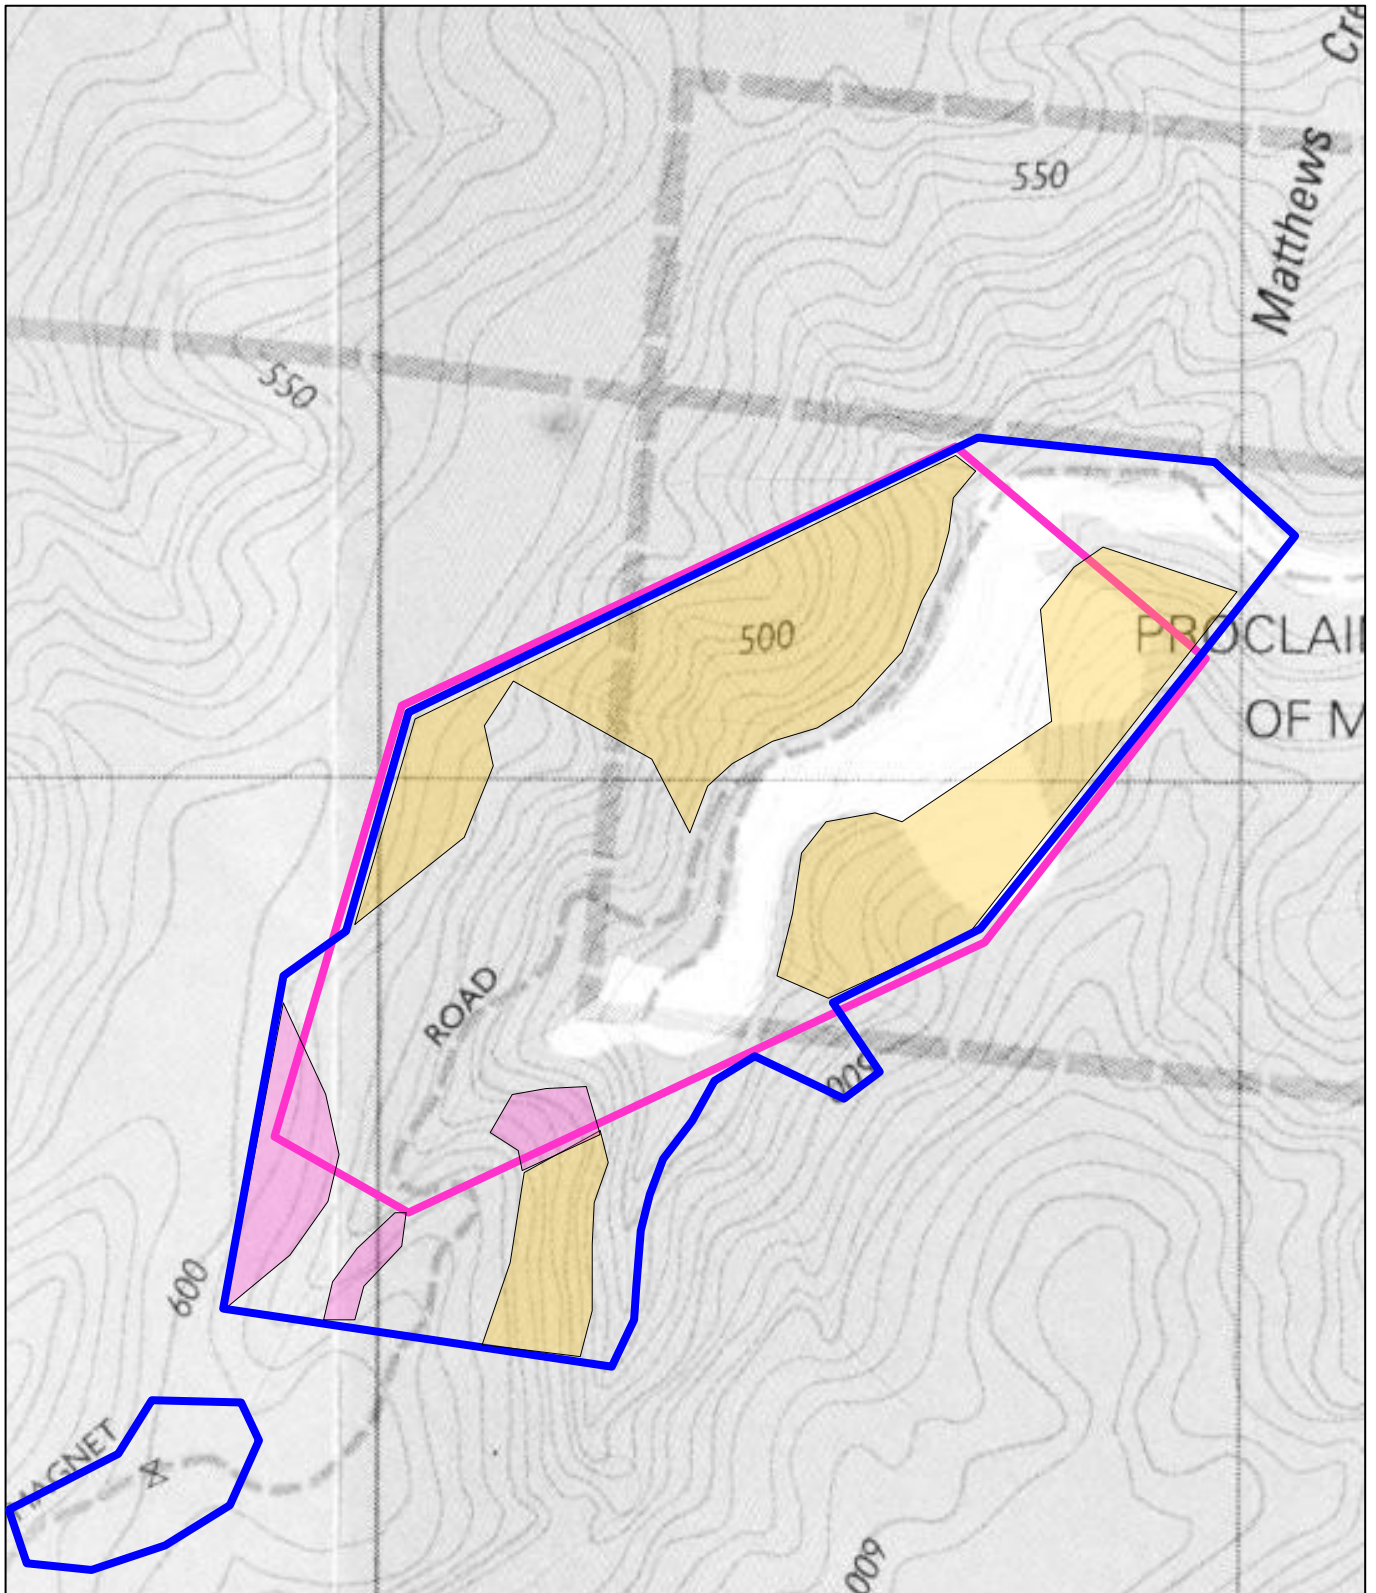
**Figure 4**

Because of the size of the area and the steep, heavily vegetated terrain it was not possible to carry out a systematic, 100% survey. The general approach was to broadly cover the study area focusing on areas of highest potential (based on historical information and Webster (2007)) and to locate the key historical features noted in the historical literature (eg, the Open Cut, adits, water races, tracks, railways, the mill and the power station). The survey approach in any one area was to work progressively in one direction, moving from one visible heritage feature to the next and following linear heritage features to the extent possible. This has meant that some areas within the surveyed area were not covered. It has also meant that some parts of the study area (ie, those deemed to have low potential for heritage) were not surveyed, and that the survey area was expanded slightly on the south and east edges to take in newly identified heritage features. The areas covered by the on-ground survey are shown in Figure 4.

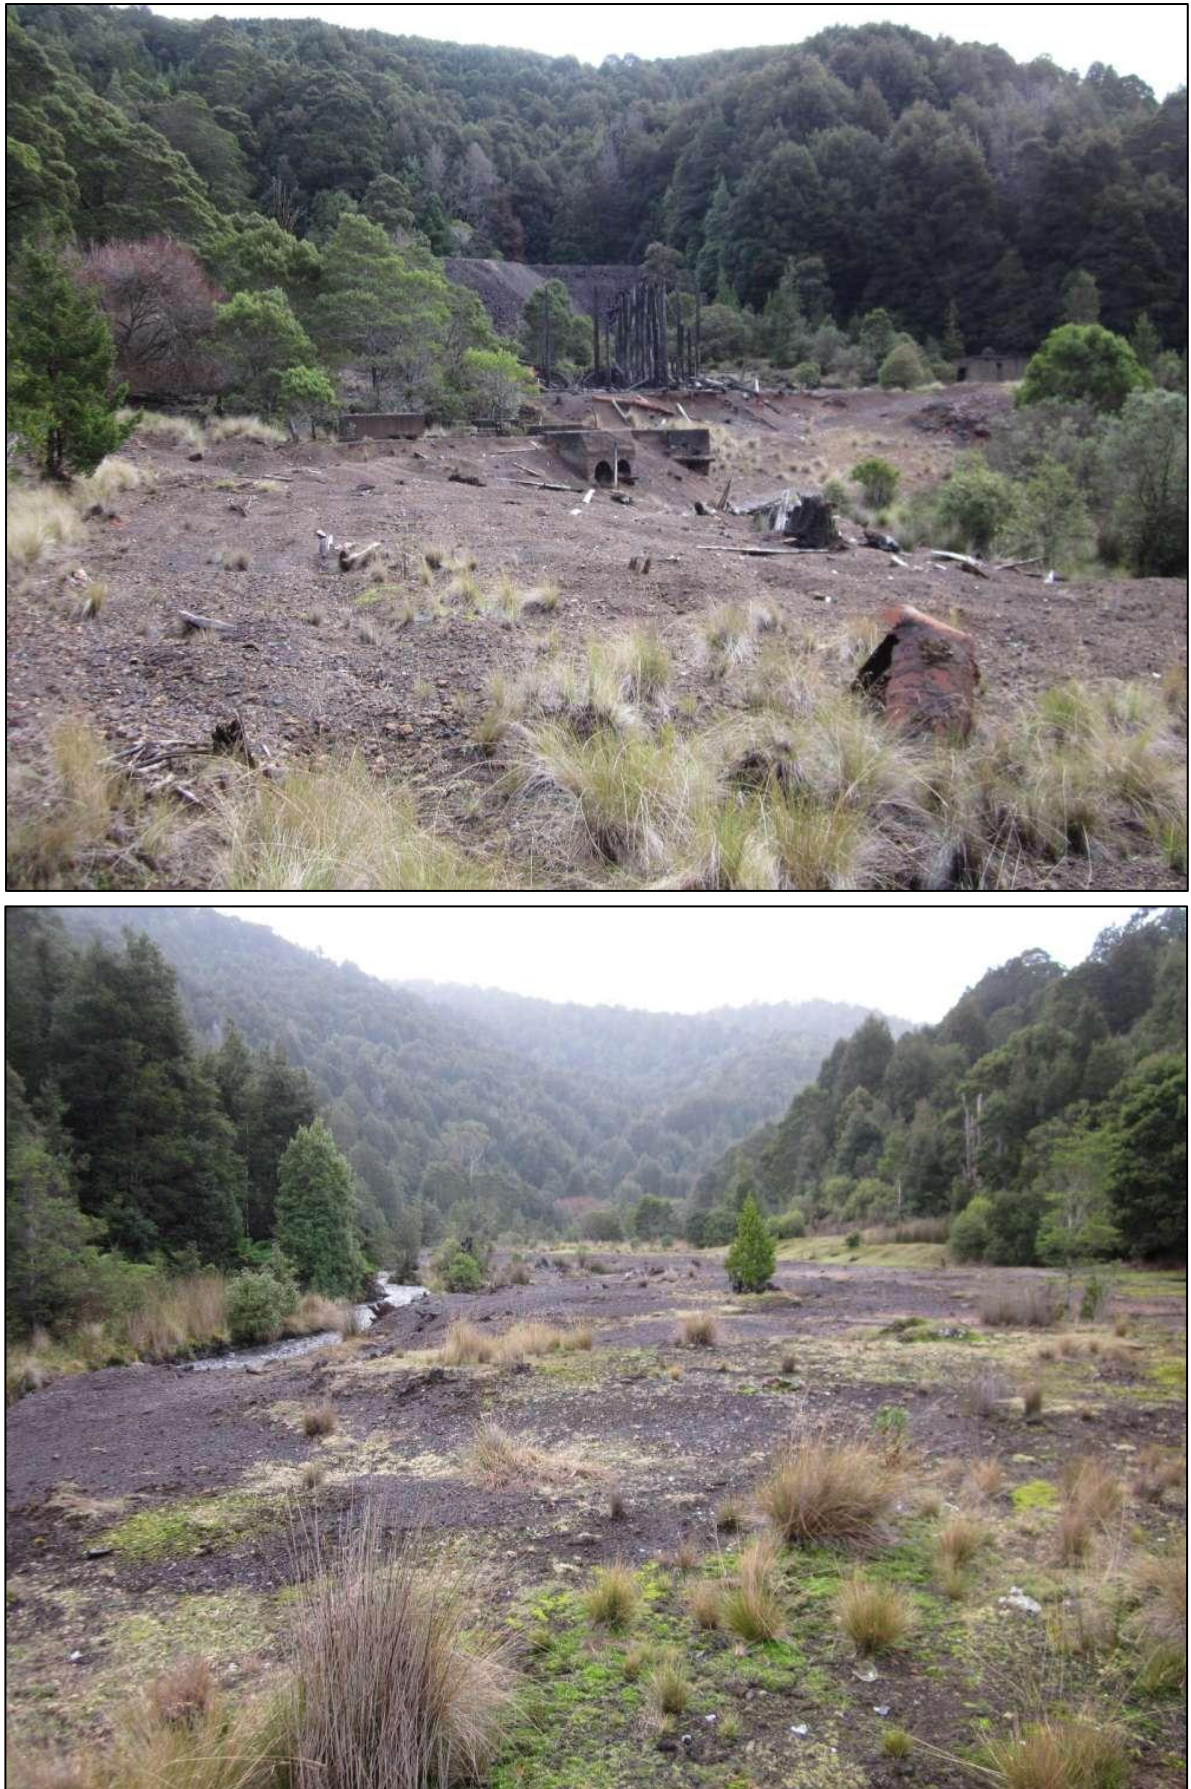
**Figure 6** Present day setting of the Magnet Mine, Top – General view of mine site from upper valley tailings across power station and mill site to the main west face and North Magnet Mine beyond (view NW). Bottom – view down valley in the Magnet Townsite area (view NE) (Images – A. McConnell, 2013).

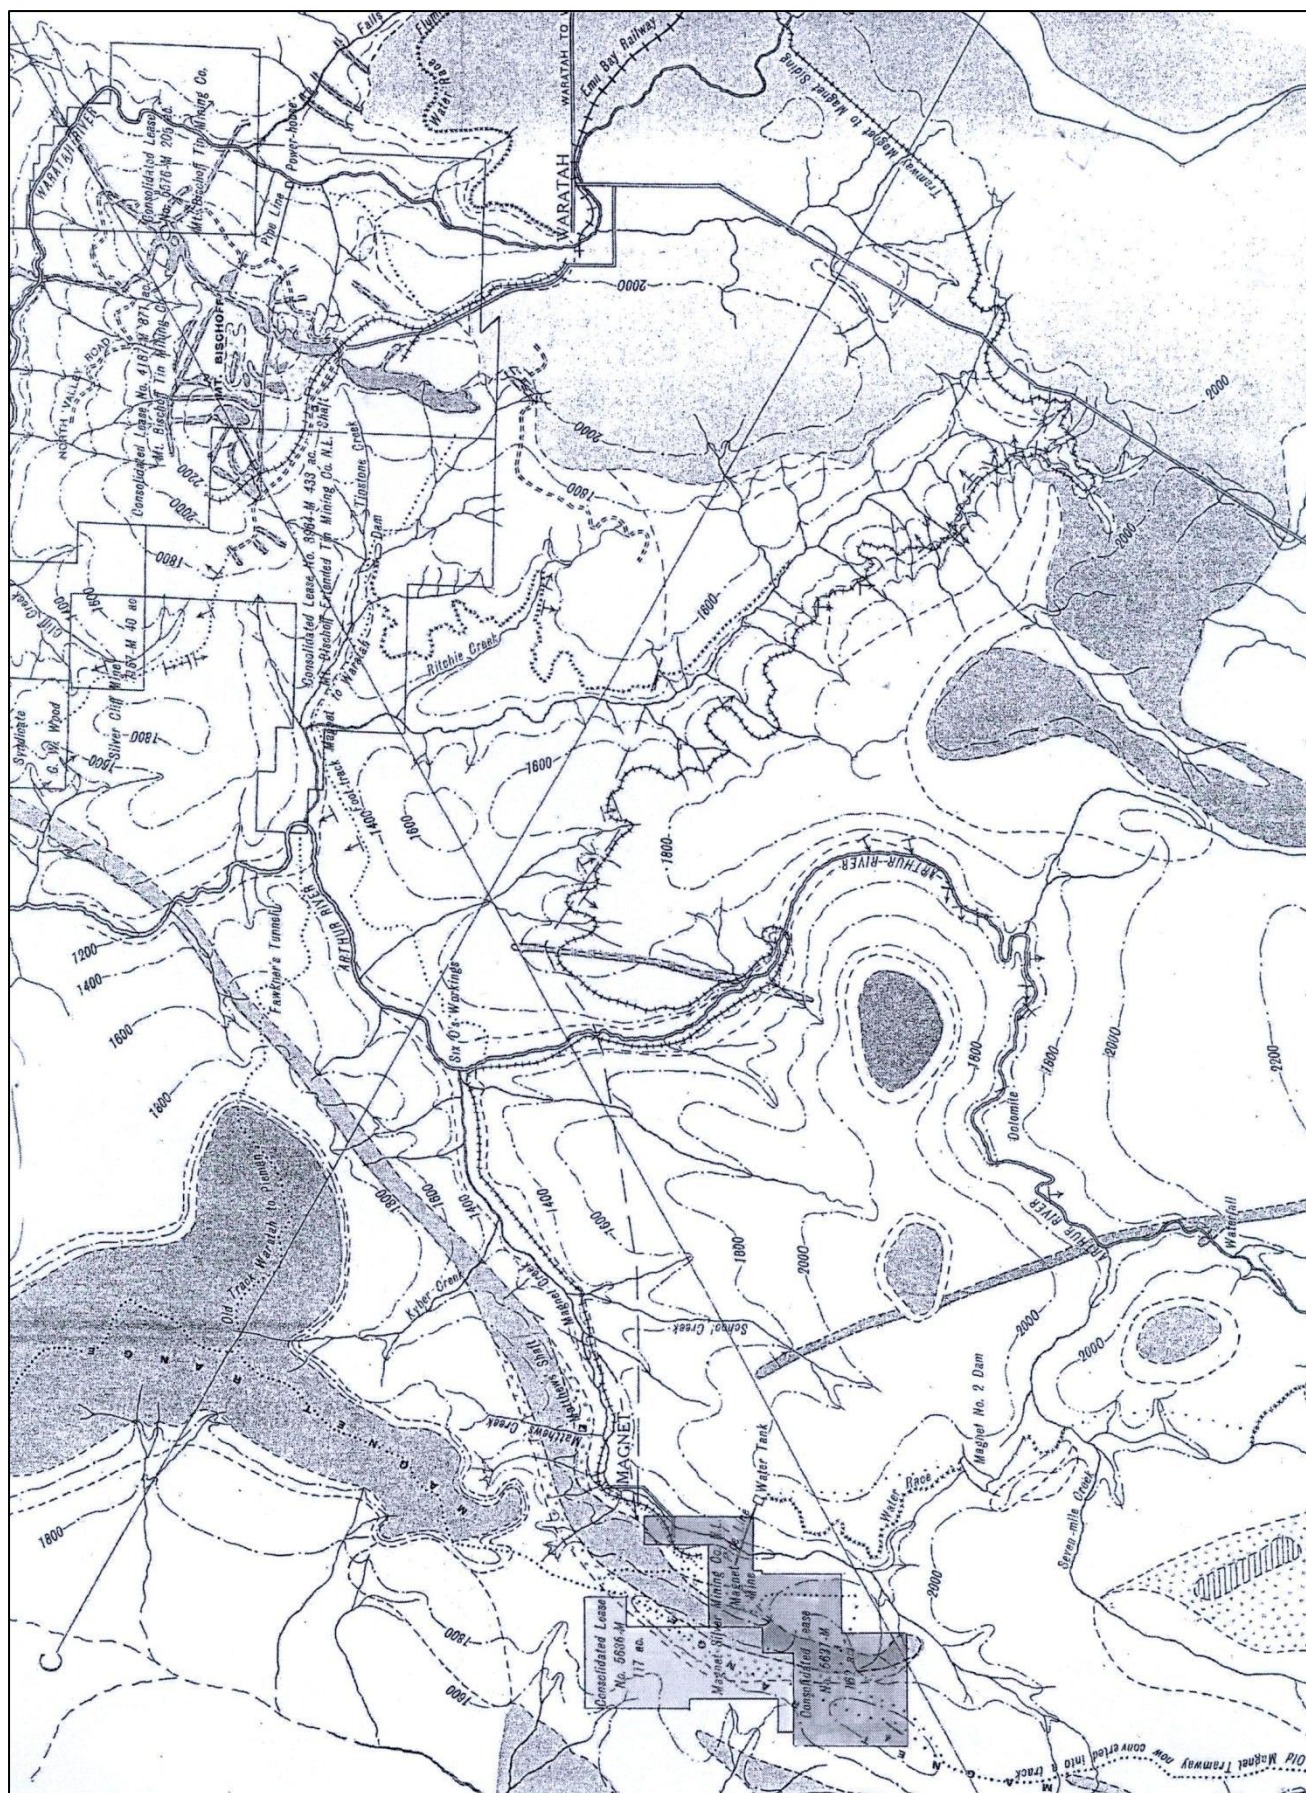
**Figure 8** Map showing historic features in the Magnet Mine to Waratah area (Source MRT no date, no reference).

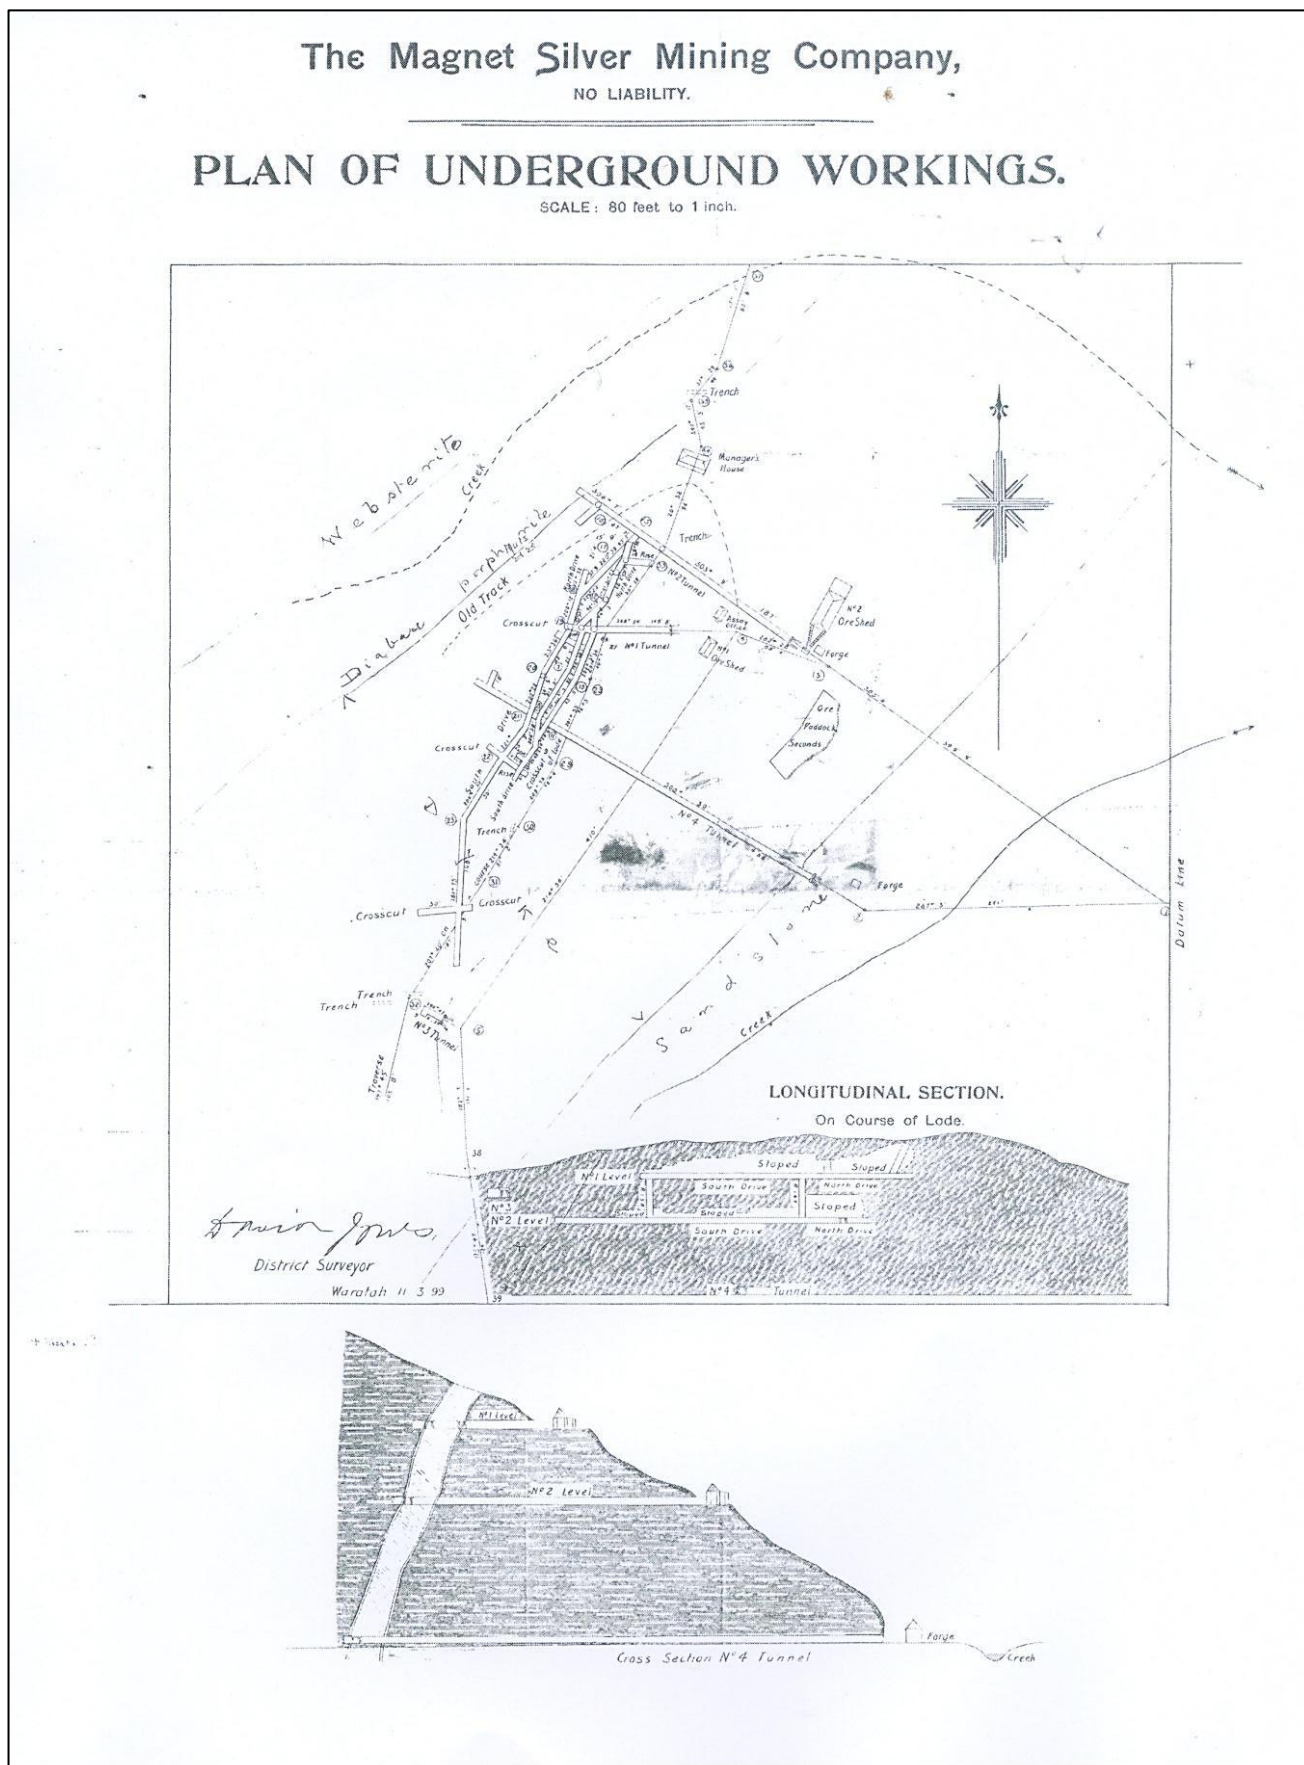
**Figure 10** Historic (1899) plan and cross section of the Magnet Mine (Source MRT 415).

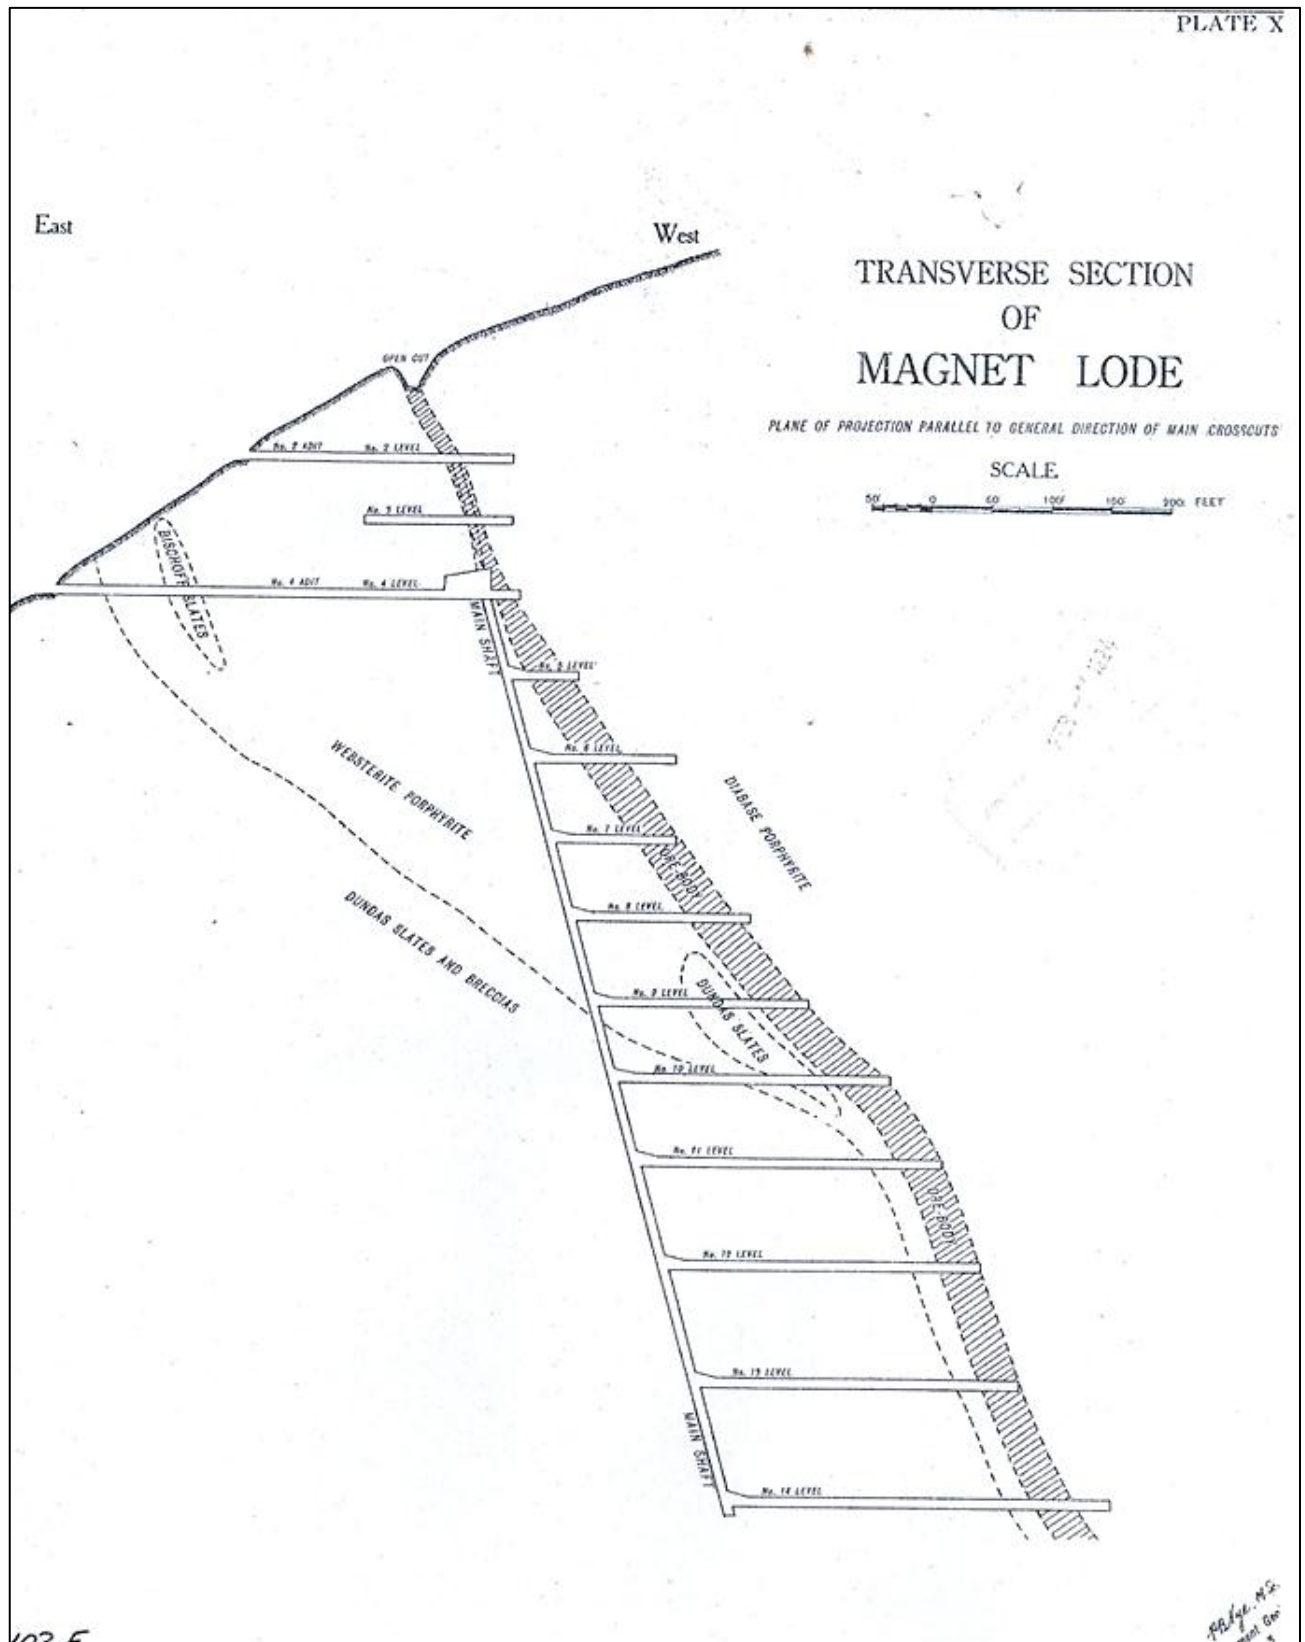
**Figure 11** Historic (1923) cross section of the Magnet Mine (Source MRT GSB33).

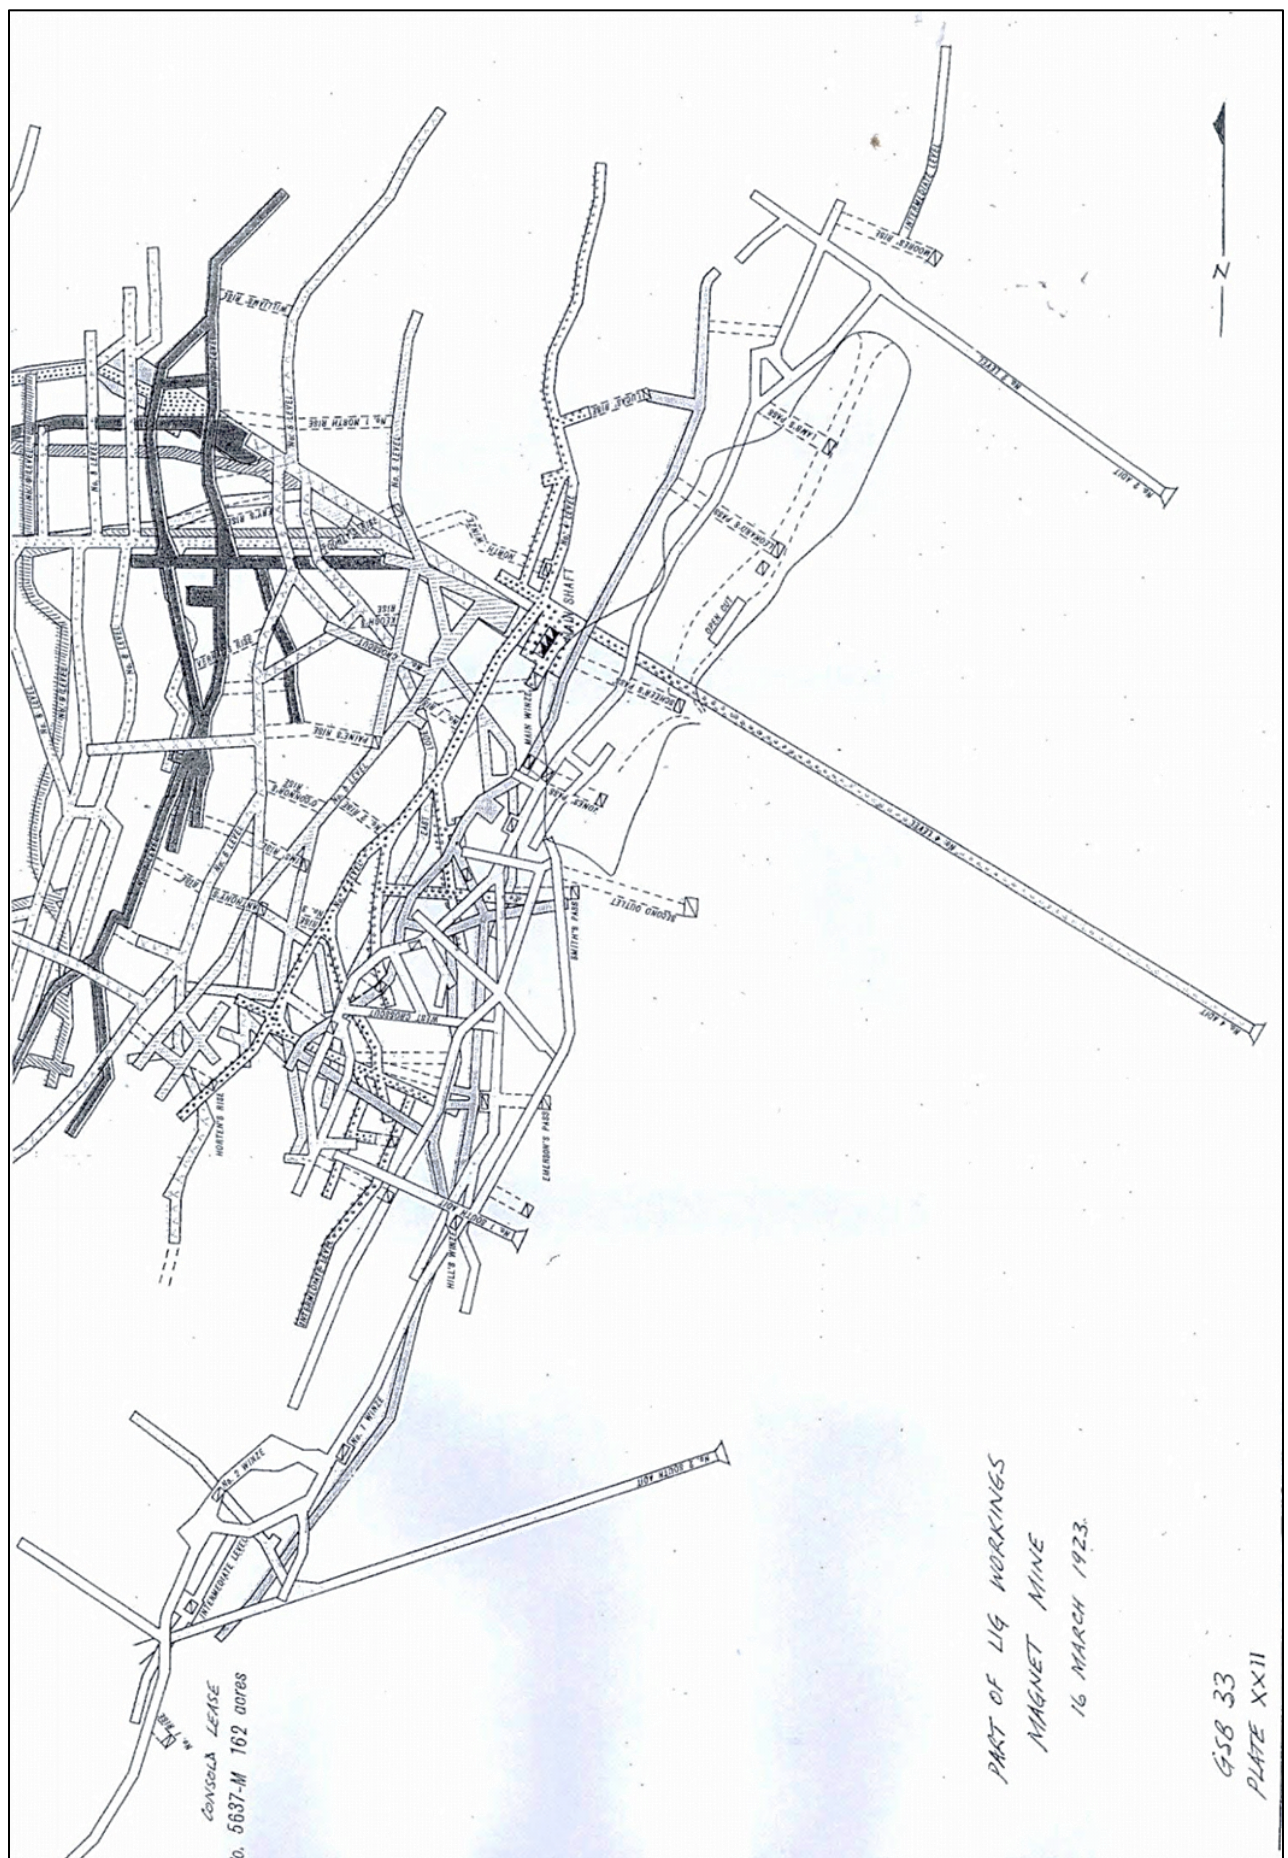
**Figure 12** Plan of the main part of the underground workings of the Magnet Mine—1923 plan (MRT GSB 33).

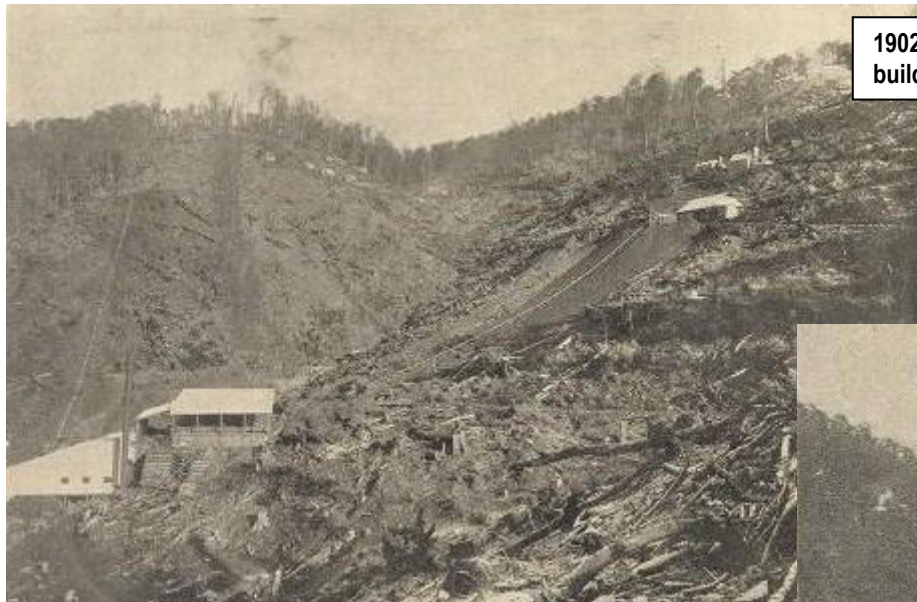
1902 View southwest across upper mill buildings to south spur (WC 2/8/1902)

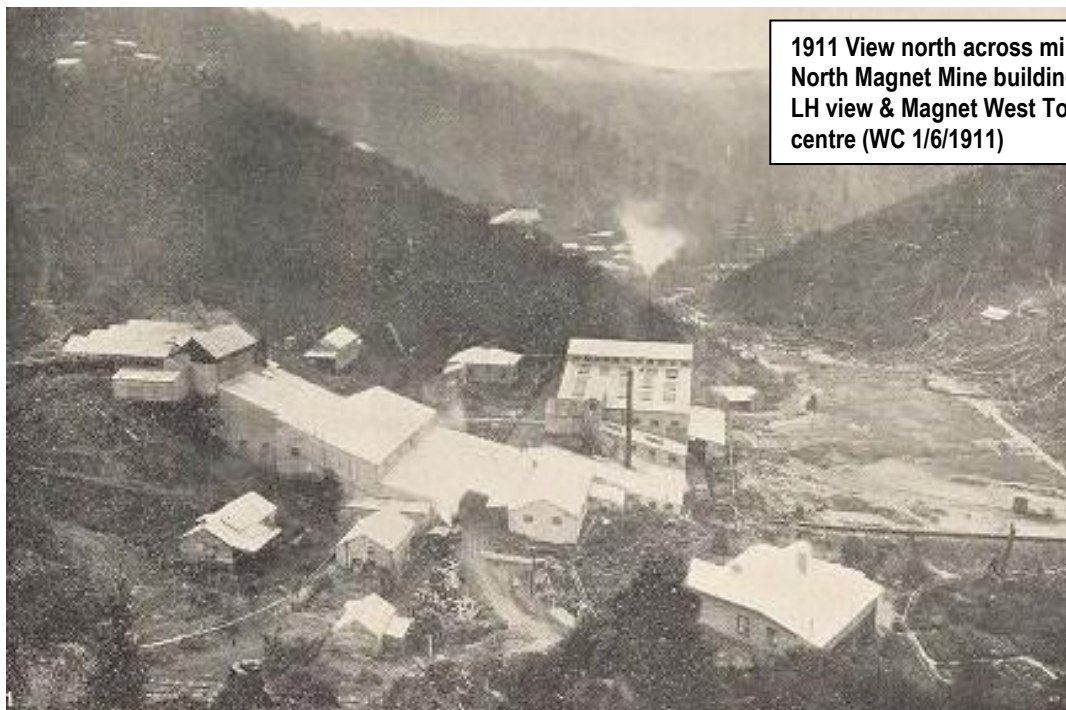
1911 View north across mill buildings; North Magnet Mine buildings in upper LH view & Magnet West Townsite in far centre (WC 1/6/1911)

MMS	F20	<b>Modified Area:</b> Area that appears to have been slightly levelled historically (now in regrowth forest) with spoil pushed to the NW forming a steep short bank in this area; difficult to interpret due to the extensive modern bulldozing (rehabilitation?) to the E.	unknown	<i>not assessed</i> (potentially of low significance)	0370187.5410667	584	
MMS	F21	<b>Mullock &amp; Cutting:</b> Low mound of mullock, c.15m long x 3-4m wide that has a c.2-3m wide opening through it (- historical mullock that has an historical track cutting through it at right; difficult to interpret due to the extensive modern bulldozing (rehabilitation?) to the E.	unknown	<i>not assessed</i> (potentially of medium to low significance)	0370167.5410610	593	
MMS	T1	<b>Tramway:</b> Benched c.8'-10'/10'-12' wide track; major track leading from main mill area (connecting to MMS T2 and MMV T2) S along and slightly above the W side of the creek to F1 and F3; the track narrows to c.4'-6' beyond F3, and it is not clear if it extends S beyond F1; near the N end it has a link track up to MMS T2, then intersects with MMS T2 further S (at F4). Originally a tramway at least to the i/s with MS T2 (refer 1917 plan in Webster 2007).	by 1902? [the N end linking to T2 is clearly evident in Weekly Courier image 2/8/1902 (& 3/10/1903); track clearly evident in 1911 (looks to be in operation) in Weekly Courier image 1/6/1911]	high	0370424.5410903 – 0370442.5410852 – 0370446.5410808 – 0370390.5410653+?	465-468-476

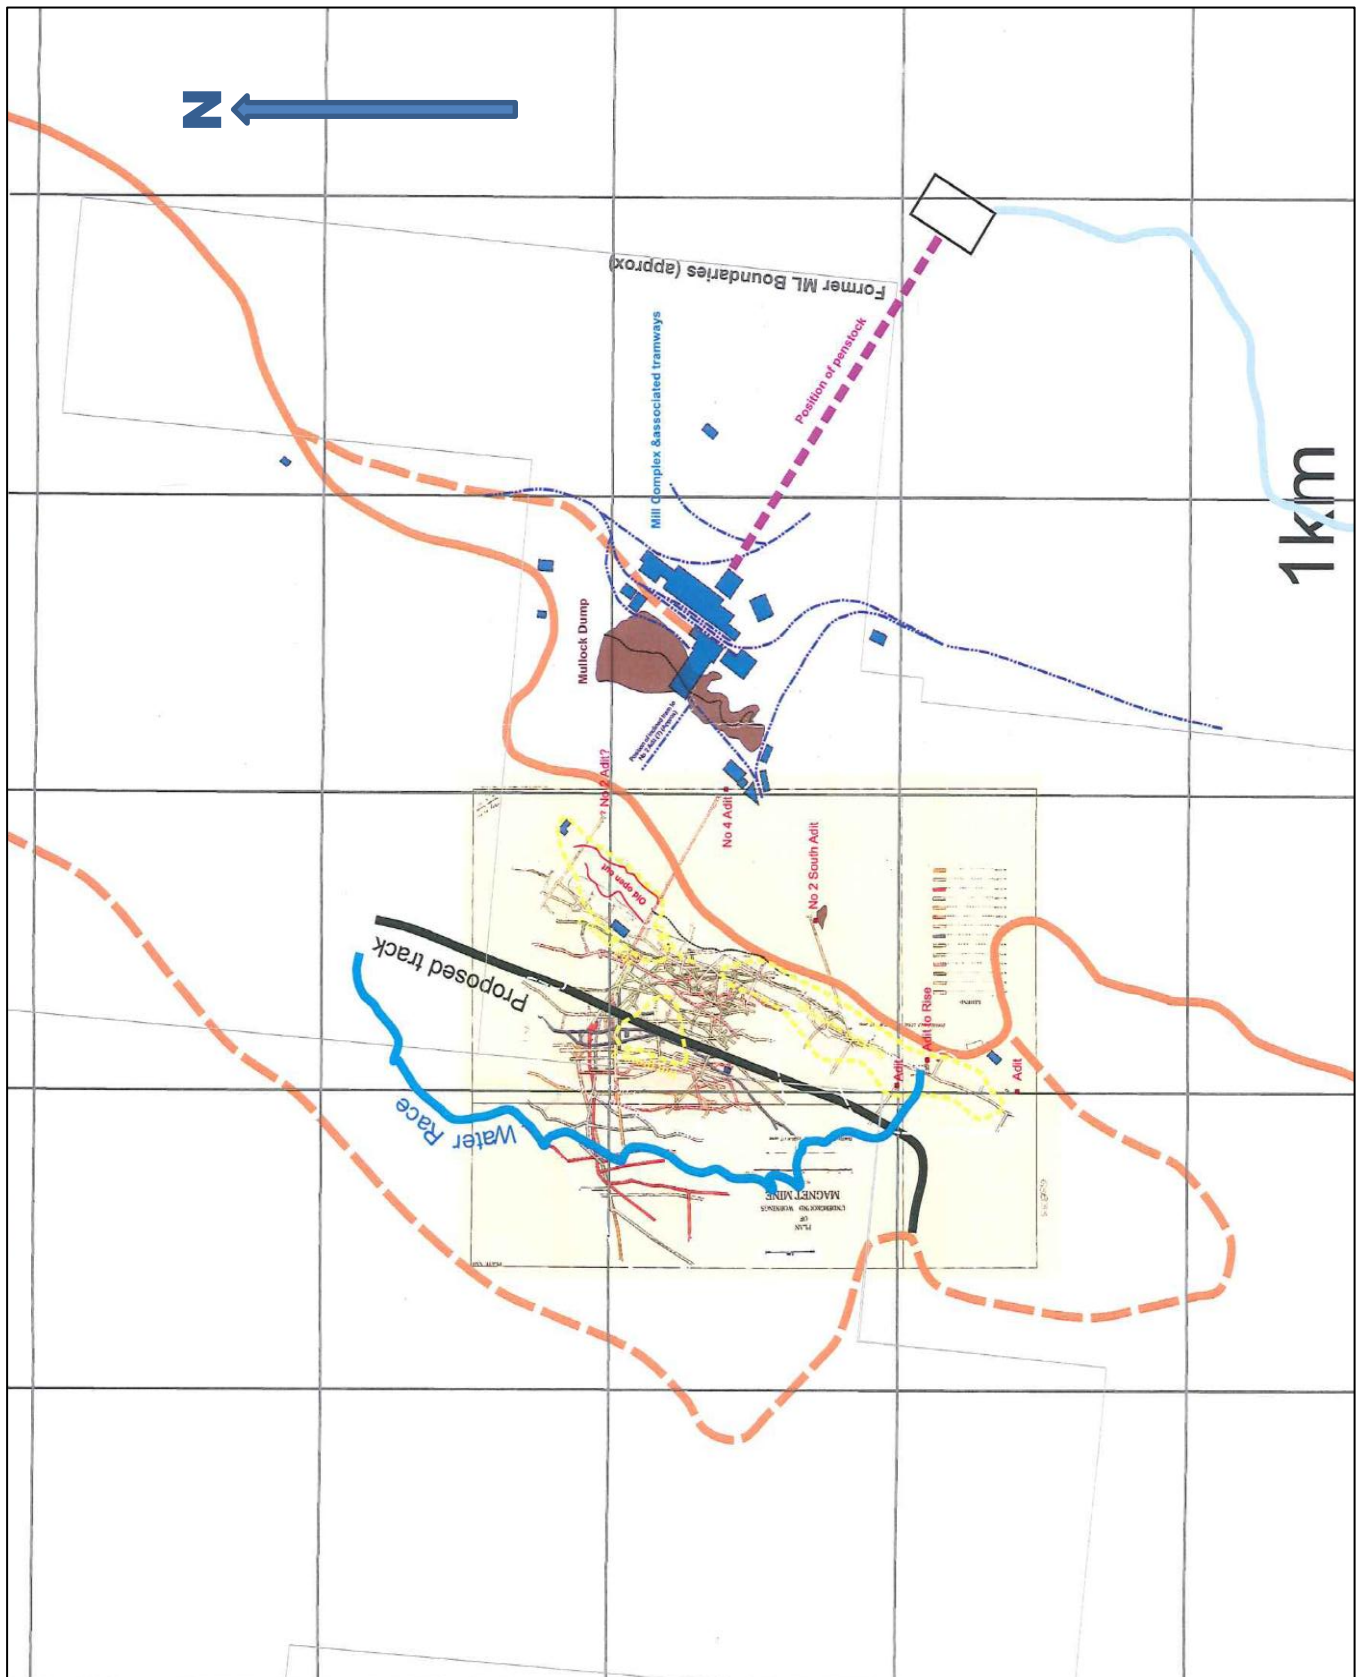
**Figure 14** Plan showing the historic heritage features located by Webster (2007) at the Magnet Mine and the extent of the underground workings in c.1923 (Source – Webster 2007).

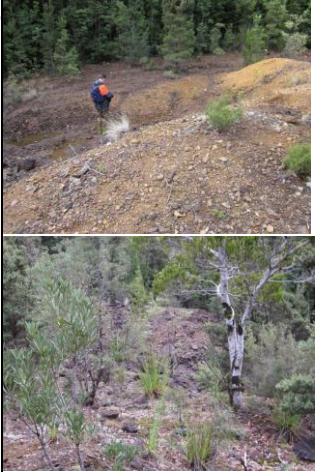
MMS	F1	<p><b>Adit – South Adit &amp; finger dumps:</b> Large adit on creek edge and c.2m above creek level with a two headed finger dump at same level extending from the front at the same level across the valley (&amp; which has diverted the creek).</p> <p><i>Adit:</i> entrance is wide and 7m long and the side walls have partly collapsed; the portal is 6' high (partly infilled?), 6' wide with a 12' rock headwall; the adit is straight on a bearing of 264° for the visible length (c.20m); there is remnant timbering at the portal and inside the adit for the visible length; there is a strong flow/volume of clear water from the adit; also smell of sulphur.</p> <p>Twelvetreets (1918, 148-49) – describes the 'South Adit' as being driven at the time of his visit in 1917 and at the time "driven into the hill on a beautifully straight west line for a distance of 1039 feet" and planned to intersect the lode at a point c.300-400' south of the most southerly workings in 'the old mine'(main mine), and notes that the drive "is designed to intersect the lode below an outcrop of mineral located in one of the south trenches", and to intersect the lode at a point c.300-400' south of the most southerly workings in 'the old mine'. Nye (1926) notes that the South Adit was connected to the main mine via a rise from the No.8 level of the mine before 1926, and that in 1926 a north drive is still being driven. Glasson &amp; Cox</p>	<p>1917</p> <p>(work (a north drive) continuing in 1926)</p>	<p>very high</p>	0370390.5410653	476

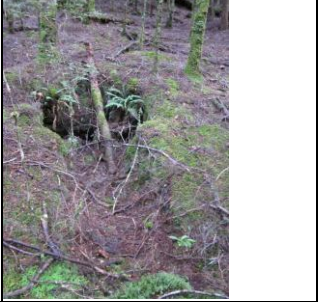
MMSW	F17	<b>Trench (possible Adit/Underlay Shaft?):</b> Large trench cut into hillslope; c.3.5m (10') long x 3' wide with a large rectangular area with a downwards sloping floor into the hillslope with a headwall of c.10'; bearing 294°; has a small spoil/mullock platform at the lower end which extends to the creek, and spoil down both sides of the trench.	unknown (probably 1920s-1932) [presumed to be the prospecting works noted by Nye (1932, 176) who notes 'other trenches still further south' (than the main mine lease).	medium	0370052.5410605	584

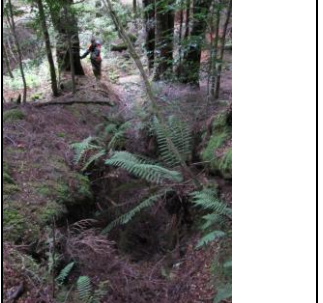
MMSW	F18	<b>Trench:</b> Large trench cut into hillslope; c.15m (45') long x 3' wide; bearing 285°; has a small spoil/mullock platform at the lower end which extends to the creek.	unknown (probably 1920s-1932) [presumed to be the prospecting works noted by Nye (1932, 176) who notes 'other trenches still further south' (than the main mine lease).	low	0370040.5410595	584

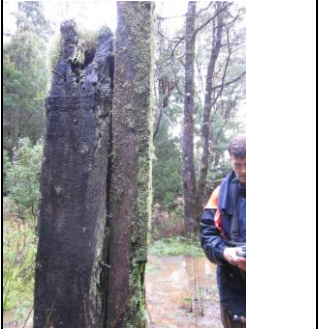
MMW	F2 (& F1)	<p><b>Cutting – for Building/Plant?:</b> Vertical sided cutting back into the S valley wall on the S side of the creek; cutting is c.10.5m (N-S) x c.12m (E-W) and the headwall is +3m high; the floor is flat and at the same level as the Adit 4 platform; there is some gci sheet in the area and remnant timbering (not diagnostic).</p> <p>Interpreted as a mine related building of plant site. No excavation is shown in this area in a 1902 Weekly courier image (2/8/1902). A Spaulding image (no date, c.1918-1920) &amp; Weekly Courier image (7/12/1922) show a new (since 1914) hut with and circular metal chimney flue on NE corner in this approximate location (but this is more likely to be the Mine Workshop which was slightly to the NE (and included F3-5). Building shown in this location on a 1917 plan (in Webster 2007).</p>	unknown (probably c.1914; by 1917) [possibly by 1899 or 1903 (Twelvetrees 1900 & 1903); or post 1914 (but by 1922) based on Weekly Courier images]	high-medium (as part of the No.4 Adit)

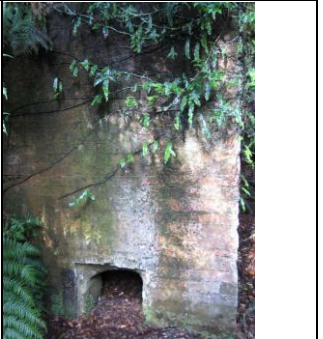
MMW	F4 (& F1)	<b>Structure – Engine Bed? (in Mine Workshop?):</b> A rectangular vertical sided brick foundation open on the E side (presumed to be a bed, possibly an engine bed, for mine equipment, possibly related to the nearby boiler (F5)); the foundation is c. 6' x 4', and c.4' high; it is located on the Adit 4 platform c.5m E of the brick chimney/flue (F3) and 5m W of the boiler (F5). This feature appears from Godfrey (1984, 54) to be part of the 'mine workshop'. Building shown in this location in 1917 plan (in Webster 2007).	unknown (probably c.1899 or 1914; by 1917) [possibly by 1899 or 1903 (Twelvetreets 1900 & 1903); or post 1914 (but by 1922) based on Weekly Courier images]	high-medium (as part of the No.4 Adit)

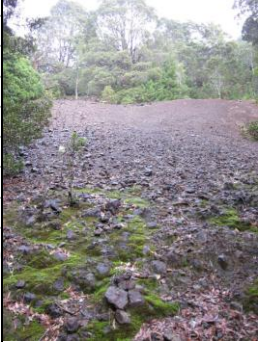
MMW	F19	<p><b>Mullock – hollow/depression in Adit 2 Main Mullock:</b> A distinct scooped out hollow into the mullock occurs in the N half of the Adit 2 mullock heap between the middle and lower platforms; it is c.5m deep x 3.5m wide and c.4m high at the headwall (sloping debris); there is shrubby native vegetation in the hollow.</p> <p>Difficult to interpret – the form and altitude suggests it is the surface of the largely buried remains of the 'Ore Paddock Seconds' (Jones 1899), although it appears to be located too far N. Thought most likely to be the partly buried remnant (by Adit 2, or later open cut, mullock) of a major bench to the N and below the Adit 2 entrance shown in a 1914 Weekly Courier image (23/7/1914); bench still exposed in Spaulding image (no date, c.1918-1920) &amp; Weekly Courier image (7/12/1922).</p>	bench in place by 1914 & still exposed in c.1918-1922	medium-low	0370338.5410960	498

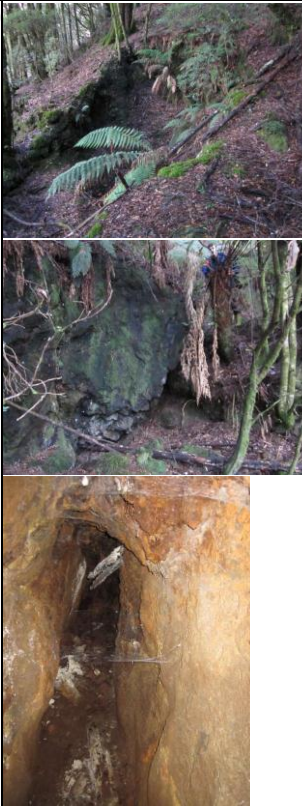
MMW	F22	<p><b>Mullock – Adit 3? finger dump</b>: Small (c.5m long at top), single finger dump located c.10m below the present day Magnet Road.</p> <p>Interpreted as part of Adit 3 (F21) from historical mapping and the presence of a shaft/collapse feature (into adit tunnel?) c.15m to the W and c.5-7m above (with Adit 1 probably destroyed by the road). A Weekly Courier image (23/7/1914) shows a small mullock pile in this approximate location with a working above (presumed to be F21) and a larger mullock fan in the location of F23 which has a small building sitting on the top (and situated below the pack track/tramway – presumably the later main mullock dump for Adit 3.</p>	c.1898-1899 (not in existence in 1897)? [extant in 1914 ]	high (as part of the No.3 Adit)	0370222.5410869	533
