# An Archaeological Survey & Assessment of the Magnet Mine, Waratah Area, Northwest Tasmania

**Prepared for Mineral Resources Tasmania**

**Anne McConnell**  
[with Nic Haygarth]

**August 2013**

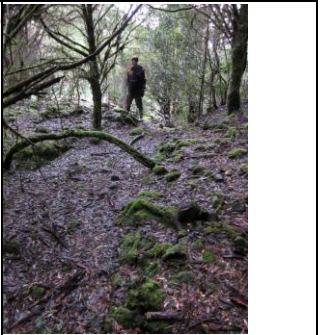
MMW	F28	<p><b>Mullock – heap/fan (– source unknown):</b> A small mullock heap (older mullock) which forms a broad fan (c.15m wide) which extends from approx the main Magnet Road downslope for c.15m (horiz).</p> <p><i>[It has not been possible to associate the debris/mullock with any particular workings – its location suggests it may have been associated with the Open Cut or Adit]</i></p> <p>First evidence of workings in this area and a small mullock heap below (below pack track/tramway) is in a Weekly Courier image (23/7/1914) – but the workings are not clear as the image is fuzzy in this area. As the area is likely to have contained the No.1 South Adit (see F30) this may be the mullock from that Adit. Spaulding image (no date, c.1918-1920) &amp; Weekly Courier image (7/12/1922) show the same deposit.</p>	by 1914 (possibly by c.1903?) [presumed to relate to Adit S1 hence to pre-date Adit S2 which was driven in 1903].	not assessed (potentially of high to low significance)	0370281.5410924	512

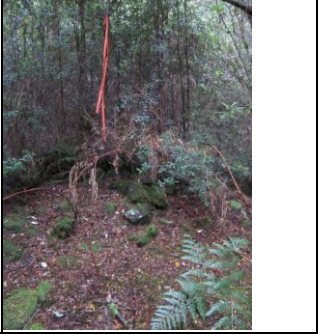
MMW	F43	<p><b>Platform – on spur for group of houses:</b> A relatively flat NE-SW trending spur which has been levelled to create a platform for a number of buildings (House Group 1 (Webster 2007)) (F44-F47); the levelled area is c.50m long (NE-SW) x 7m wide at the north end and c.20m wide at the S end; at the S end the platform has been benched into the spur (c.0.5m) and the cut bank has been lined with drystone walling in the W corner; there is also drystone walling embankment on the N side at the head of the creek (where there appears to have been some fill in the head of the creek line) and on the SE edge at the S end (c.10m); a possible track leads off the SE end (- possibly leads up to House Group 2 (Webster 2007)) (F53-F55).</p>	<p>by 1899</p> <p>[presumed to be associated with the initial working of the Open Cut]</p>	high-medium

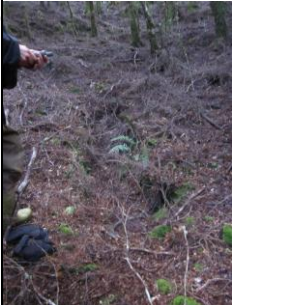
MMW	F58 (& T8)	<b>Trench:</b> Small trench cut into hillside (costean?); c.4-5' long x c.2' wide; is cut into the hillside from the inner edge of track T8.	unknown (probably by 1923)	low	0370151.5410890	582

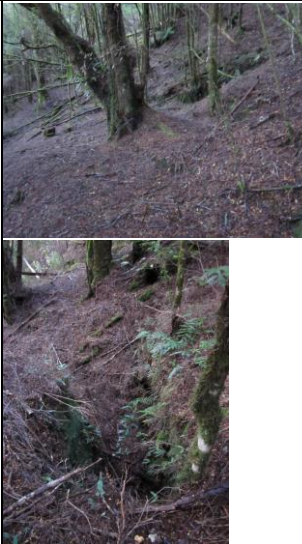
MMW	F75	<b>Platform - Building/House?:</b> A rough approx level area with at least 1 right angled corner; at least c.4m x c.6m; located below and c.20m E of F76 (building/house?) and c.15-20m N of the water race fall line channel (F80) near the end of the Water Race (F79). Interpreted as a probable house or other building site.	unknown (probably by 1923)	medium-low	0370115.5410863	593	
MMW	F76	<b>Building/House:</b> A low, roughly square stone rubble mound c.8m N of the Water Race (F79) and nearby creek; although there is no evident levelled area or footings, the land between the Water Race and the stone mound is flat and approx horizontal and the mound is interpreted as a chimney butt for a house.	unknown (probably by 1923)	medium	0370081.5410869	592

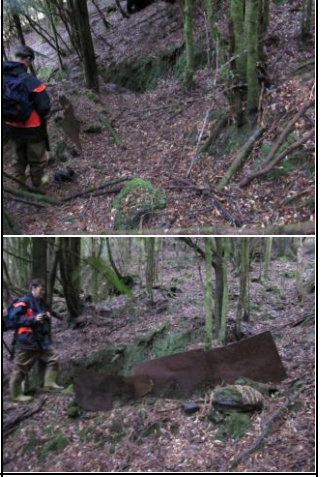
MMW	F82	<b>Artefact – ore skip:</b> Small metal ore bin/skip in creek – presumably not in situ?; immediately below MSW F10.	unknown	low	0370204.5410784	543	
MMW	F83	<b>Platform – Building/s:</b> A c.20-25m long (N-S) x 5m wide (E-W) approximately level benched area in the area of the N creek (between the 2 tributaries) immediately below track T1 (not inspected in detail). Interpreted as a platform for houses or other buildings associated with the early mining (Open Cut and Adits 1-2 and/or North Magnet).	unknown (probably by 1899)	medium

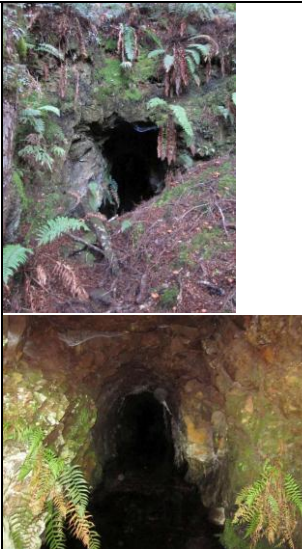
MMN	F2	<p><b>Cut Platform – plant/building site:</b> C.3-5m S of Upper Adit is a large square level area cut into the hillslope; the levelled area is c.6.5m N-S x 5m E-W, with a 3-4m high vertical headwall cut into bedrock (W wall), and with the outer edge built up with cut material.</p>	<p>by 1900 (post-1897) (abandoned by 1917-18) [presumed to be associated with the North Magnet Mine workings]</p>	high-medium (as part of the Upper Adit)	0370452.5411114	501	
MMN	F3	<p><b>Platform – Building/House:</b> Rectangular benched area cut onto slope (approx on spur nose); platform is c.8m N-S x 3.5m E-W and the inner cut wall is vertical and c.1m high; the platform has scattered building materials including mortared brick with gci shuttered concrete render on 1 side, bricks, flat metal sheet, and a gci chimney flue (on the ground on the E edge of the platform; possibly accessed by small (c.4') track (T5)).</p> <p>Possibly shown in 1903 Weekly Courier image (3/10/1903), but not evident in 1911 (Weekly Courier image (1/6/1911)). Also possibly pictured in J.H. Robinson's c.1908 image.</p>	<p>by 1900 (post-1897) (extant 1903, not extant 1911) [presumed to be associated with the North Magnet Mine workings]</p>	medium	0370442.5411049	498

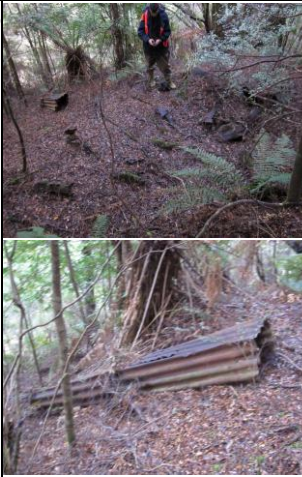
MMN	F4	<p><b>Platform – Building/House:</b> Large rectangular benched area cut onto slope (on W side of spur nose); platform is c.14m NW-SE x 5m NE-SW and the inner cut wall is vertical; there is a smaller approx square flat platform c.1.5m below the W corner of the main platform; no artefacts noted; accessed by small (c.4') track (T5).</p> <p>Possibly shown in 1903 Weekly Courier image (3/10/1903), but not evident in 1911</p>	<p>by 1900 (post-1897) (extant 1903, not extant 1911) [presumed to be associated with the North Magnet Mine workings]</p>	medium-low	c.0370438.5411049	502

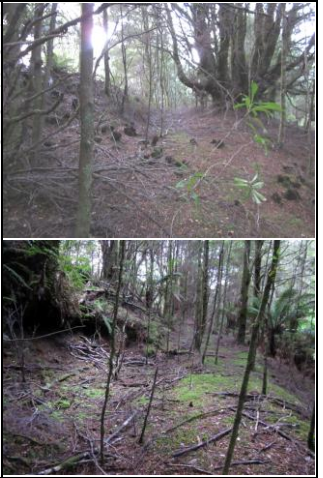
MMN	T2 (& F5, T1)	<b>Track:</b> C.4-5' wide, well benched track that starts from the main contouring track (T1) N of the main MMN area and sidles down the slope to SE for c.160m to the spur nose, then bends sharply N and down ( <i>but could not be followed beyond this</i> ); is intersected by, or is the end/start of, at least 4 other tracks; there is a scatter of domestic artefacts (N end of F5) on the track at GR c. 0370433.5411157.  Interpreted as a bridle/pack track connecting the MMN area with the valley and township.	by 1900 (possibly late 1890s) [presumed to be associated with the North Magnet Mine workings]	high-medium	0370421.5411199 0370434.5411169 0370433.5411157 0370442.5411102 0370443.5411085 0370462.5411057+	533- 524- 522- 505- 502- 498-

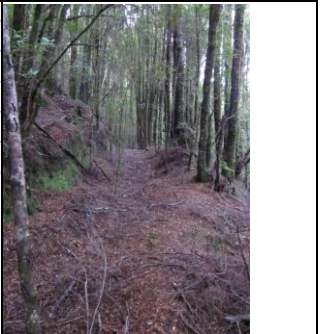
MMN	T3 (& T2)	<b>Track:</b> Small (c.3-4' wide) benched track leading down to the NW from T2 ( <i>not followed</i> ). Interpreted as a foot or bridle/pack track.	by 1900 (possibly late 1890s) [presumed to be associated with the North Magnet Mine workings]	low	0370434.5411169	524-

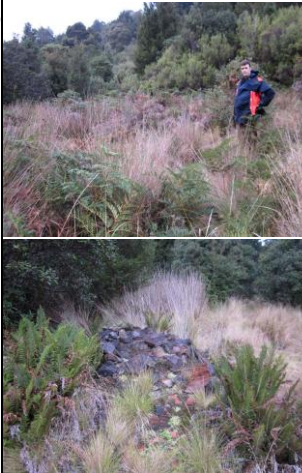
MTW	F11	<b>Structure - Building (House)?:</b> A square, vertical sided stone mound (- chimney butt?) located on the Magnet Creek valley floor between the E valley road (F4) and the creek, and c.5m from the creek; situated in an undisturbed area that also appears to have no tailings and which has shrubs and thick native tussock grass; there is a probable track (F12) that leads from F10 and past the W side of the stone mound; artefact scatter (dom glass) on open tailings on E side. Interpreted as the chimney of a house, with house to S. Located on the N side of Low Street. Probably one of 7 buildings in area shown in a 1917 plan (in Webster 2007)	by 1917?	medium-low	0370803.5411319	423

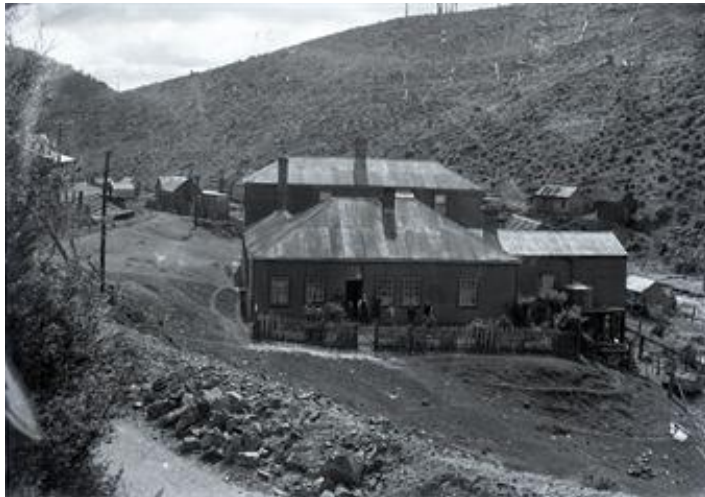
Magnet Hotel - view east from the west side of the railway line across the Magnet Creek valley, J.H. Robinson, no date, (source – Nic Haygarth, Oresome times website).

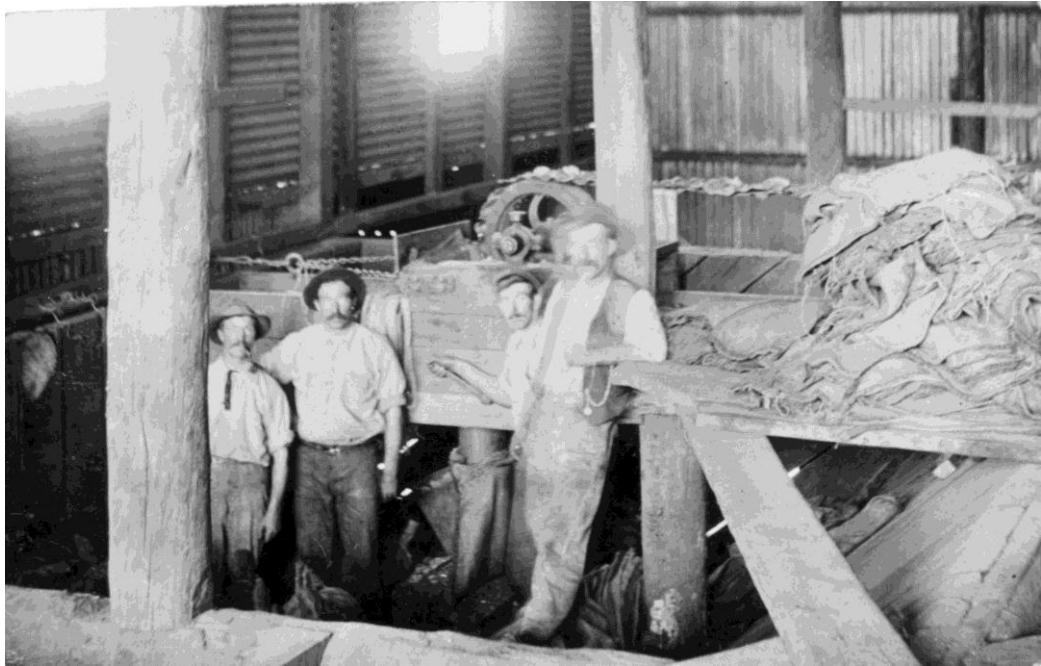
Magnet Mine, workers on the bagging floor, no date (source – Nic Haygarth).
