# Rehabilitation of Mining Lands Trust Fund

2025-26 Annual Report

This annual report was developed by Mineral Resource Tasmania's Land & Tenements Branch, to detail the outcomes and progress of remediation efforts funded through the Rehabilitation of Mining Lands Trust Fund in the 2025-26 financial year.

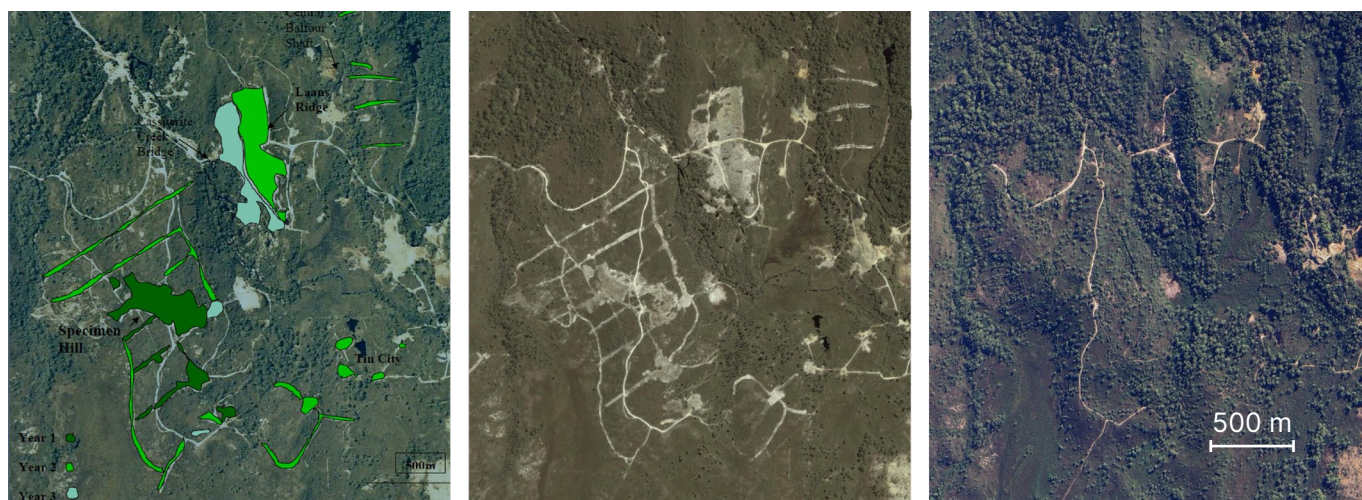
The 2025-26 financial year saw the completion of a comprehensive revegetation program that commenced in 2004, aimed at addressing soil stabilisation, revegetation and drainage impacts across multiple sites (Figure 3).

**Figure 3.** Comparative images of revegetation over Balfour Site, 2004 – 2025.

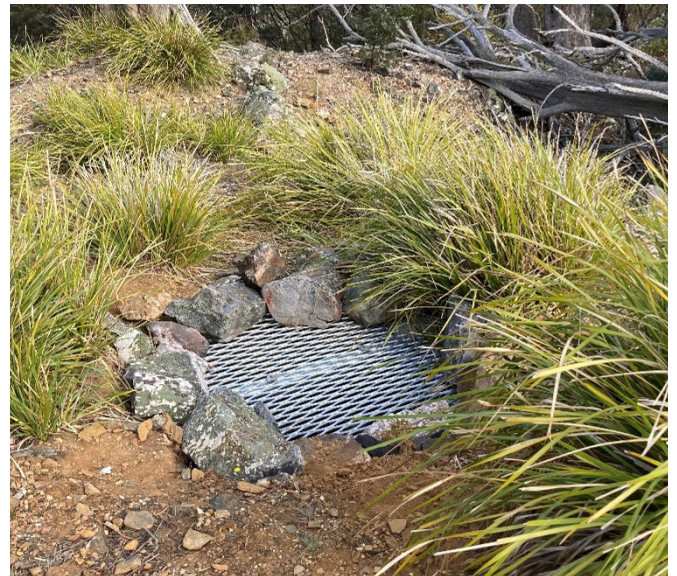
**Figure 23.** Shaft Closure completed pre (left) and post (right) work at Storys Creek (March 2026).

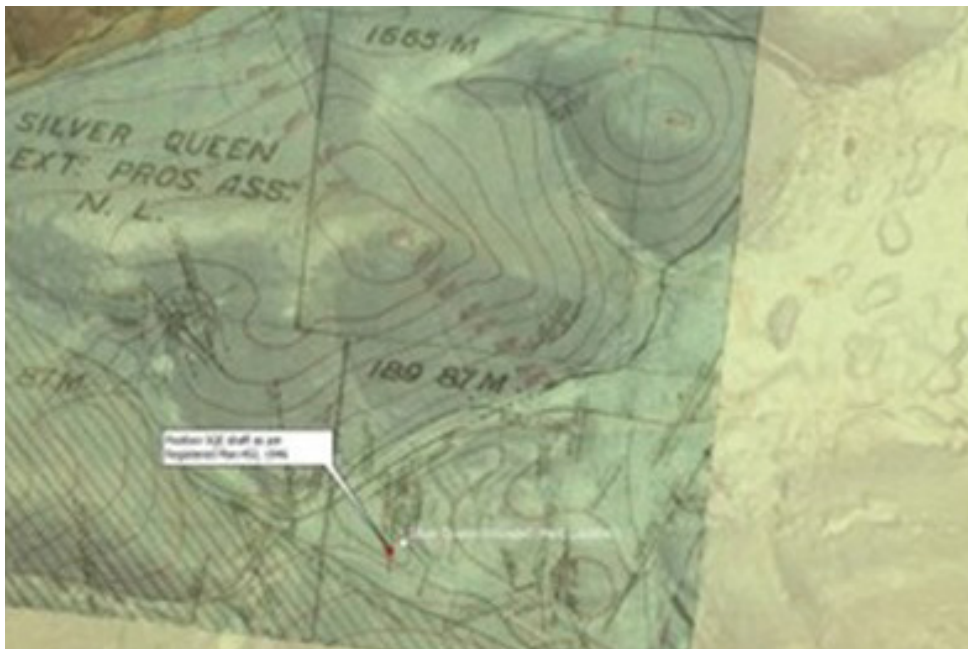
**Figure 24.** Historical mine mapping relating to Silver Queen Extended site.

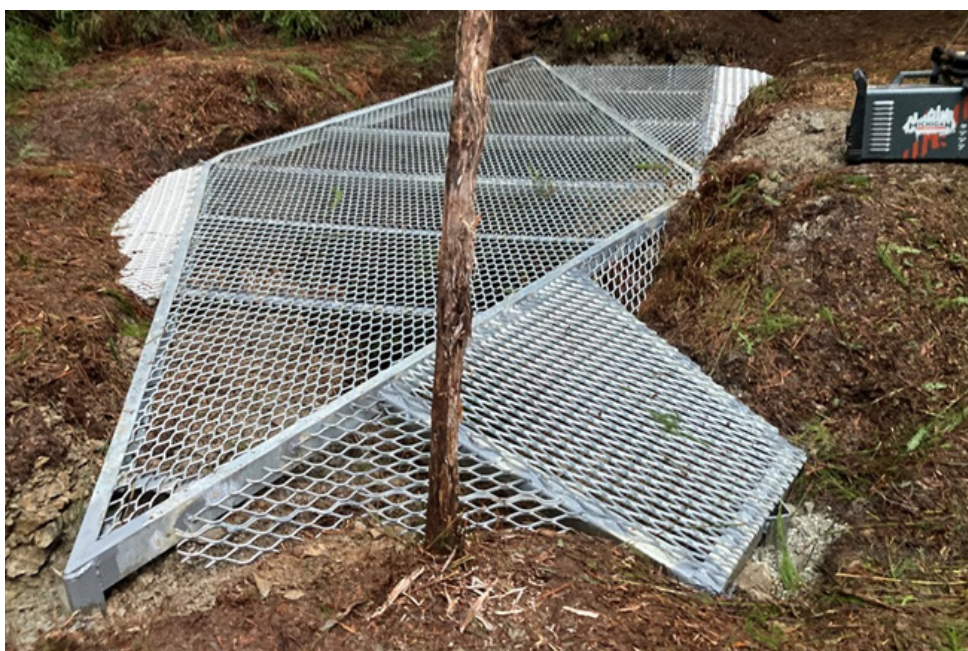
**Figure 25.** Silver Queen Extended closure cap (June 2026).
