1979/41. Site investigation for the proposed Cam River water treatment plant, Somerset.

R.C. Donaldson

Abstract

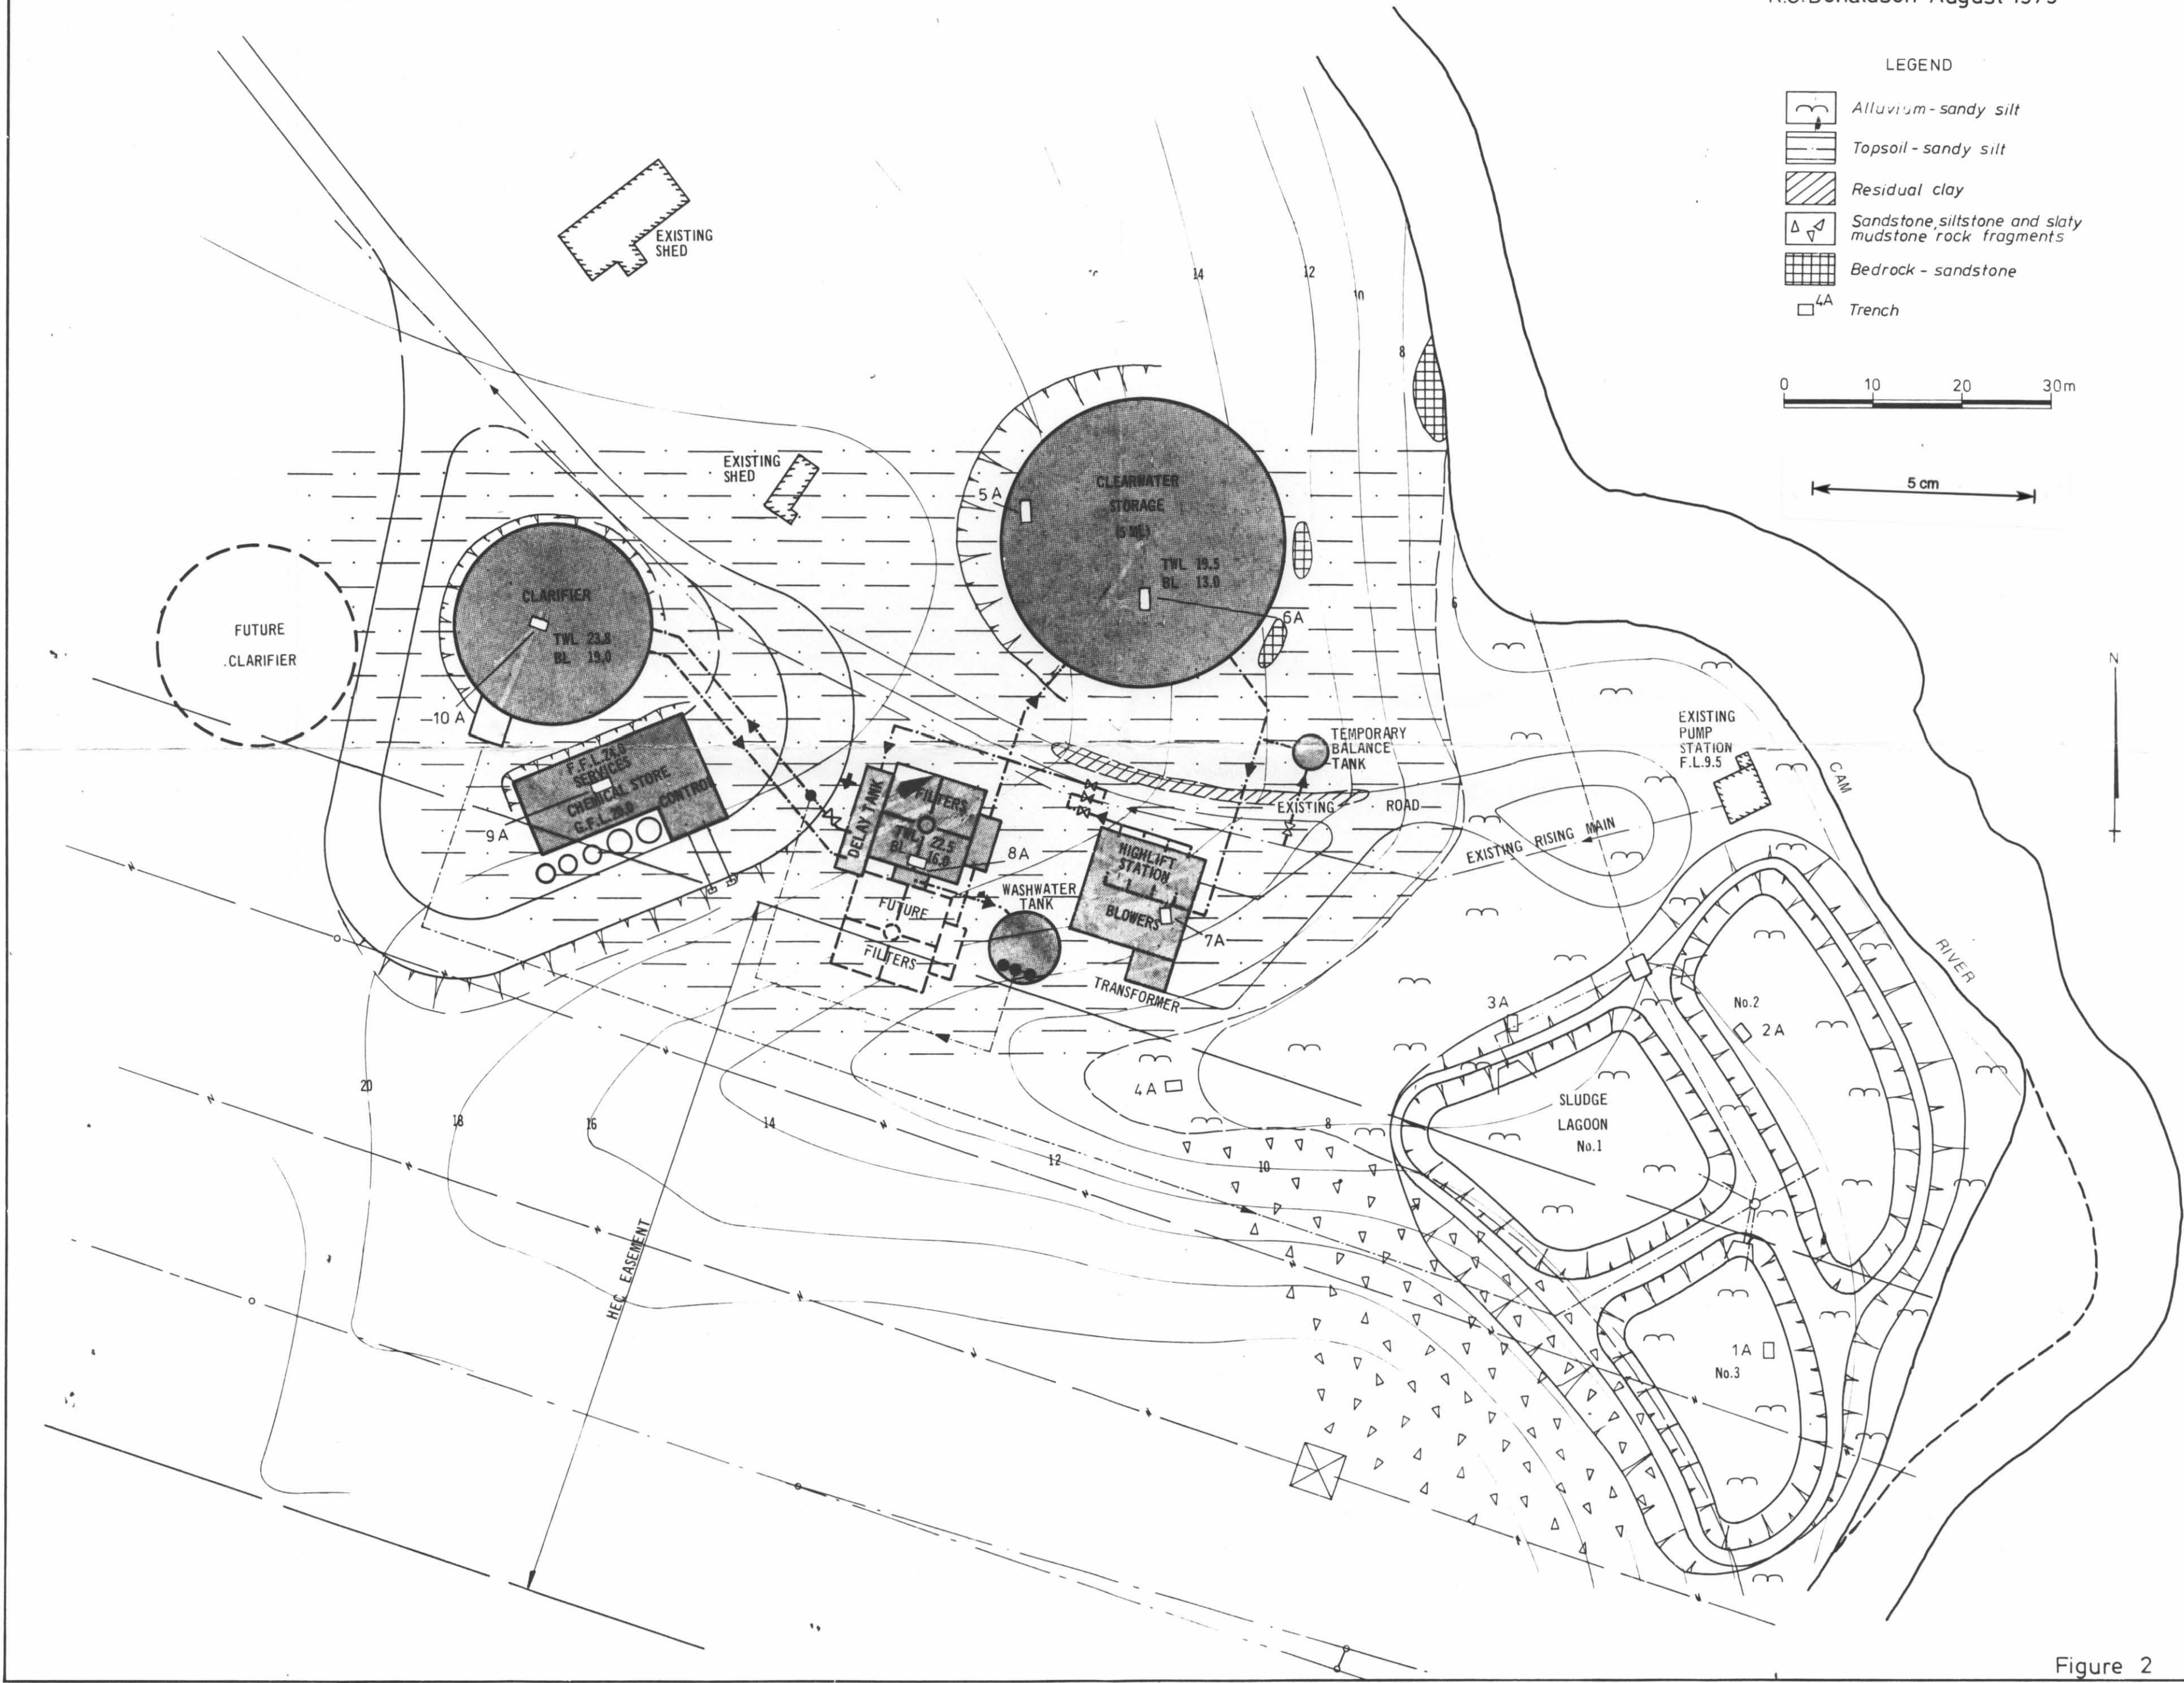
Figure 2

Reconnaissance geological mapping at the site has confirmed this to be the case. The trenching programme showed that within the limits of excavation, bedrock comprised an extremely weathered to moderately weathered sandstone and siltstone sequence on which residual clay derived from the *in situ* weathering of these sediments has developed. Overlying this, a discontinuous surficial unconsolidated sandy gravel horizon with a surface layer of sandy silt and clay was found to exist on the slopes above the river (Trenches 5A - 10A). Alluvial and possibly colluvial processes were active in the deposition of the silt, clay and gravel overlying bedrock on the river flats (Trenches 1A - 3A) and in the gully (Trench 4A).

At the time of the investigation, the design called for the wash-water tank to be located in the bottom of the gully close to the site of trench 4A. Excavation revealed that the unconsolidated organic clay and gravel was prone to collapse, and with the presence of high water levels, this site was abandoned for the present site (fig. 2).

CAM RIVER WATER TREATMENT PLANT
GEOLOGICAL PLAN - SITE A
R.C.Donaldson August 1979

Further investigations at Site A should concentrate on obtaining a more thorough knowledge of the foundation conditions beneath the larger structures. Additional trenching across their diameters would probably be sufficient, but a drill hole may be necessary if trenching does not provide adequate foundation information. In conjunction, consolidation tests are recommended, together with bearing capacity determinations to ensure against settlement or foundation failure.

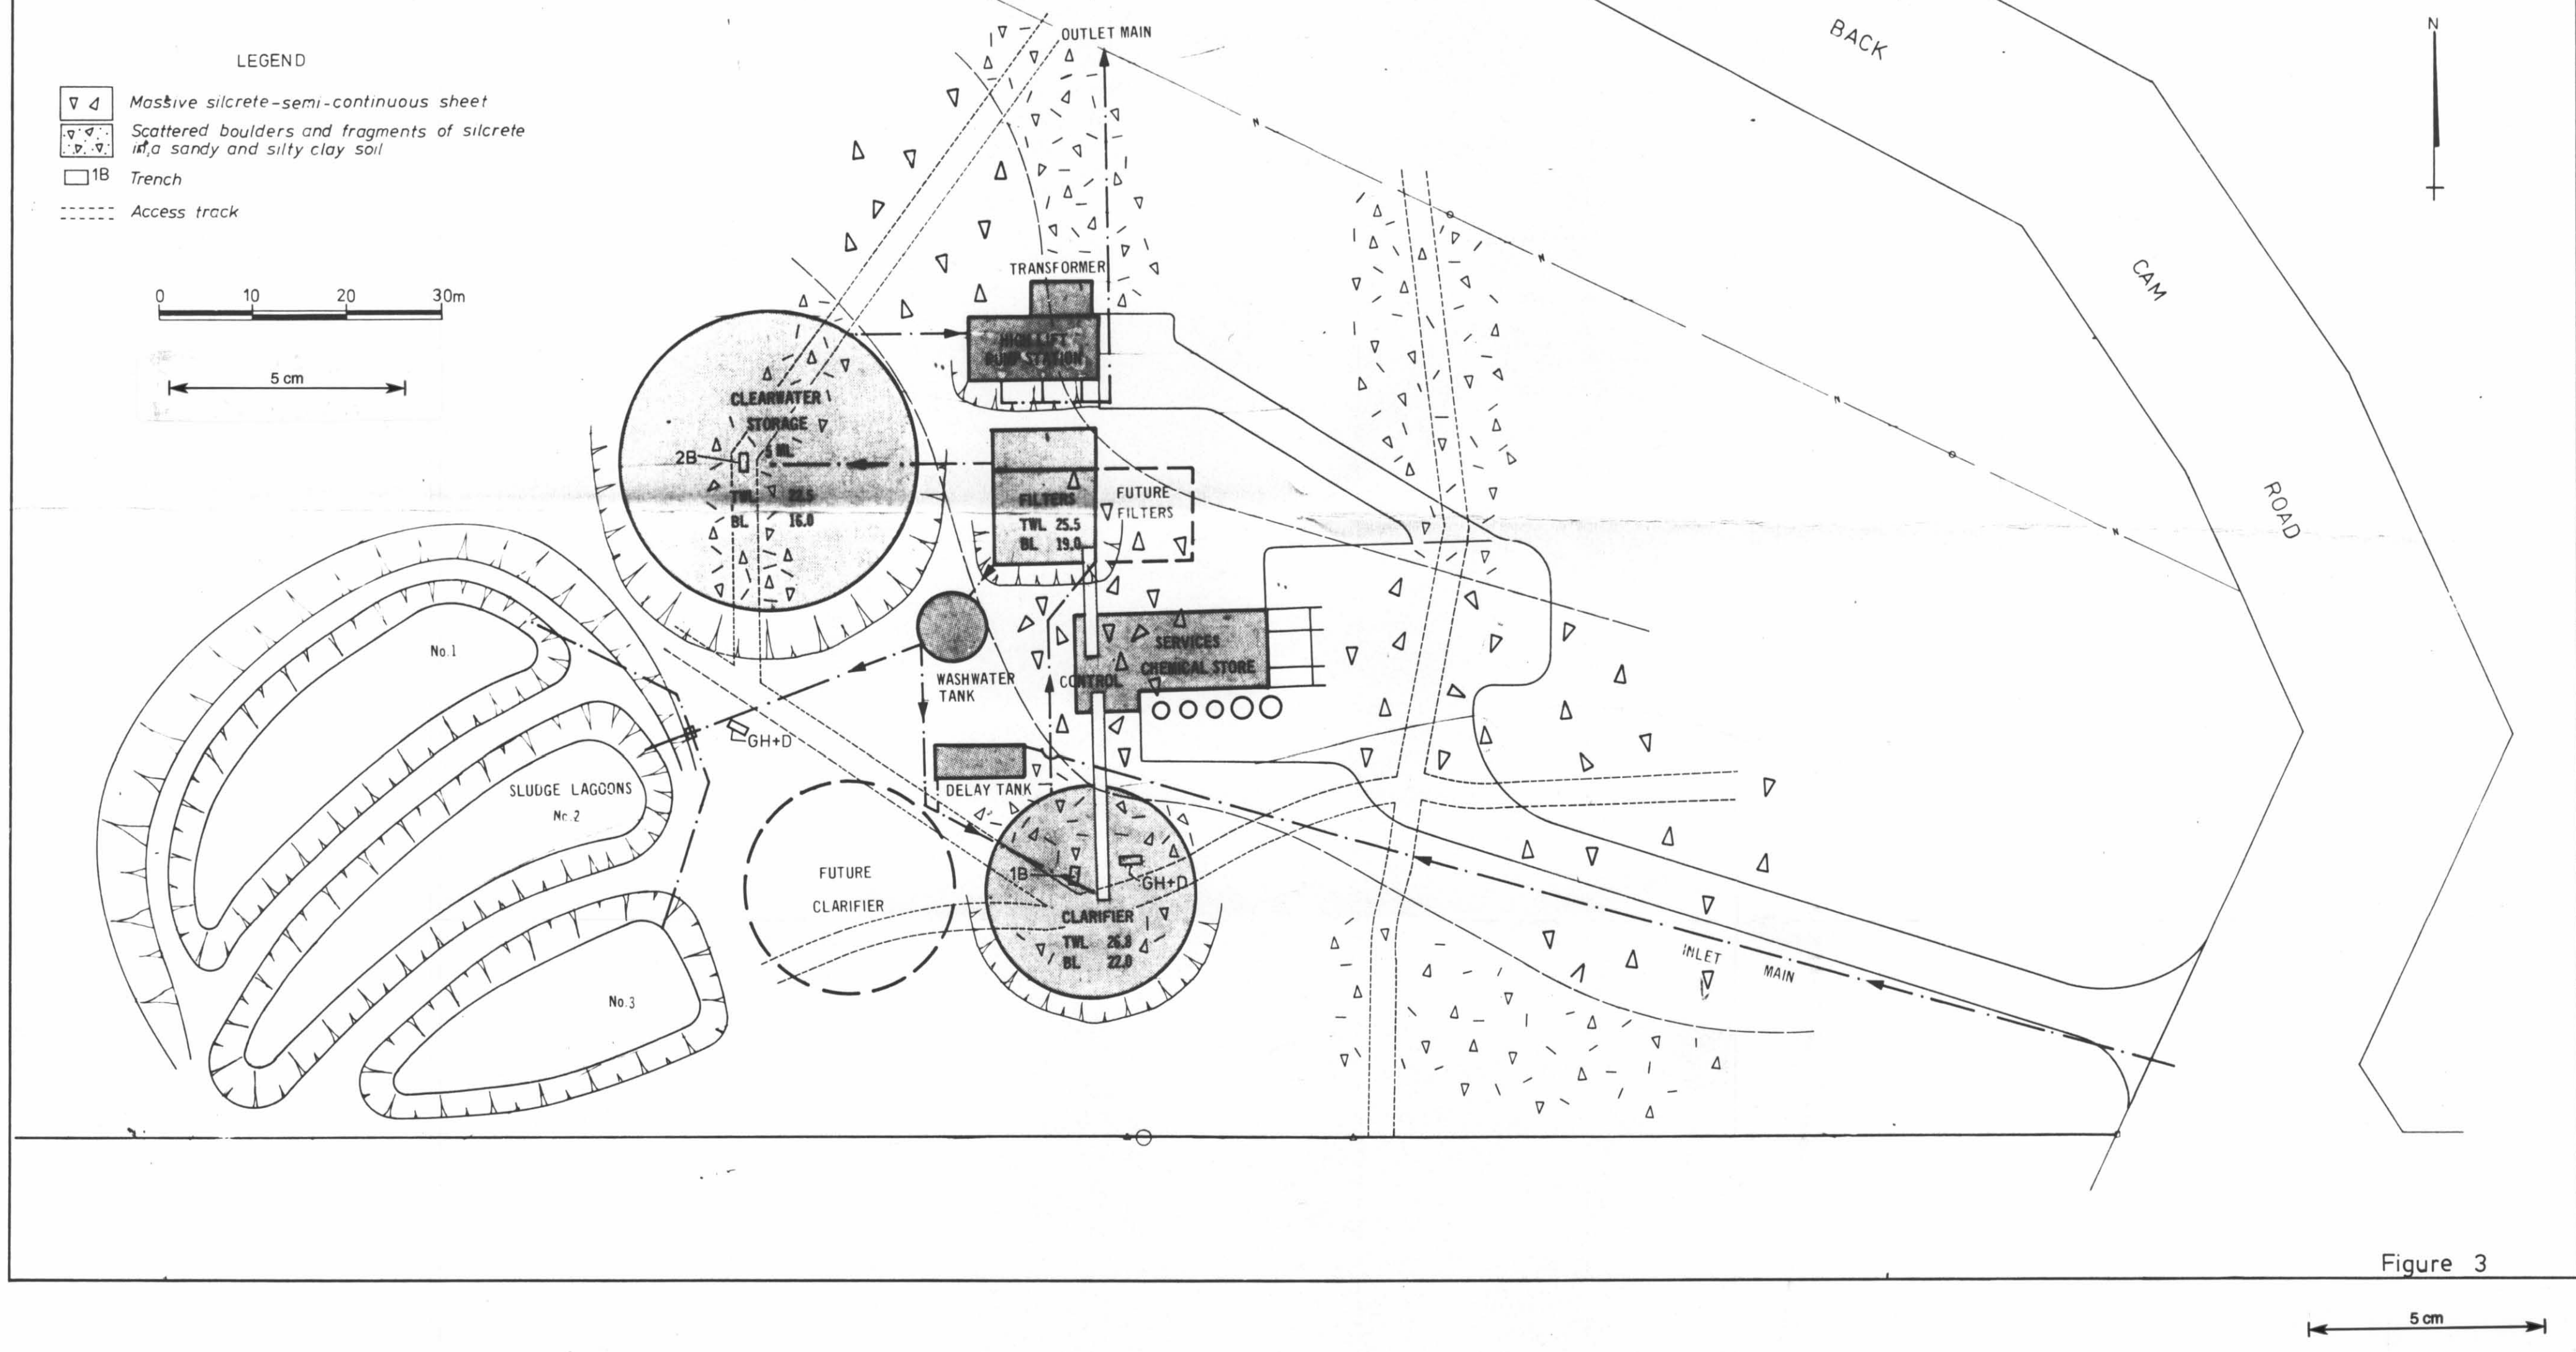
CAM RIVER WATER TREATMENT PLANT
GEOLOGICAL PLAN - SITE B
R.C.Donaldson August 1979

The results of the geological mapping (fig. 3) show the presence of a narrow elongate north-west - south-east trending feature cutting across the site. The material, of uncertain origin, is essentially a silcrete, a siliceous cemented quartz conglomerate. Evidence suggests it lies unconformably on the Burnie Formation and occurs as a superficial deposit which is sporadic in occurrence, is discontinuous and of variable thickness. The remainder of the site is covered by scattered boulders and fragments of silcrete in an organic sandy and silty clay topsoil.

The silcrete is a hard dense rock and any excavation will require drilling and blasting where it occurs as massive unbroken sheets. The boundaries depicted on Figure 3 are the result of a pace and compass survey and are therefore only approximate. The dense bush in various places also hindered the accuracy of the mapping. It is anticipated the maximum depth of this material over the site should be in the order of about one metre; it is exposed in the Back Cam Road cutting to a depth of 600 mm. The thickest accumulation noted in the region is a 2 - 3 m exposure immediately to the north of the junction of the Murchison Highway and the Back Cam Road, where it lies unconformably on the Burnie Formation.

At Site B, it is recommended that the nature and boundaries of the silcrete layer be determined more precisely. This would be best accomplished by the use of a backhoe for one day. The decision is then whether to relocate parts of the plant away from the silcrete or to excavate into it.
