Tasmania Department of Mines — Unpublished Report 1988/44

Examination of land at Nobelius Drive, Freshwater Point

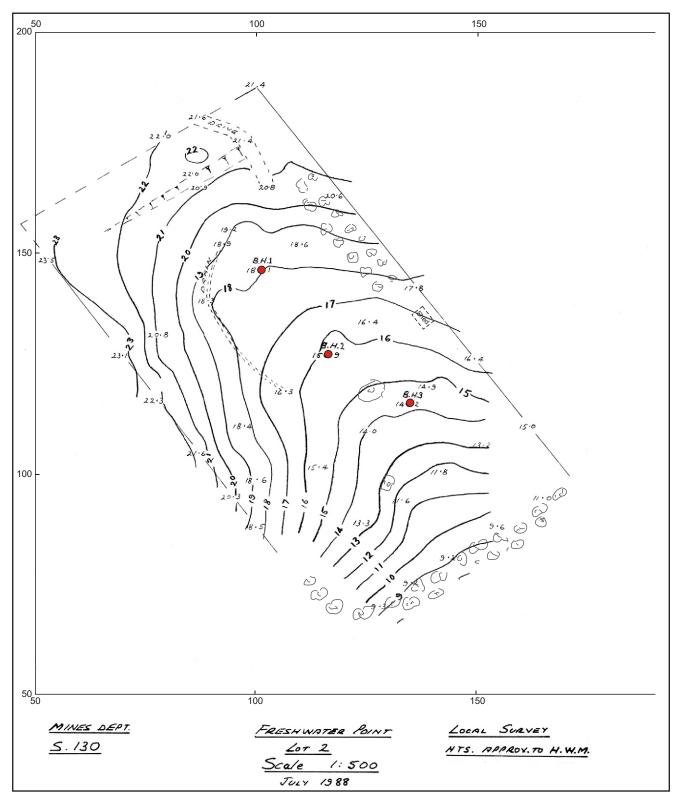
Figure 1

The outline of the northern part of the lot, where development was regarded as possible, has been surveyed, with determination of spot heights allowing approximate contour lines to be drawn. The auger hole positions were surveyed and their positions are marked on Figure 1.

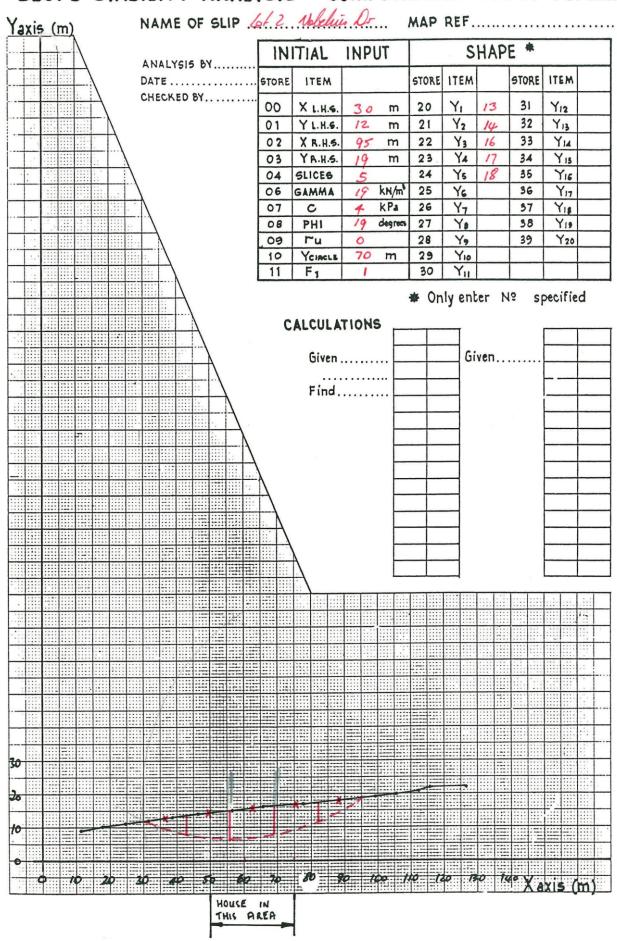
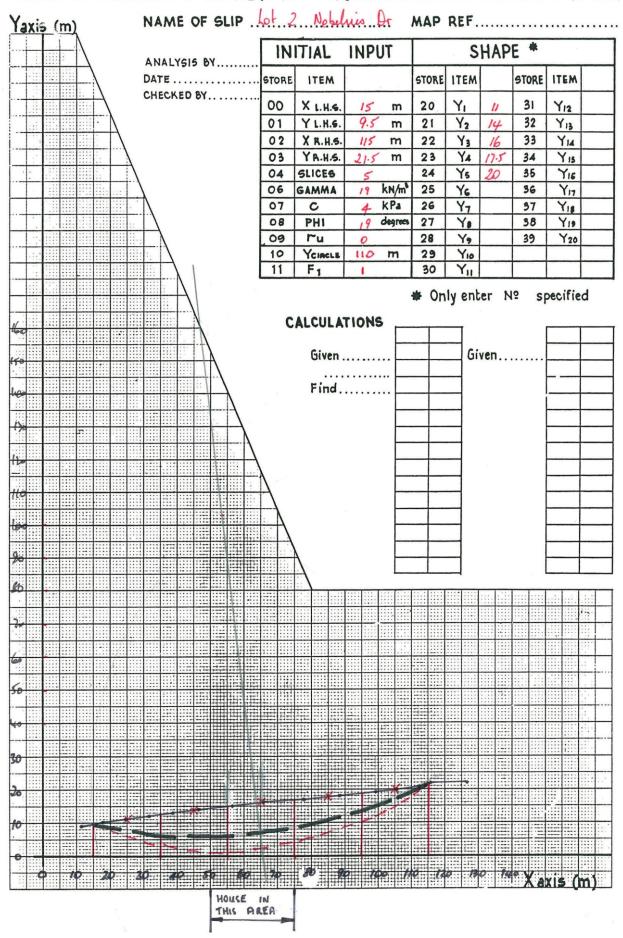
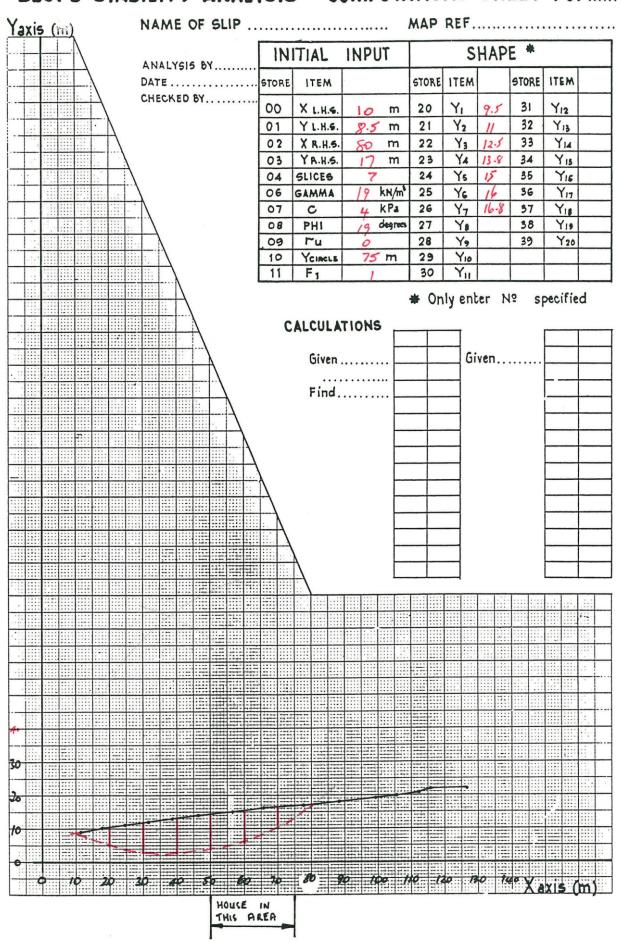
APPENDIX 3

Diagrams of the theoretical slip circles are attached for cases 1, 2 and 3 (Appendix 3). The first series of calculations selects the critical circle radius (Yc), e.g. 100 m, 80 m, 130 m and 110 m for the above strength values respectively for Case 1. Calculations have then been performed using these theoretical slip circles and varying the pore pressure present in the slide mass (Ru) (Ru of 0.5 = complete saturation or a water level at the surface while for Ru = 0, the standing water level is below the slip surface). It can be seen in Case 1 that only for 'r = 11, c'r = 0 and Ru of greater than about 0.3 are unstable conditions indicated (FS less than 1.3). Similarly for cases 2 and 3 unstable conditions may prevail if pore pressures are high. Stability is indicated in all three cases using the actual measured strength values.

Using the first measured residual strength values ($'_r = 19$, $c'_r = 4$) some theoretical slip surfaces were drawn under the slope of the proposed house site. This, as surveyed, has a uniform slope of about 8°. In addition various other strength values were used in separate calculations (namely [11, 4],

[19, 0] and [11, 0] for ' $_r$ and c' $_r$ respectively). In the Tamar region values of ' $_r$ =10–11° are relatively common in areas affected by landslip and the comparison is useful.

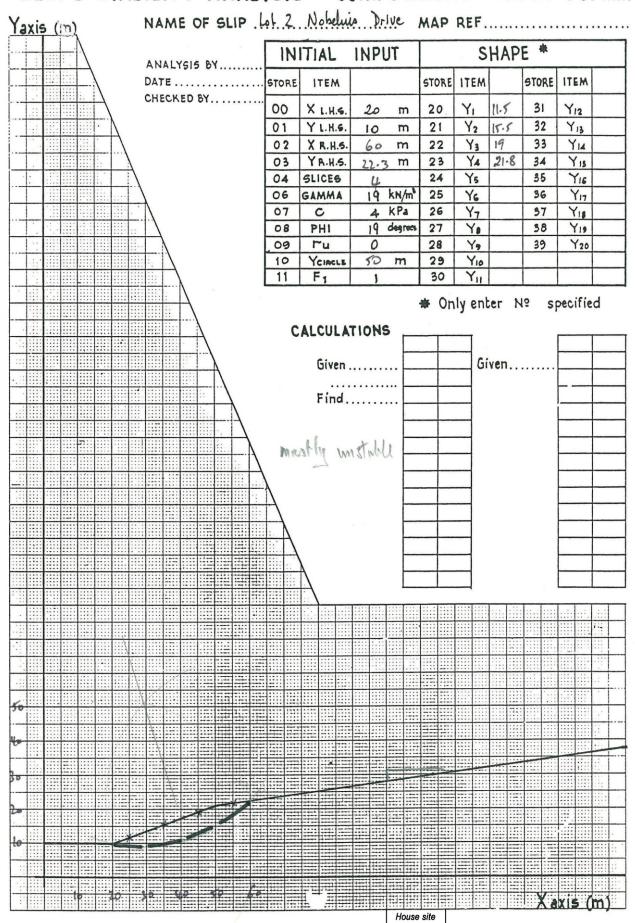
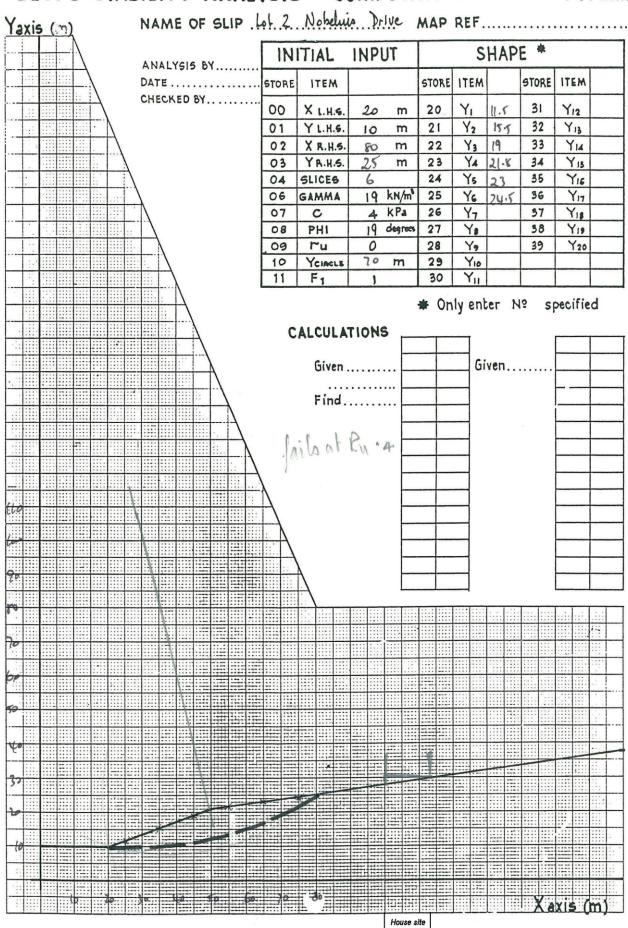
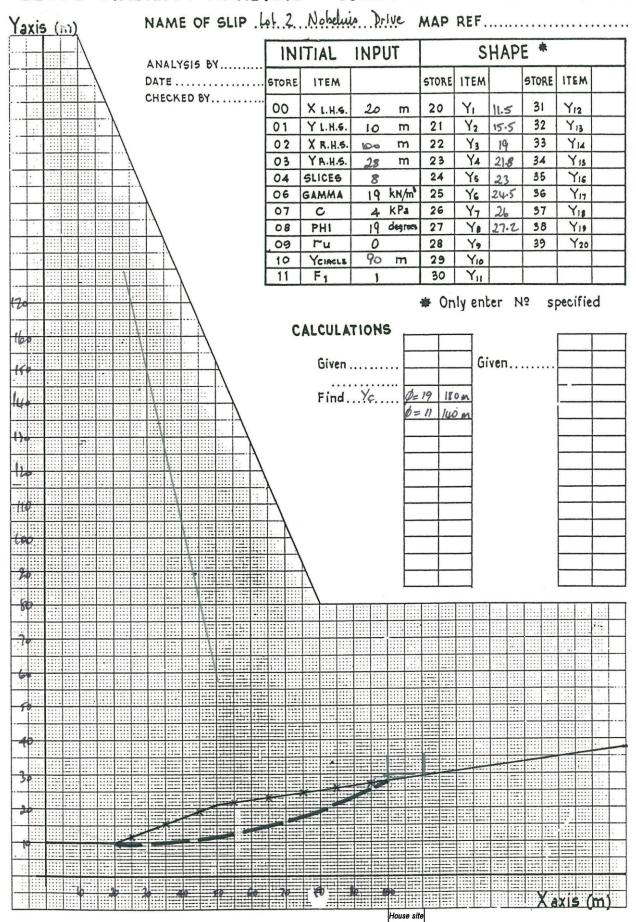
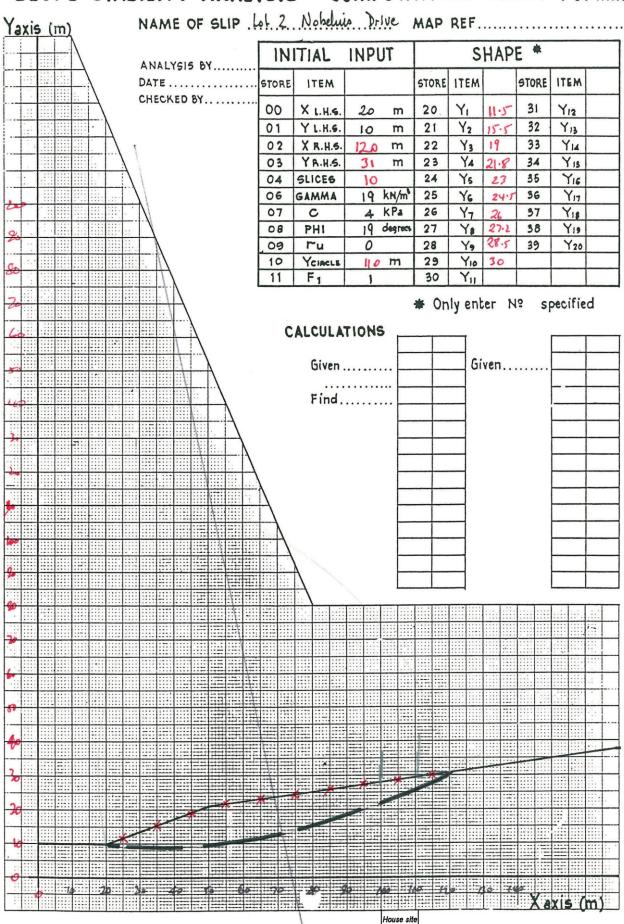
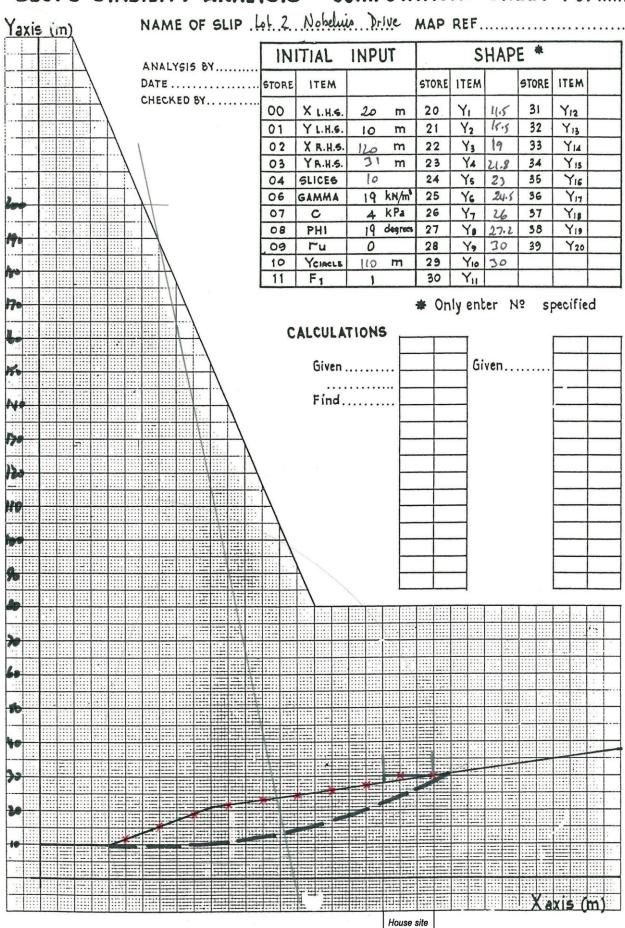
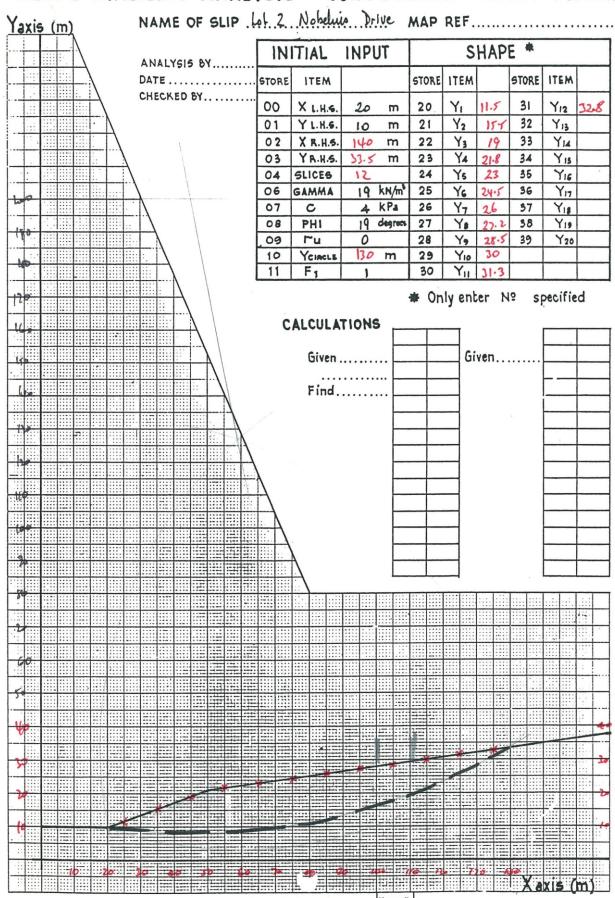
From field observations, the most likely area for unstable conditions to develop would be the area around the steeper slope to the flood plain. Cases A, B, C, D, D (loaded) and E (Appendix 3) deal with various theoretical slip circles as shown on the diagrams. The two sets of measured strength factors have been applied to each of these cases. Again the first set of calculations produce a critical circle and FS is then calculated using varying pore pressures (Ru). In Case C the values of strength factors used in the earlier calculations (cases 1–3) have been included while in Case D (loaded) two Yc values are used. These calculations suggest that instability on the steep slope just above the flood plain is likely under most conditions (cases A and B) while large single movements that include land near and upslope of the house site are possible when high pore pressures prevail.

Case		A	В	С
Circle		through toe and 10 m	through toe and 30 m	through toe and 50 m
		behind change in slope	behind change in slope	behind change in slope
Yc		60	110	170
FS at $r_u =$	0.0	1.308	1.596	1.811
	0.1	1.185	1.445	1.641
	0.2	1.062	1.295	1.471
	0.3	0.939	1.145	1.300
	0.4	0.816	0.995	1.129
	0.5	0.694	0.846	0.960

Case	Yc	FS	ru	
Е	200 —	1.311	0.4	— 90
				80
D/D(loaded)	200 ———	1.305 1.310 ←	0.36 on 10 for loaded slope	— 70 edo
				eo ein s
С	170 ———	1.300	0.3 —	
				40 49 se behi
В	110	1.295	0.2	— 30 ₩
				20
Α	60 —	1.308	0.0	— 10
	Change in slope		ope	— 0

The most likely location of landslips affecting the block is the steeper slope to the flood plain. Progressive failure on this slope could extend towards the house site under adverse conditions. Large single movements extending from the flood plain to the house site area are possible when pore pressures are high.
