Dust particulates and asbestiform material, Savage River Mines, Savage River

by M. E. Curtain

OCCUPATIONAL HEALTH SURVEY SAVAGE RIVER MINES

SEPTEMBER 1991

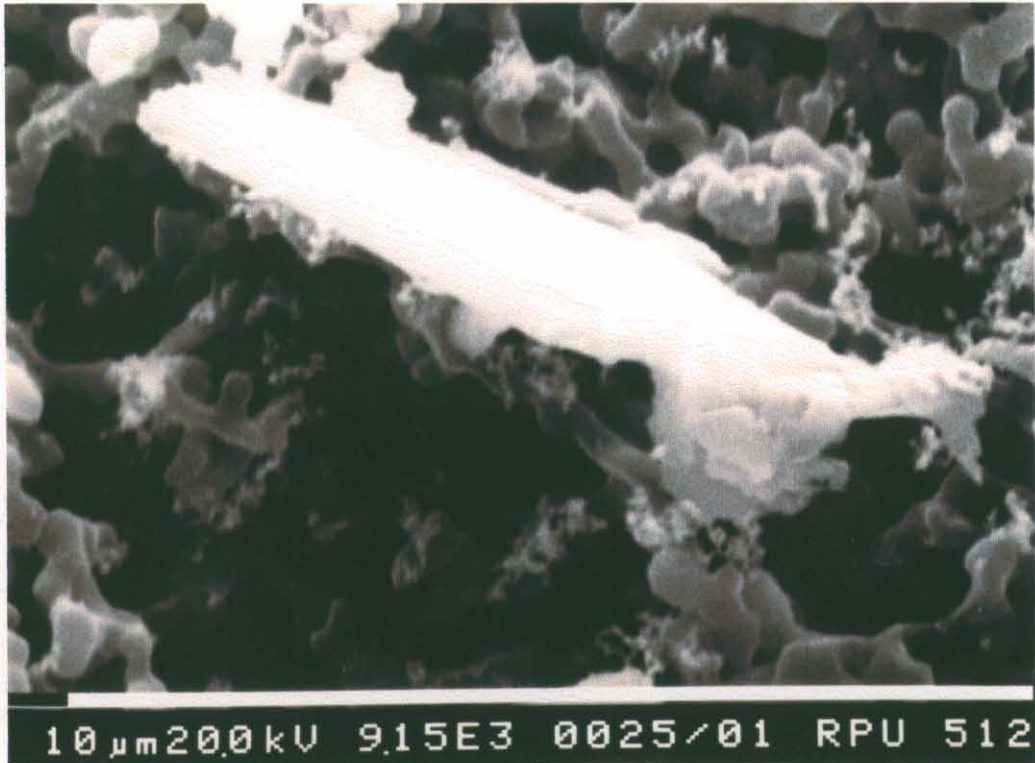
SEM photograph of asbestos fibres on a Millipore membrane filter,
Sample 19, PH 1 shovel, Centre Deposit.
Magnification: 9150x, scale bar = 10 µm.

PH1 shovel: – fibre and amphibole material present.

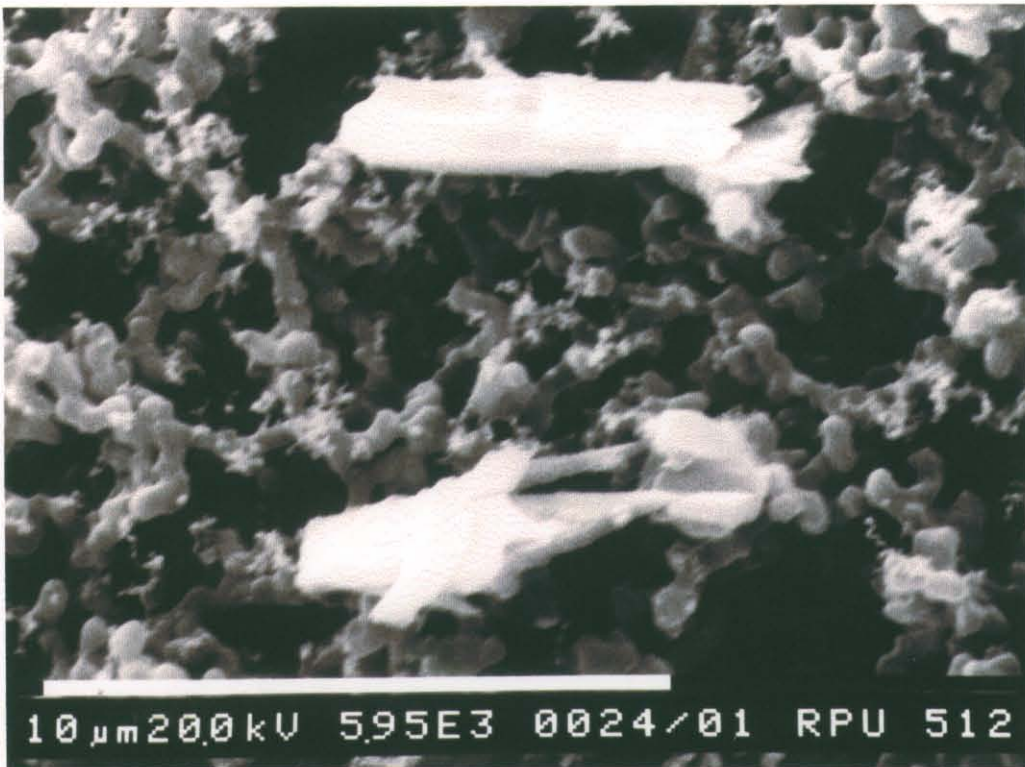
SEM photograph of an asbestos fibre on a Millipore membrane filter,
Sample 19, PH 1 shovel, Centre Deposit.
Magnification: 5950x, scale bar = 10 µm.

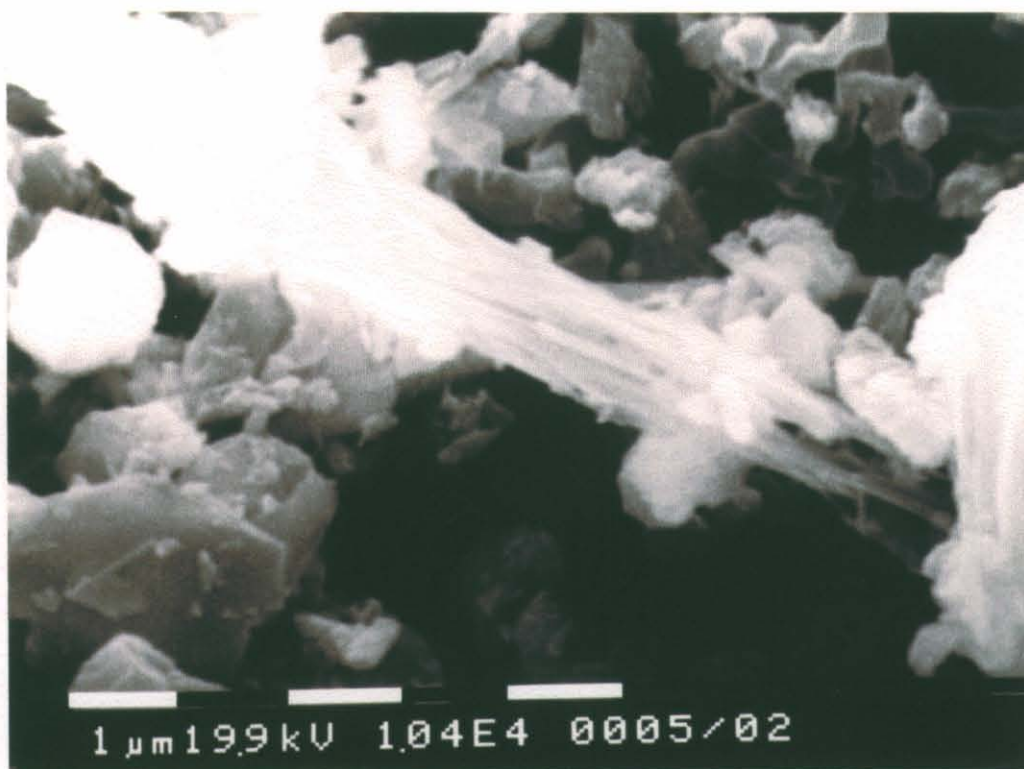
SEM photograph of asbestos fibres on a Millipore membrane filter,
Sample 107, drill 45R2, South Lens.
Magnification: 1040x, scale bar = 1 µm.

Drill 45R2: – fibre, amphibole and some antigorite present.
– high inspirable dust.

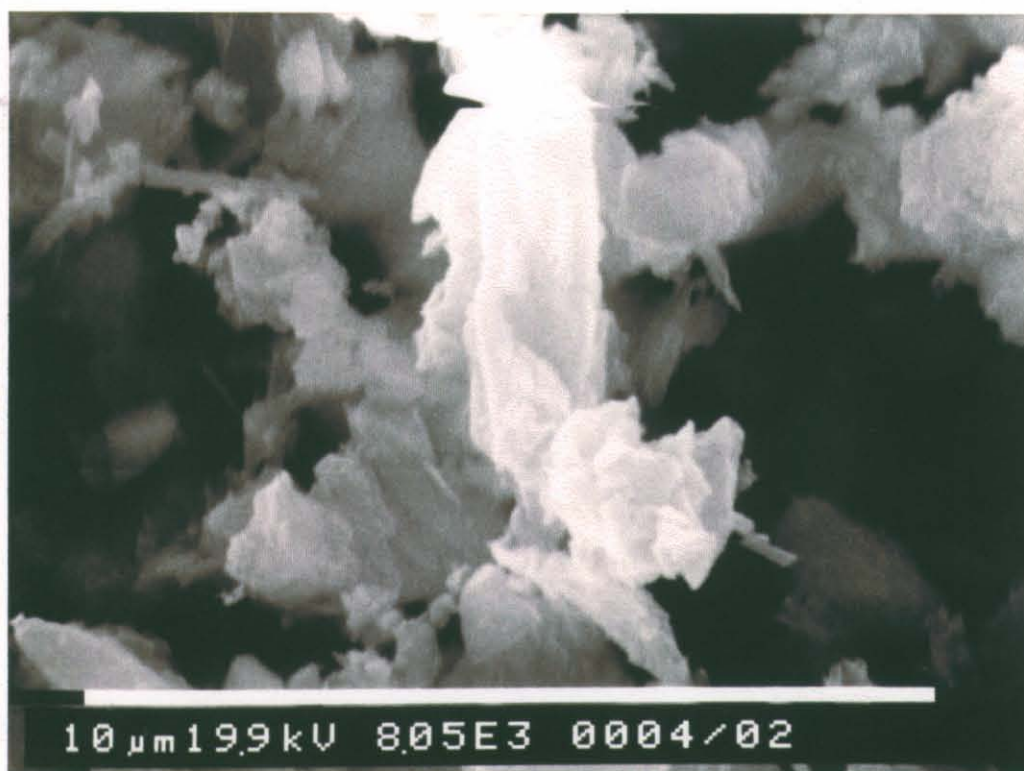
SEM photograph of an asbestos fibre on a Millipore membrane filter,
Sample 107, drill 45R2, South Lens.
Magnification: 8050x, scale bar = 10 µm.

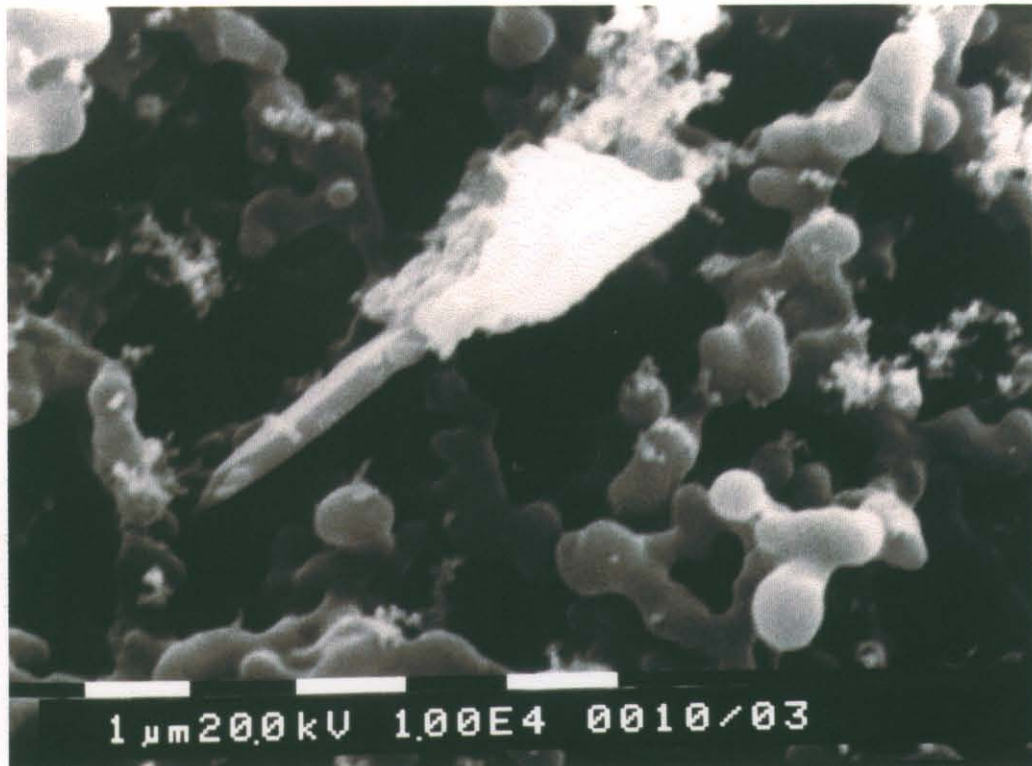
SEM photograph of asbestos fibres on a Millipore membrane filter, Sample 113, crusher cab. Magnification: 10 000x, scale bar = 1 µm.

– fibre and amphibole present.
– slightly high inspirable dust inside cabin.

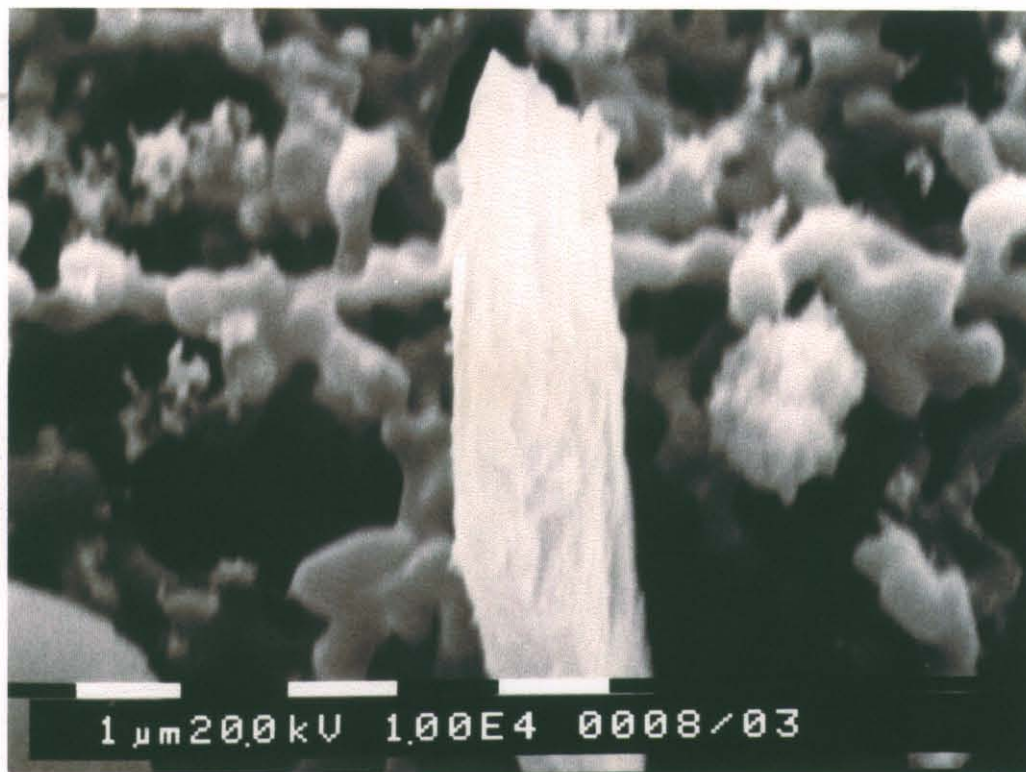
SEM photograph of an asbestos fibre on a Millipore membrane filter, Sample 113, crusher cab. Magnification: 10 000x, scale bar = 1 µm.

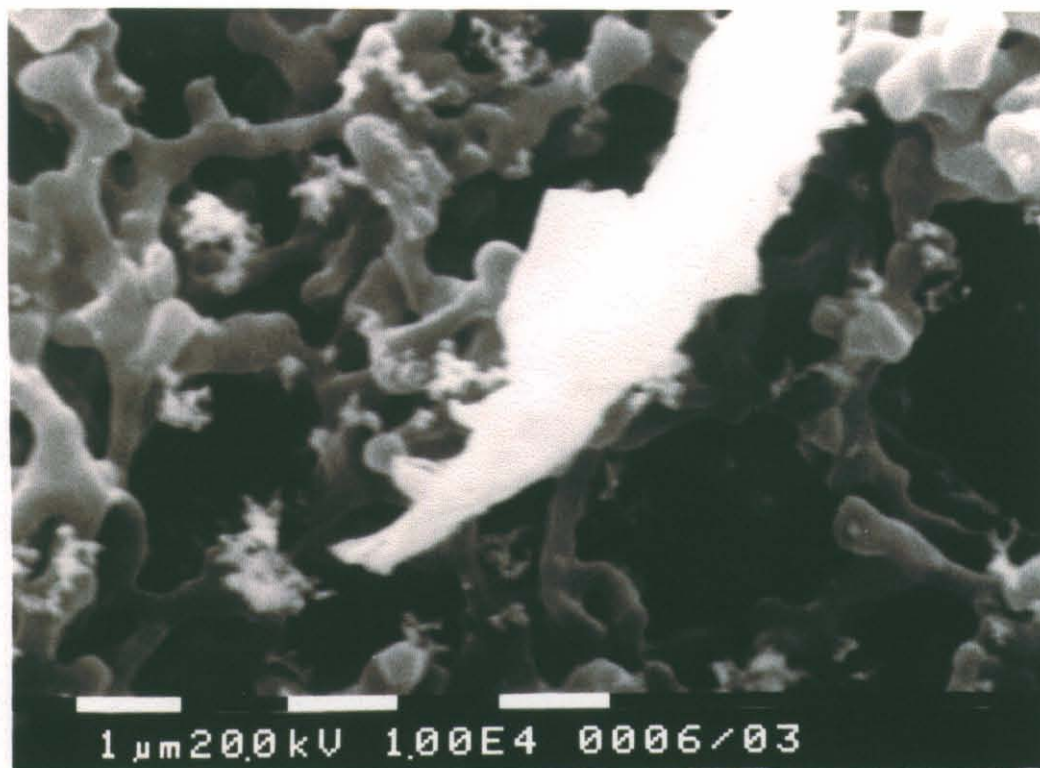
SEM photograph of asbestos fibres on a Millipore membrane filter, Sample 113, crusher cab. Magnification: 10 000x, scale bar = 1 µm.

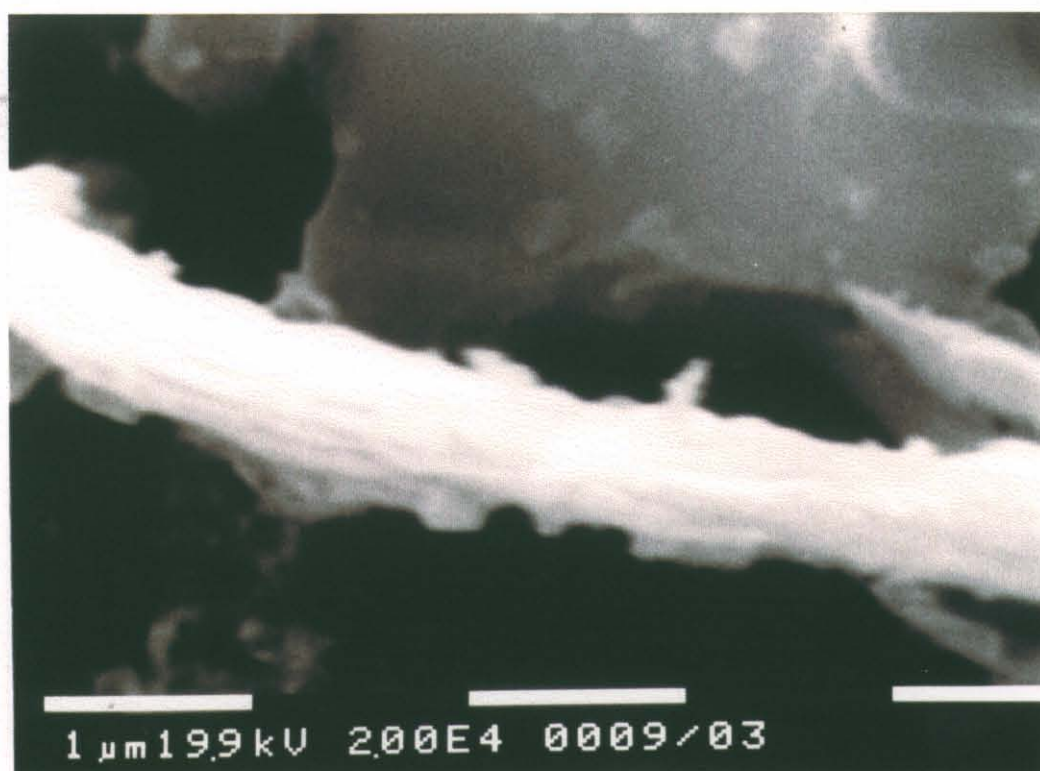
SEM photograph of an asbestos fibre on a Millipore membrane filter, Sample 113, crusher cab. Magnification: 20 000x, scale bar = 1 µm.

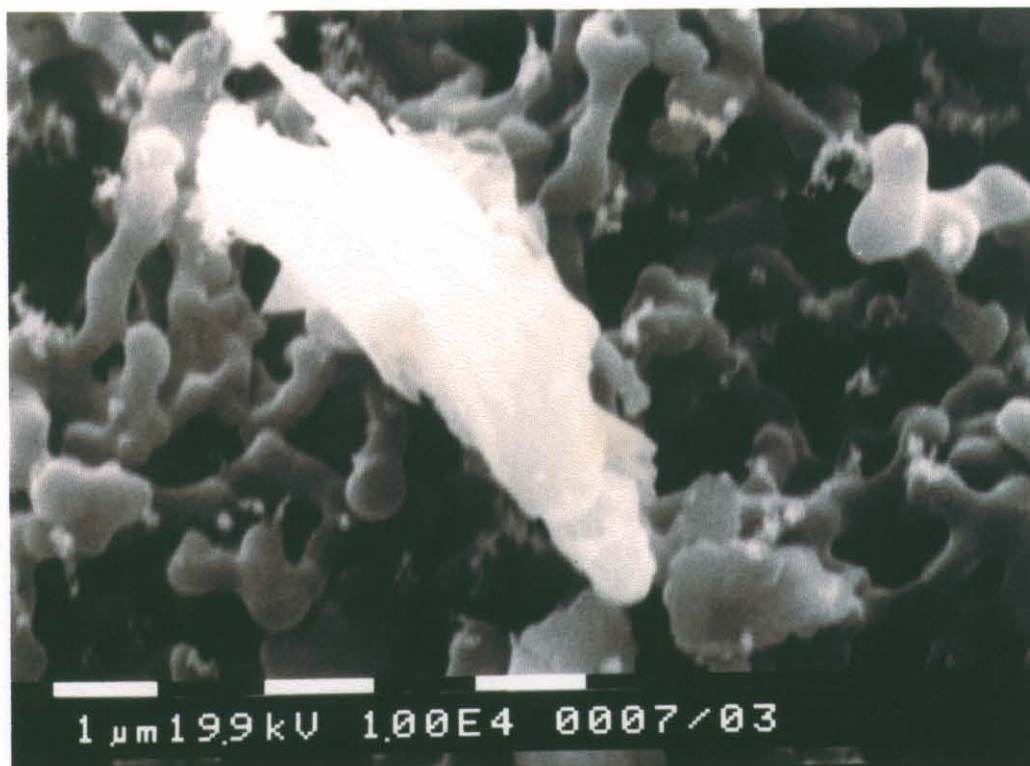
SEM photograph of asbestos fibres on a Millipore membrane filter, Sample 113, crusher cab. Magnification: 10 000x, scale bar = 1 µm.
