An investigation of land stability in the Tarooma area

by M. Latinovic, A. Waite, C. R. Calver and S. M. Forsyth

Tasmanian Geological Survey Record 2001/01

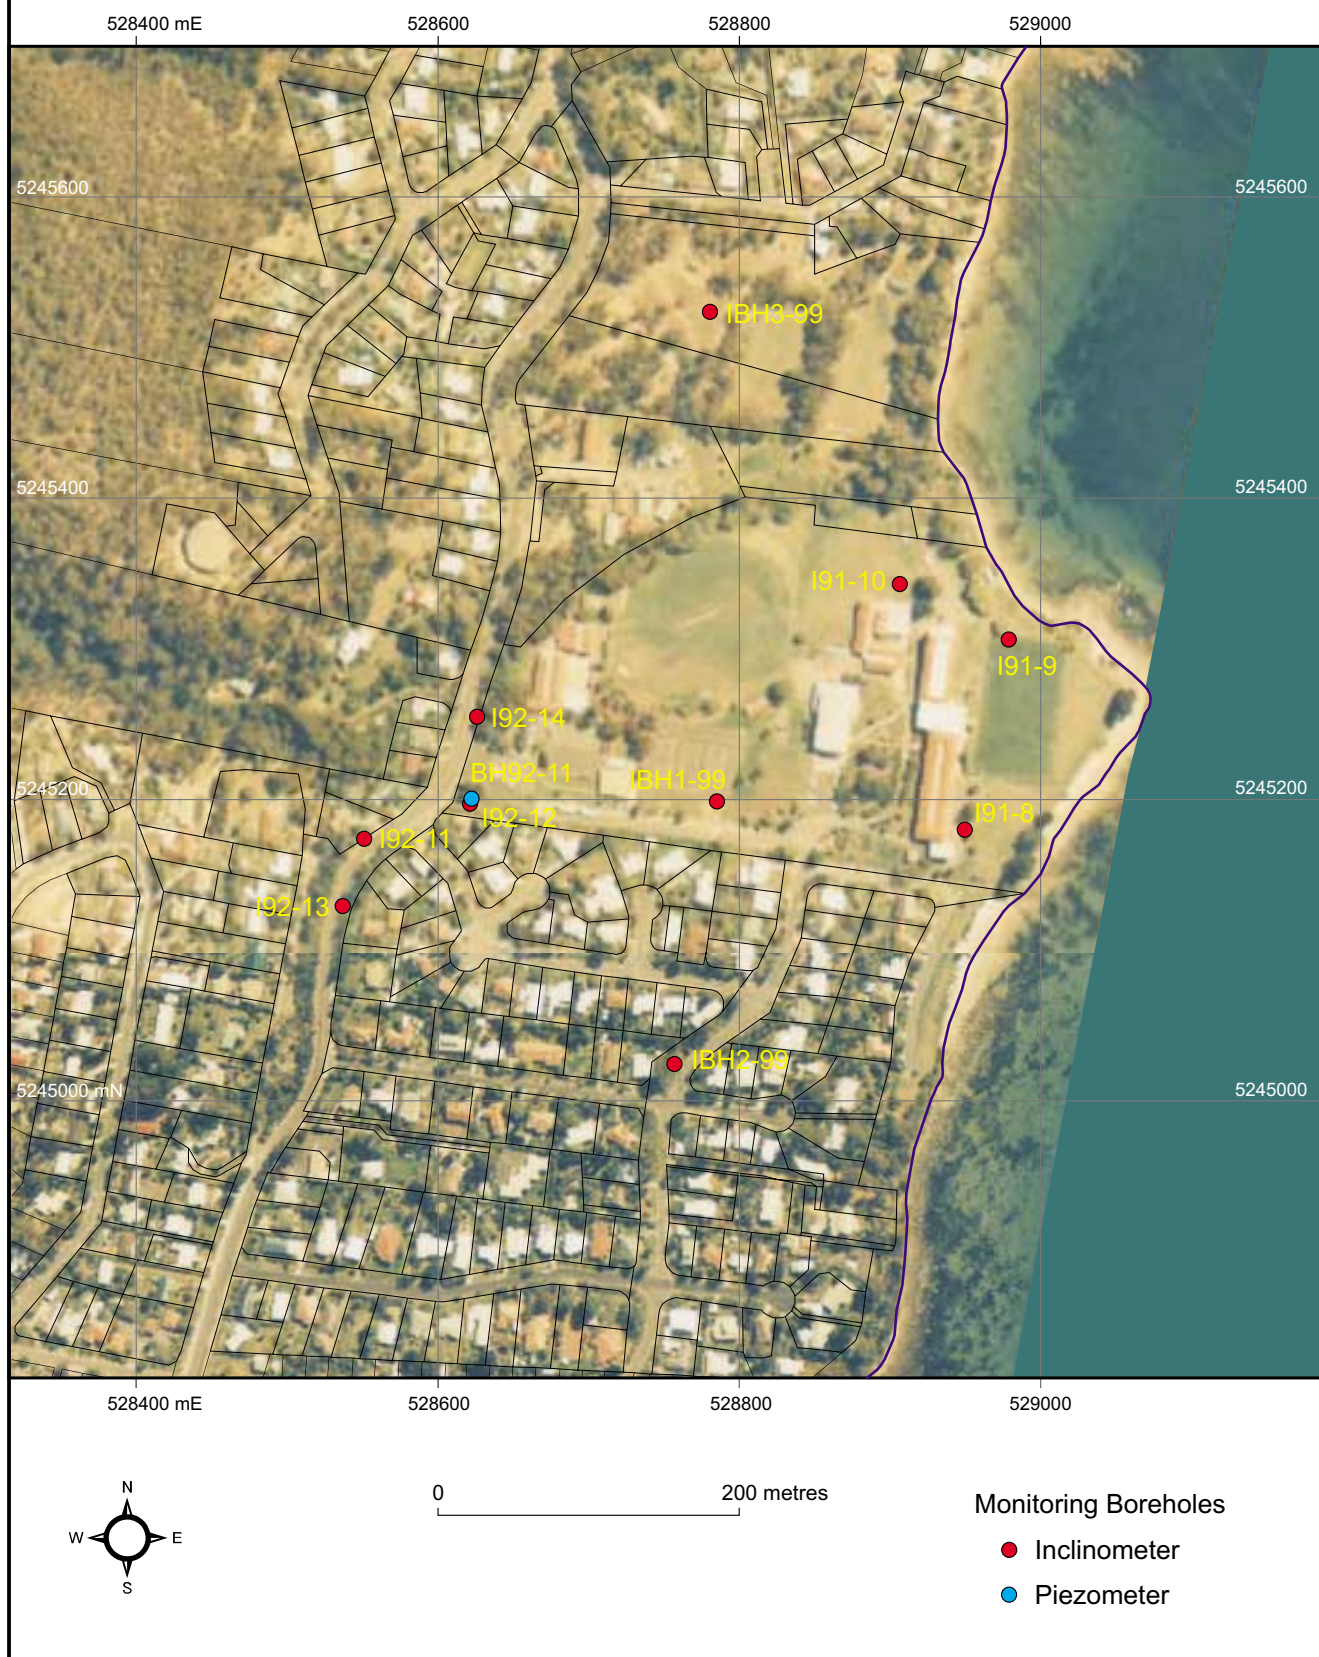
Figure 2

TAROONA BOREHOLE MONITORING NETWORK

Mineral Resources Tasmania commenced a study in March 1999 to further investigate the causes and extent of land instability in the area. The location of the study area is shown in Figures 1 and 2.

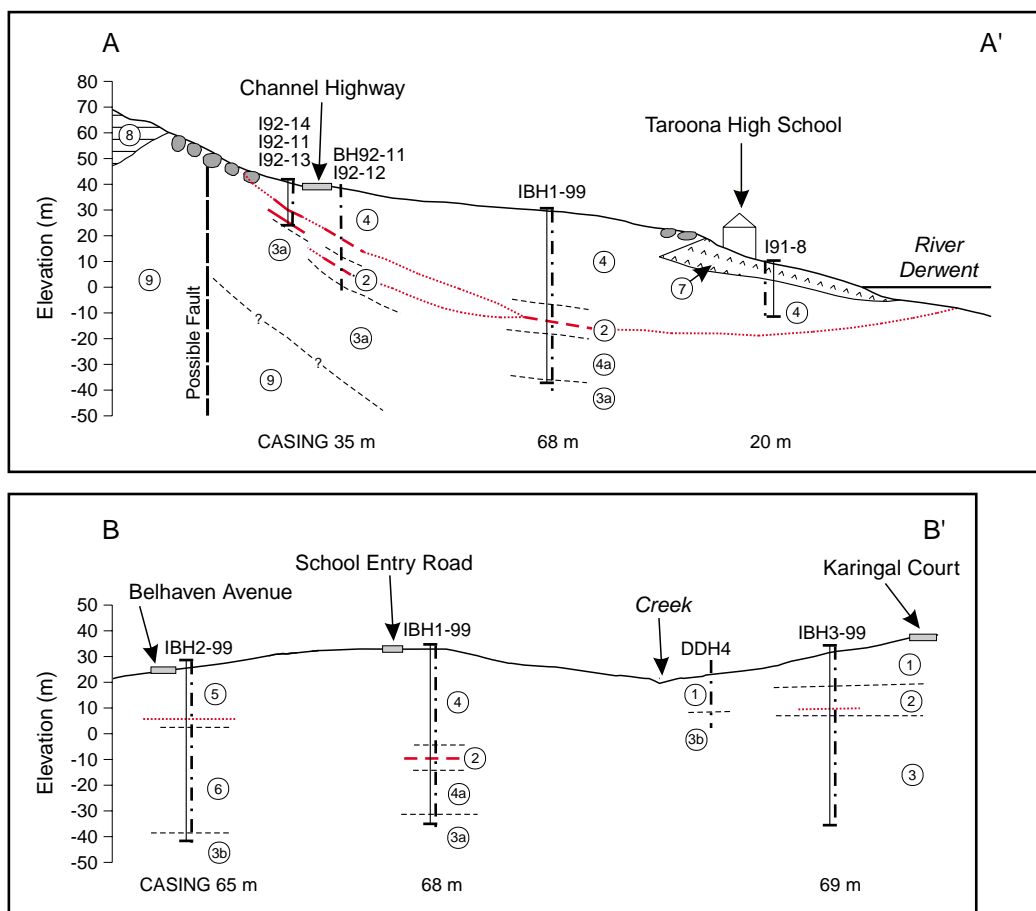
TAROONA HIGH SCHOOL AREA

GENERALISED CROSS SECTIONS A-A' and B-B'

- Depth of movement measured in inclinometer boreholes
- - - Depth to possible slip zone observed in cored borehole
- Depth to possible slip zone

eastwards, and can be tentatively traced from the existence of steeply dipping shear zones in boreholes and significant displacements observed at shallow depth in inclinometers I92-11, I92-13 and I92-14. An interpreted headscarp feature is also present along the Channel Highway between 5 245 010 mN and 5 245 170 mN. The current topographic orientation of this feature may imply a certain degree of structural control on its formation.

To the east of this headscarp feature, subsurface indications of the main slip surface (or surface of rupture) are less obvious. The data from the deep inclinometers in boreholes IBH1-99 and IBH2-99 indicate that possible signs of movement may be being detected at depths of 54 m and 36 m (elevations -26.7 m and -17.9 m ASD respectively). Other inclinometers in the main body of the landslide are presumed to terminate above the main slip surface. The form of this slip surface is assumed, from borehole data, to be rotational (fig. 7). It is probable that the toe of this landslide extends beyond the shoreline. The southern limit is not known.

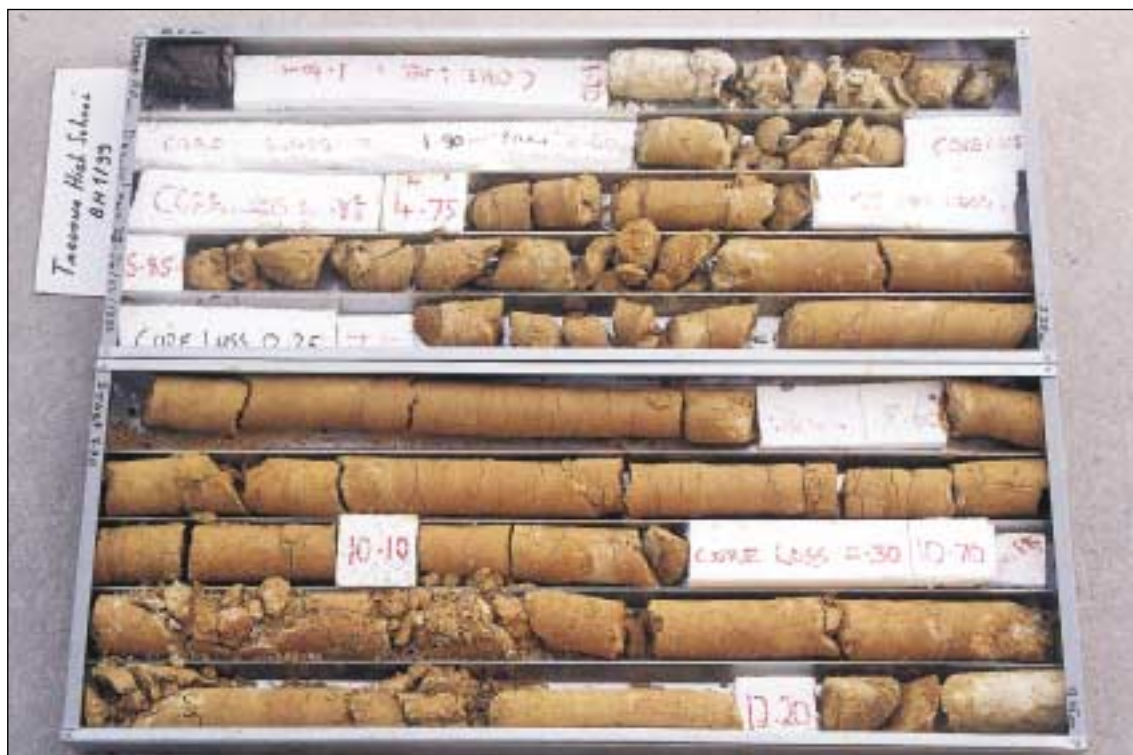
BH1/99

0.0
to
13.45 m
