Mt Wellington Rockfall 2014

The Mount Wellington rock fall event of 8 July 2014 described; with implications for MRT rock fall modelling methodology

C. Mazengarb, M. D. Stevenson and K. Knight

Tasmanian Geological Survey Branch

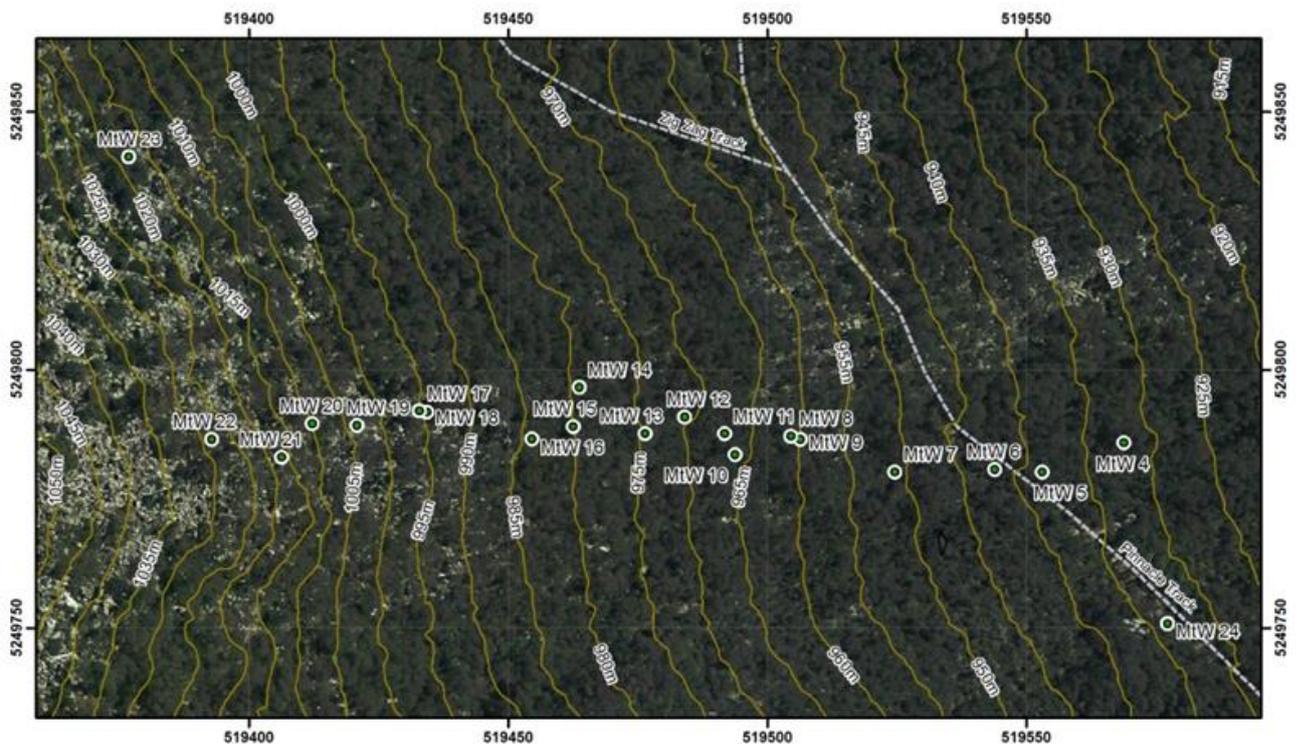
Figure 2. GPS derived observation points for the investigation. Additional information includes 2011 Mount Wellington orthophoto, LiDAR derived contours (5m intervals) and tracks (source: LIST). Map grid in MGA zone 55 (GDA94).

The location of all observations, photographs and notes is stored in digital form attached to the rock fall record in the MRT landslide database. Figure 2 shows Location numbers referred to in the following text.

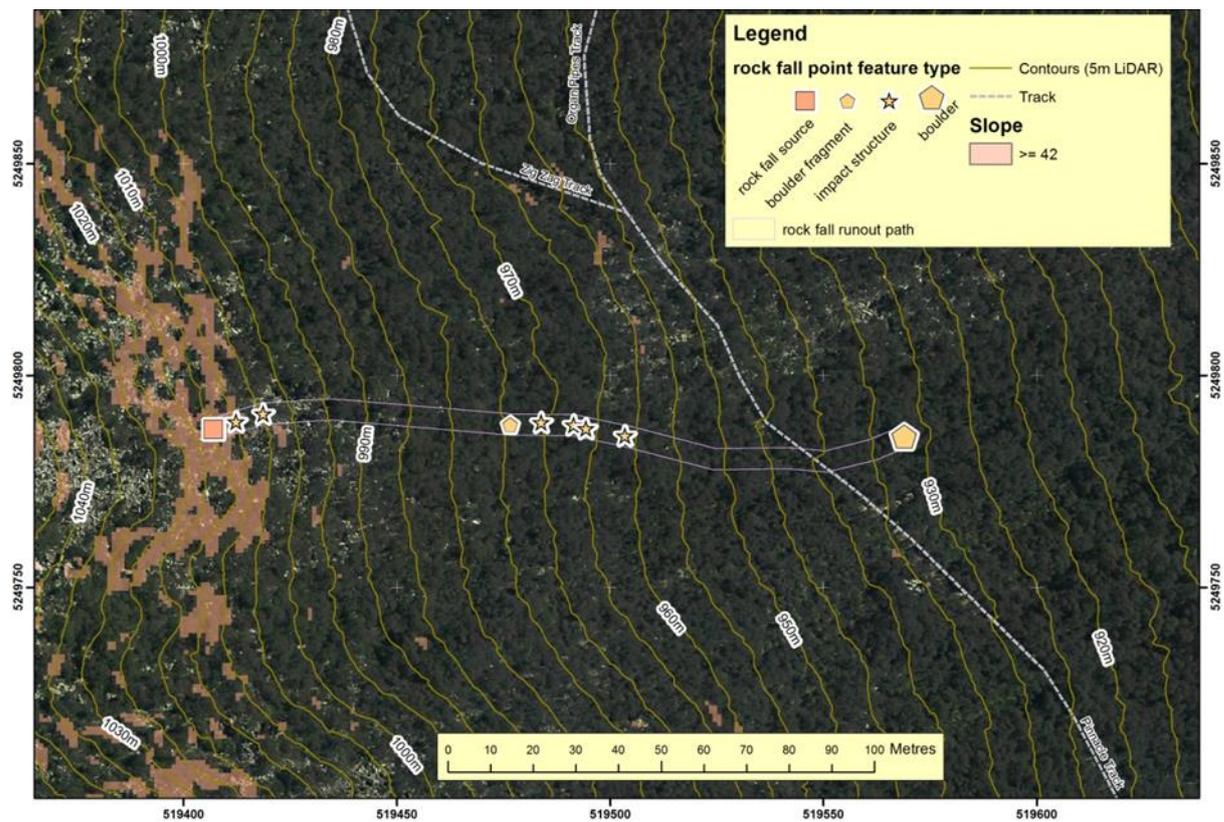
Figure 3 Plan of the rock fall path. The orange overlay indicates areas of slope ≥ 42 degrees where, in the experience of MRT staff, most rock falls originate. Map grid in MGA zone 55 (GDA94).

The following description of the rock fall event is subdivided into descriptions of the boulder, the source and the path. Figure 3 provides an interpretation of the major features.

The 2014 rock fall event is situated within the area of the Hobart rock fall susceptibility modelling (Mazengarb, 2004) but was not predicted by this map. The reason for the non-prediction appears to be the quality of the DEM used in the earlier modelling, being derived from photogrammetric contours that were, until the LiDAR imagery acquisition in 2011, the only data available. These contours were created for other purposes and do not

sufficiently capture the topographic detail on the dolerite slopes. Furthermore, the accuracy of photogrammetric contours in forests, where the operator cannot see the ground surface, is often poor. However, when the rock fall modelling is repeated with the benefit of the LiDAR derived DEM, the 42 degree slope threshold criterion successfully predicts the source area (Figure 3).

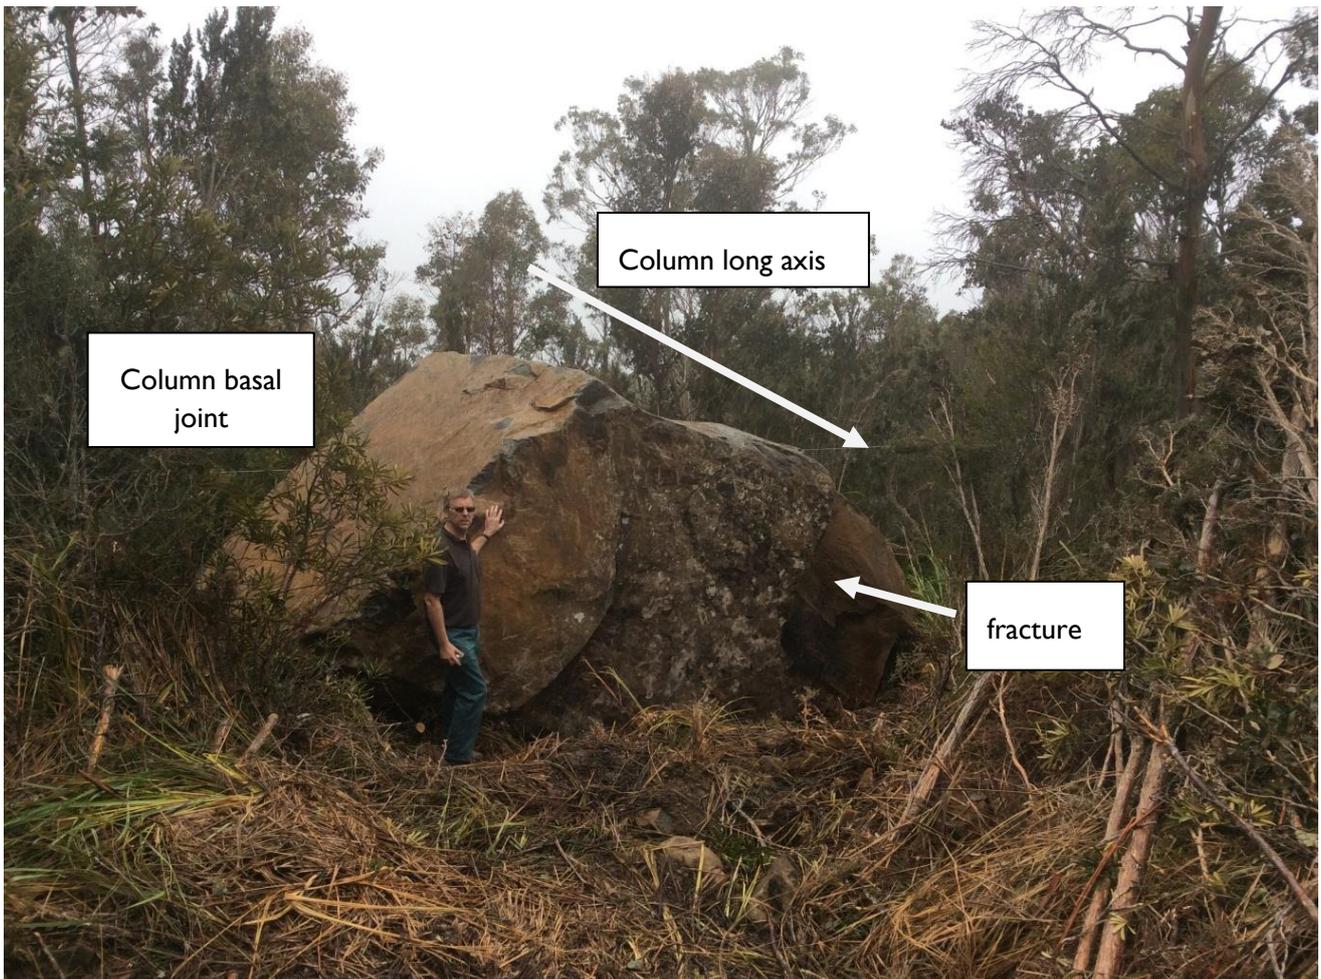
A large dolerite boulder has come to rest about 15m downslope of the Pinnacle Track (Location MtW4, Figure 4). The sides of the boulder are generally planar with dimensions of approximately 3.75 m x 3 m x 2 m (22.5 m³); although it is somewhat rounded and narrower at one end, giving it a slightly eccentric shape. From the general shape of the boulder it appears to be part of a dolerite column with the long axis as shown in Figure 4, and with a fracture where a smaller fragment has been flaked off. We have identified a fragment that is likely to be the flake about halfway along the runout path (Figures 3 and 9), which has dimensions 1.7 x 1.9 x 0.6 m (~2 m³). The column segment is rectangular and four-sided, with the basal joint (depicted) at about 15 degrees from normal to the column axis. The overall shape of the boulder is classified as Columnar (one dimension considerably larger than the other two) according to the CRSP classification (Andrew, *et al.*, 2012). Assuming a volume of 22.5 m³ and a density of 2.88 tonnes/m³, the boulder has a mass of about 65 tonnes.

The boulder has come to rest against some much smaller rocks that appear to be only slightly displaced from their original positions.

Figure 2. View of boulder showing planar surfaces with person for scale. Location MtW4.

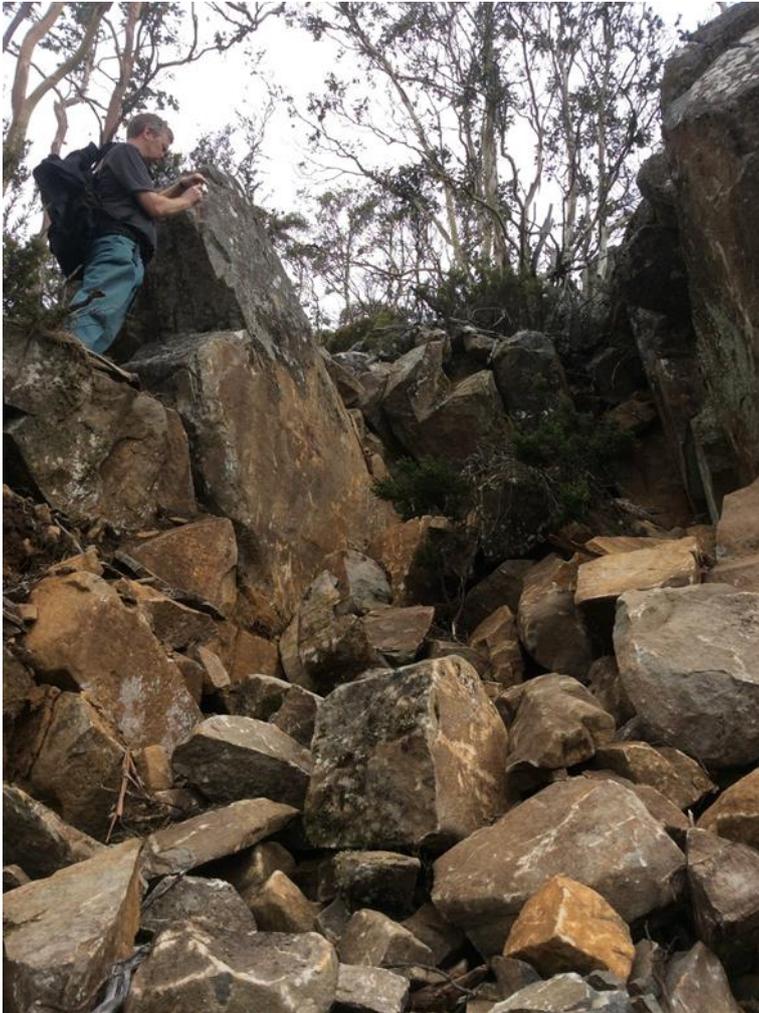
The source area is clearly identified in the field (Location MtW21, Figure 5), consisting of a cavity between two forward tilted dolerite columns (2.1 – 2.47 m wide) where a column once existed. In fact, we were able to match the dimensions of the cavity with the main displaced boulder and match the original contact surfaces with adjacent

Figure 3. Rock fall source in cavity to right of person. Note the precarious rocks above the cavity. Location MtW21.

columns; allowing the original orientation of the boulder and basal joint to be determined. The remaining dolerite columns form a small bluff about 6m high and local slope of over 50 degrees. The released boulder would appear to have detached from the constraining forces of the adjacent columns and, by virtue of a joint across the column, toppled forward over a drop of about 2 m height, hit the ground below, and then started rolling downhill, initially end over end (Figure 6).

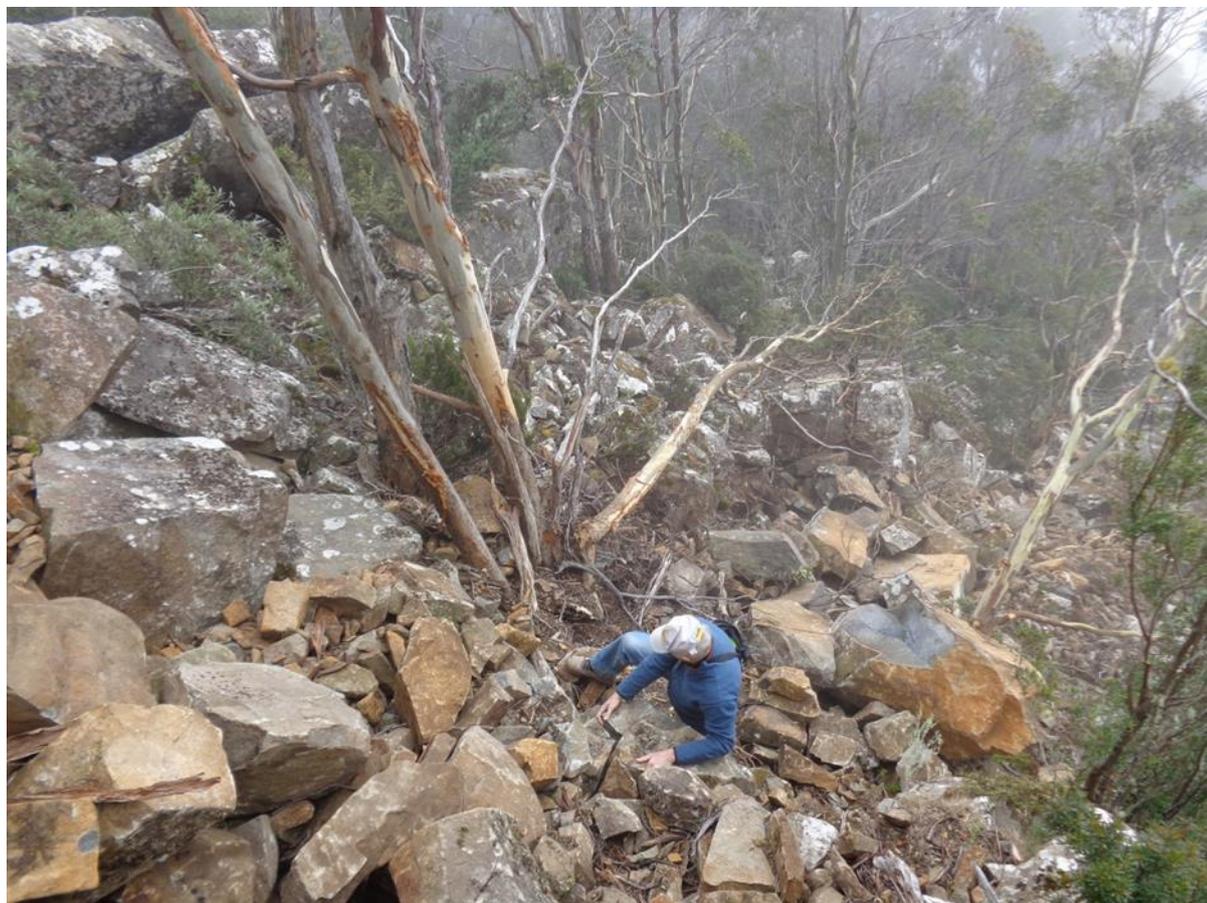
bouncing. Our observations suggest that an initial topple movement from the release point is likely, dropping the boulder onto its end as it impacted the ground and setting up a rotational movement normal to the long axis (i.e. the boulder rotates end over end). We observed a number of impact structures along the length of the runout path, spaced between 5-10 m apart. The uppermost impacts (Figures 3, 6, 7) have fractured underlying boulders and were associated with the initial end over end motion of the boulder.

Figure 4. View of runout path as observed from the release point facing downslope. Fresh fractured boulders can be seen in middle ground attesting to the impact. The boulder travelled end over end between the two light-coloured tree trunks and further down turned and began rolling lengthwise.

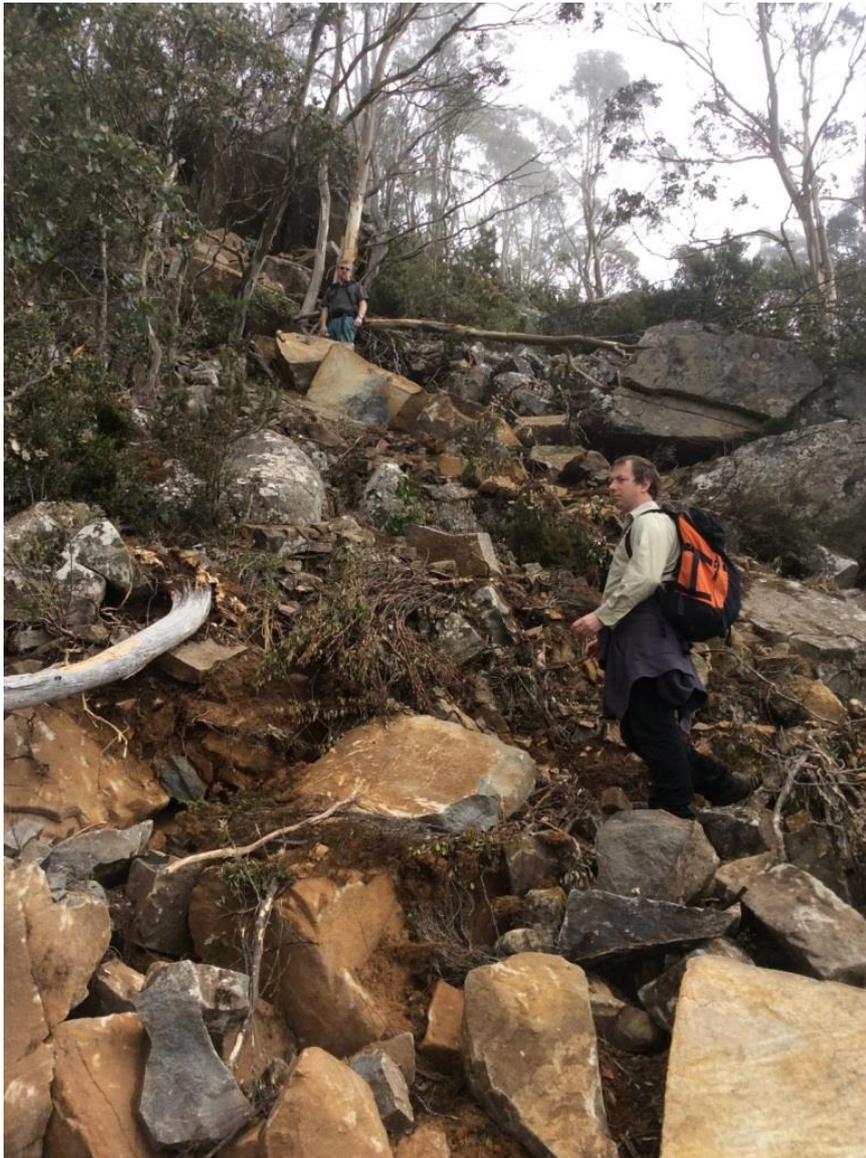
Figure 5. The two people are standing on impact structures (Locations MtW19 and MtW20) approximately 10 m apart in the upper part of the rock fall swath, where the boulder rotated end over end.

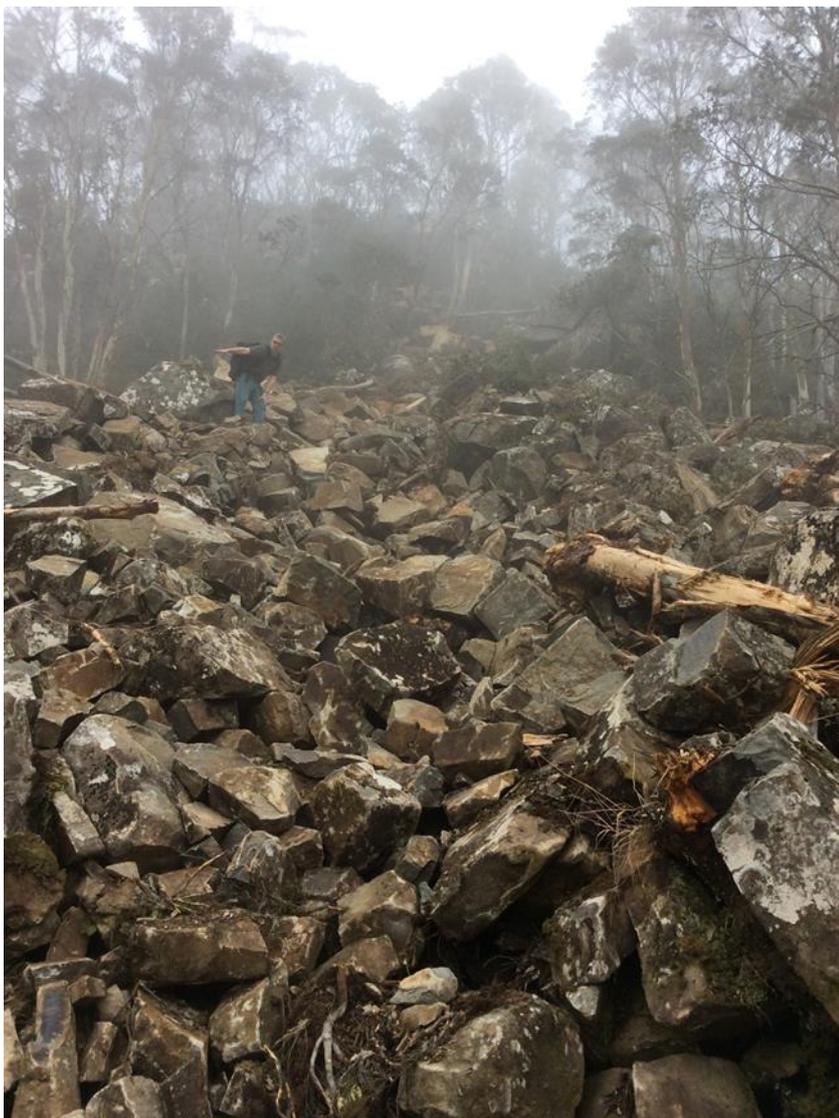
A broad groove in the upper talus segment of the slope suggests that the boulder was in contact with the ground at all times during this part of the journey (Location MtW17, Figure 8).

Figure 6. Upper part of runout swath showing groove facing uphill, showing a broad groove in the talus. The source area is partly obscured behind trees above and right of the person. Location MtW17.

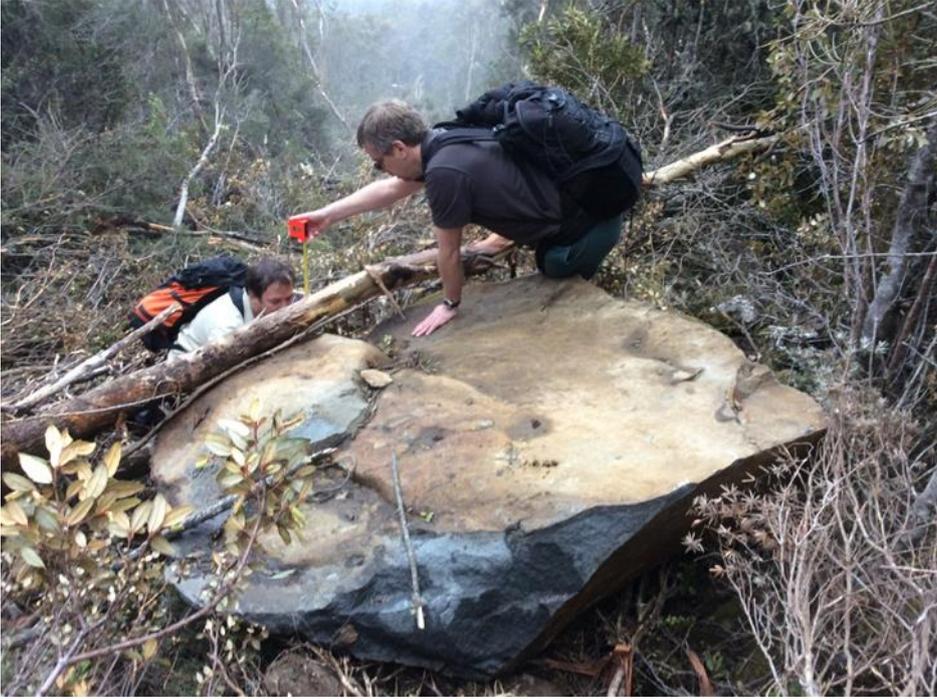
Further impact structures were observed around the middle of the runout path (Figure 3) near where a substantial fragment of the original boulder appears to have flaked off (Location MtW13, Figure 9). These lower impact structures appear to be associated with bouncing over an area where low, in-situ rocks have provided launching points. The generally flattened vegetation and tree damage on the edge of the swath, measured in a few places at up to 3 m above ground (Figure 10), suggests that the bounce height may not have been particularly great.

Figure 7. Likely fragment of the dolerite boulder deposited on the runout path at Location MtW13.

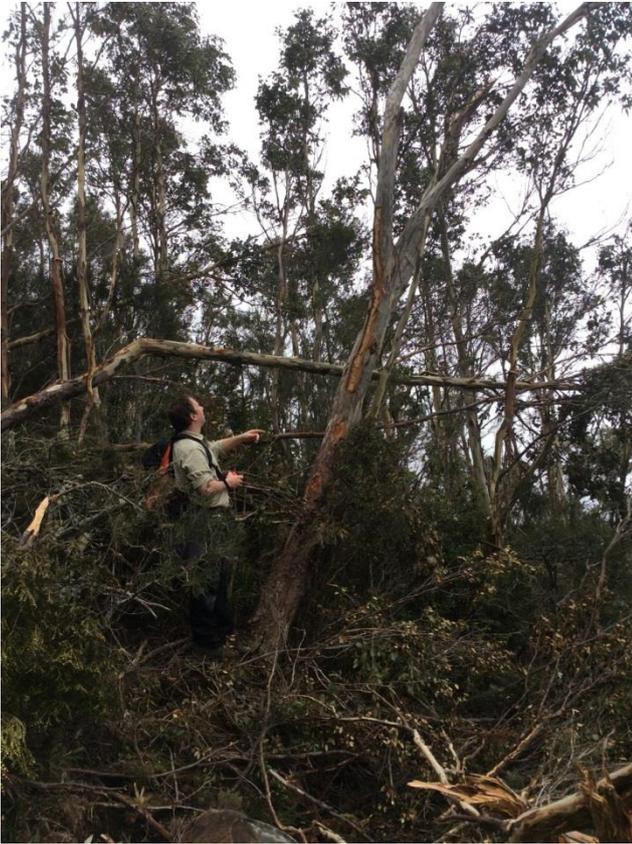
Figure 8. Damage to tree approximately 3m above the ground. Location MtW9.

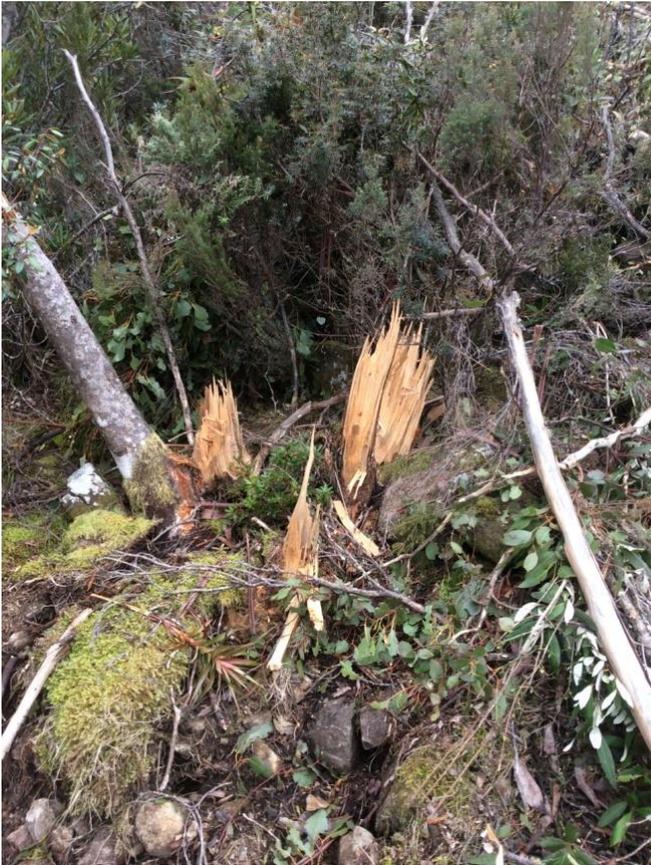
Figure 9. Splintered tree trunk on the runout path. Location MtW8.

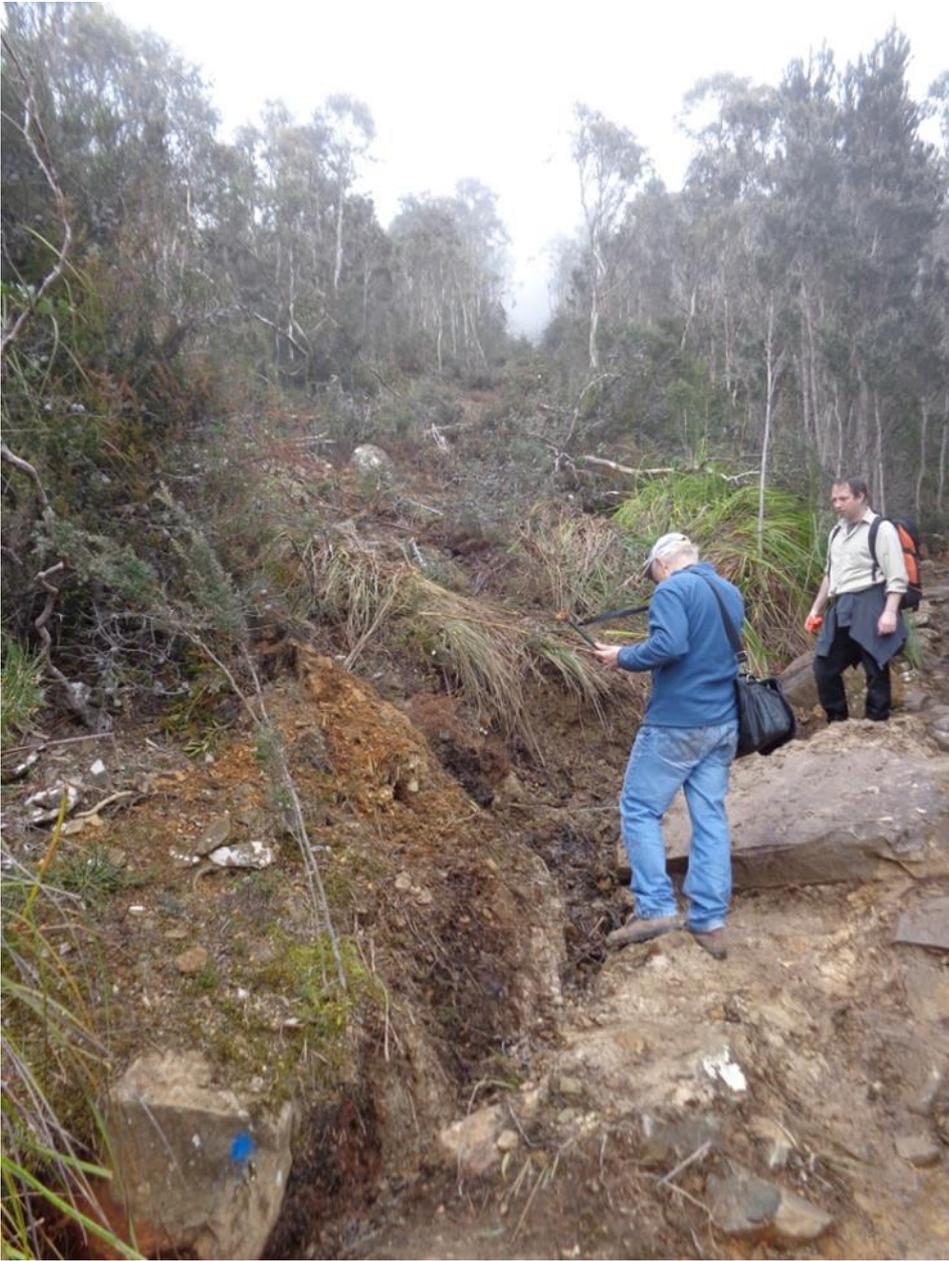
The runout path of the rock fall is easily mapped out as it forms a cleared swath about 170 m long (plan distance) and 5 m wide through stunted sub-alpine forest (Figures 10,12). However, not all of the path is in forest as the upper most part (above Location MtW15) is only lightly vegetated bouldery talus (Figures 6, 8).

Figure 10. View of rock fall swath facing uphill from the Pinnacle Track.

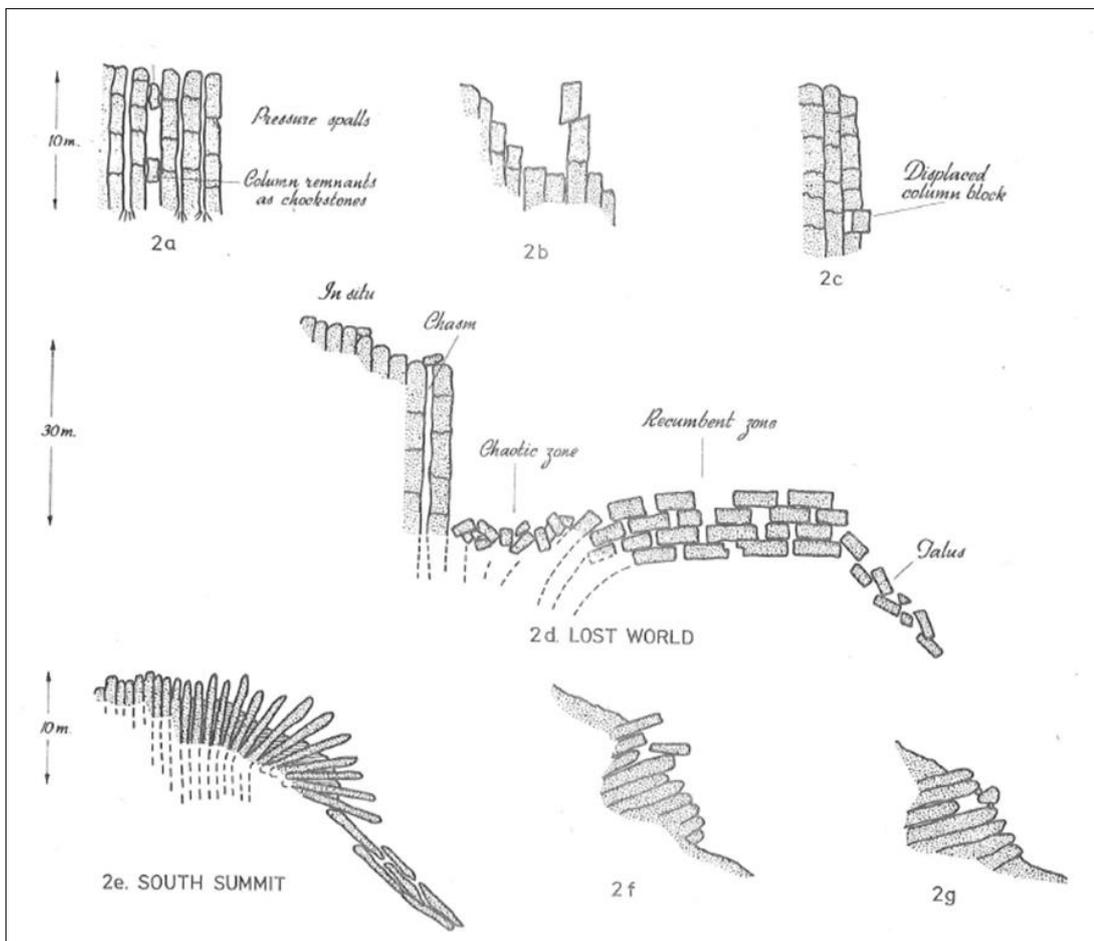
Where intact outcrops are obvious, such as the Organ Pipes (Figure 1), the columns are in general near vertical. In detail though, the flanks of the escarpment contain many examples of inclined dolerite columns and boulder fields, as described by P.C. Stevenson (1980) and shown in Figure 13. The widespread forward toppling process is seen particularly well in stereo-imagery, ranging from vertical columns with progressive rotation ending with columns that lie entirely on their sides on the hillslope facing downhill, having rotated over 90 degrees from their original position. The toppling process has been accompanied by fragmentation of the columns to form boulder fields. In some cases detachment and block sliding of dolerite masses containing multiple columns has also occurred.

Figure 11. Examples of dolerite escarpment deterioration from P.C. Stevenson (1980). Example 2f provides the closest model for the 2014 rock fall source area.

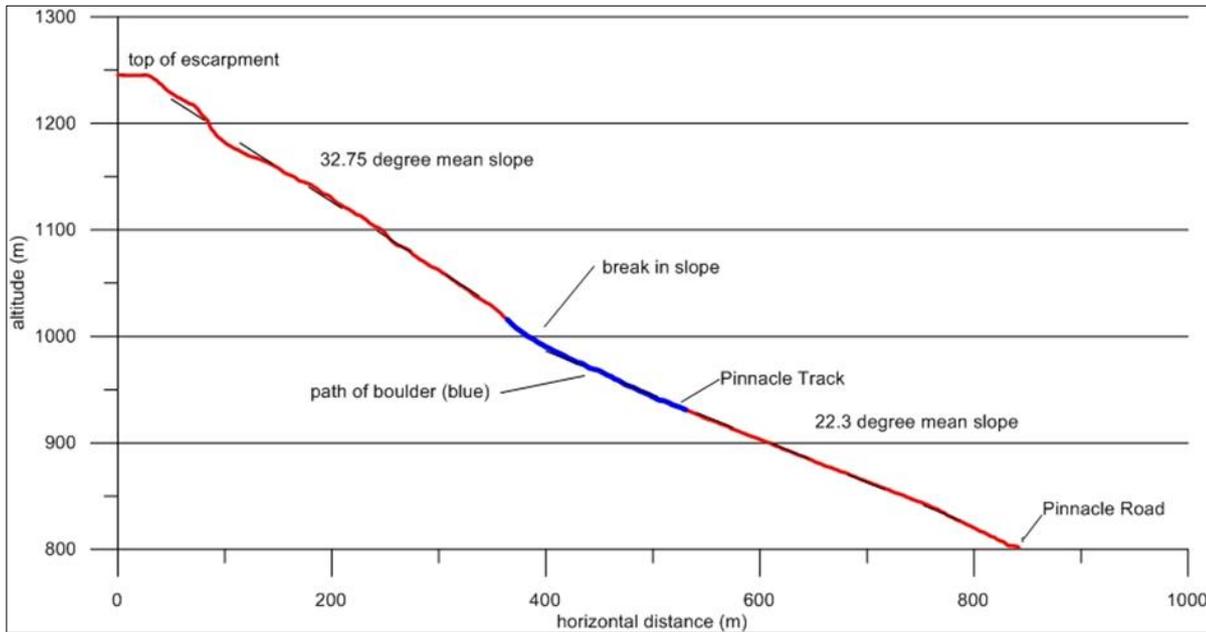
The topographic profile from the top of the escarpment to the Pinnacle Road, which is approximately parallel to the direction of aspect (Figures 1, 3), can be split into two parts; the upper part with a mean slope of about 33 degrees corresponding approximately to the extent of the Tasmanian Dolerite, and a lower slope of about 22 degrees underlain by Parmeener Supergroup. In detail the upper profile contains minor steeper segments (≥ 42 degrees) where, based on our observations and previous modelling parameters rock fall source areas are expected. Despite the *Mercury* newspaper article indicating otherwise, the lower slope profile is relatively uniform down to the Pinnacle Road.

Figure 12. Topographic profile approximately parallel to general slope direction and coinciding with the rock fall path. The labelled break in slope is the approximate contact of the Tasmanian Dolerite over the Parmeener Supergroup. H:V ratio = 1.

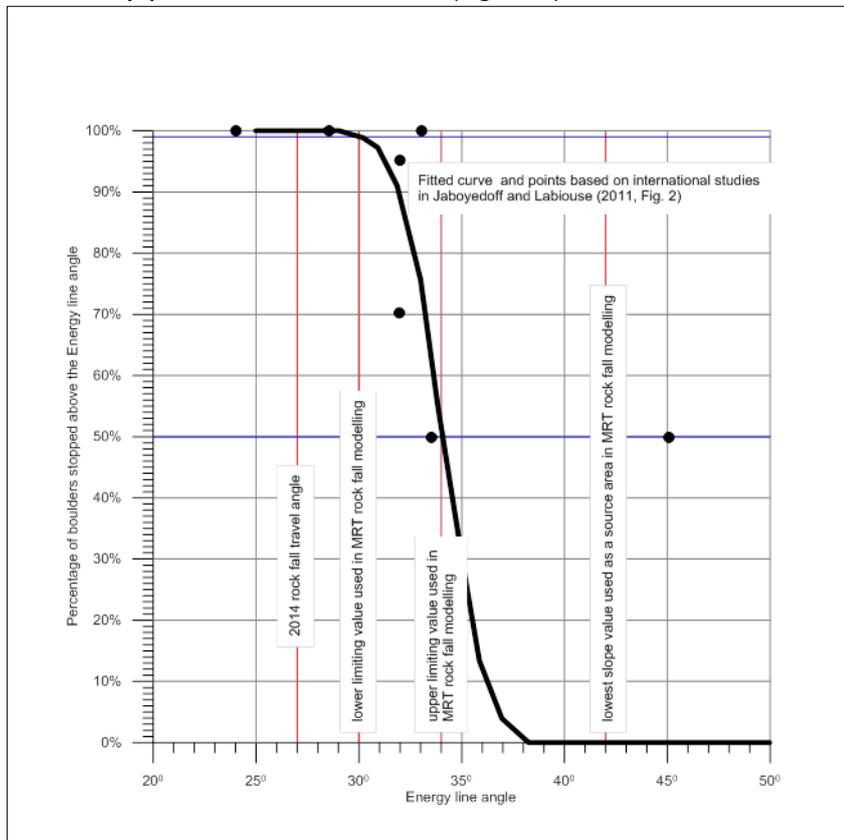
Figure 13. Parameters used in MRT rock fall runoff modelling as compared with those in international studies summarised in Jaboyedoff and Labiouse (2011). The 2014 Mount Wellington rock fall is also shown.

MRT rock fall modelling to date has used travel angles of 34 and 30 degrees to constrain rock fall runout based partly on limited empirical observations in Tasmania but also with reference to international studies (summarised by Jaboyedoff and Labiouse (2011)). In the afore-mentioned paper, the two angles have statistical significance representing 50% and 99% population distributions respectively (Figure 15) and equivalent to the lower thresholds for the High and Low quantified susceptibility descriptors of the Australian Geomechanics Society (AGS, 2007a).

However, the travel angle for the 2014 boulder, at approximately 27 degrees, is significant in that it is lower than that used in MRT's modelling to date; i.e. this

boulder has travelled further than previous MRT modelling would predict. If the fitted distribution in Figure 15 is applicable, it indicates that <1% of rocks travel at below 30 degrees but values as low as 24 degrees are still possible. This raises the question as to whether segments of dolerite columns behave differently from rock material involved in the published studies, and whether the travel angle distribution is different, or is the 2014 event truly exceptional and a statistical outlier representing <1% of the rock fall population? We consider that there is insufficient information to resolve this question. However, if the latter option is adopted then the 2014 rock fall event would conveniently fit in the Very Low quantified susceptibility descriptor of the Australian Geomechanics Society (AGS, 2007a).

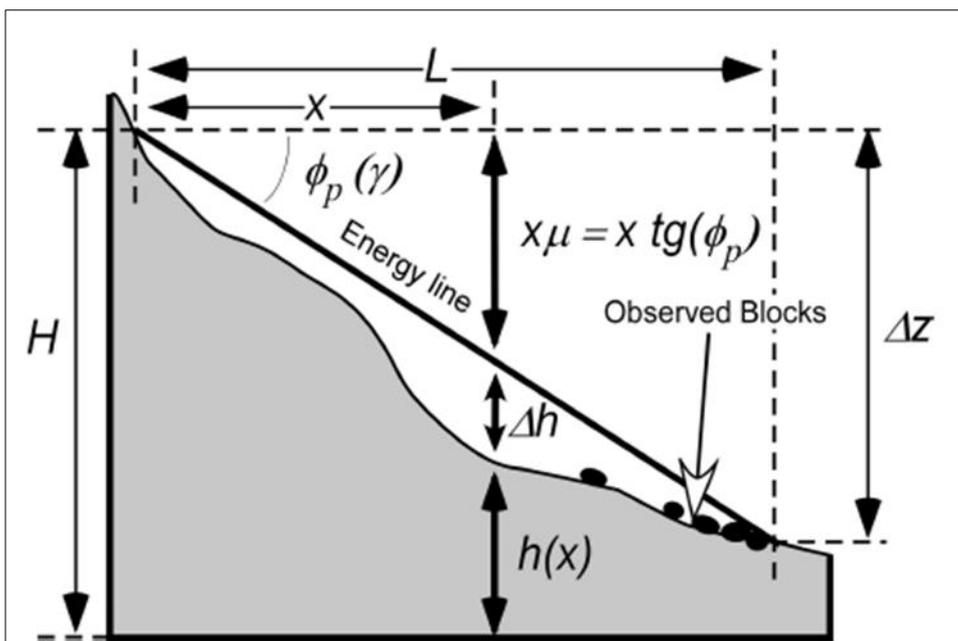
Figure 14. Sourced from Jaboyedoff and Labiouse (2011).

The Conefall method (Jaboyedoff and Labiouse, 2011) applies radiating (cone/fan-shaped) straight-line runout methods and the energy line concept (Figure 16) for creating rock fall susceptibility maps. Input parameters required are predefined source areas, fan angle and shadow angle. According to the authors, Conefall allows a first estimate of rock fall propagation zones but should only be used as a preliminary mapping tool.

However, the energy line concept allows the calculation of instantaneous velocities of rock fall (v) along a runout path based on the height difference between the energy line and the topography (Δh) using the formula below and where g is the gravitational acceleration constant:

Fig. 1b. Variables used to calculate velocities and energies based on the energy line concept. The example uses the more distant block to define ϕ_p and estimate Δh , which is used to calculate the velocity $v = \sqrt{2g\Delta h}$. This illustrates the tailor-made possibilities of the cone method.

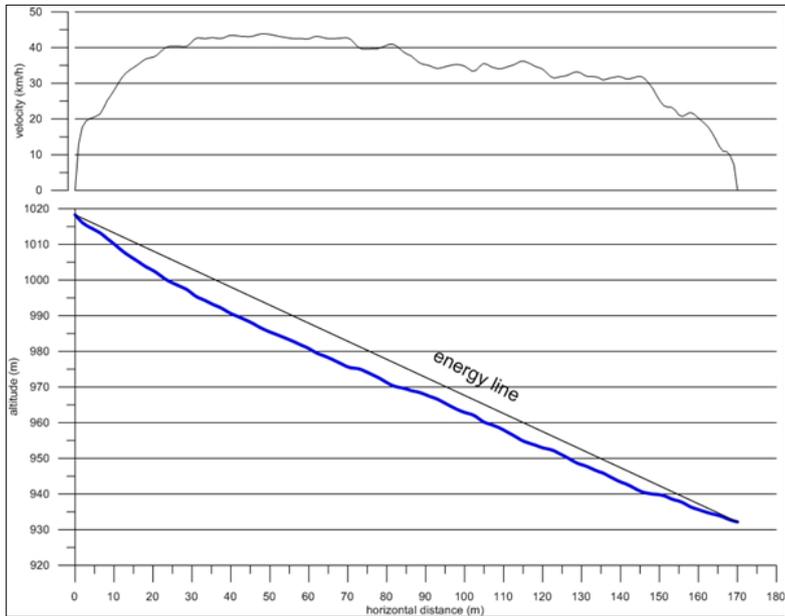
As a demonstration of the principle, we have applied the energy line equation to provide a rough estimate of the maximum velocity of the 2014 rock fall (Figure 17) suggesting it may have exceeded 40km/hr with a kinetic energy of 400kj. It is worth cautioning the reader that other, more sophisticated software which takes other factors, such as the effects of the forest barrier, might produce different estimates.

Figure 15. Topographic profile along the 2014 rock fall path with energy line (lower) and calculated velocity (upper).

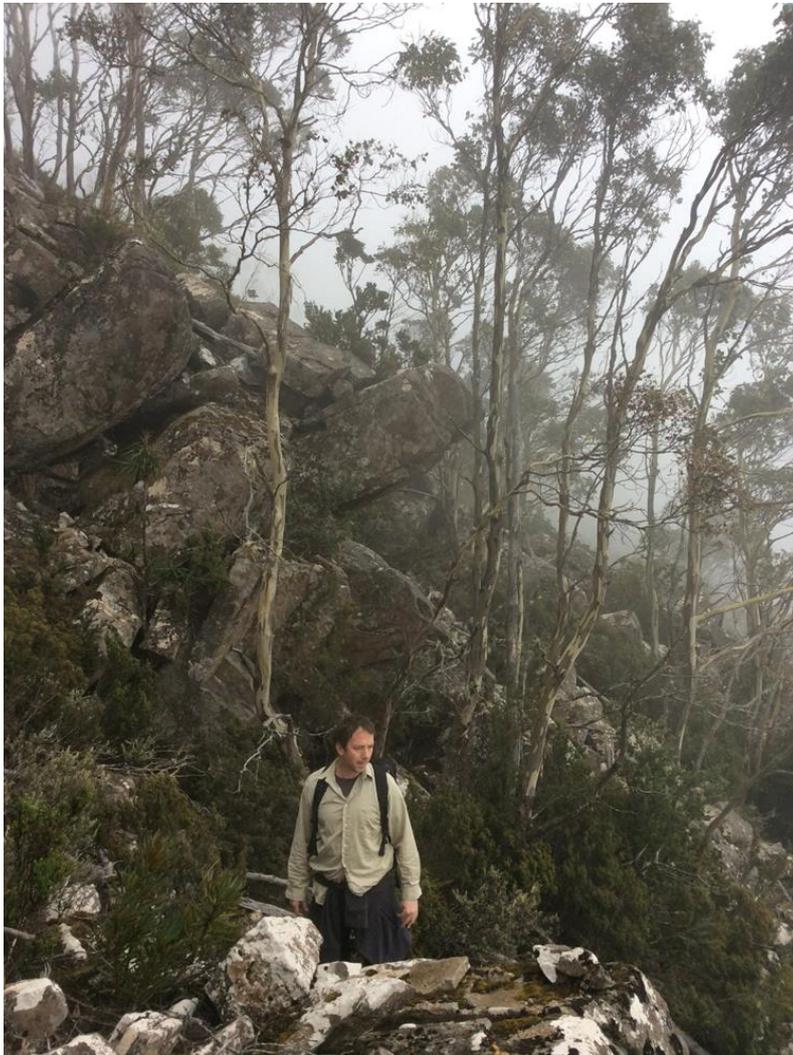
Figure 16. Example of forward tilted blocks of dolerite, behind person. Location MtW22.

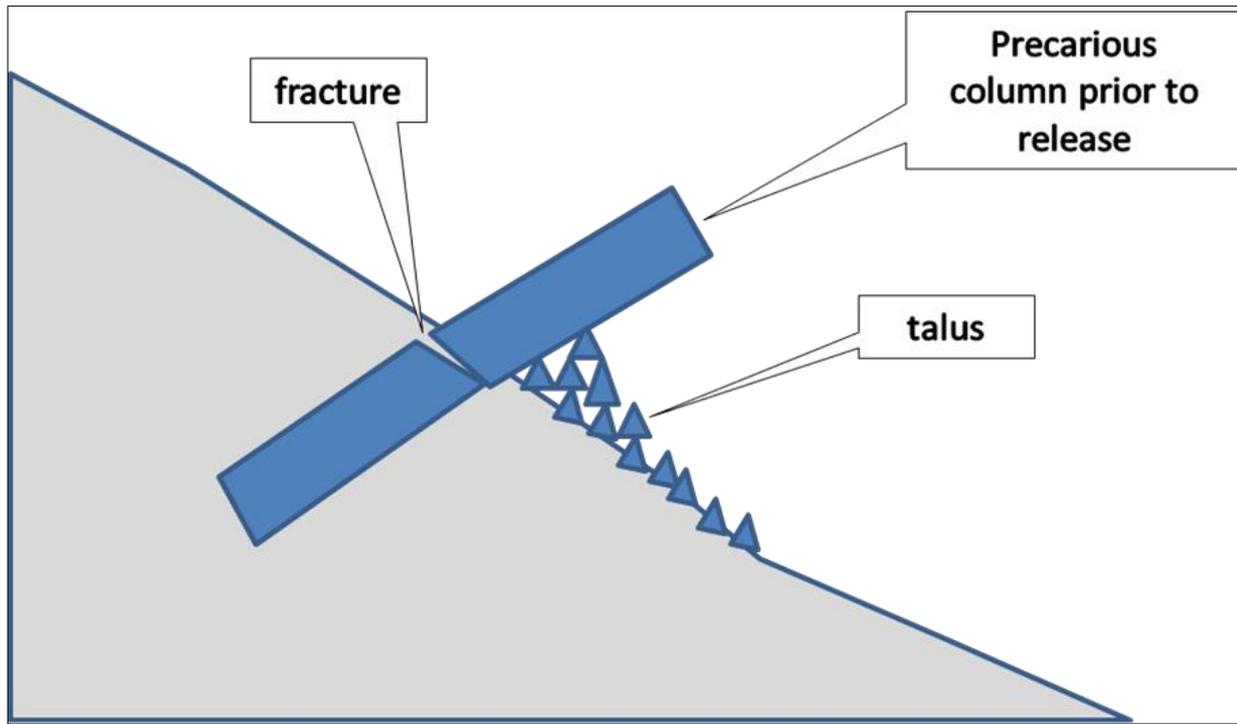
The geomorphic setting and the mechanism of dolerite escarpment deterioration help explain some of the preparatory causal factors (Popescu, 2002) for rock fall on Mount Wellington. Forward tilting (toppling) of dolerite columns on escarpments as described by P.C. Stevenson (1980) (Figure 13) is presumed to be a gradual process, possibly occurring in periglacial environments associated with globally cooler climatic conditions in the Pleistocene. The physical process of toppling of small sets of columns away from the escarpment allows the originally vertical cooling joints to widen and loosen their lateral constraints. This process along with the formation of cross-cutting joint sets creates precarious situations that can lead to rock fall (Figure 19).

Figure 17. Conceptual model for the 2014 rock fall source area.

The remaining columns appear stable and we confidently walked over them. However, on geological time scales these columns will also ultimately fail. One of the adjacent columns has a joint across it at a similar angle to the original basal joint for the rock fall boulder (refer to Figure 19).

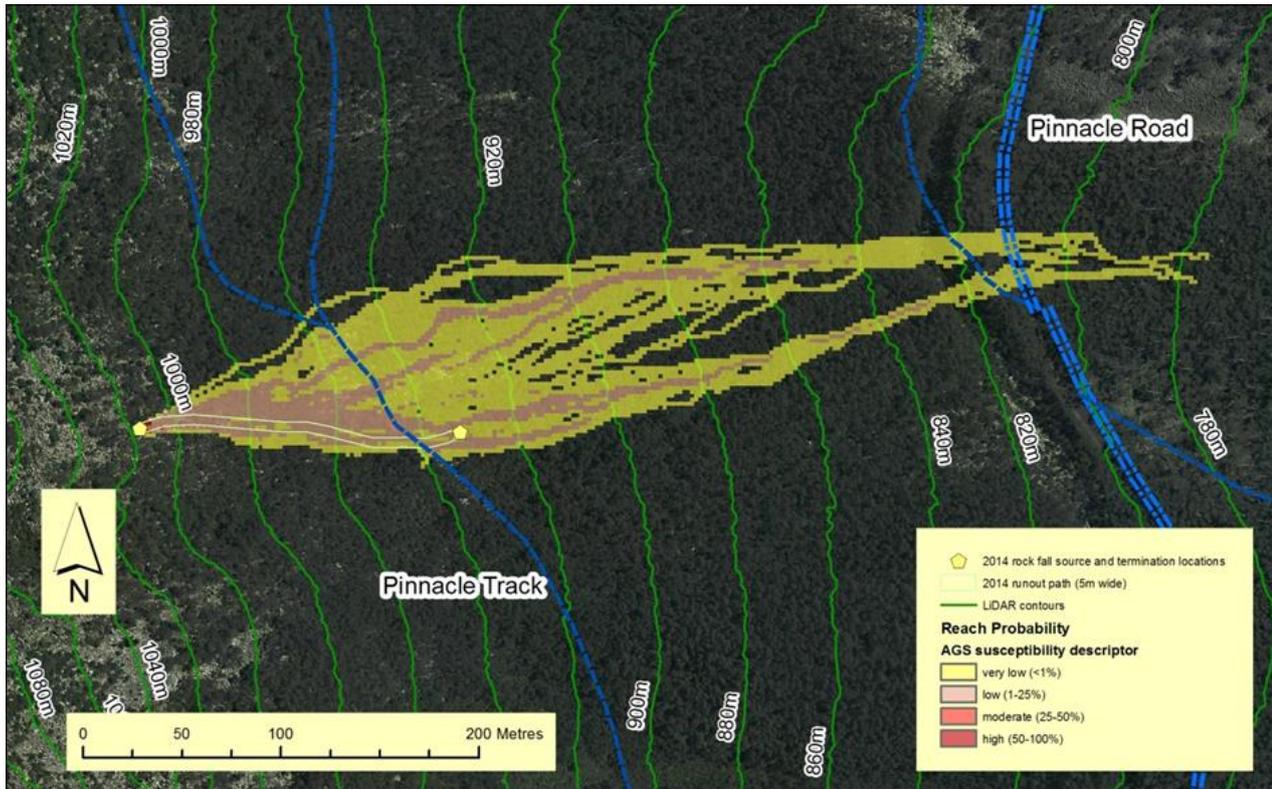
The software has been evaluated on the area of the 2014 rock fall (Figure 20). The most obvious difference from the MRT modelling approach is that much more information is required as input layers and model parameters. In the simulation provided, spatial estimations of surface roughness, ground hardness and vegetation were provided along with specific rock fall dimensions, shape and density. The simulation was performed 1000 times on a 2 m DEM with a 1m drop height. Processing time was less than 1 minute from the single source. However, processing time would be expected to be significantly longer if all potential source areas were considered in the area modelled.

The reach probability output shown on Figure 20 indicates a diverging then converging pattern of rock fall distribution from the single source area. The initial divergence is related to minor variations in initial propagation direction created for each simulation occurring on a slightly convex slope in the source area. Lower down the

Figure 18. Rock fall reach probability using the Rockyfor3D software. Note that Moderate and High susceptibility areas are restricted to the vicinity of the source area.

hillside a subtle concave slope provides for topographic focussing and convergence. The mapped runout path of the 2014 rock fall is consistent with the simulation output, situated within the 1–25% probability area (a Low quantified susceptibility in terms of AGS (2007a)). Interestingly, the model indicates that a boulder equivalent to the 2014 feature could make it all the way to the Pinnacle Road but the probability of this happening is <1% (a Very Low quantified susceptibility in terms of AGS (2007a)). The furthest runout path shown in this simulation has a travel angle of 23.6 degrees which is just beyond but close to the limit of rock fall runout as shown in Figure 15. It should be stressed that the simulation is indicative only and should not be relied on as we have not mapped in sufficient detail the ground conditions in the entire runout area and the model parameters need further calibration.
