Borehole log

Engineering log – Cored borehole

BH-013

M MAC
P POINT Macquarie Point
Geotechnical Investigation

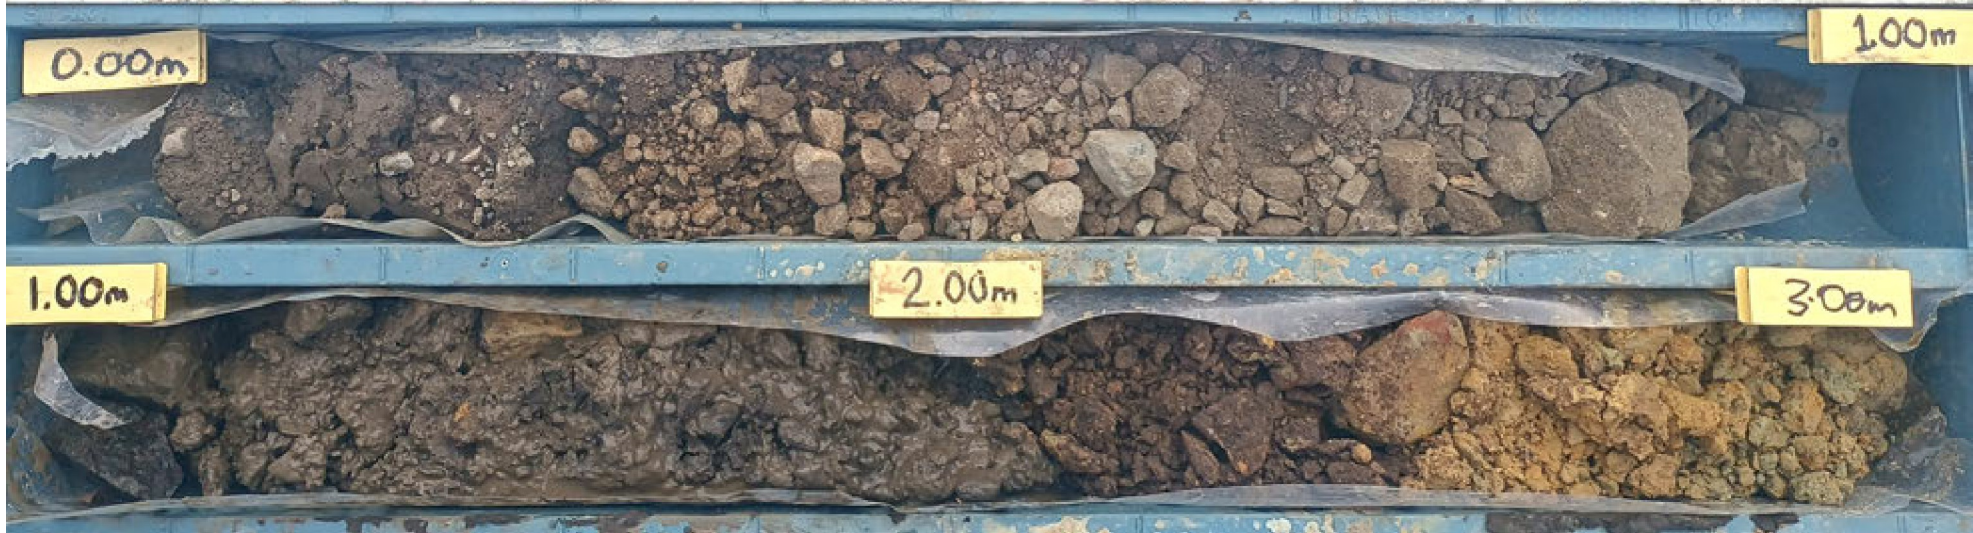
PointID: BH-013 Depth Range: 0.0 – 3.0 m

BH ID: BH013
Depth: 0-3m
Core Tray No.:
Date: 15/05/24

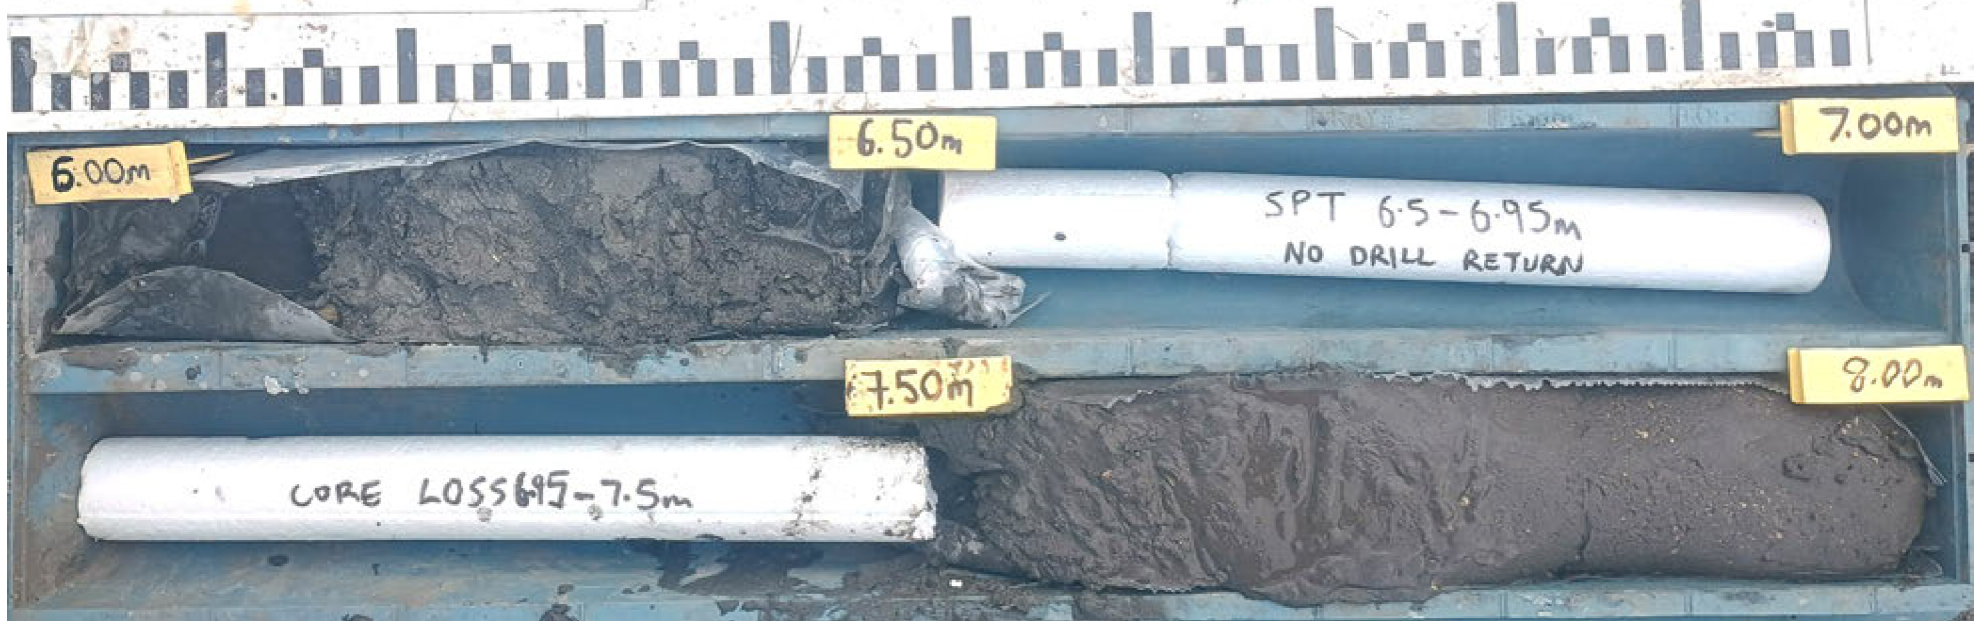
PointID: BH-013 Depth Range: 6.0 – 8.0 m

BH ID: BH013
Depth: 6.0 - 8.0m
Core Tray No.:
Date: 15/05/24

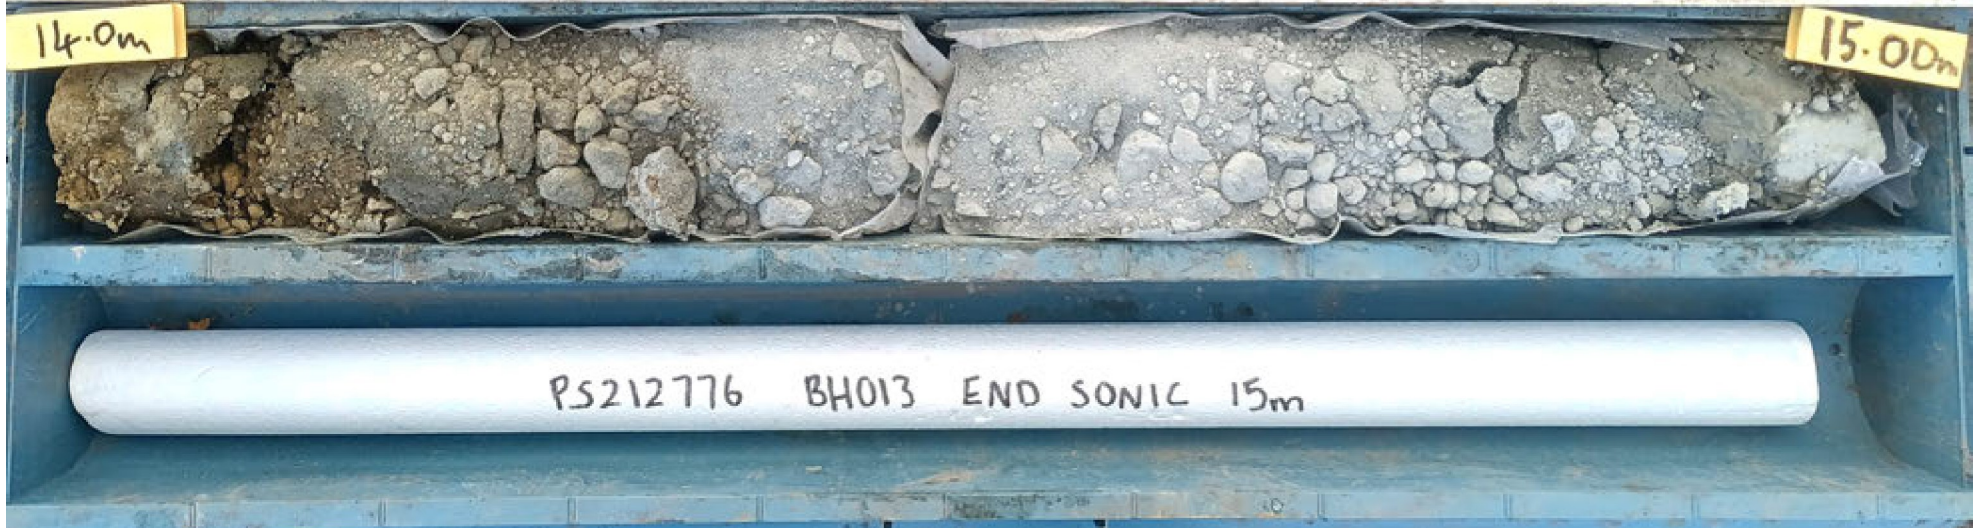
PointID: BH-013 Depth Range: 14.0 – 15.0 m

BH ID: BH013
Depth: 14.0 - 15.0m
Core Tray No.:
Date: 15/05/24

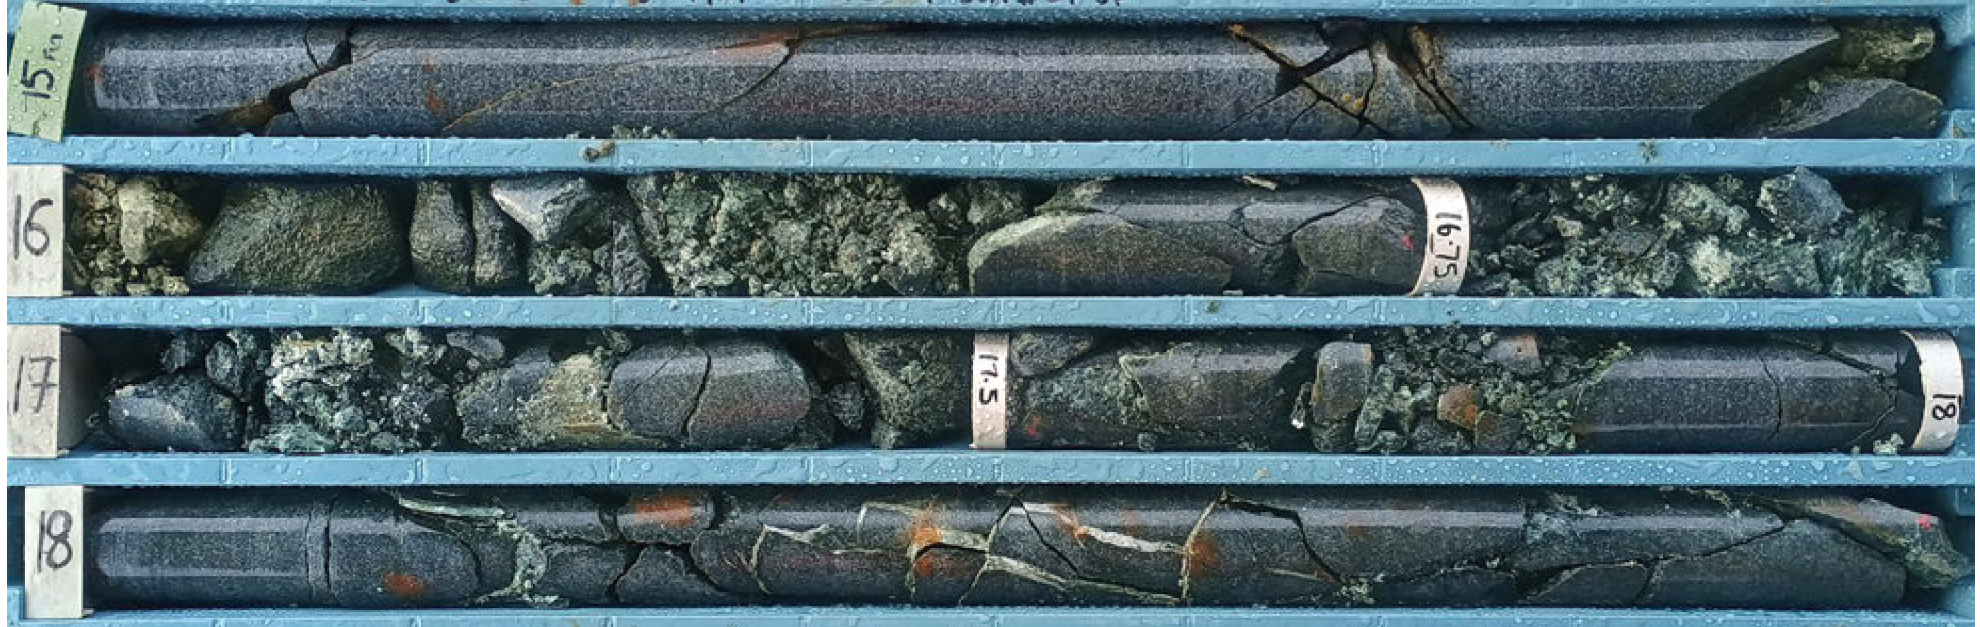
PointID: BH-013 Depth Range: 15.0 – 19.0 m

Depth: 15.0 - 19m

15.0		DOLERITE: grey (olive grey on joint faces); SW, unstained; fine-medium grained; high strength; variably fractured					— 45°, RF, I, CN	Jurassic dolerite

16.0		Silty sandy GRAVEL: grey-green, Dolerite: grey, SW, fractured,					— 60°, RF, I, CN, conjugate — RF, I, CN — Crush zone?	
						16.75		Silty sandy GRAVEL: grey-green					— Crush zone?

17.5		Dolerite: grey, SW, fractured,					— Crush zone?	
						18.0		Silty sandy GRAVEL: grey-green					— SV, RF, I, ST, Ca; several	
						19.05							— SH, RF, CN — SH, RF, Ca
