Client :	Department of State Growth	LOCATION No. BH01	SHEET 1 OF 13
Project :	Tamar River Crossing Centre Alignment Geotechnical Investigations		
Location :	Tamar River, Launceston		
Position :	510336.0 E, 5415057.0 N GDA2020\	Surface RL : -9.60m Riverbed AHD	Angle from Horiz. : 90°
Contractor :	KMR Drilling	Rig Type : Hydrapower Trekker 2100 (Rig No. 7)	Processed : UP
Date Started :	29 Aug 22	Date Completed : 1 Sep 22	Checked : JRN
		Logged by : Kia.I	Date : 28 Feb 23

Job No.
12570434

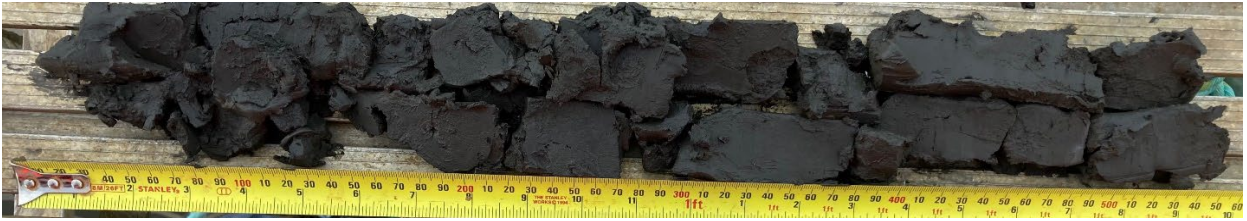
SPT1 (1.8 - 2.25 m) 0/0/0 N = 0, Recovery=450mm

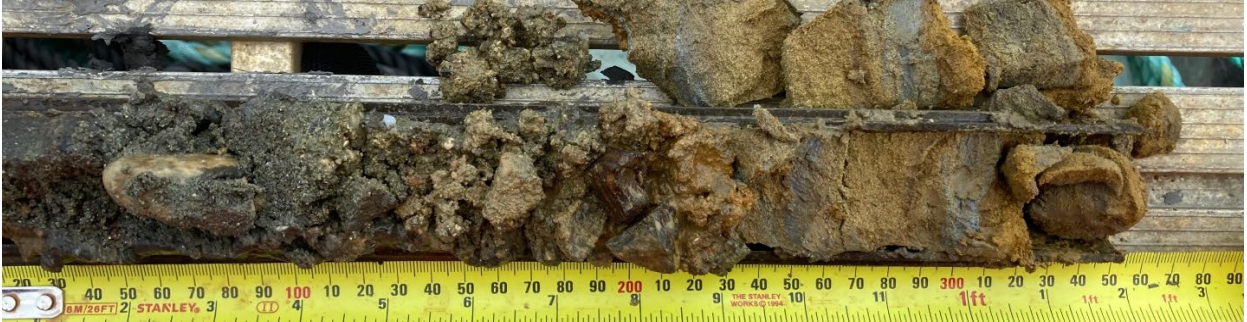
SPT2 (5.1 - 5.55 m) 9/12/7 N = 19, Recovery=350mm

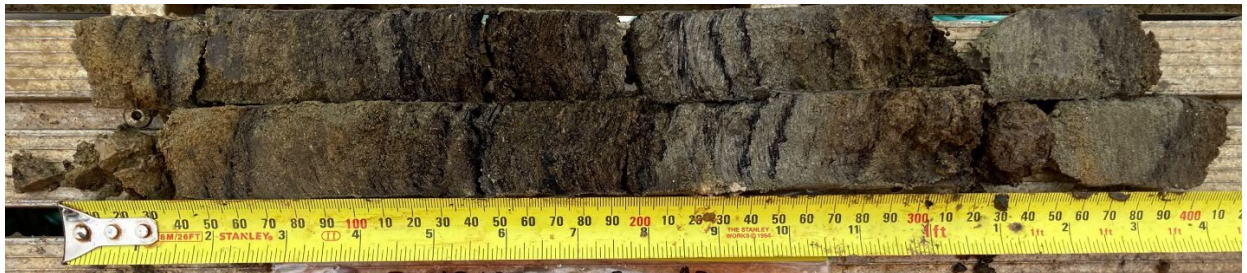
SPT3 (6.5 - 6.8 m) 9/23/* N = R, Recovery=450mm

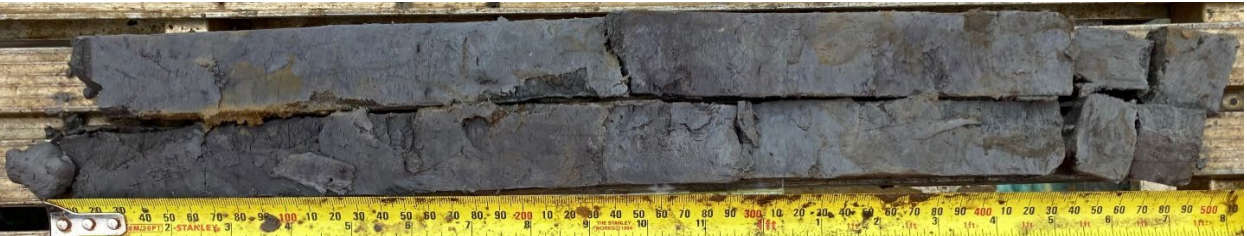
SPT4 (8.2 - 8.65 m) 5/7/11 N = 18, Recovery=450mm

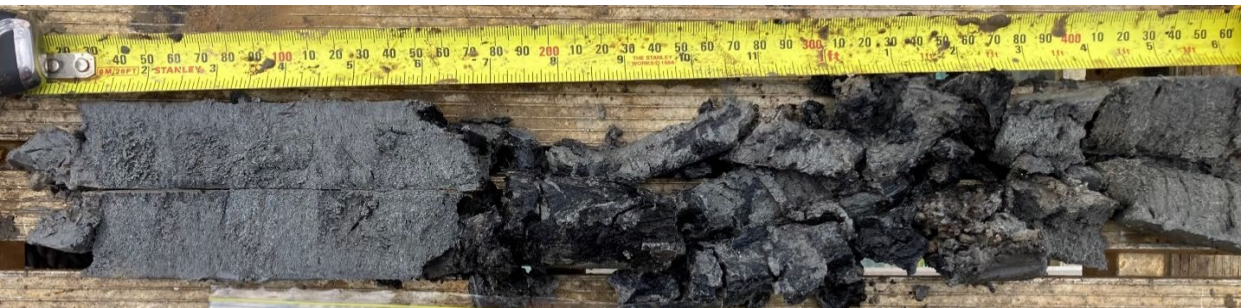
SPT5 (9.5 - 9.95 m) 6/10/13 N = 23, Recovery=450mm

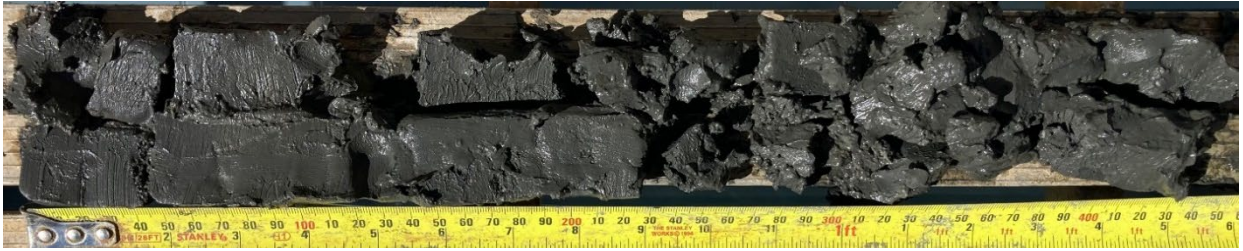
SPT1 (3.2 - 3.65 m) 0/0/0 N = 0, Recovery=450mm

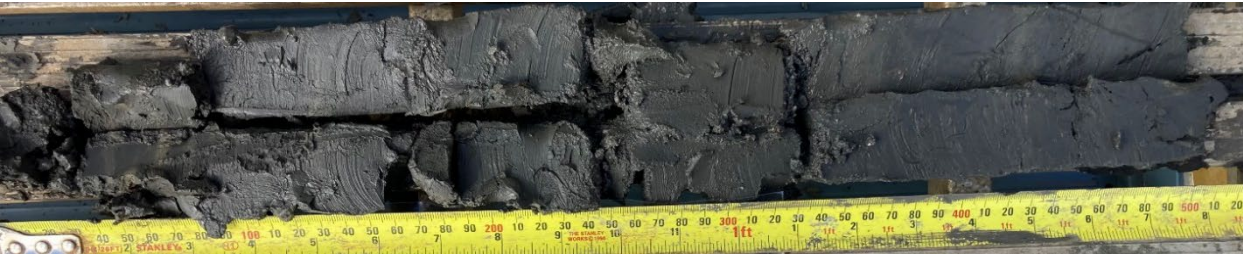
SPT2 (6.5 - 6.95 m) 0/0/0 N = 0, Recovery=450mm

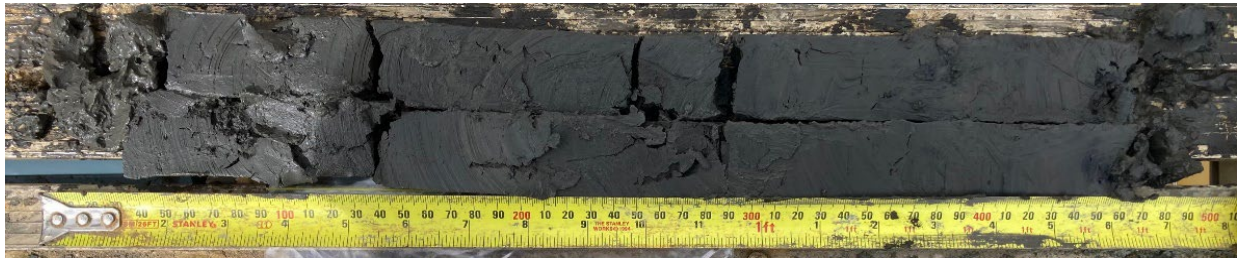
SPT3 (6.5 - 6.8 m) 9/23/* N = R, Recovery=450mm

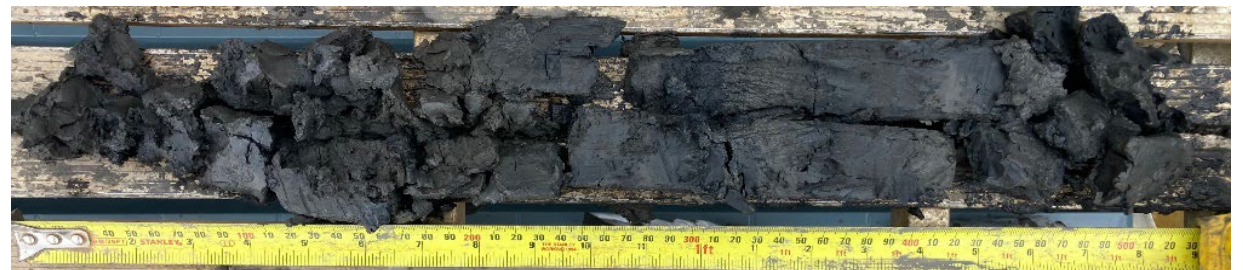
SPT4 (8.2 - 8.65 m) 5/7/11 N = 18, Recovery=450mm

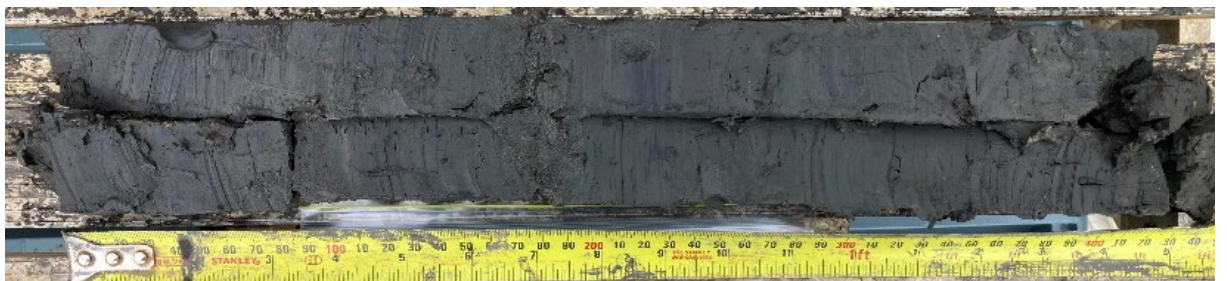
SPT5 (16.4 - 16.85 m) 0/0/0 N = R, Recovery=450mm

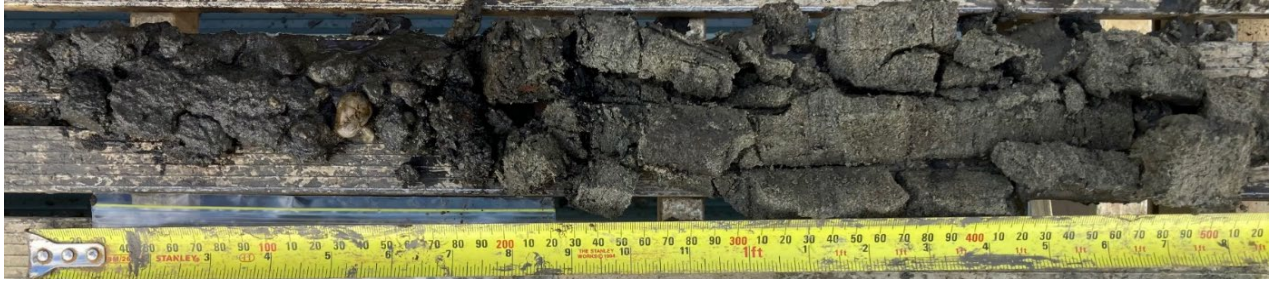
SPT6 (17.9 - 18.35 m) 10/9/18 N = 27, Recovery=450mm

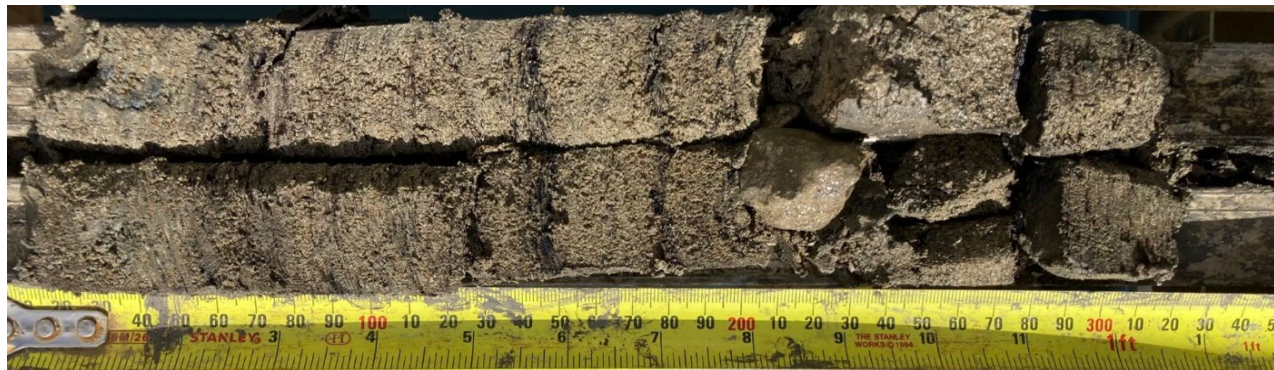
SPT7 (19.4 - 19.7 m) 11/25/* N = R, Recovery=300mm

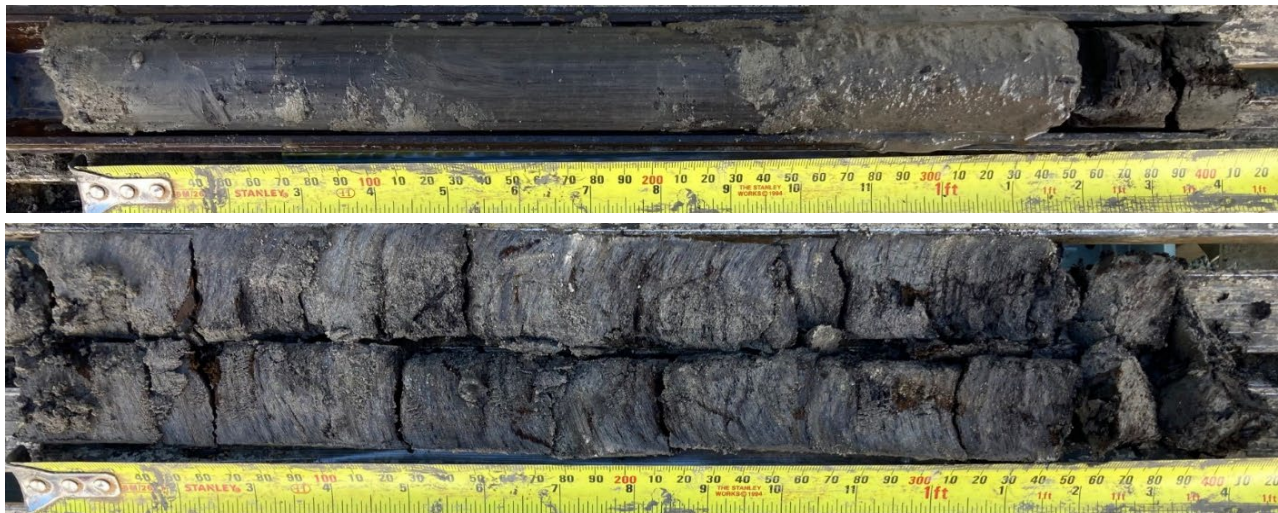
SPT8 (20.5 - 20.9 m) 13/25/15* N = 15*, Recovery=400mm

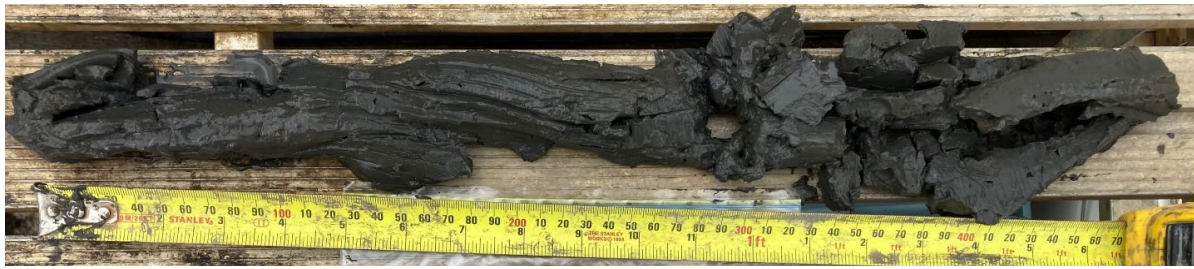
SPT1 (2.6 - 3.05 m) 0/0/0 N = 0, Recovery=450mm

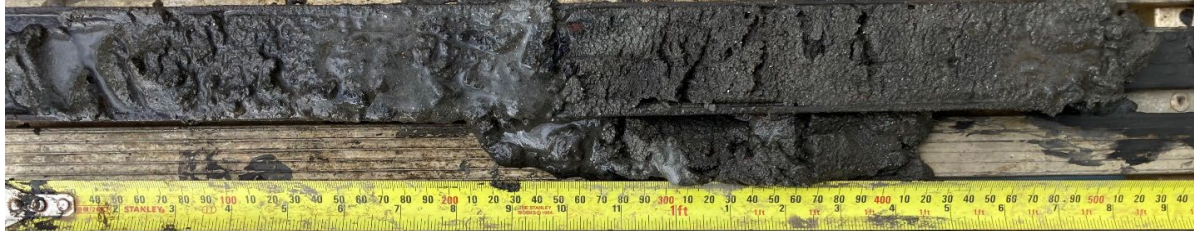
SPT2 (5.7 - 6.15 m) 0/0/0 N = 0, Recovery=450mm

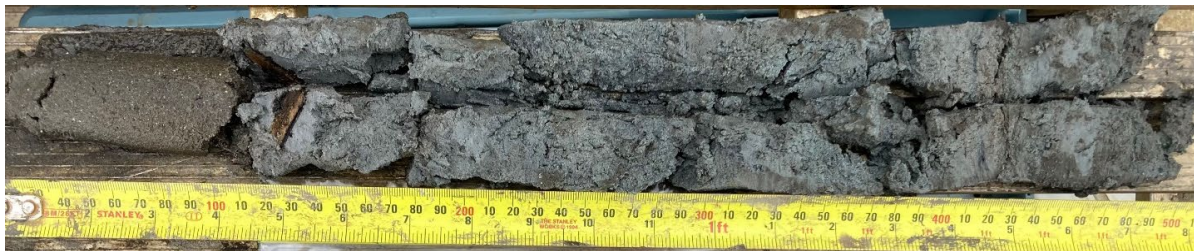
SPT3 (7.3 - 7.75 m) 1/3/4 N = 7, Recovery=450mm

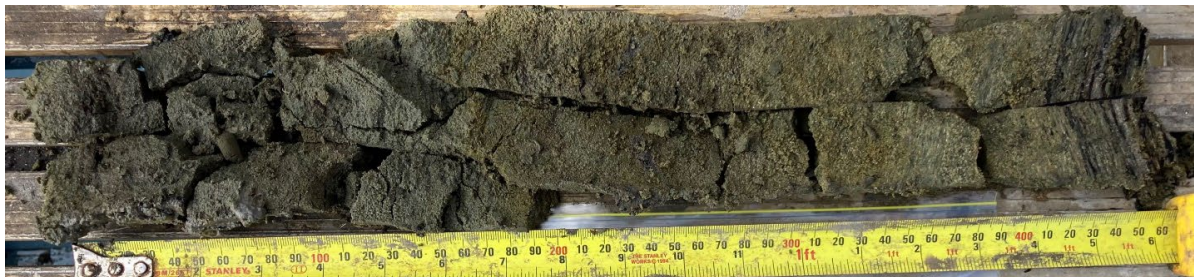
SPT4 (9.7 - 10.15 m) 7/9/18 N = 27, Recovery=450mm

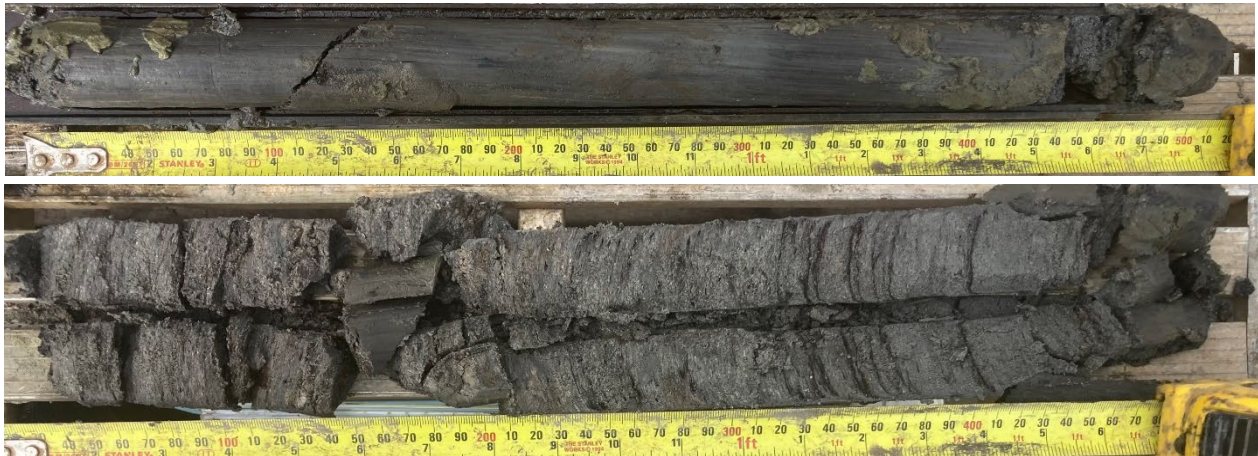
SPT5 (12.1 - 12.55 m) 10/18/33 N = 51, Recovery=450mm

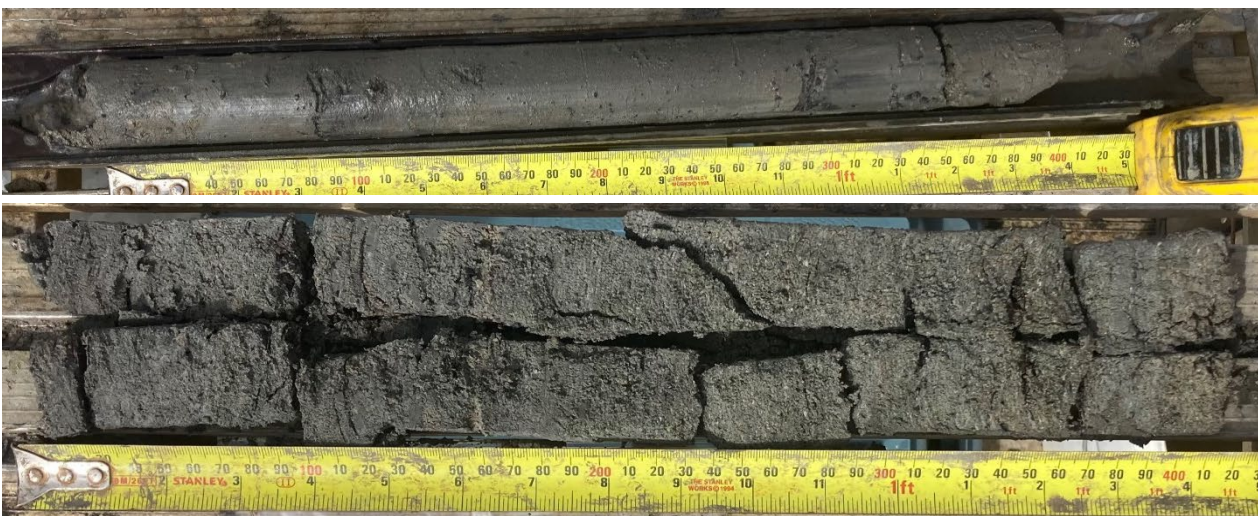
SPT6 (13.6 - 13.9 m) 12/23/* N = R, Recovery=400mm
