SOIL LOG SHEET

Client : Tasmania Parks and Wildlife Service	LOCATION No. BH05
Project : Parks - TA/DK Geotech Assess of Sites 10, 16 & 17	SHEET 1 OF 4
Location : Tasman Arch, Eaglehawk Neck Tasman Arch, Eaglehawk Neck	
Position : 577370.0 E, 5233862.0 N MGA20\	Surface RL : 55.70m
Contractor : KMR Drilling	Rig Type : Hydrapower Trekker 2100
Date Started : 2 May 23	Date Completed : 2 May 23
Angle from Horiz. : 90°	Processed : K.I
Logged by : K.I	Checked : JRN
Date : 2 Aug 23

Job No.
12592496

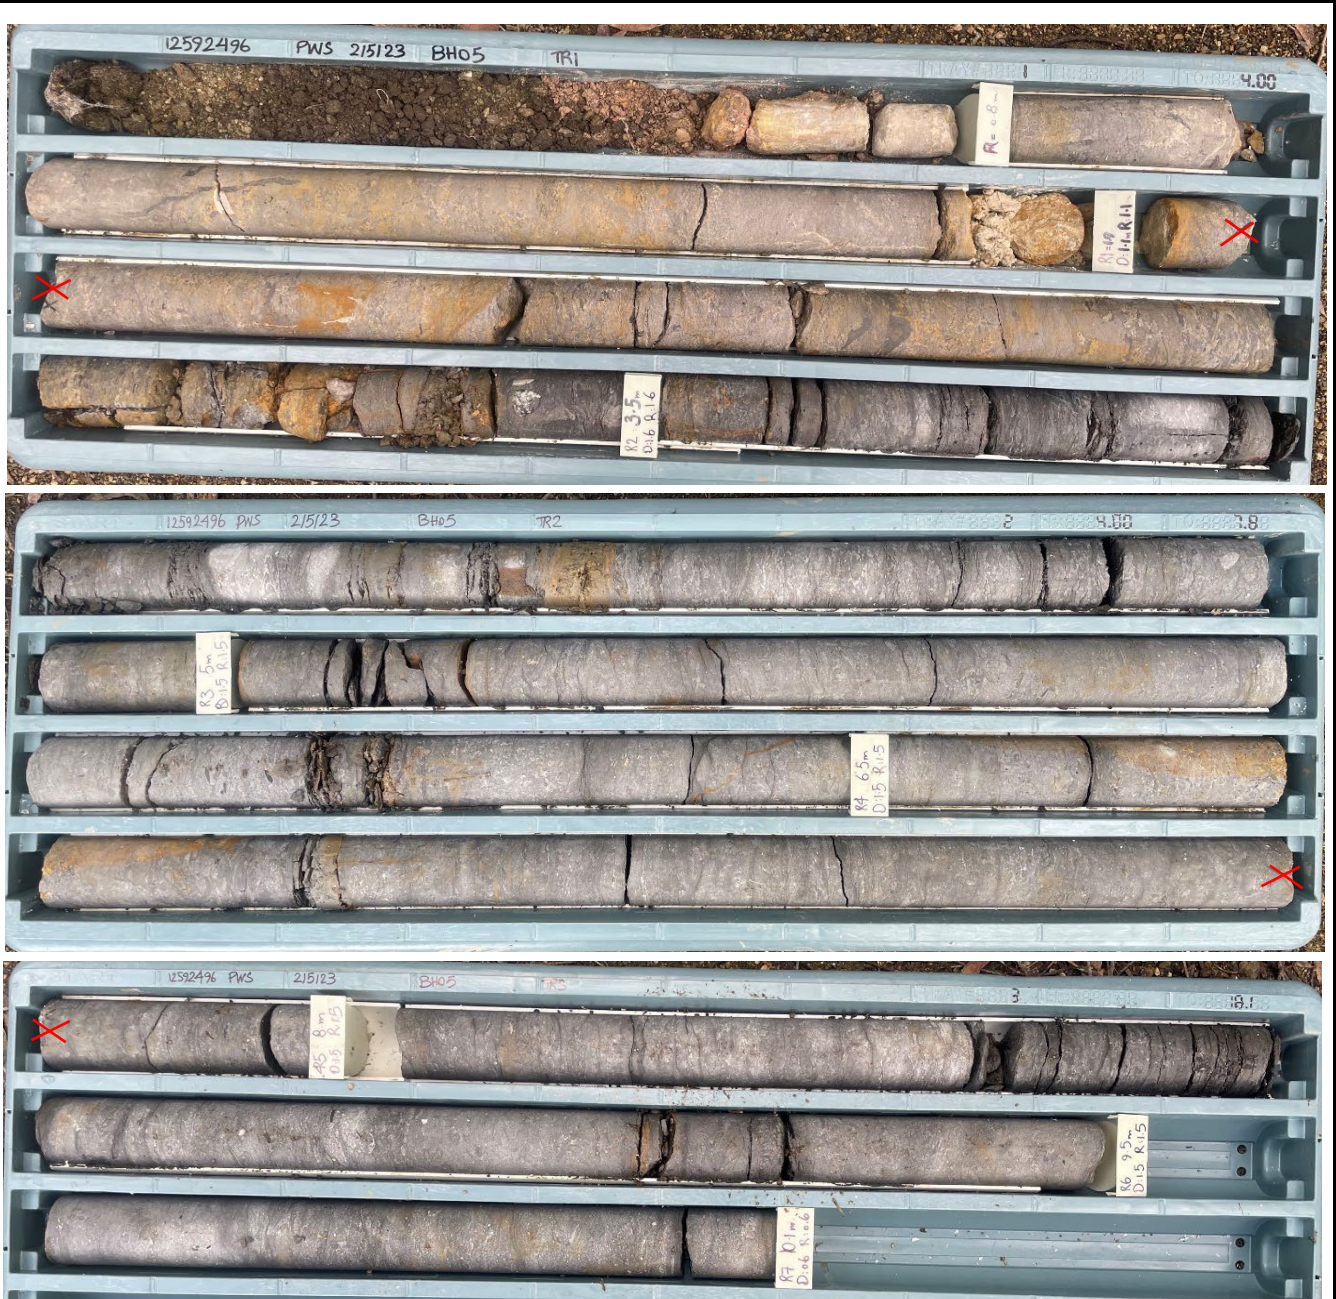
Prepared By Kia.I	Date 08-May-23	Job Number 12592496	A4	Title Photographic Log BH05	Client Parks and Wildlife Service

✗ indicates drilling/handling break

0.80 (54.90)		Start of coring at 0.8 metres. See Soil Log Sheet for soil interval. SILTSTONE, pale grey, Fe staining, sandy lenses	MW	H-VH		73				
1		1											1.14 m: Jt, 25°, So, Pln, Fe, Sn

1.53 m: Jt, 20°, So, Pln, Fe, Sn	
													1.72 m: Pt, 10°, Rf, Pln, Fe, Sn	
2		2								51		PL	1.8 - 1.9 : too disturbed to log defects Sandy SILT, low plasticity, sand is fine grained 2.0 m: Is(50) = 2.7 MPa

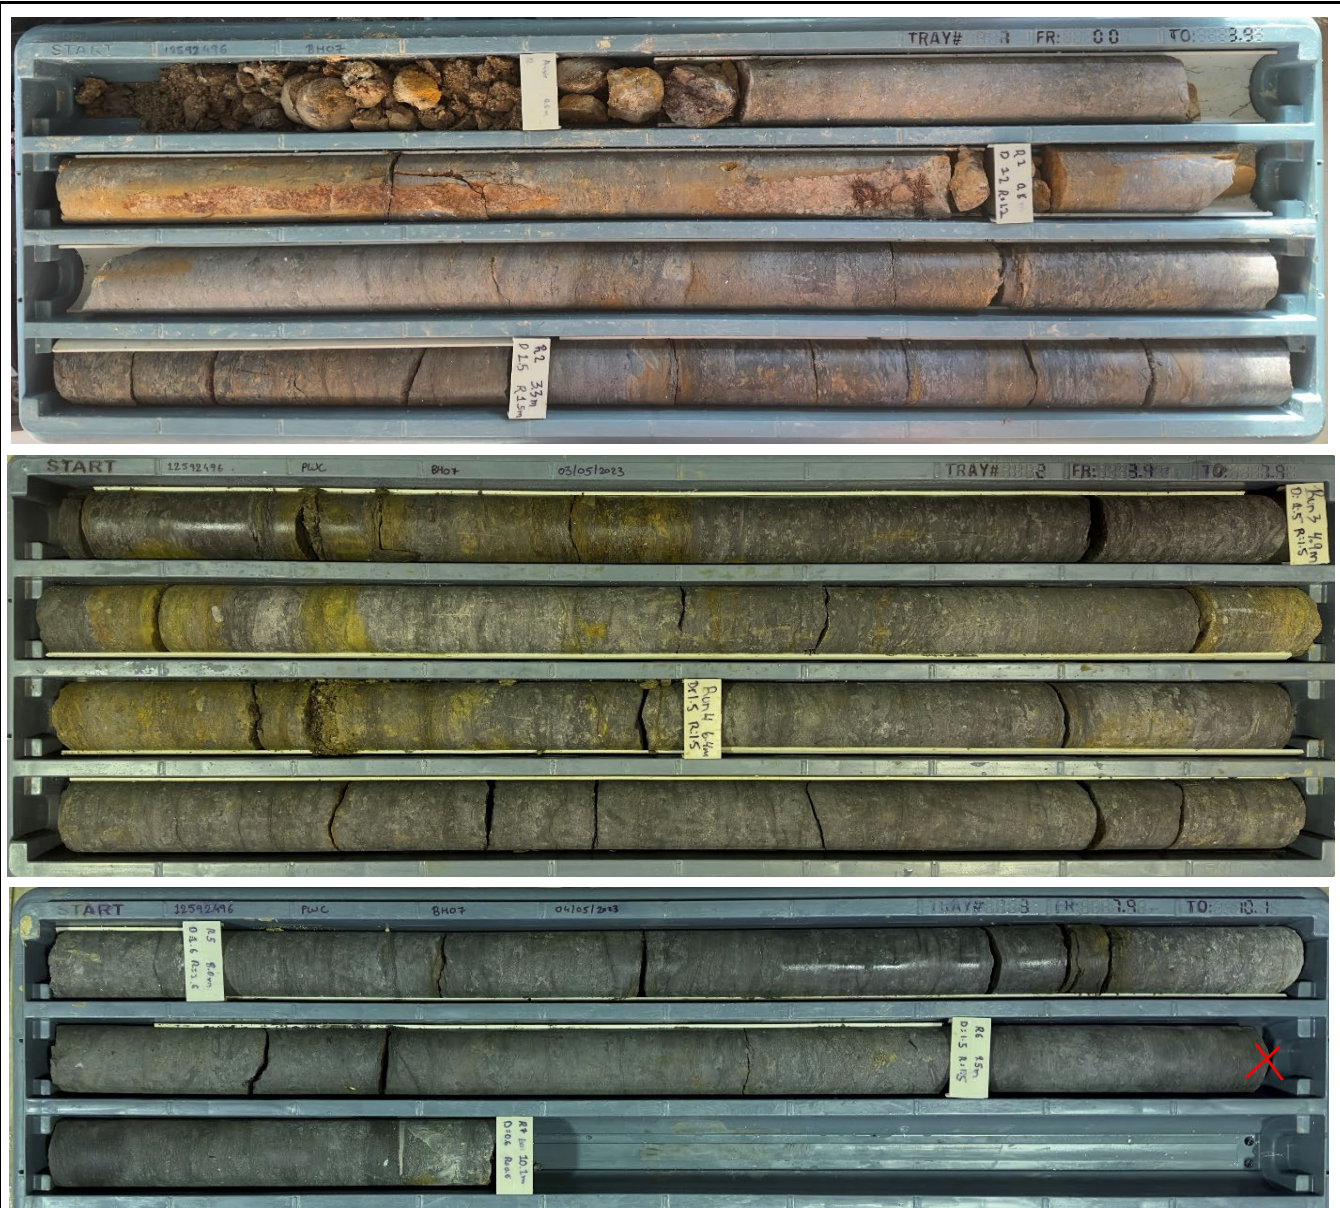
Prepared By Kia.I	Date 08-May-23	Job Number 12592496	Title A4 Photographic Log BH07	Client Parks and Wildlife Service	
Revision A	Date			Project Parks - TA/DK Geotech Assess of Sites 10, 16 & 17	
				Figure No

X indicates drilling/handling break

0.60 (56.10)		Start of coring at 0.6 metres. See Soil Log Sheet for soil interval. SILTSTONE, pale grey, Fe staining, sandy lenses	MW	H-VH	86				0.6 - 0.7 m: Drilling Breaks 0.7 m: Pt, ~5°, Rf, Pln, Fe, Sn	
1		1											1.32 m: Pt, ~5°, Rf, Pln, Fe, Sn	1
2		2	GNO						97				1.8 - 1.85 m: Drilling Breaks	2
3	HQ Coring	3										PL	2.35 m: Pt, ~5°, Rf, St, Fe, Sn 2.65 m: Pt, ~5°, Rf, Pln, Fe, Sn 2.95 m: Is(50) = 2.2 Mpa	3
4		4							87			PL	3.12 m: Pt, ~5°, Rf, Pln, Fe, Sn 3.19 m: Pt, ~5°, Rf, Pln, Fe, Sn 3.21 m: Pt, ~5°, Rf, Un, Fe, Sn 3.61 m: Pt, ~5°, Rf, Pln, Fe, Sn 3.72 m: Pt, ~5°, Rf, Pln, Fe, Sn 3.8 m: Pt, ~5°, Rf, Pln, Fe, Sn 3.9 m: Pt, ~5°, Rf, Pln, Fe, Sn 3.92 m: Is(50) = 3.2 MPa 3.99 m: Pt, ~5°, Rf, Pln, Fe, Sn 4.13 m: Pt, ~5°, Rf, Pln, Fe, Sn 4.34 m: Pt, ~5°, Rf, Pln, Fe, Sn	4
5		5							87					5

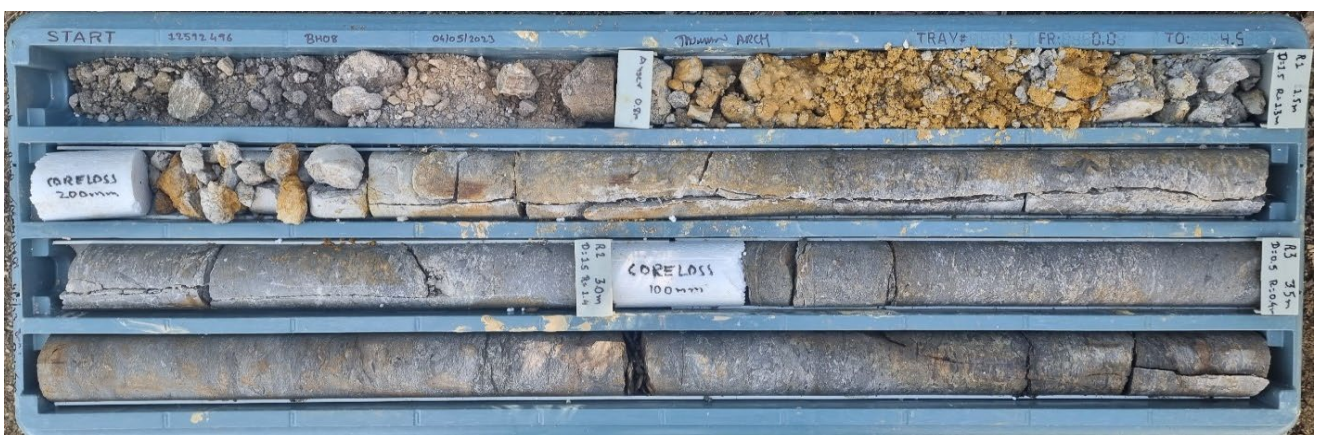
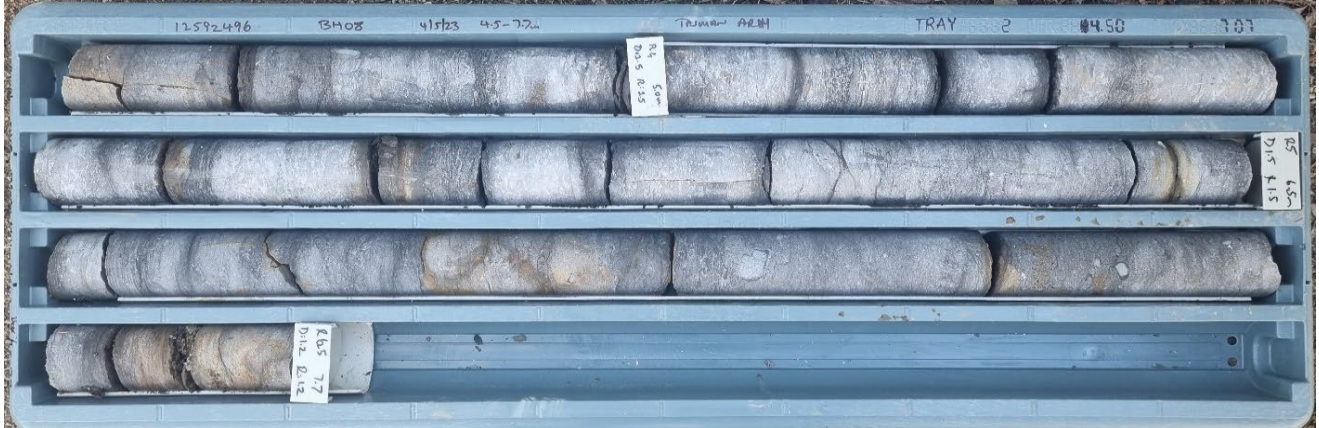
Prepared By Kia.I	Date 08-May-23	Job Number 12592496	Title A4 Photographic Log BH08	Client Parks and Wildlife Service	
Revision A	Date			Project Parks - TA/DK Geotech Assess of Sites 10, 16 & 17	
				Figure No

✗ indicates drilling/handling break

0.80 (57.30)	X	Start of coring at 0.8 metres. See Soil Log Sheet for soil interval. CORE LOSS (200mm)	-	-		0				
1		1		1.00 (57.10)	○ ○ ○ ○	GRAVEL, medium to coarse, subangular, medium dense, moist, pale grey (RS-XW Siltstone)	RS-XW	Soil

1.40 (56.70)	— — — —	SILTSTONE, pale grey, Fe staining, disturbed bedding, sandy lenses, rip up clasts	HW	L-M		8			1.4 - 1.5 m: Drilling/handling breaks

1.50 (56.60)	X	CORE LOSS (100mm)	-	-					1.6 - 1.8 m: Drilling/handling breaks	
				1.60 (56.50)	— — — —	SILTSTONE, pale grey, Fe staining, disturbed bedding, sandy lenses, rip up clasts	HW	L-M					1.88 m: Jt, Rf, Pln, Fe, Sn	
2		2					MW	H-VH					2.6 m: Jt, Rf, Pln, Fe, Sn
