Anchor mine tailings dam site investigation, June 2011

*by Jennifer Parnell, Mine Leasing and Liaison Officer, Mineral Resources Tasmania
and Greg Dowson, Manager — Water Section, Environmental Protection Authority*

Introduction

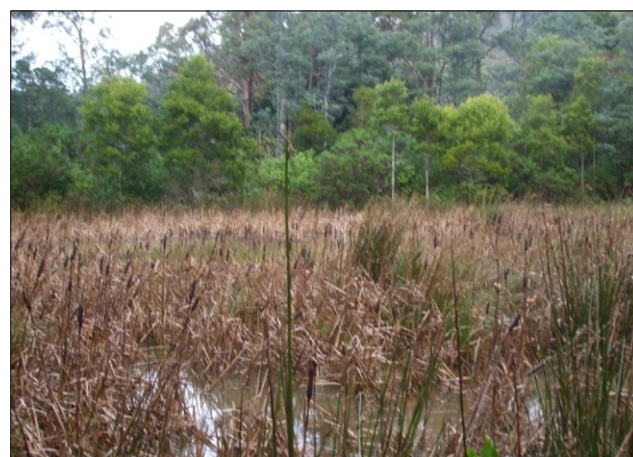
Figure 3
Polishing pond

The polishing pond (fig. 3), which has developed a wetland plant community, is effectively reducing some of the identified metal pollutants, significantly cadmium, copper and zinc, although some levels, namely iron and to a lesser extent manganese, are elevated at the discharge. The iron is most likely associated with colloidal fluxes and adsorbed to suspended solids, while the manganese is principally in a dissolved form. Depending on the pond residence time some anomalies between input and output, particularly complicated by storm flow events, would be expected to occur.

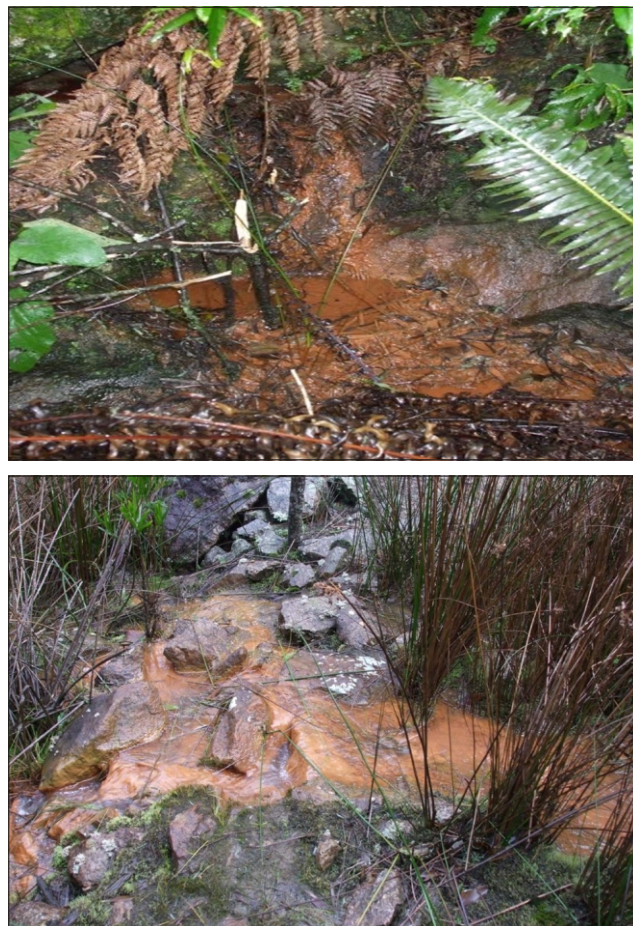
Figure 4

Acute toxicity to aquatic insects has been reported at iron concentrations ranging from 320 g/L to $16\,000 \text{ g/L}$. Iron is principally found as colloidal suspensions of ferric hydroxide, and may remain suspended in water or settle and harden. Although elevated levels were not being reflected on the day at the upstream and downstream locations, it is evident from the photos of the treatment system and seeps that suspended colloidal material is causing elevated turbidity and discolouration, noticeable in Figure 4.

Evidence of discolouration around polishing pond

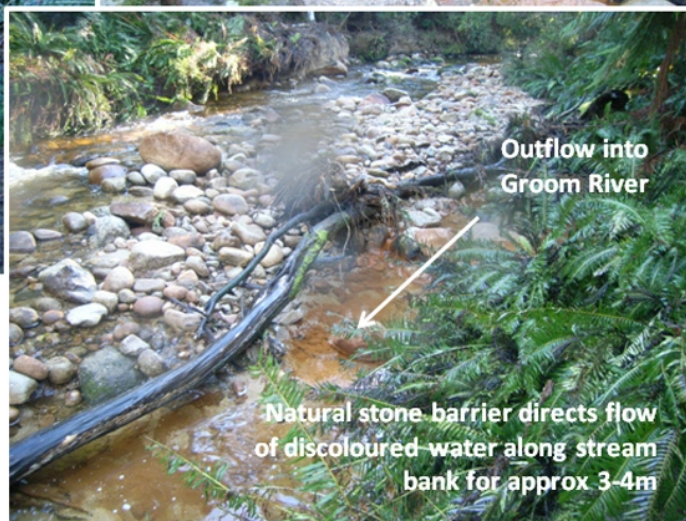
Sample Points 2 and 3 – Groom River

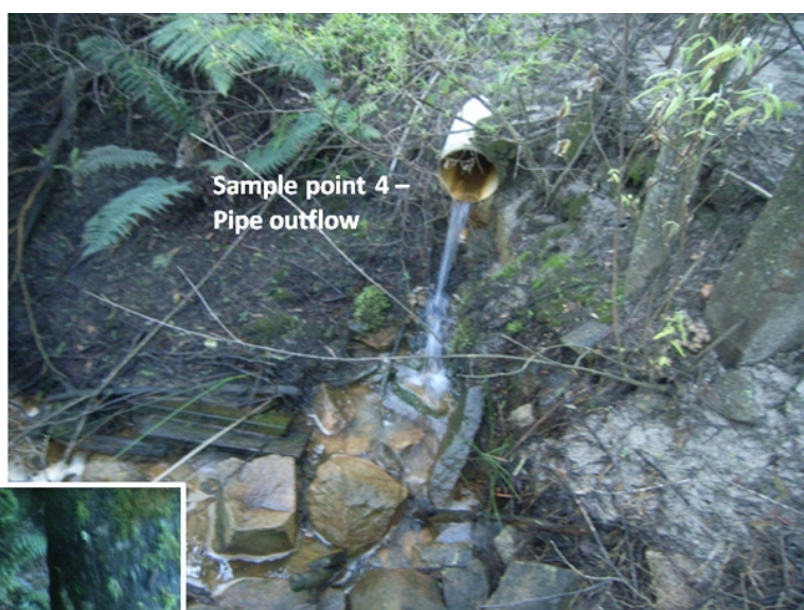
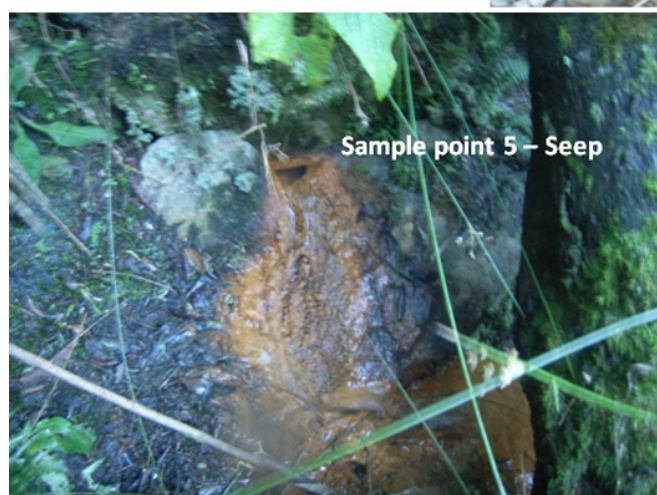
Sample Points 4 and 5 –
Anchor Mine tailings
