A Brief Archaeological Inspection of the Site of Proposed Exploration Drilling at the Magnet Ag-Pb Mine, Tasmania.

November 2007

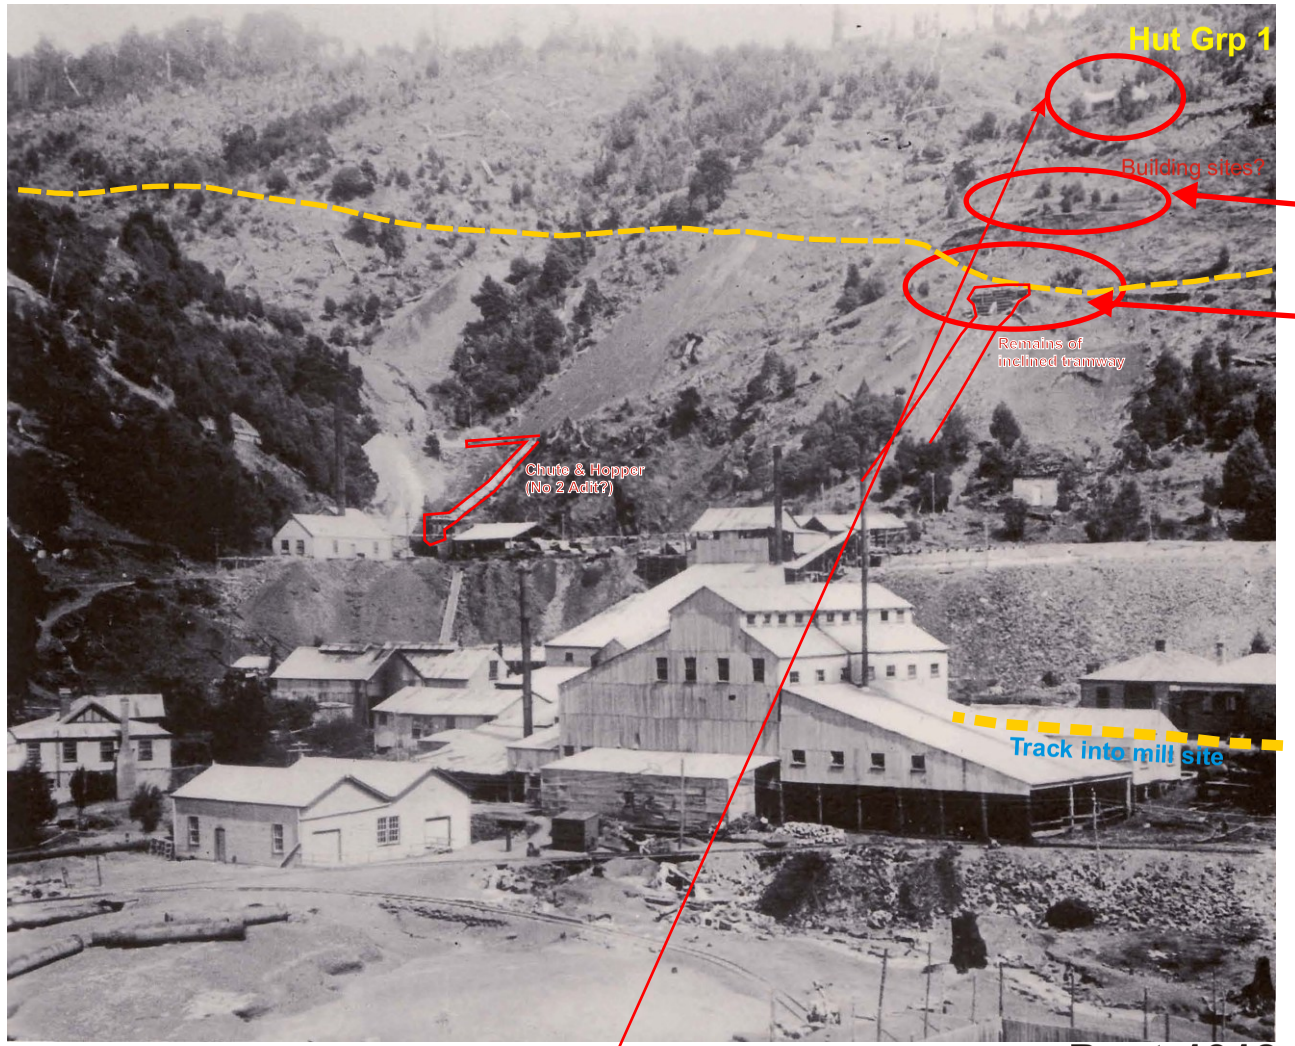
Below: Earlier photo than the similar view **at left** (the trees in the background are much less well developed). The buildings at the top of the inclined tramway are still present and the incline appears to still be in use. Therefore, the incline was dismantled well-before mine closure and the lean-to on the side of the main building is a later addition.

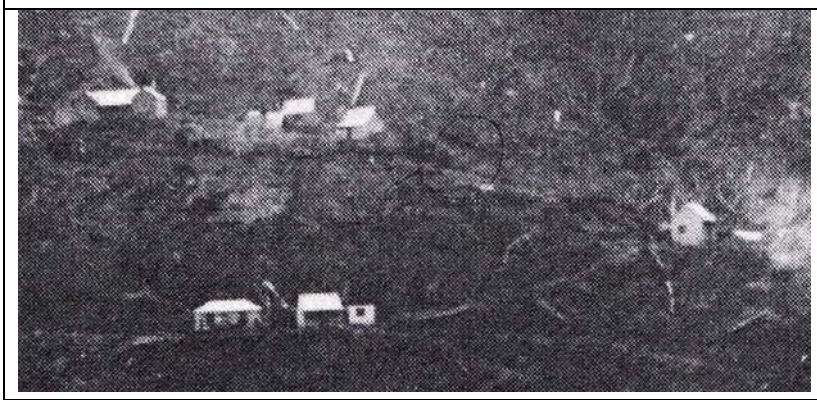
Hut group 1 is interpreted to be the remains of the large twin gabled house on left and the two cottages (tents?) on the right in the upper left part of this view. The Square hut at centre-right is probably located at the northeastern end of the old open cut and remnants of a platform were identified in this approximate location. This hut was still standing after 1918 and is shown on the 1917 fir plan (Appendix 2).
Historic Photo Post-1918	
	The twin-gabled house still stands in this view but the small huts to the NE & those on the open cut bench are gone. The sites of the lower buildings were not located & may have been mined away by the old open cut. They may also have been associated with the operation of the inclined tramway from the mill to the No 2 Adit & been removed on its decommissioning (pre-1918).
	Photo 20. Dry stone retaining wall at front of the site interpreted to be the double-gabled house shown above and marked 'A' on Figure 4, Hut Group 1. View approximately S. The old track and some terracing are visible to the left of the view.

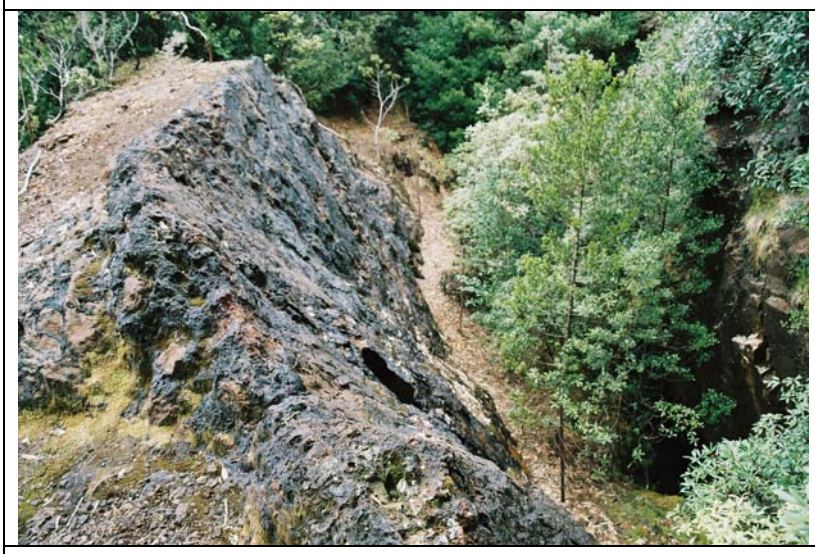
Photo 23, roll 2 by Greg Dickens. View of the eastern wall of the old open cut (looking approximately S). This excavation is much more extensive than is apparent at this location. It extends into the bush to the south and the high wall is just below Hut Group 1. The open cut workings are highly significant.
	Photo 25, roll 2 by Greg Dickens. View of the western wall (cutting bank) of the new open cut developed by mineral fossickers (looking approximately N). Historic workings in this area have been totally destroyed.

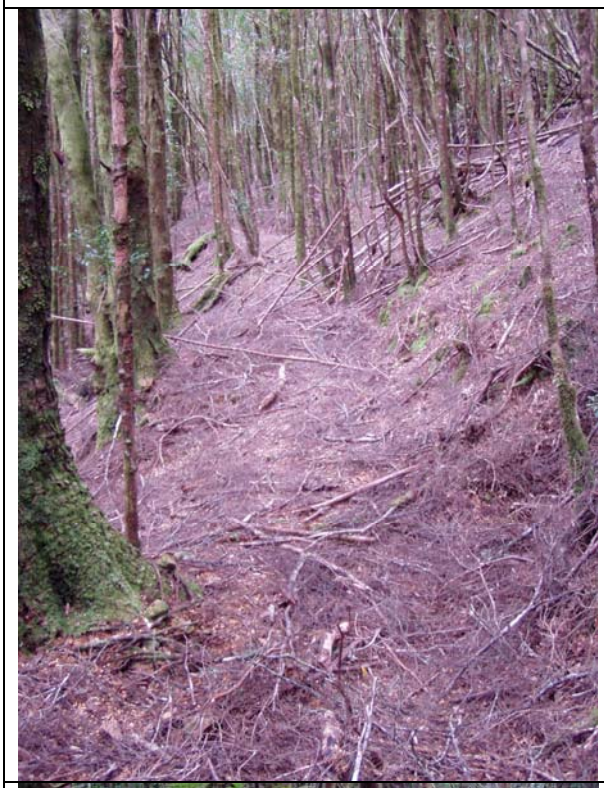
Photo 5. Shallow water race draining south to north. Possibly originally flumed because it seems too shallow to have held water.
	Photo 6 (looking N). Deep earthen embankment wall on race where it crosses the line of an E flowing drainage line. Was this race designed to cut the runoff from these perennial creeks and channel it into the main Magnet Creek? This position also represents a change in slope in the race and it drains S from here.
	Steel plates embedded upright at meeting point of two drainage channels/races (one from the adit above, to N, and one from uphill - collapsed pass and main water race described above). This site is at the south end of the main race. Plates to deflect runoff from the adit portal below?

It will be necessary for the exploration track to cut the steep southwestern section of the water race. As long as the track works do not disturb an unnecessarily large part of the channel, it will have little impact on the fabric of the race.
