Archaeological Survey Report 2001/01

An archaeological survey of the Langloh Colliery site, Hamilton, Tasmania

By A. E. Webster

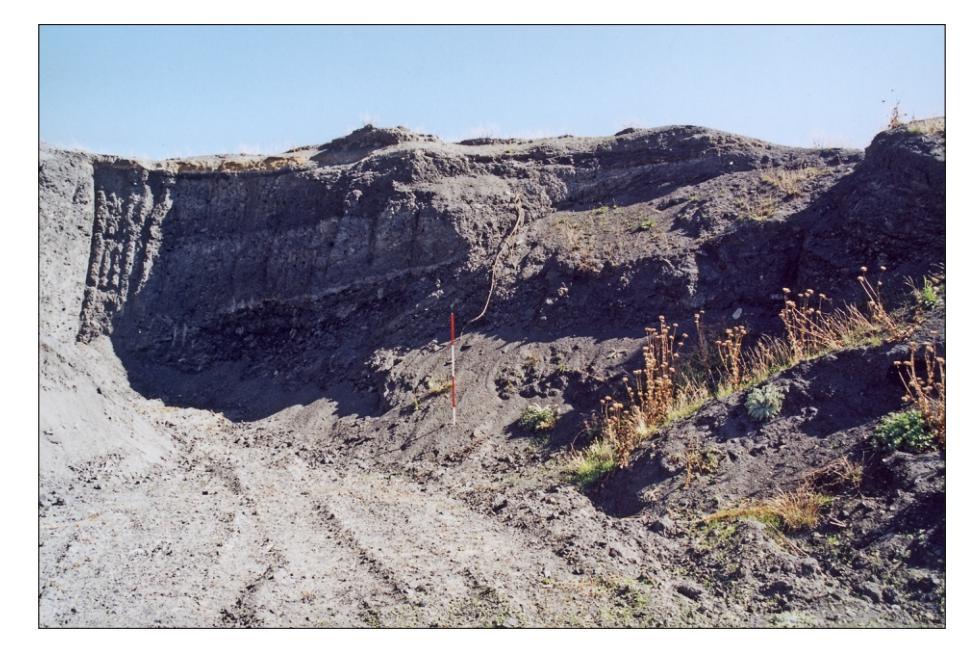
Figure 7

Detail of the layering of the mullock dump exposed within the northern face of the excavator cutting. Note the stratification. [MRT 3211]

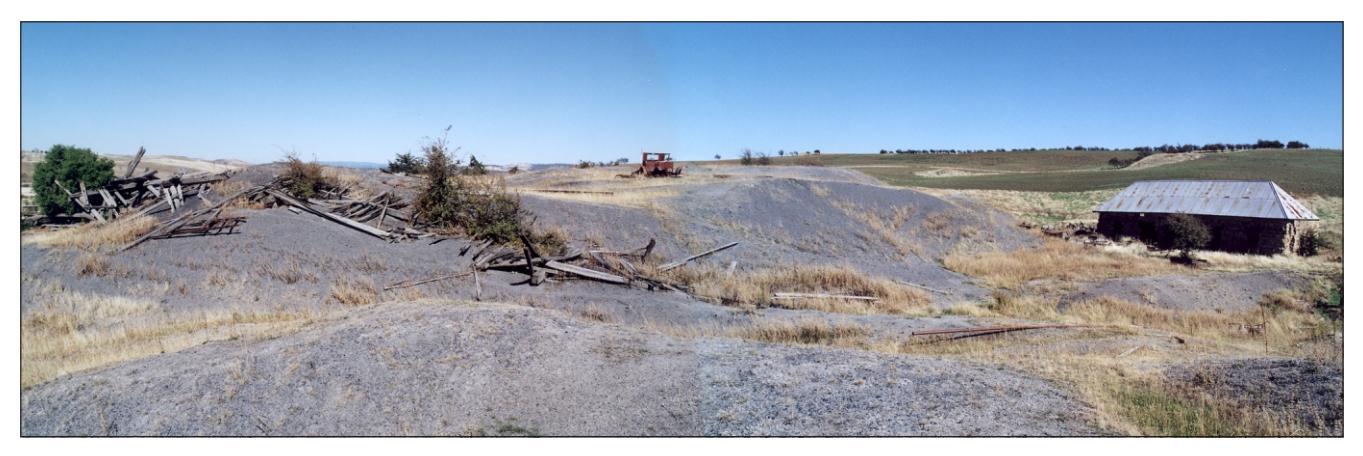
Figure 8

Panoramic view of the upper surface of the mine dump looking south across the ruins of the timber gantry on-ramp. The heaped timber to the left is the remains of the trestling that led to the gantry and coal bins (shown in detail in Figure 13). The sandstone stables are to the right (refer to Figure 3 and see below). The mine portal is to the right of view. [MRT 3263, 3264]

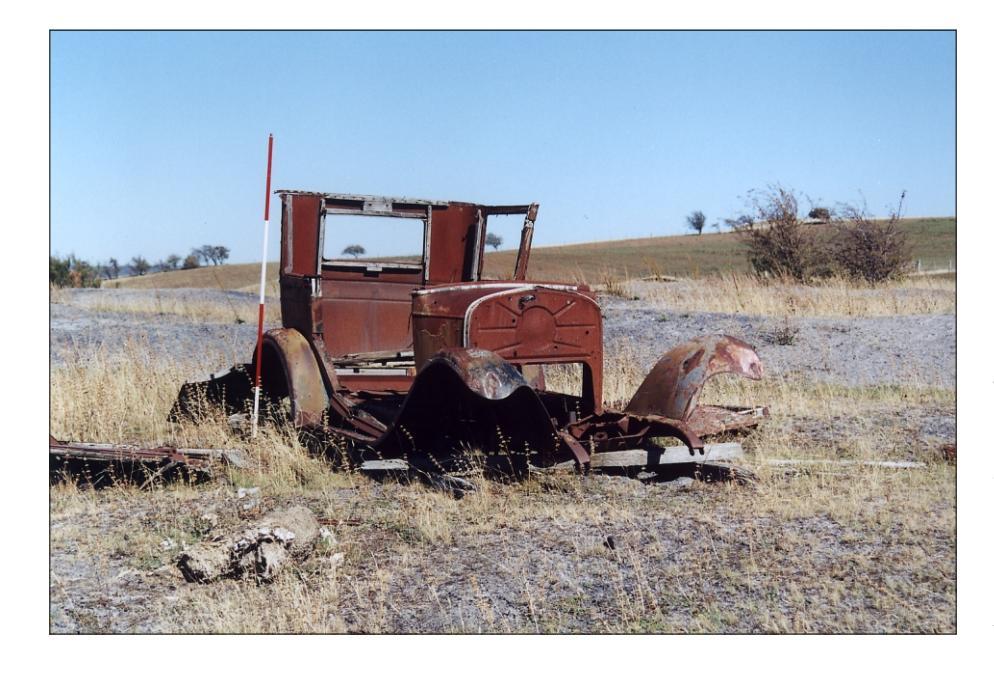
Shell of 1930's Chevrolet lying on top of the dump, to the south of the gantry ramp (see fig. 8). The car was originally owned by a station hand and was driven into this position where it broke down and was abandoned. It was in road-registered condition when originally abandoned here (E. Archer, pers. comm., April 2001). [MRT 3265]

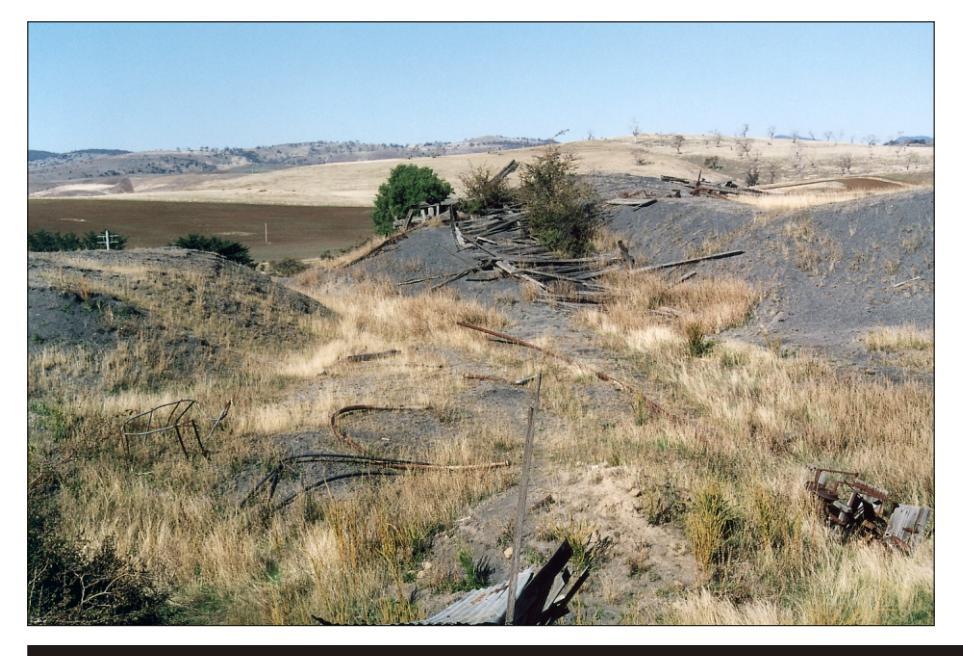
Figure 11

Structural timber scatter with some rail-related iron artefacts that formed the 'on ramp' leading from the dip drive portal to the timber gantry and crusher structure. The linear depression in the upper centre to lower right of the view was the formation for the rails that carried the coal trucks onto the timber staging. An abandoned iron framed coal truck lies in the lower right. Note wire rope at centre left. View is approximately east. Refer to Figures 2 and 3. [MRT 3242]

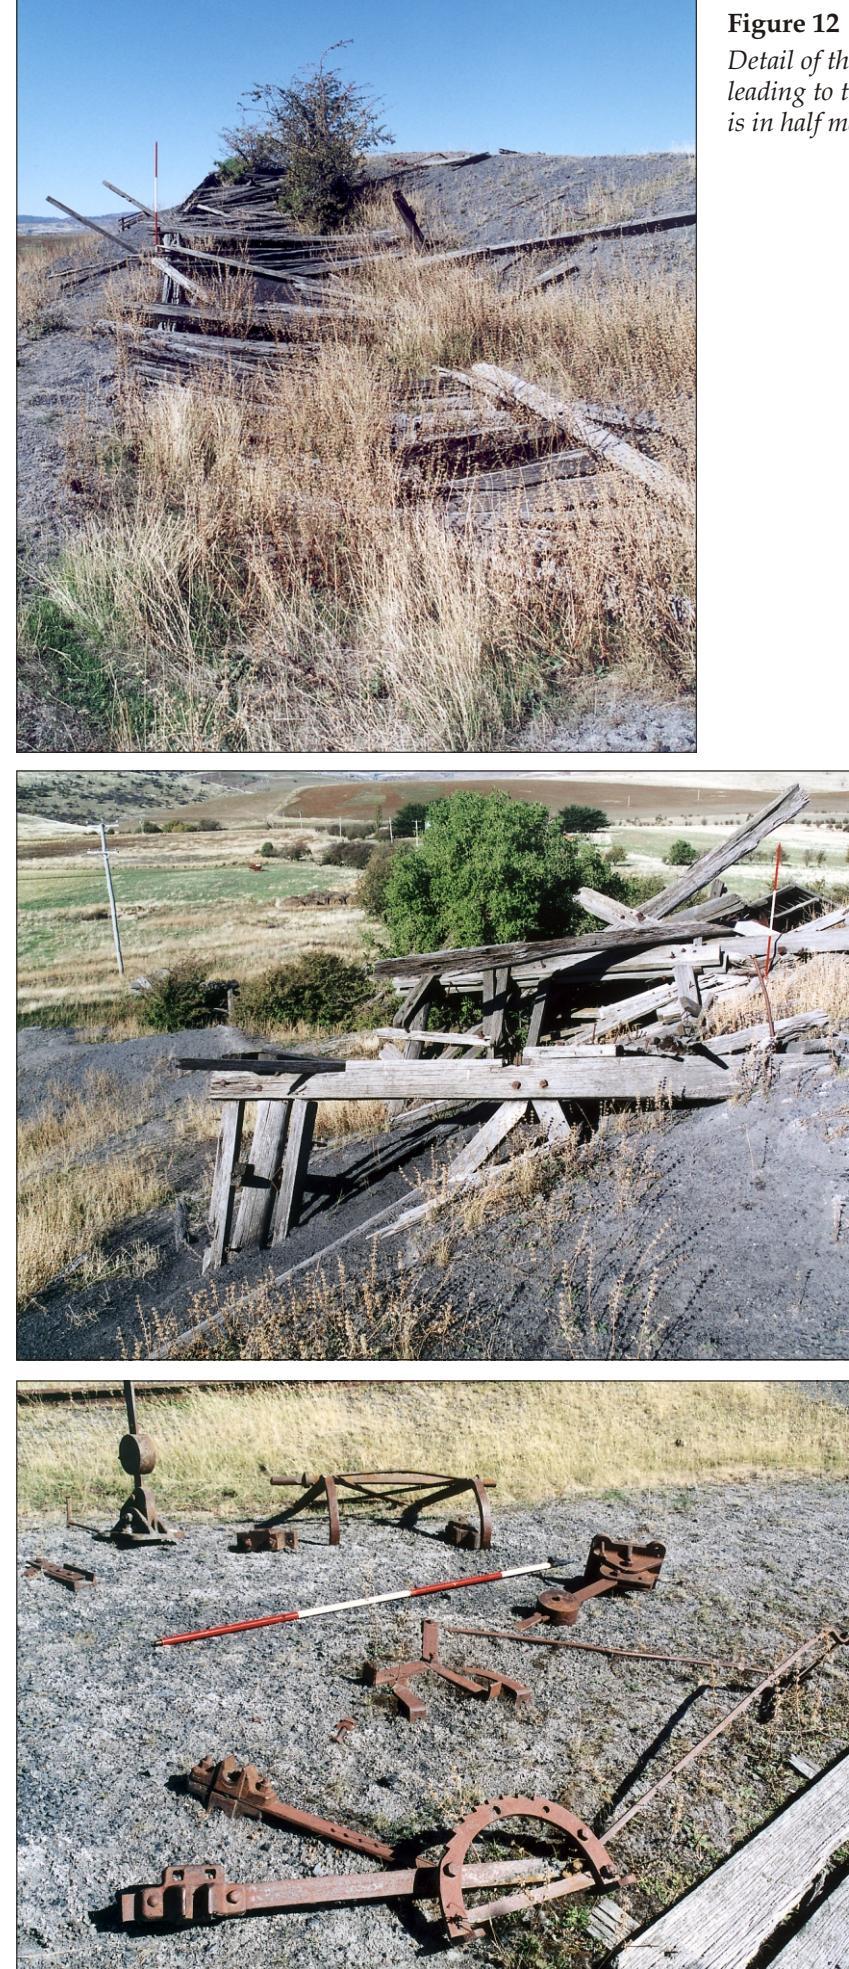
Detail of the timbers that formed the on-ramp staging leading to the gantry structure. View is to the east. Scale is in half metre divisions. Refer to Figure 3. [MRT 3266]

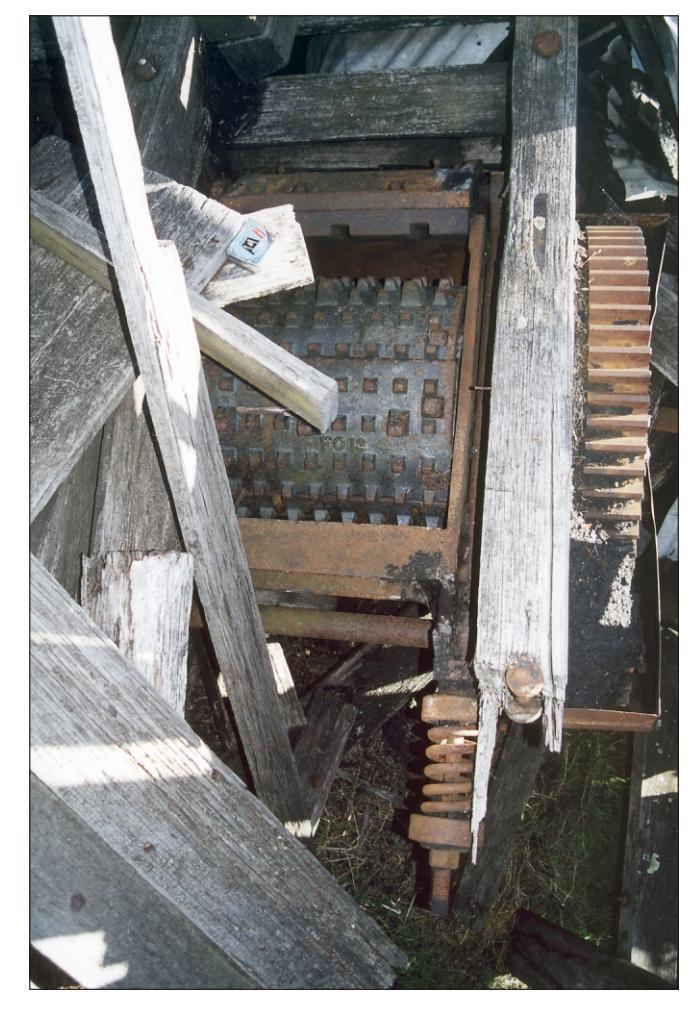
Figure 16

The Jaques crusher lying within the tangled wreckage of the timber gantry structure. Field of view is approximately 1.5 metres. [MRT 3282]

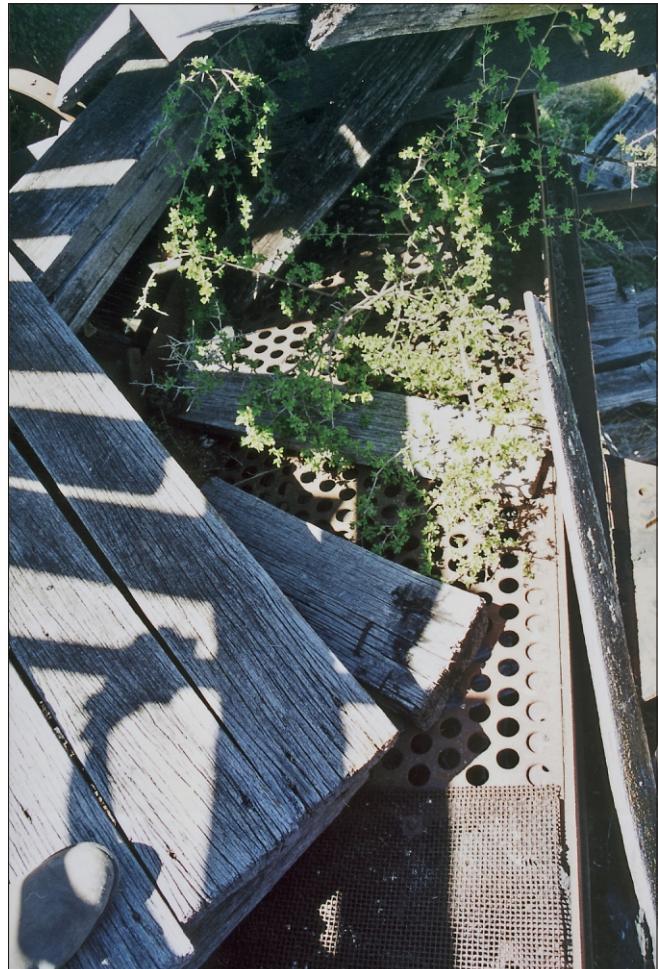
Figure 17

Steel sizing screen in the ruins of the crusher and coal bin structure. The screens were probably part of a coal sizing and screening mechanism and were probably powered by the main steam engine. Coal was probably transported from the screens to the coal bins by conveyor. Field of view is approximately 1.5 metres. [MRT 3281]

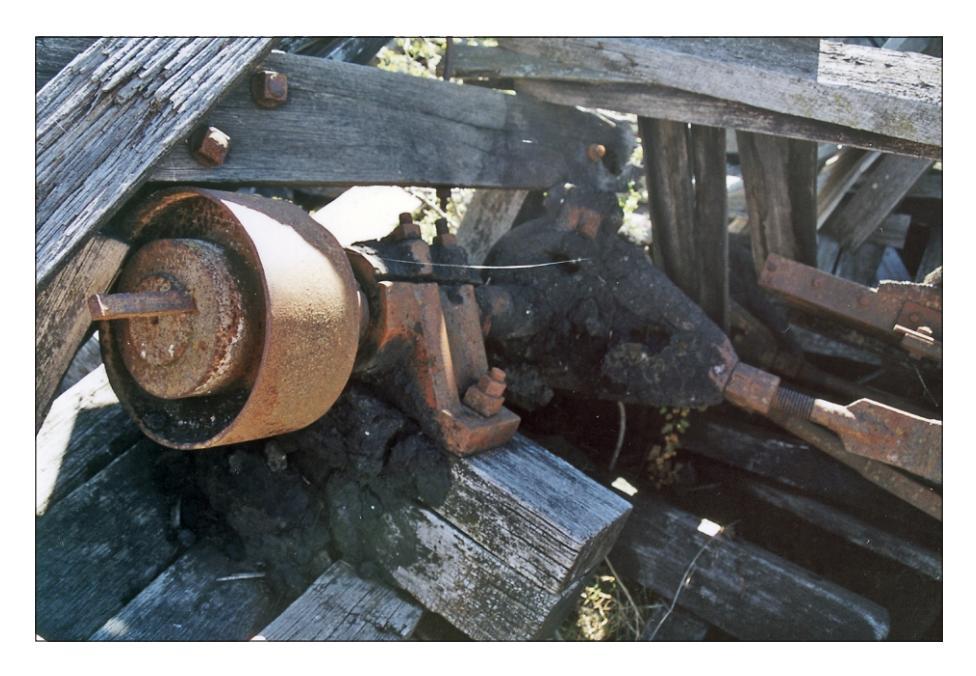
A belt roller forming part of the drive mechanism of the sizing screens or crusher lying in the wreckage of the timber gantry. Roll is approximately 200 mm in diameter. [MRT 3284]

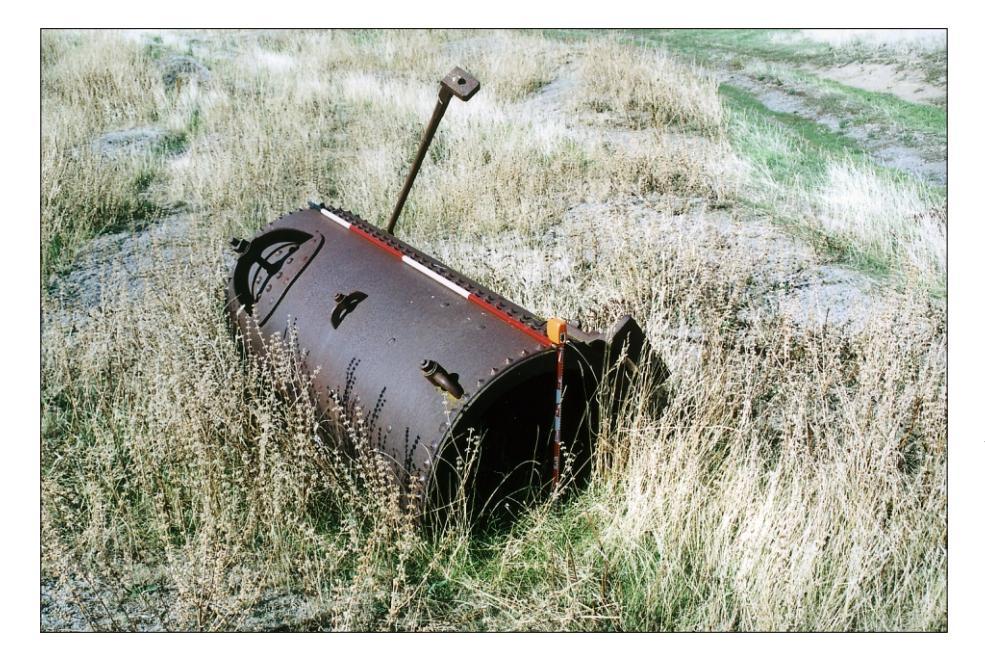
Figure 19

A possible vertical boiler that may have driven smaller pieces of steam machinery (e.g. the crusher). See Figure 2 for location. Scale in half metres. It may also have supplied hot water to the showers. [MRT 3277]

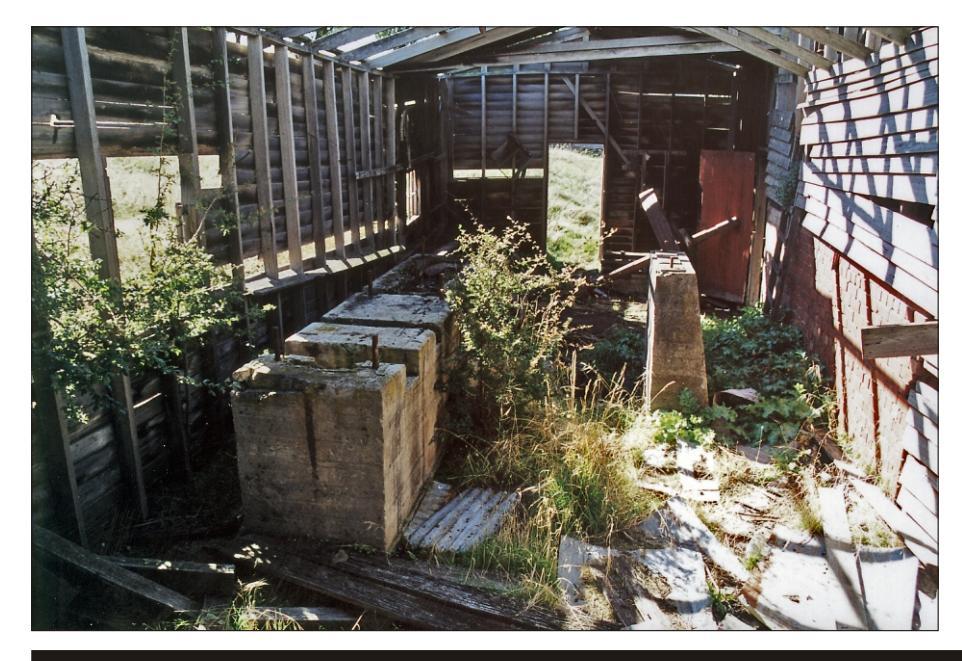
Figure 23

Horizontal steam engine beds in the engine house. The main engine cylinder was mounted on the large bed on the left and the support for the belt drive wheel is the smaller concrete base to the right. The belt drive wheel lies in the workshop area in the background. View is looking north. The red brick boiler bed wall is to the right. Refer also to Figure 3. [MRT 3248]

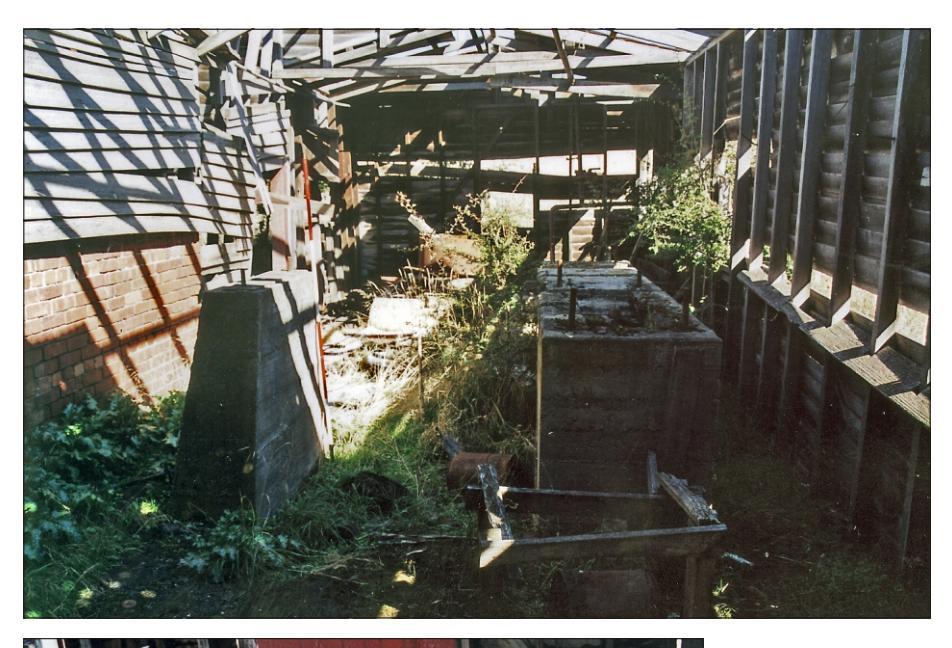
Horizontal steam engine beds within the engine house. The main engine cylinder was mounted on the large bed on the right. The flywheel axle is on the left. View to south. The red brick boiler foundation wall is to left of view. Scale bar is in half metre segments. [MRT 3251]

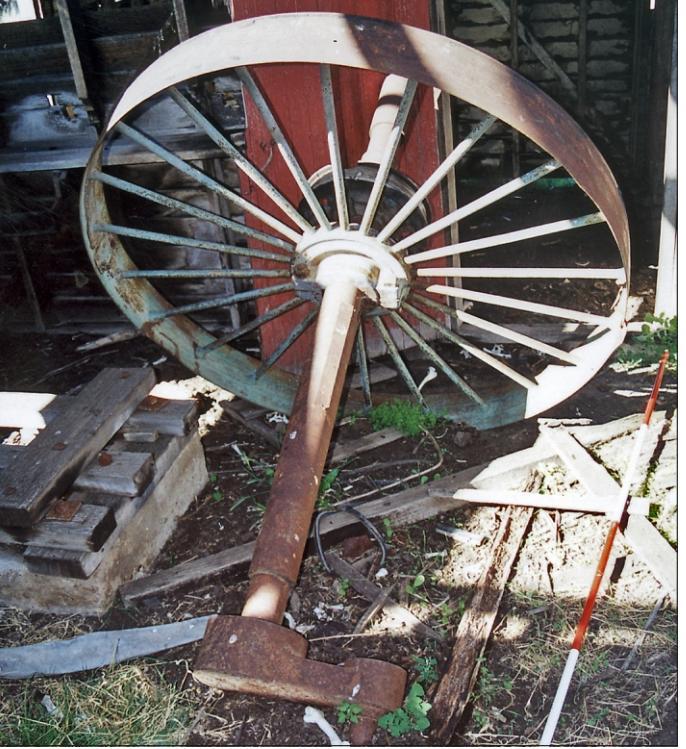
Figure 25

Belt drive wheel (and/or flywheel) of the horizontal steam engine inside the engine house. The wheel and axle assembly lies against the wall of the overseer's office. A small concrete and timber engine bed is visible at lower left. The end of the axle lying on the ground was mounted on the smaller concrete engine bed shown in Figures 23 and 24. Scale is in half metres. [MRT 3254]

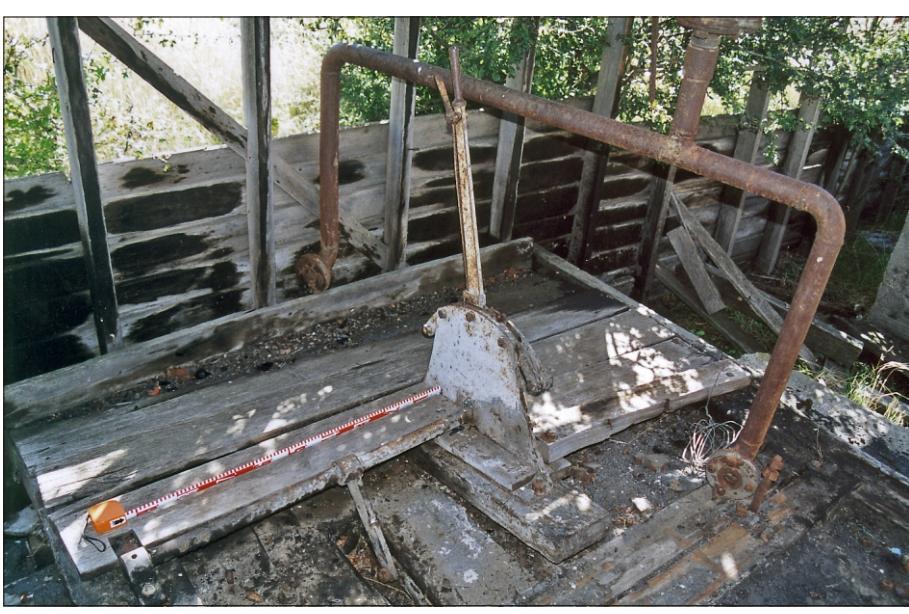
Figure 26

Winder driver's platform and braking handle in the southern wing of the engine house. Scale is in 100 mm increments. [MRT 3249]

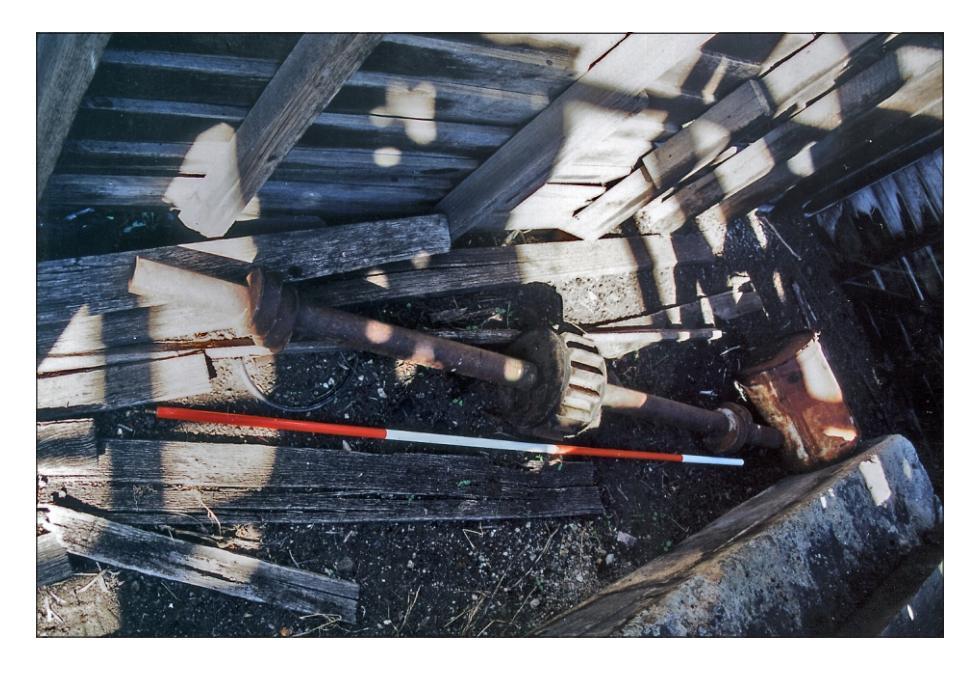
An axle from the winding engine lies adjacent to the winding engine bed of the engine house. Scale bar is divided into half metre lengths (red and white). [MRT 3250]

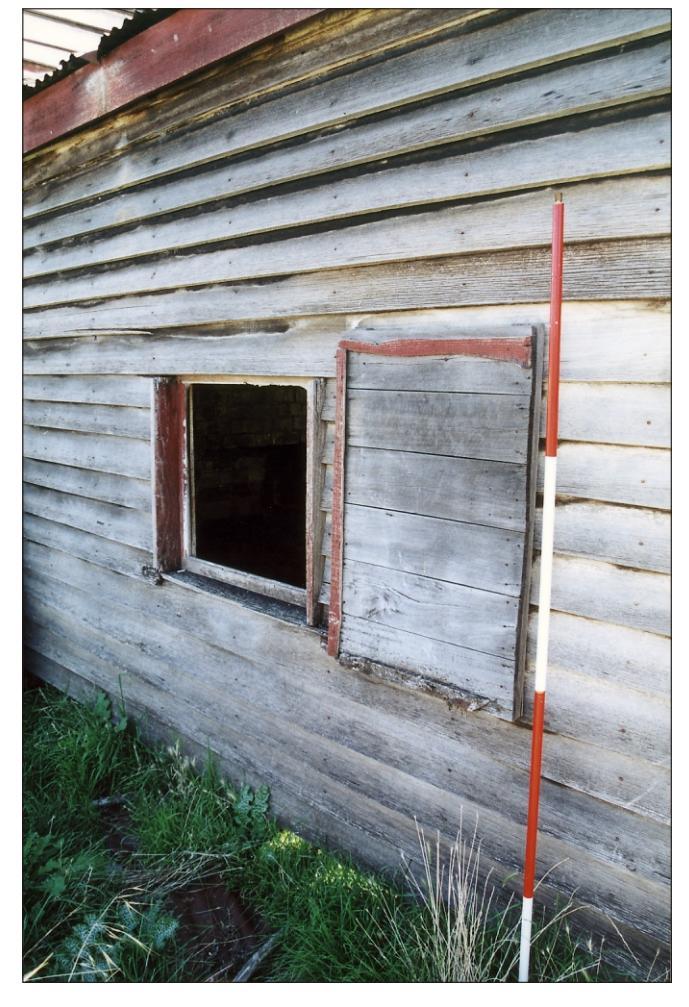
Figure 28

External detail of the overseer's office and notice board, eastern side of the engine house. The overseer used to sit with his back against the boiler bed wall. Apparently the men were paid through this window (E. Archer., pers. comm., April 2001). This office does not appear on the 1944 plan and so is presumed to have been added later. Scale is in half metre intervals. [MRT 3239]

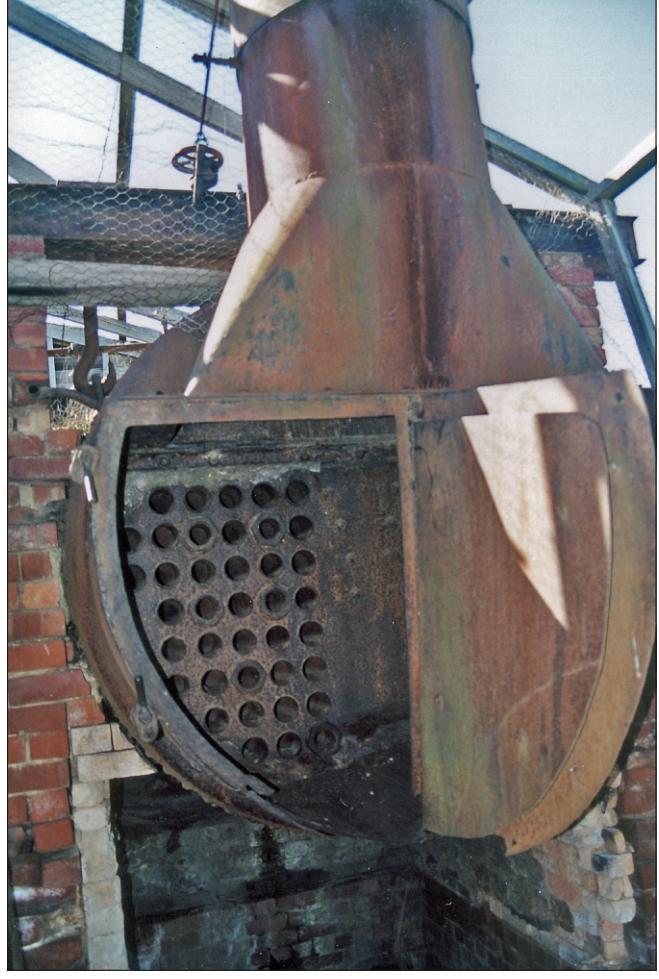
Figure 29

The fire box end of the boiler which is open to the outside of the engine house building. It is uncertain whether this boiler was coal fired because there does not seem to be adequate provision for stoking. It may have been oil fired, although there are no oil tanks evident. The base of the steel smokestack joins the boiler casing at this point. [MRT 3247]

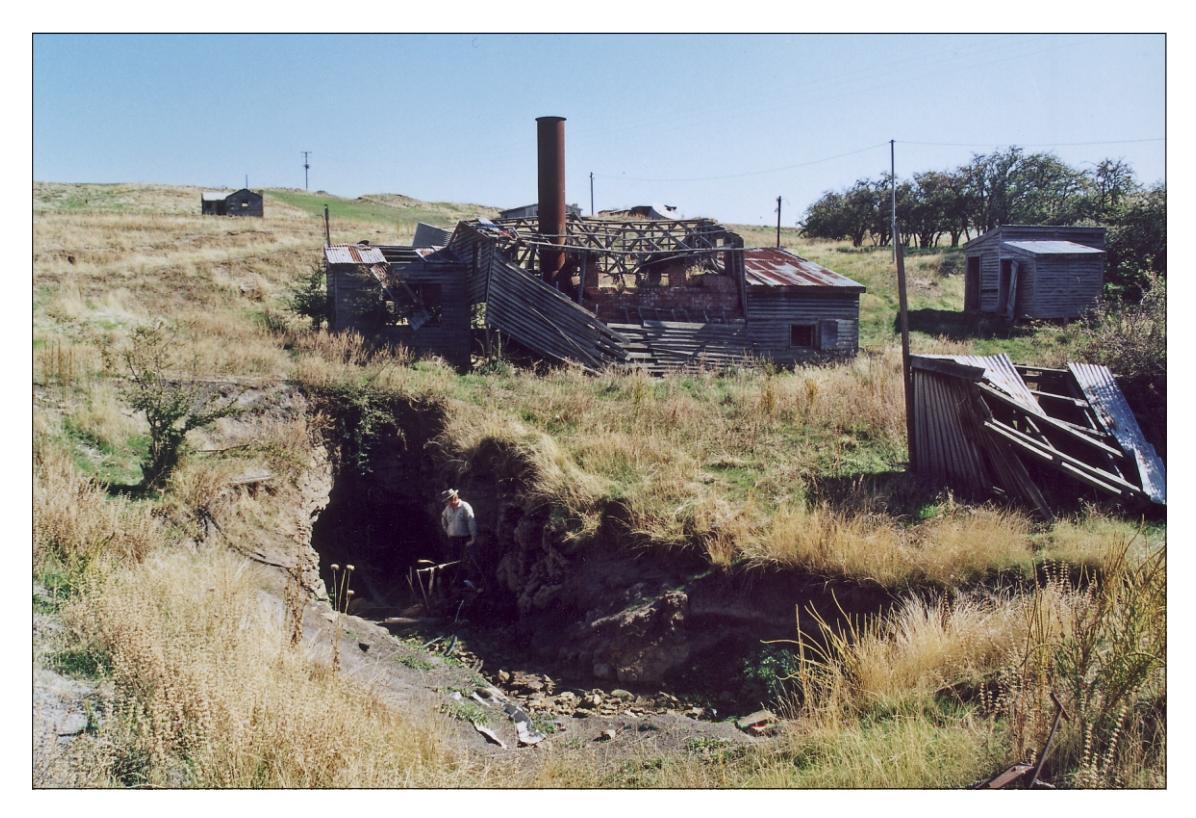
Figure 33

Entrance portal and ramp cutting to dip drive. Engine house in centre middle ground (to west). Winder house is the small wing to the south (left) of the smokestack and coal haulage was achieved by way of a wire rope from the winder in this small building passing up to the gantry structure and returning back down the drive. [MRT 3219]

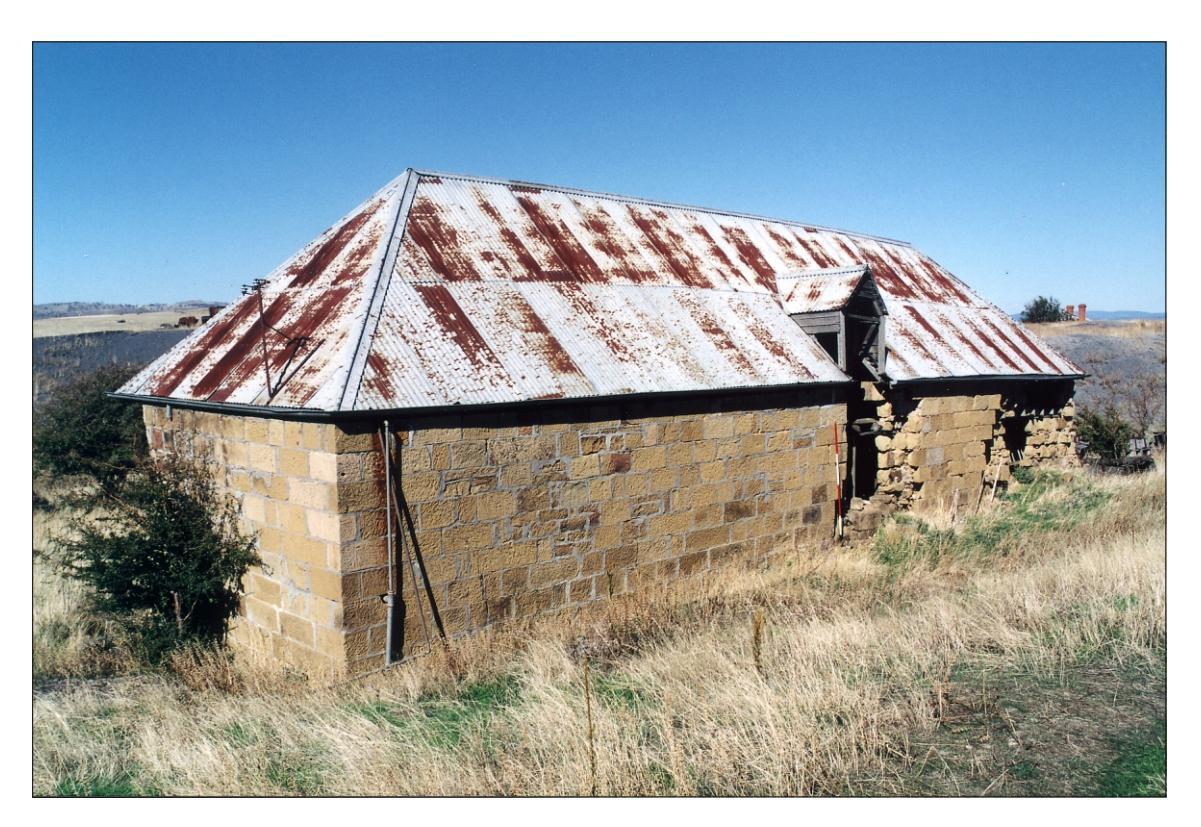
Figure 34

The building is relatively sound but has suffered due to the removal of the outer facing of good quality ashlar masonry on the eastern facade (see Figure 40 below). Lintel beams over a former doorway on the eastern facade are deeply pitted with borer. The eastern wall will eventually collapse. The corrugated iron roof is in very good condition.

Sandstone stables viewed looking southwest. Note the gabled hay loft. E. Archer (pers. comm., April 2001) mentioned that there was once a wooden staircase leading up to the upper floor in this position. He suggests that the top floor was used by the coal miners as a canteen or some similar use. The staircase has since been removed. Scale bar is in half metre intervals. [MRT 3259]

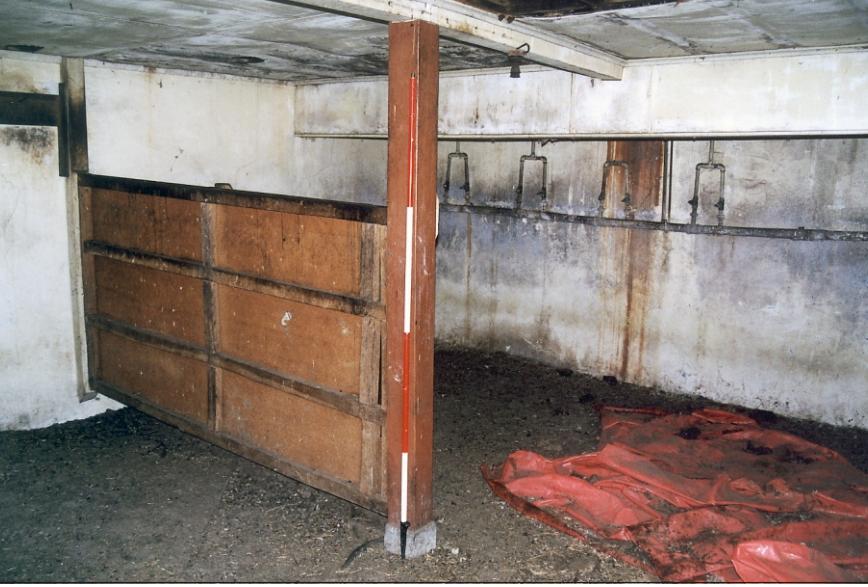
Figure 36

Internal view of the stables building showing the northern section that has been converted into a shower and change area. Note the wooden partition. No clothing hooks were seen and it is unclear where the miners stored their clean clothes. Water drained through a hole in the base of the wall and out into a small circular stone sump on the other side. Scale bar is in half metre intervals. [MRT 3237]

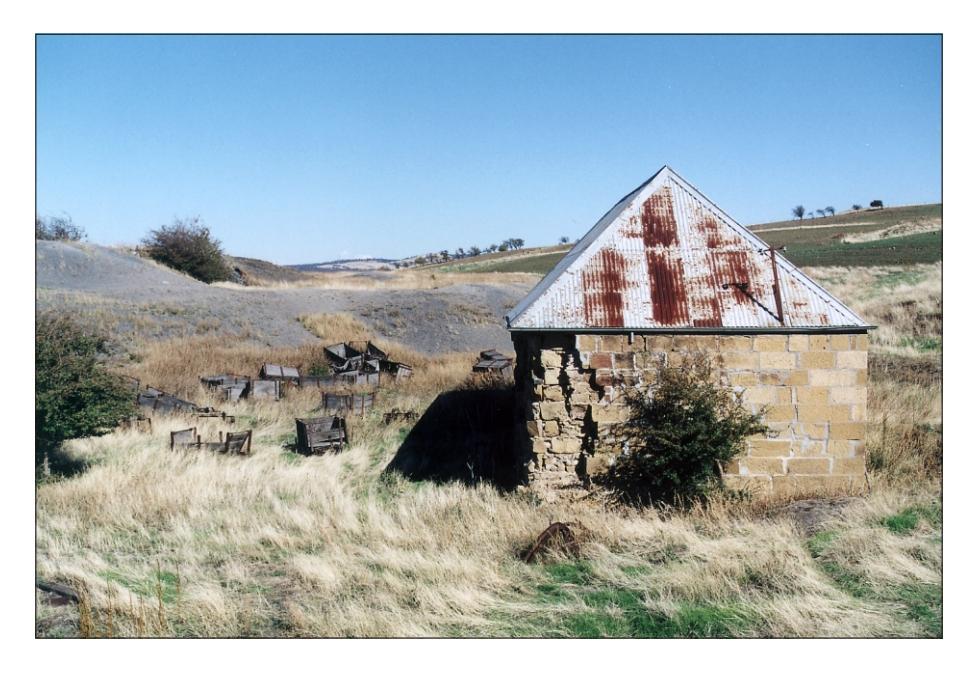
View showing the relationship of the coal truck scatter to the eastern side of the sandstone stables and the mullock dump. View is to the south. Refer to Figure 3. [MRT 3241]

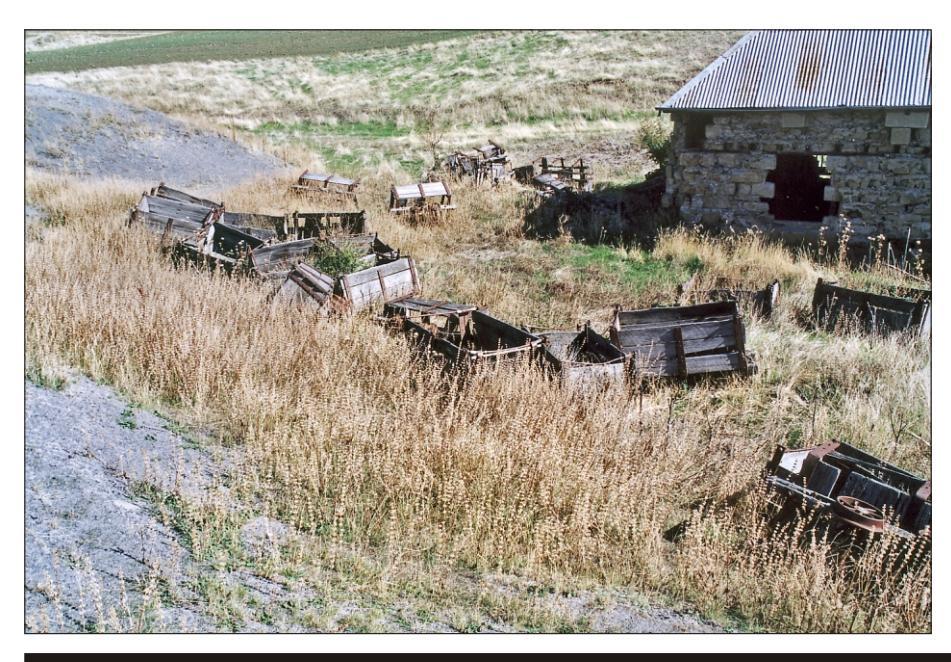
Figure 40

Detail view showing the relationship of the coal trucks to the eastern side of the stables. Refer to Figure 3. Photo taken from the mullock dump and is looking west. Note the almost complete removal of the outer layer of ashlar masonry on the eastern wall of the stables. [MRT 3273]

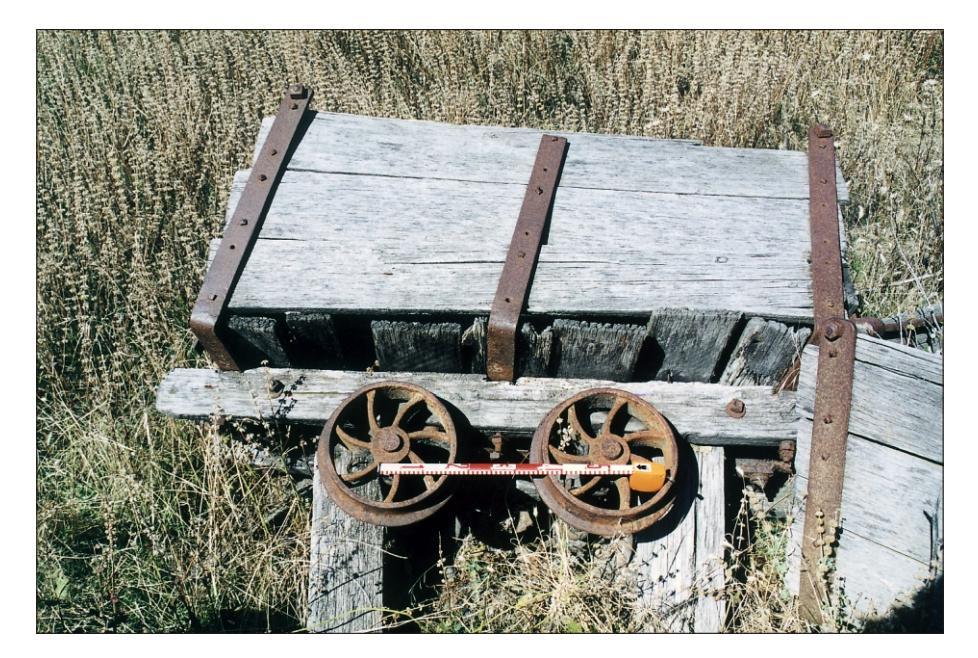
Figure 42

Detail view of the wooden chassis and cast iron wheels of one of the wood and iron coal trucks adjacent to the stone stables. Scale is in 100 millimetre increments. [MRT 3274]

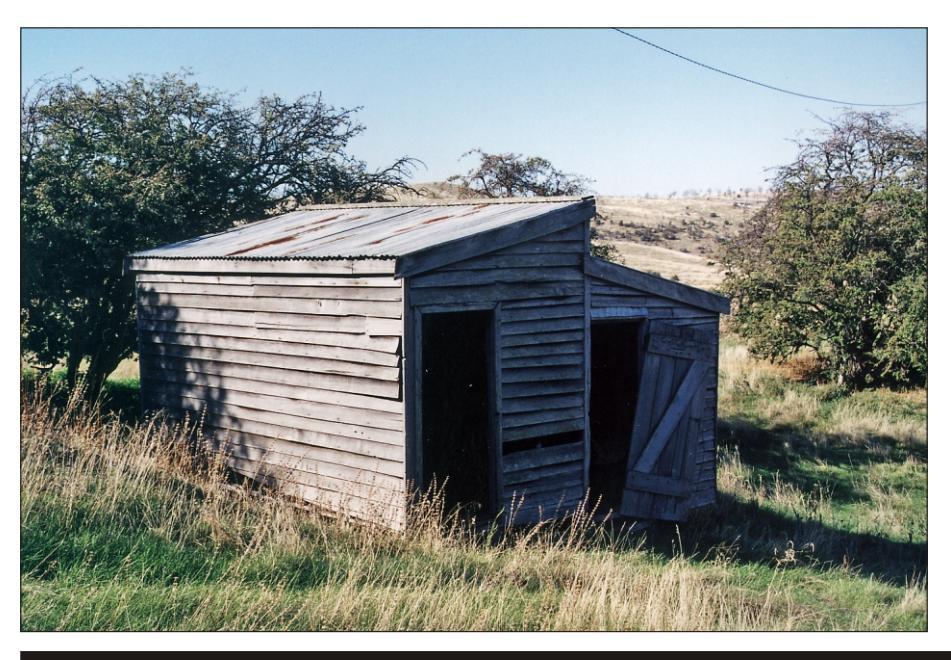
Figure 43 View of the 'store' building looking northeast. [MRT 3229]

Site feature E, a small square timber-framed and weatherboard-clad building that lies to the north of the engine house (fig. 43) was described as a store by E. Archer (pers. comm., April 2001). It is built on brick and concrete foundations. The building consists of two

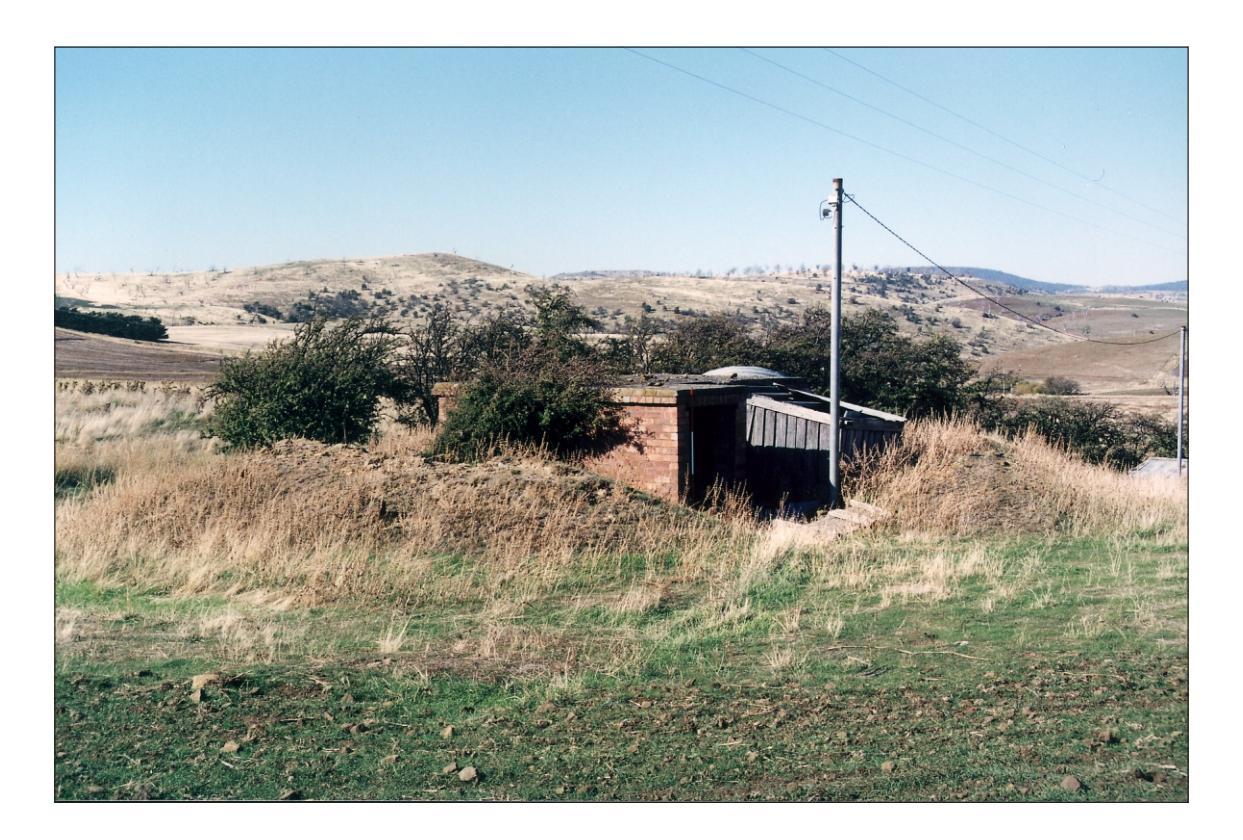
Figure 44

Brick fan house covering the ventilation shaft. The low mound is probably the spoil dump from an early coal exploration shaft that was later utilised for mine ventilation. [MRT 3232]

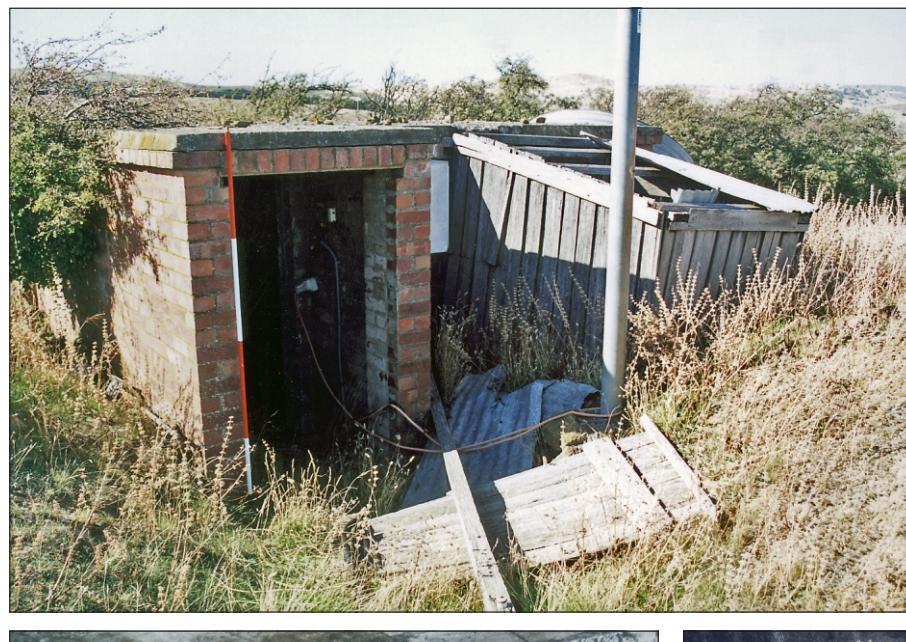
Red brick and timber building covering the ventilation shaft and housing the ventilation fan of the colliery. The shaft is located in the brick building on the left (the doorway opens directly onto the open shaft collar). The fan building is out of view to the rear and the small timber lean-to may have housed the engine that drove the fan. Scale bar is in half metre increments. [MRT 3233]

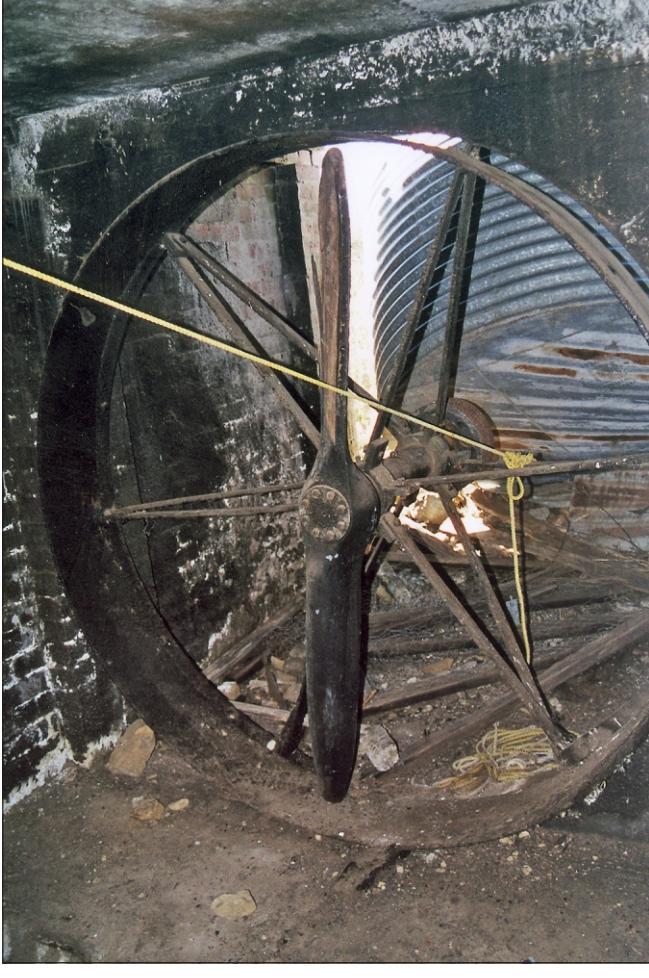
Figure 46

Detail view of wooden twin-blade aircraft propellor used as a ventilation fan at the head of the ventilation shaft. Mr Archer referred to this as a 'Tiger Moth' propellor. The fan is covered by a timber-framed and weatherboard extension to the brick building that covers the shaft. The fan was belt driven, probably by a small static or electric engine housed in the timber lean-to. The corrugated iron tanks have possibly been placed there to prevent sheep from entering. [MRT 3217]

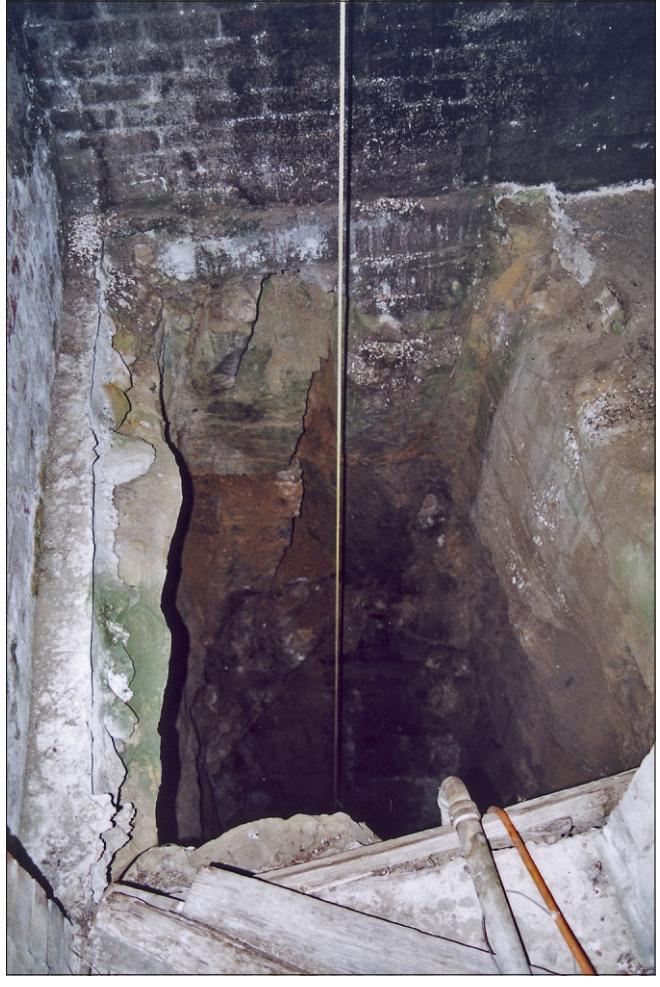
Figure 47

Collar of ventilation shaft, originally one of the earlier exploration shafts; this one was re-used in the 1940's as a ventilation shaft. The shaft is covered by the small brick shed shown in figures 45 and 46. This view is taken from the doorway of the brick building shown in Figure 45. The shaft is now used to draw the water that is stored in the underground workings for use on the 'Ellengowan' property (note galvanised pipes and electric cable). The shaft is probably one of the early coal access shafts put in in the late 1930's (or possibly earlier). [MRT 3218]

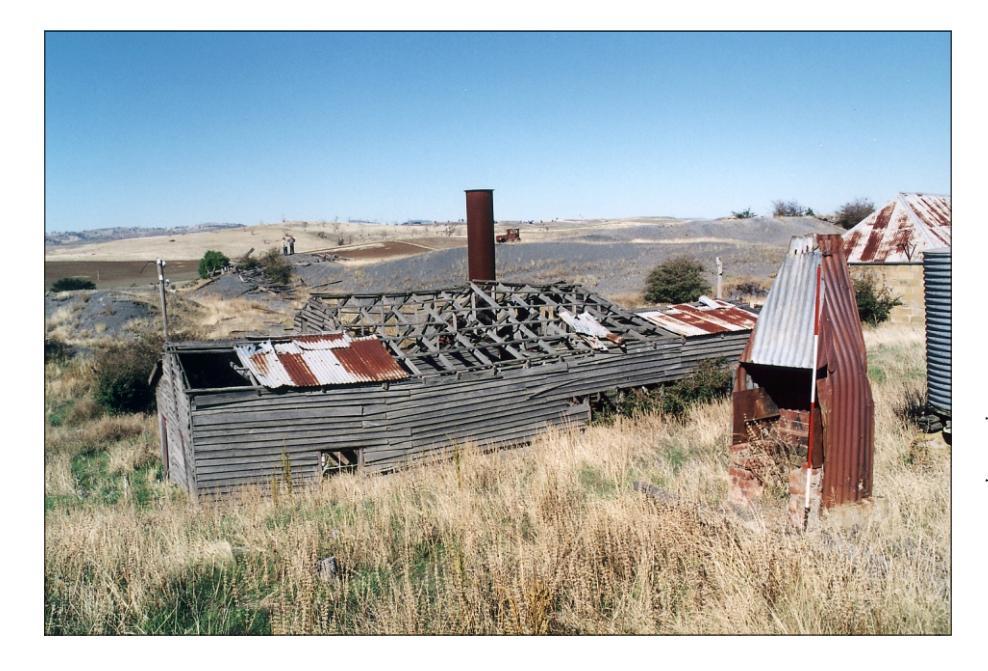
In the foreground is the corrugated iron-covered red brick chimney, flattened cutting site and rear embankment wall of the site feature labelled as the 'Office' on the 1940's mine site plans (see fig. 2 and 3). The engine house is in the middle ground and the mullock dump is in the background. View is to the southeast. [MRT 3255]
