Archaeological Survey Report 2001/01

An archaeological survey of the Langloh Colliery site, Hamilton, Tasmania

By A. E. Webster

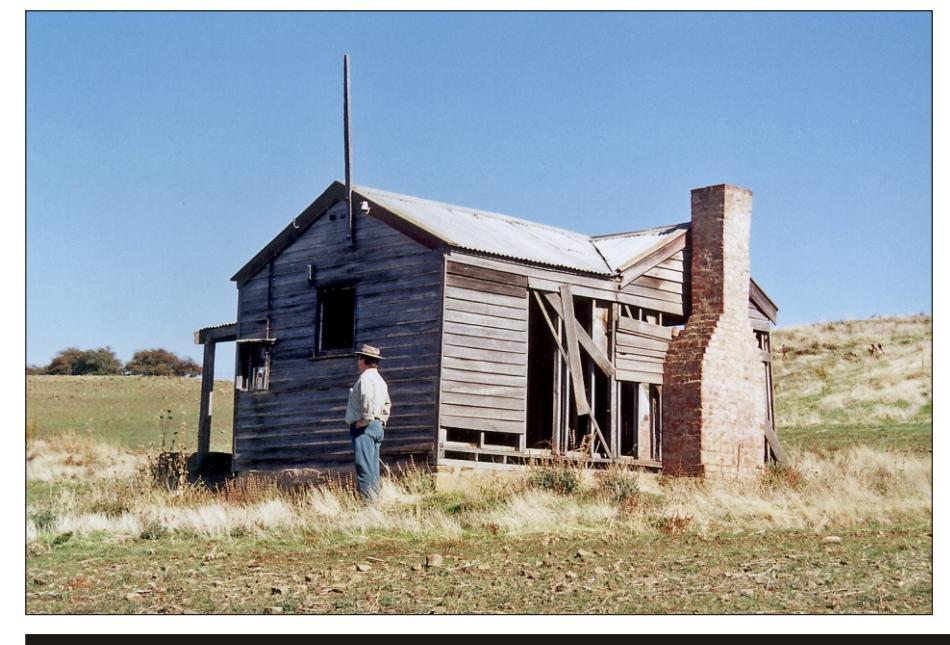
Figure 50

The cottage appears to be structurally sound apart from some loss of weatherboards to animal activity. The inside was not inspected because of a European wasp nest. The timber floor was seen to be deeply encrusted with dung and mud. Electricity was once connected to the house, as the connection point is visible on the gable (fig. 50).

Site feature J looking southwest. Note vertical weatherboard cladding and brick chimney and foundations. [MRT 3216] In the southeastern portion of the surveyed area there is a multi-roomed timber and weatherboard dwelling, circa 1890's in style. The residence is of timber and weatherboard construction and set on a sandstone foundation (fig. 51).

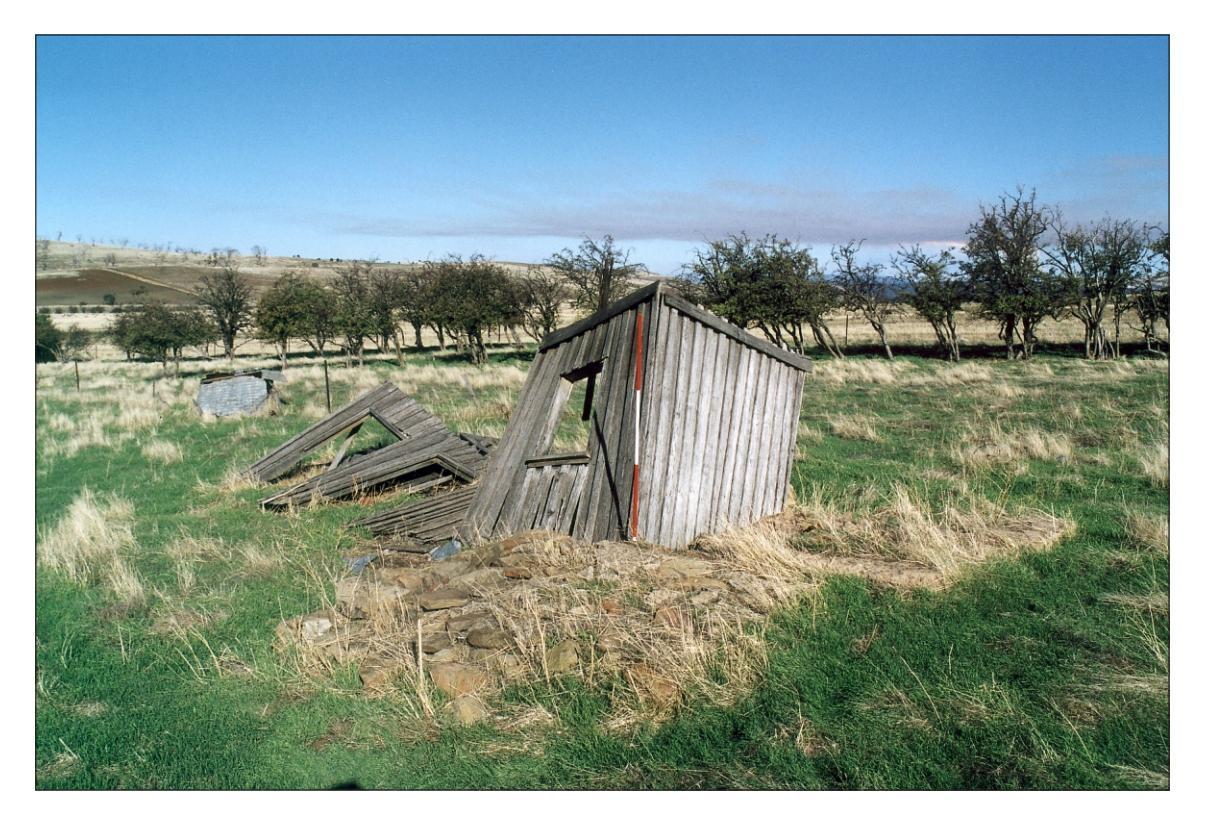
The best-preserved example of one the row of single men's shacks located to the immediate southeast of the original 'Langloh' homestead. The scale is in half metre graduations. [MRT 3225]
