## Stability of land at Windermere, East Tamar.

P.C. Stevenson

[1 April 1974]

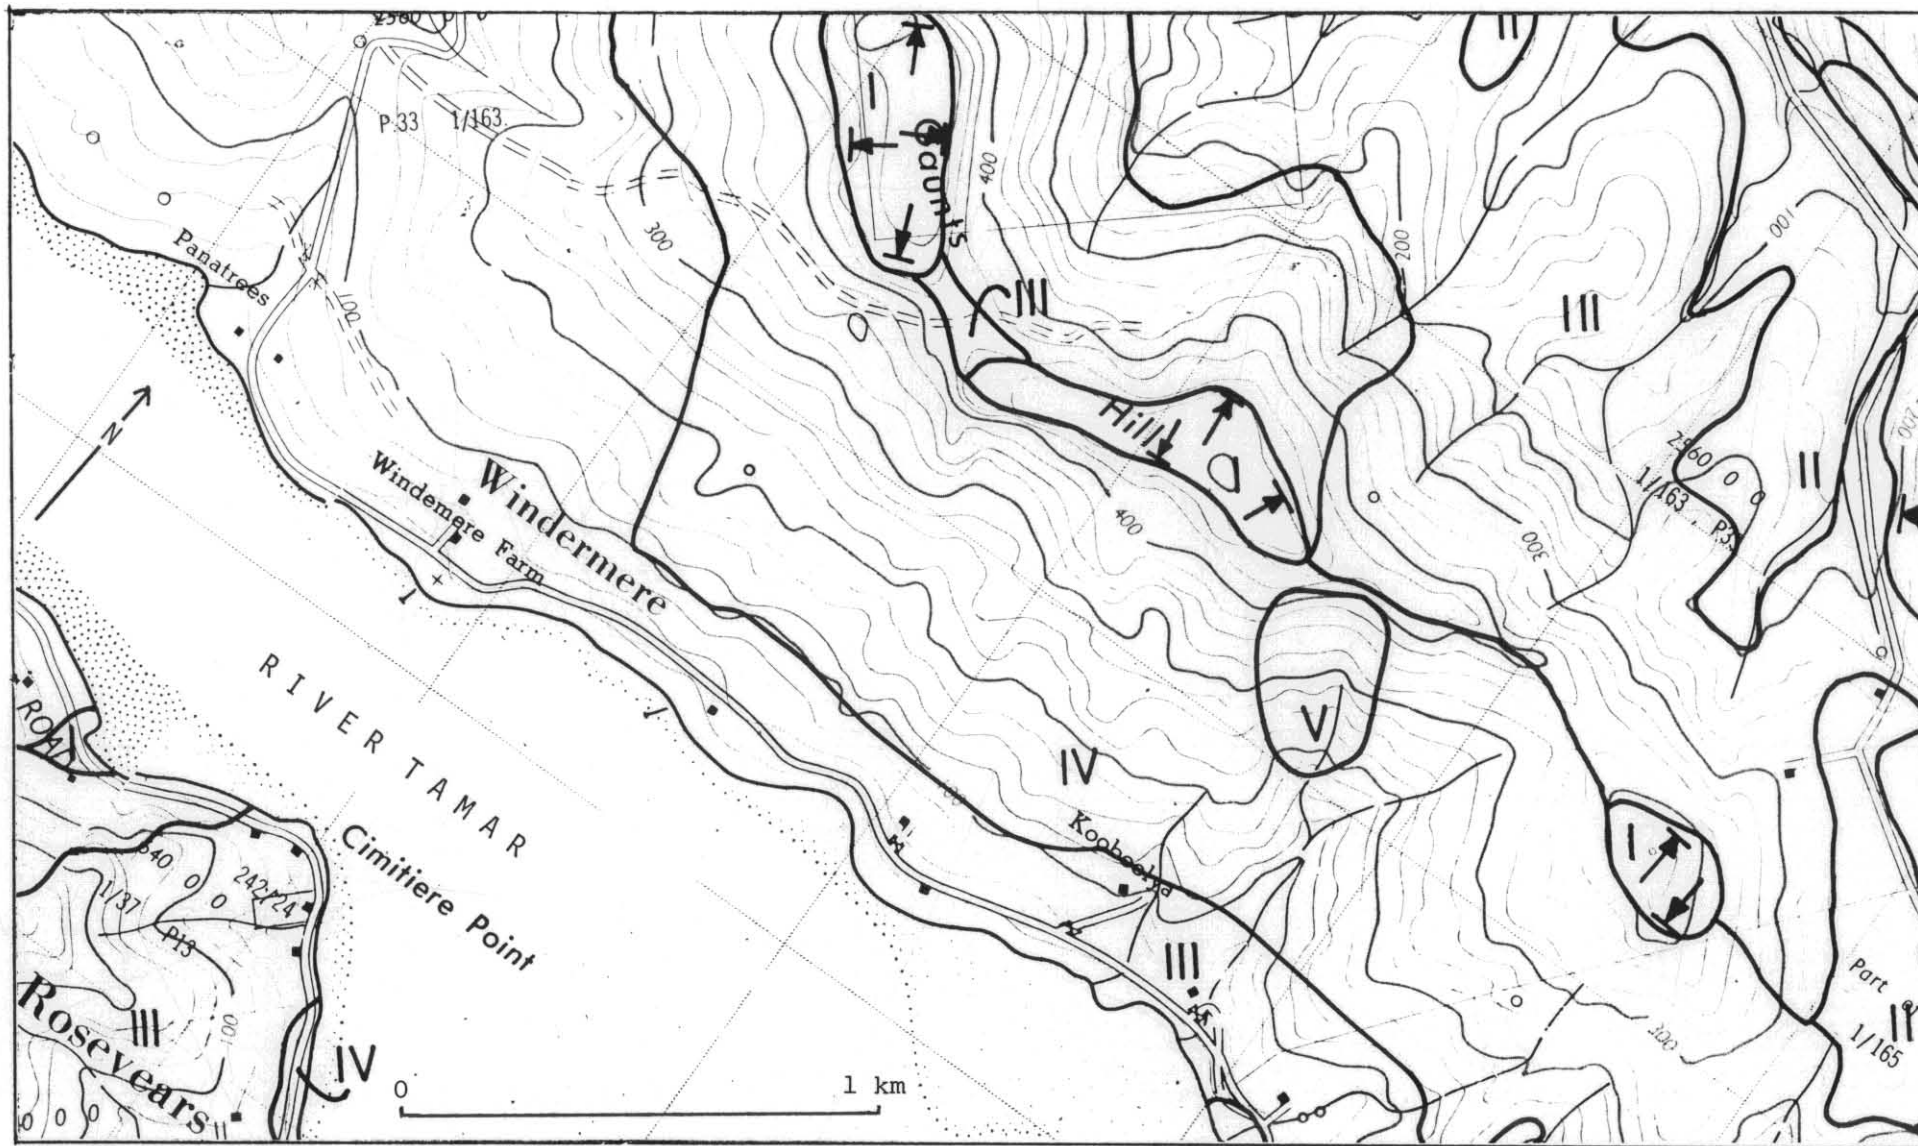
The whole region has been zoned as Zone III (Potential Landslip area) or Zone IV (Old Landslip area) on the Tamar Valley Landslip Zone Map. An extract of this map is appended as Figure 2.

Figure 2. Portion of Tamar Valley Landslip Zone Map.
