1976/71. Engineering geology investigation of a proposed cutting on the Murchison Highway at Somerset.

W.R. Moore

The Public Works Department (P.W.D.) requested the Department of Mines to undertake a rock stability analysis of a 200 m cliff section of the Murchison Highway at Cam River, Somerset [DQ019553] (fig. 1; plate 1).

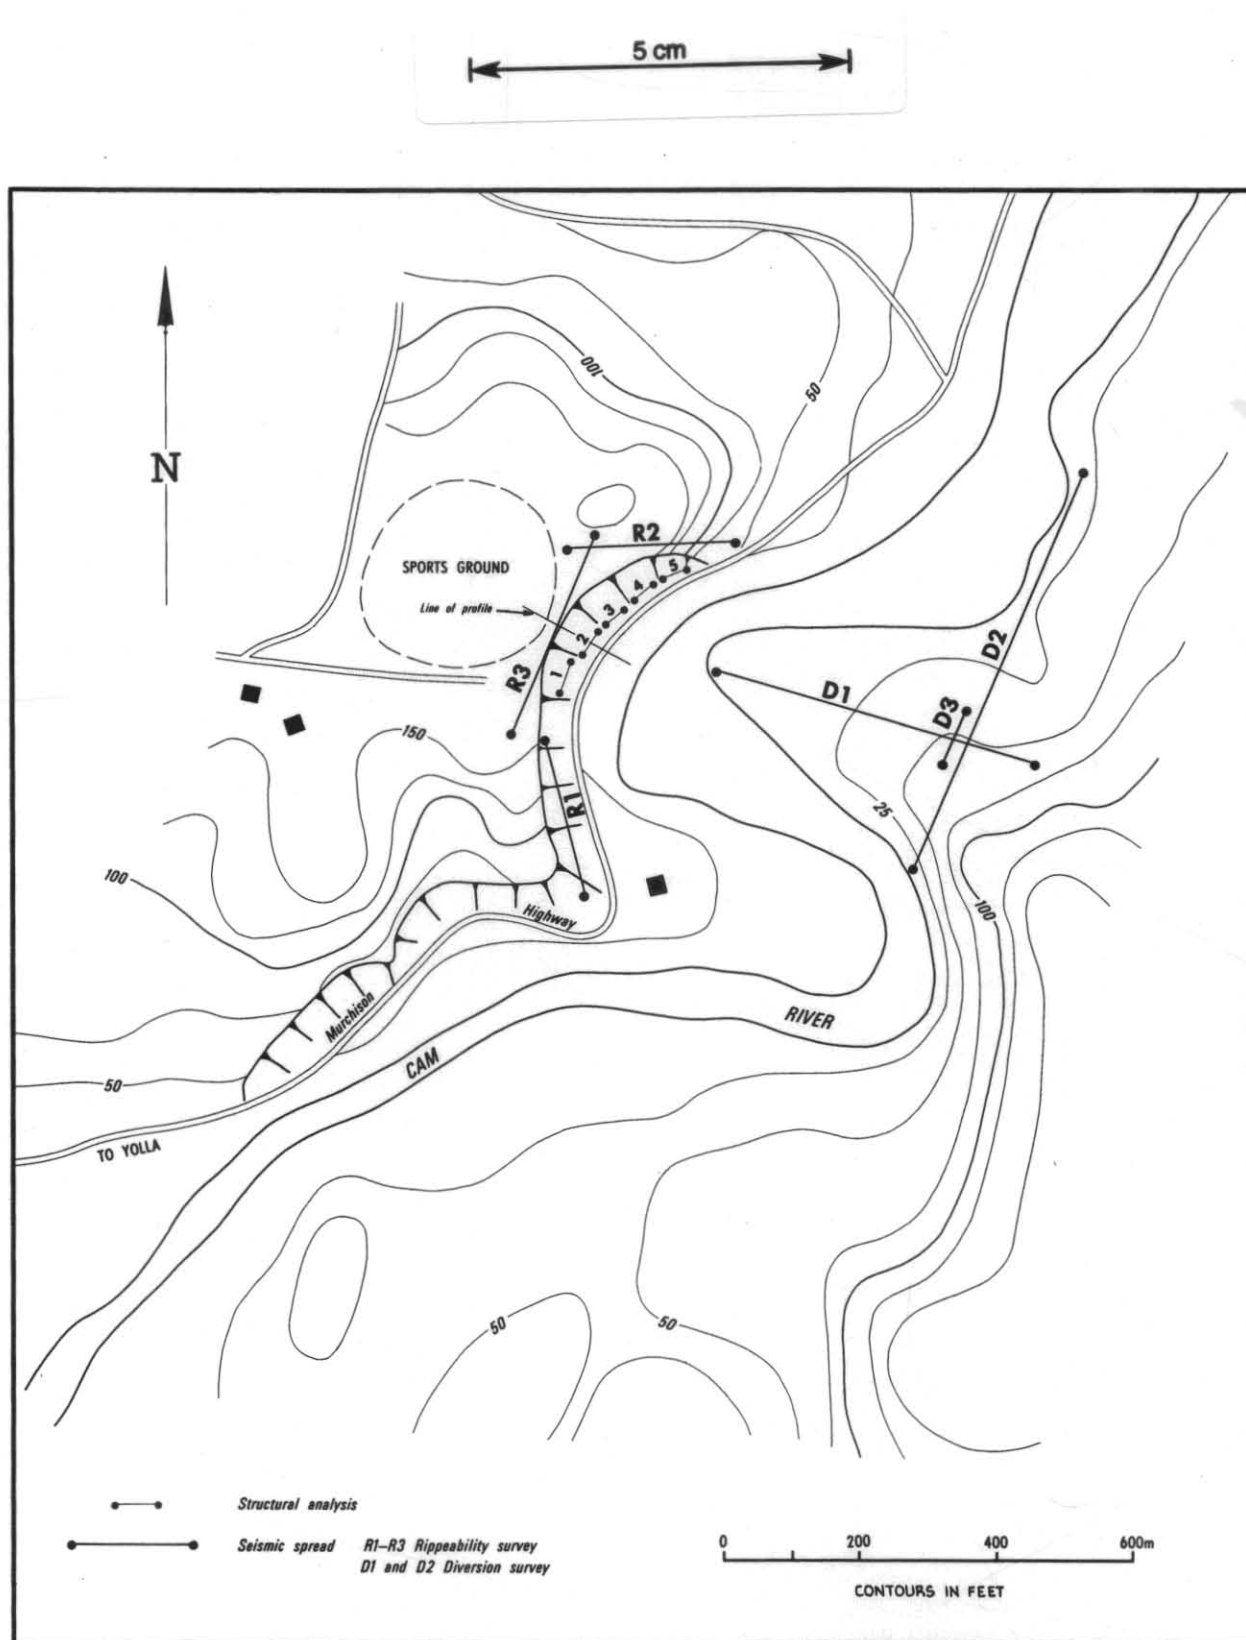
Figure 1.

A tension crack about 1-1.5 m long and about 4 cm wide was found on the upper surface in the area of an old wedge failure above measured section 3 (fig. 1). This upper surface tension crack connects with a series of cracks which run from road level to the top of the cliff. These cracks are clearly visible from the road (plate 4). The tension crack on the upper surface of the wedge could not be traced continuously because of the cover of vegetation but isolated cracks were found over the area of upper surface in the position and in the anticipated direction where a large wedge failure will occur. Little imagination is required to visualise the continuous ledges present as having been formed by intersecting tension cracks on which movement has already taken place.

The second potentially dangerous area is at the northern end of the cliff, above measured section 5 (fig. 1). A planar failure has already occurred along a bedding plane of a thick silty argillite bed when most of the upper limb of a fold fell. The P.W.D. then removed some further material considered dangerous after this initial rock fall. On what appears to be the initial southern release surface of this planar slide are a series

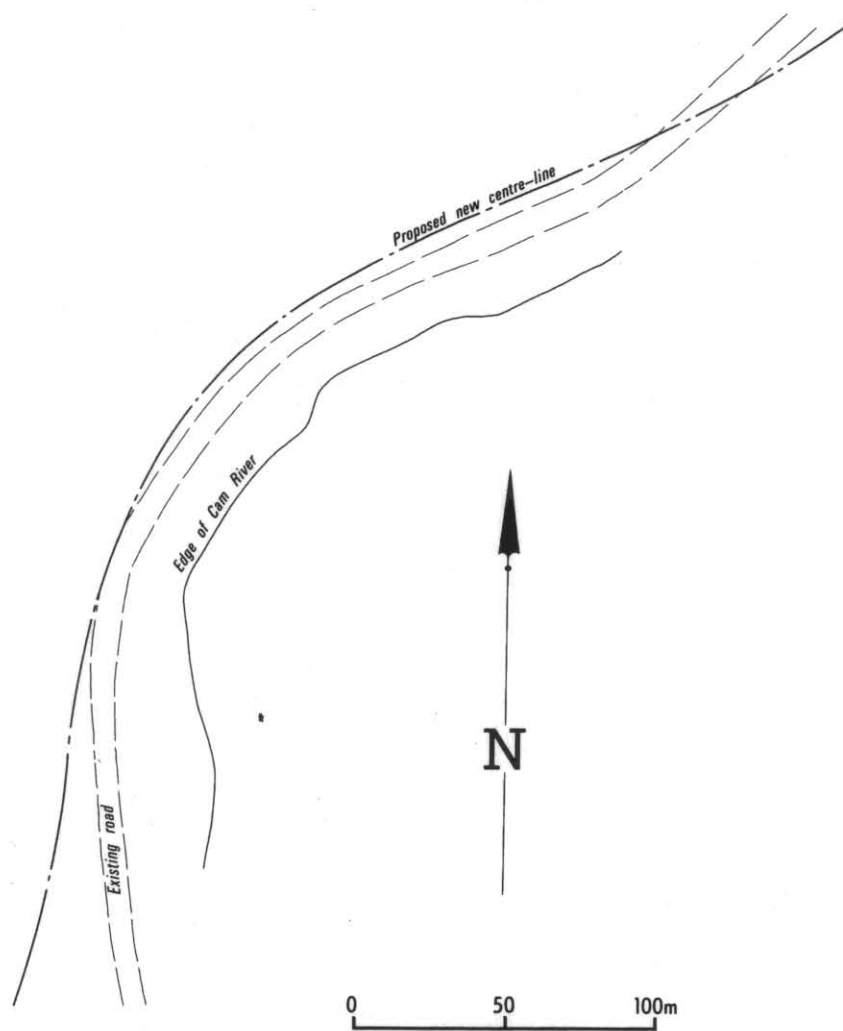
Figure 2.

PLAN SHOWING  
PROPOSED NEW CENTRE-LINE

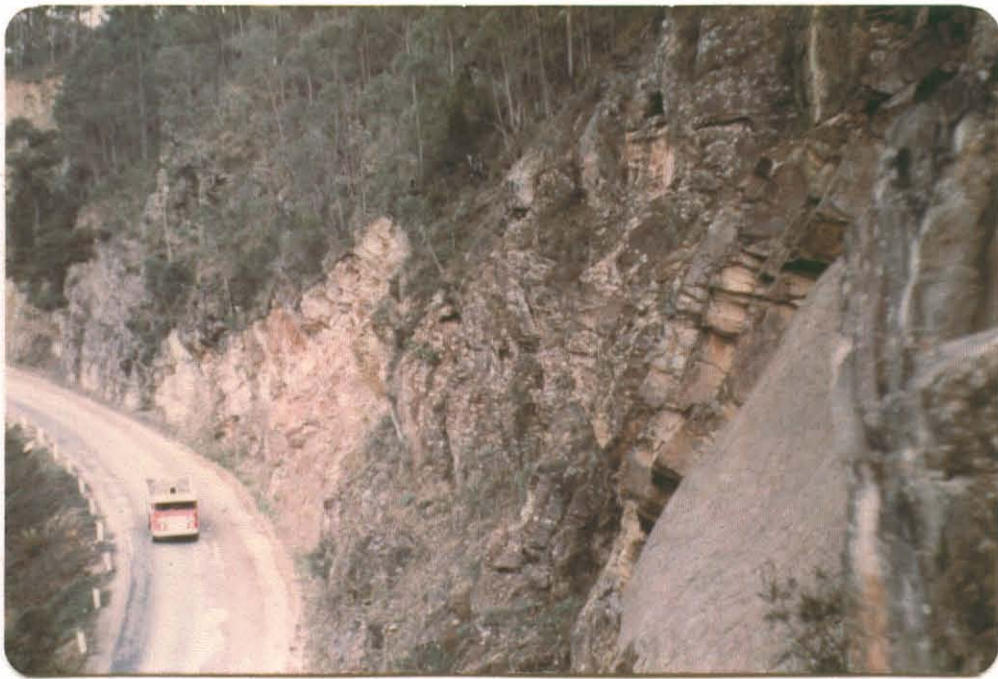
With jointing so closely spaced and the joint scatter so wide the only failure likely to occur on this section of the cliff line is fretting. This type of failure is present on the cliff face in this area and has already occurred on the new face south of this section (plate 1). No back analysis plot is given as no other types of failure were seen in section 1.

Plate 1. *Cliffed section of the Murchison Highway, above the Cam River, Somerset.*
