UR1985-64

1985/64. Slope stability of Watchorn's Estate at Brickmakers Point, Deviot

W.R. Moore

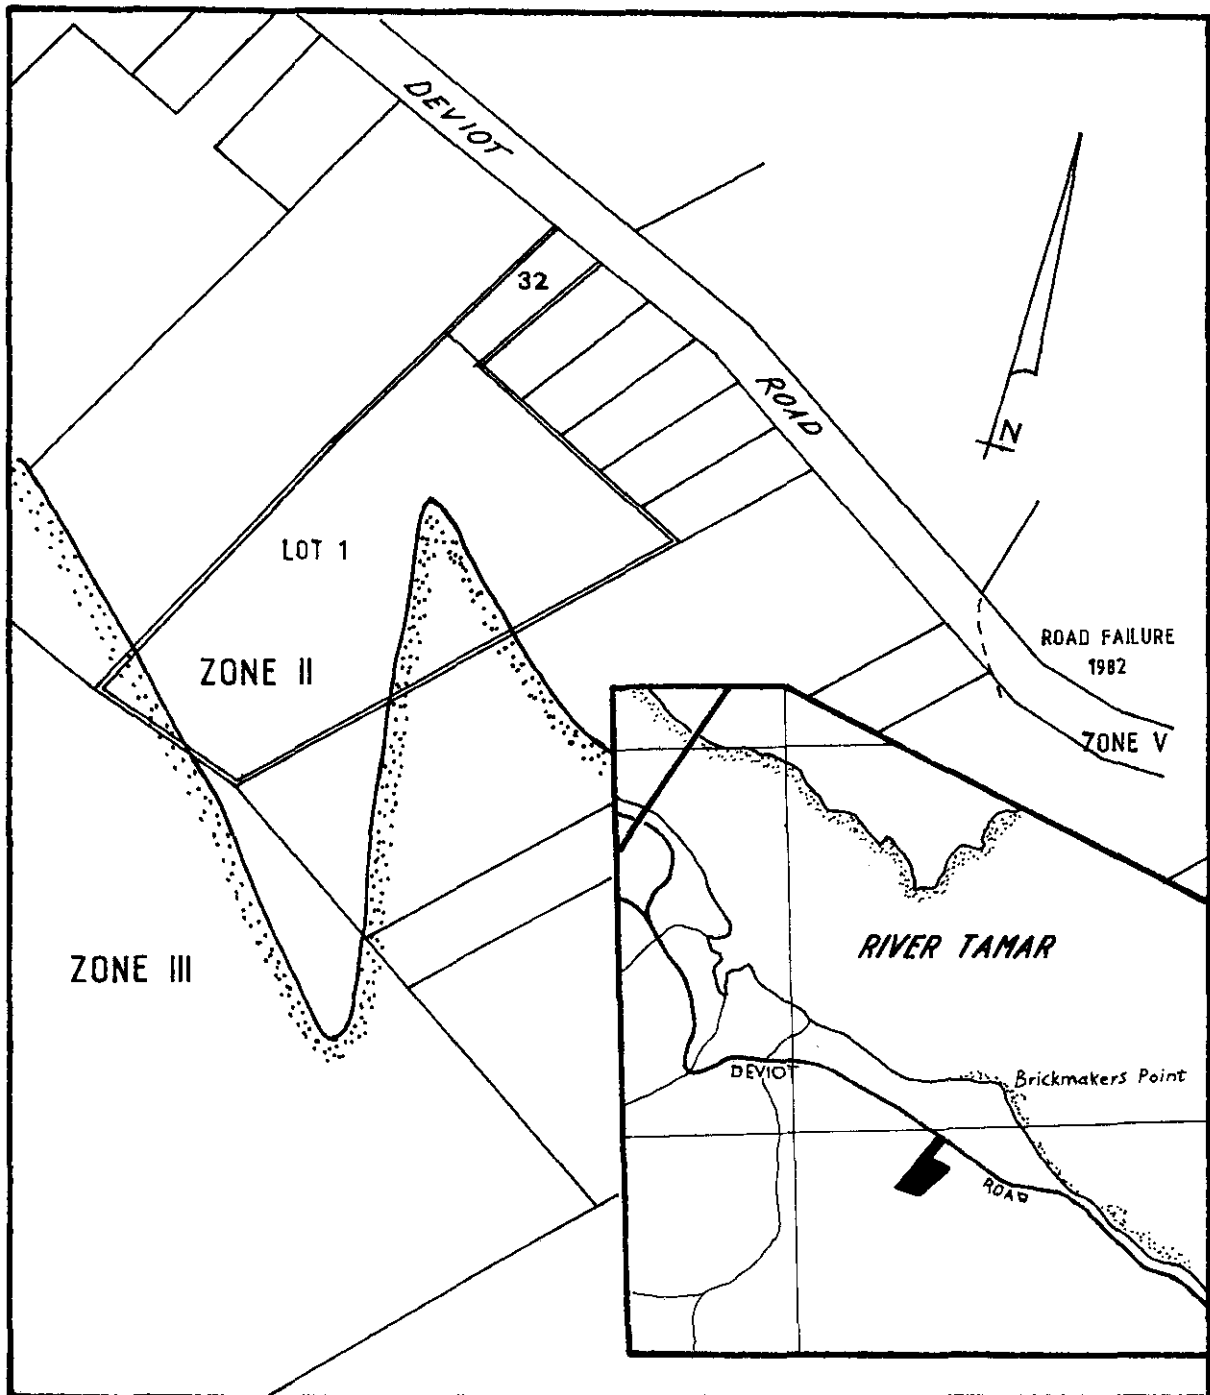
Figure 1. Location of investigation area. Former landslip zones as marked.

The landslide zoning plan submitted by C.J. Cohen (fig. 1) was taken from the Department of Mines Tamar Valley Regional Landslide map. It is difficult to reconcile this zoning with the existing landscape morphology and geology. The zoning appears more related to the Batman Bridge dolerite contact area, approximately 100 m to the north in the vicinity of block number 6017.
