# A review of groundwater monitoring at Rosetta (1991–2001)

A. Waite

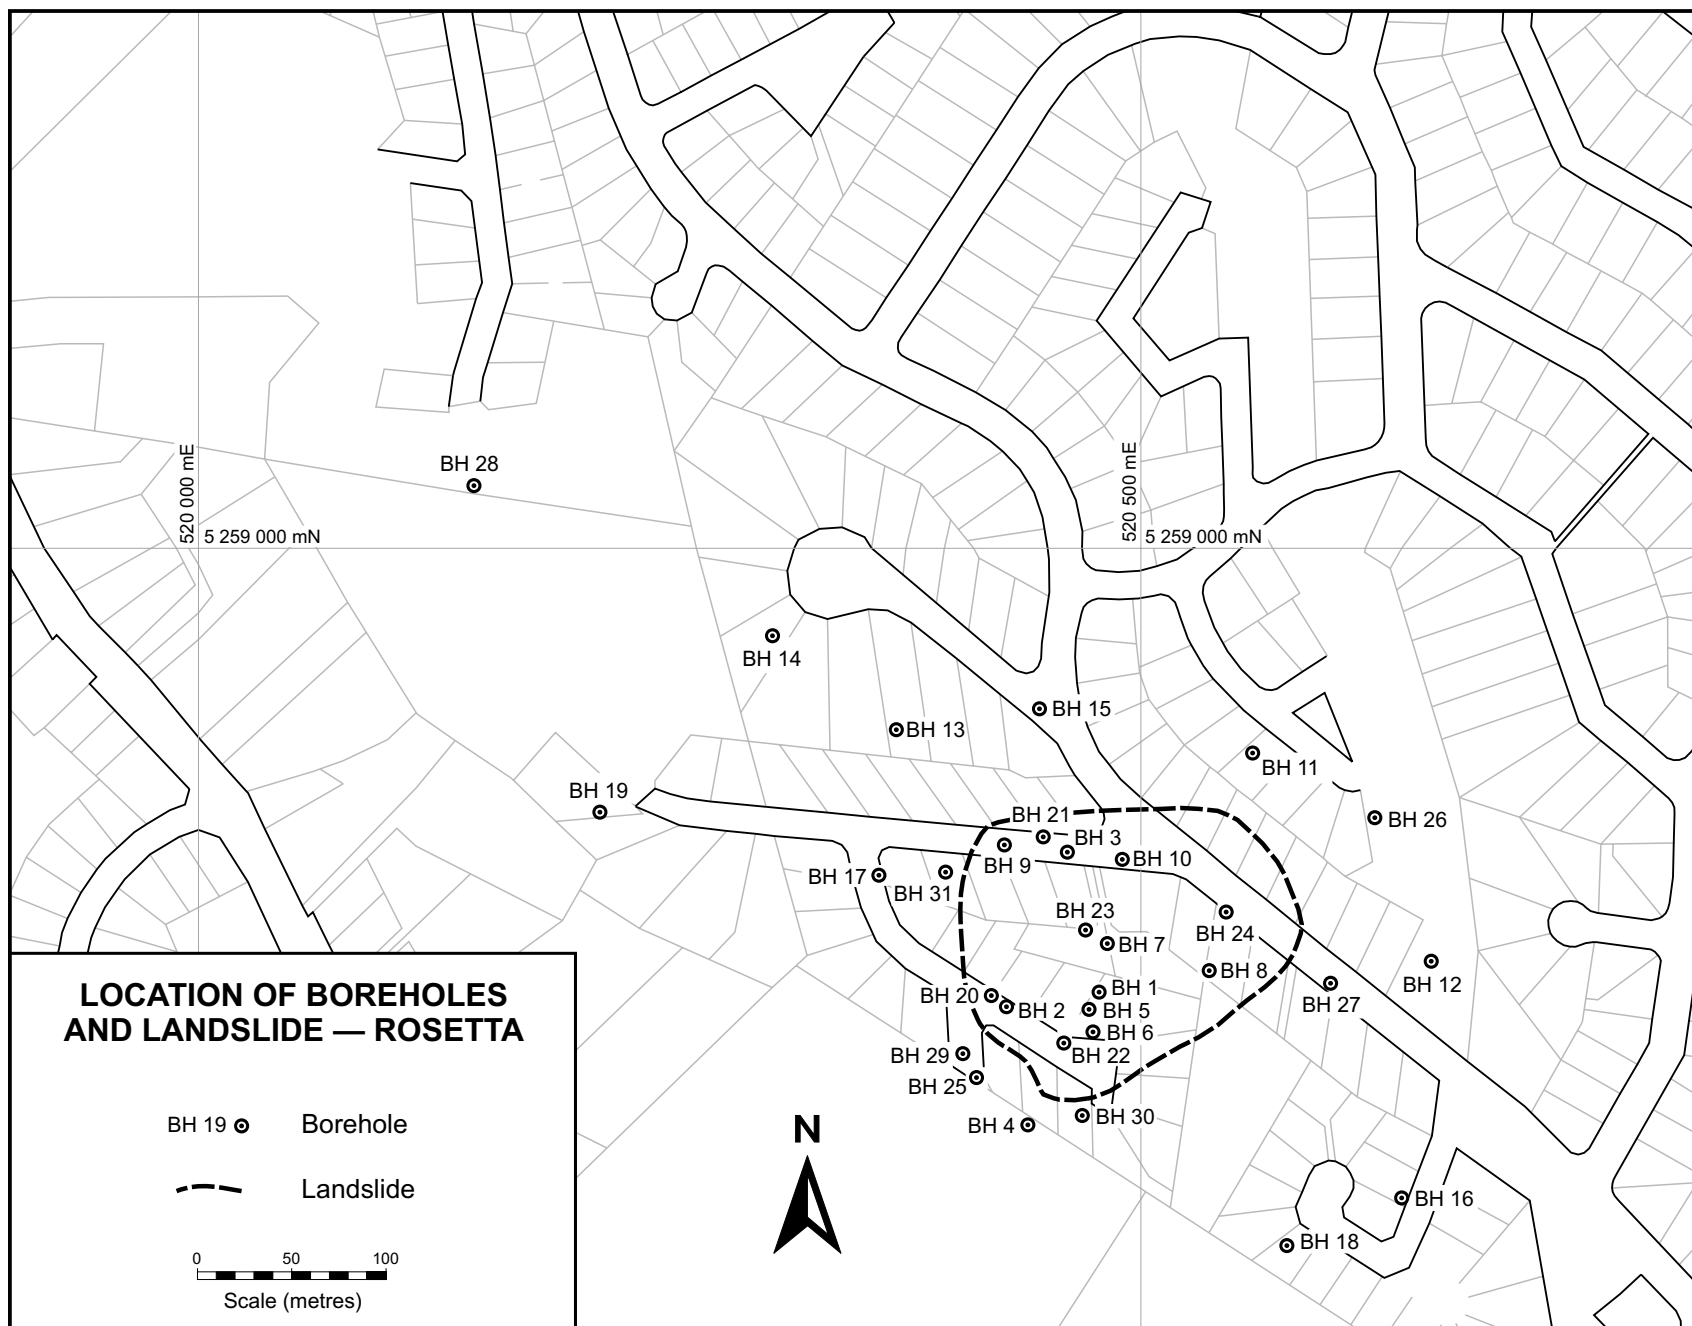
Figure 1

Investigations in 1990 (Weldon, 1990a, b) and 1991 (Donaldson, 1991) confirmed the existence of an active landslide in the Hone Road area at Rosetta. During the investigation work by Donaldson (1991), a number of piezometers were installed in boreholes to monitor groundwater levels in the body of the landslide and the surrounding area (fig. 1).

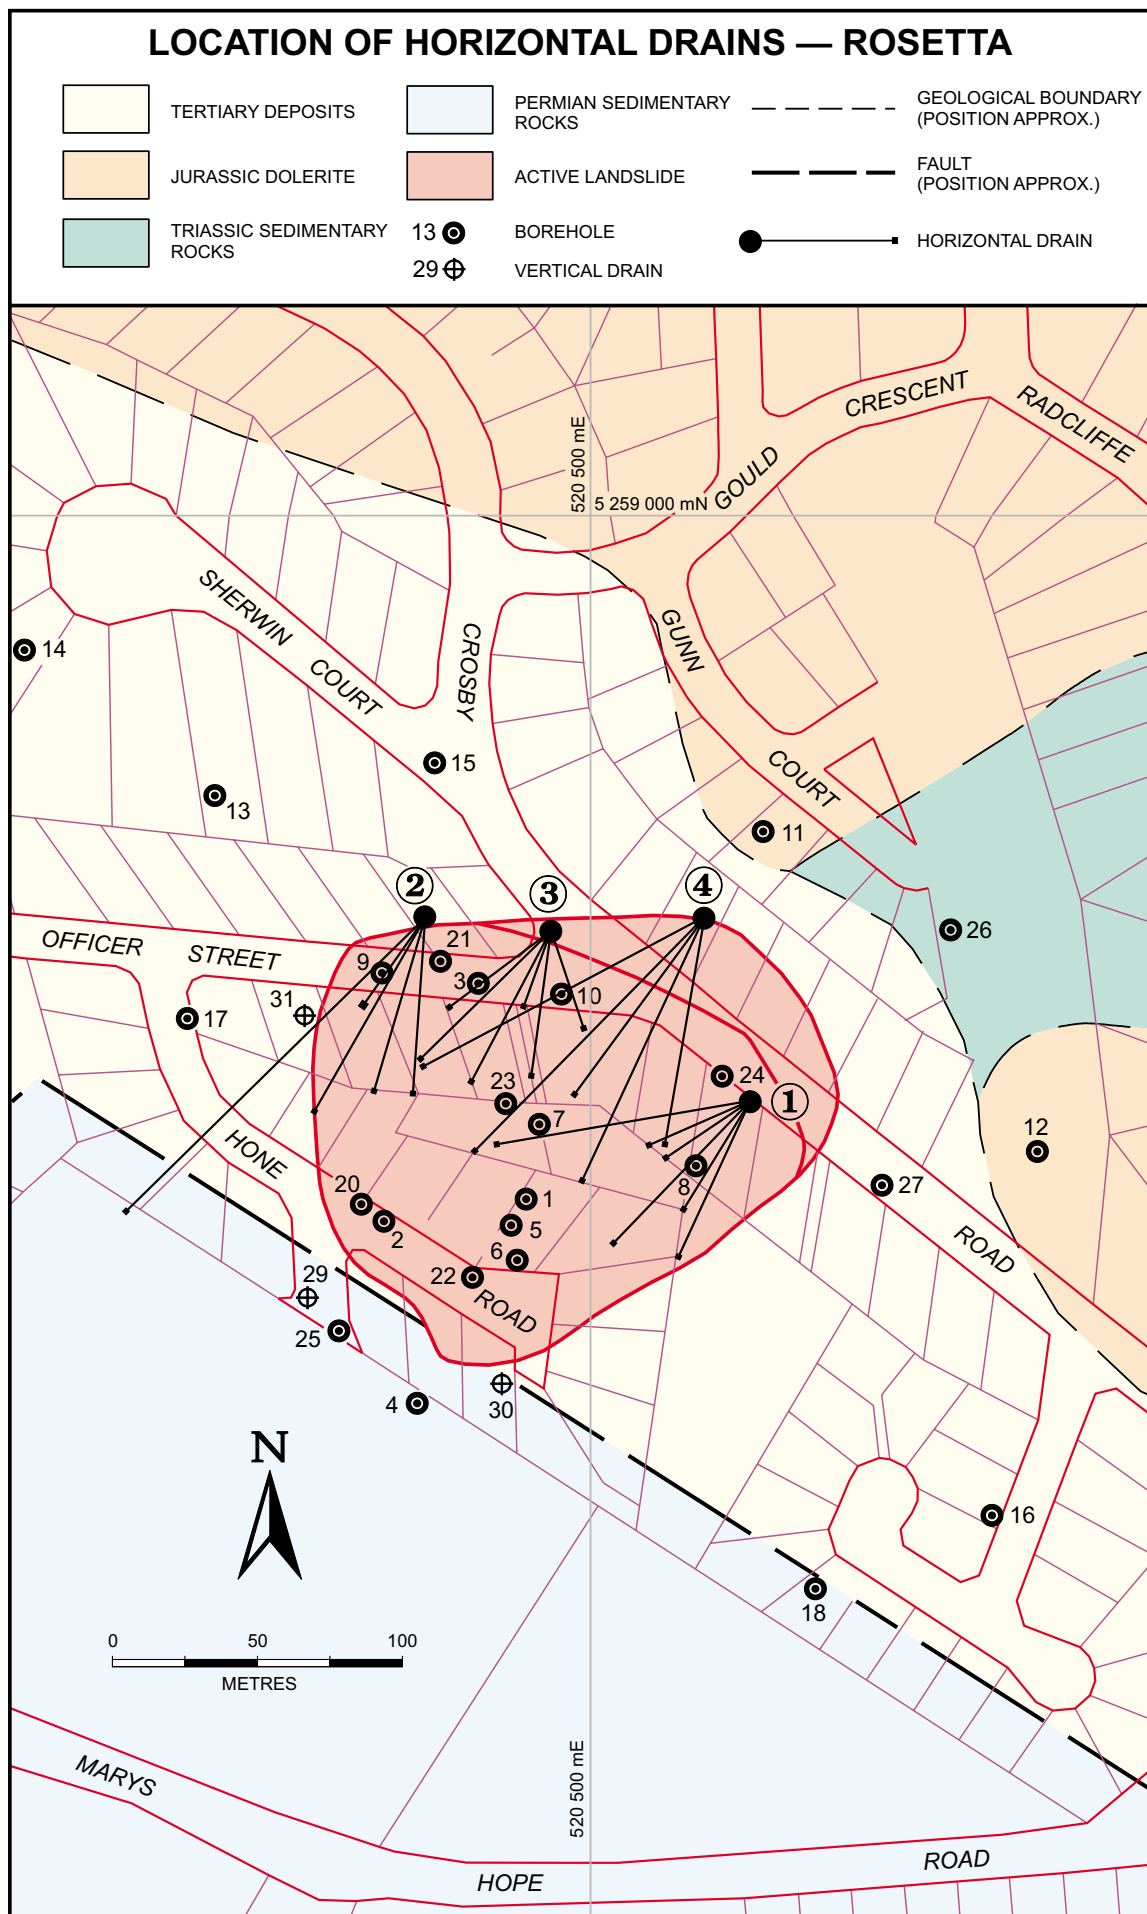
Figure 2

The investigation by Donaldson (1991) identified groundwater levels as a significant contributor to the activity of the landslide. In the period 1991–1992, the Glenorchy City Council installed a number of active and passive drainage systems in the area to control groundwater. These consisted of a number of horizontal drains drilled at low angles into the landslide body, and three vertical extraction boreholes up gradient of the active landslide and fitted with automatically operated borehole pumps. Water produced from these drainage systems was directed to stormwater lines outside the landslip zone. The locations of the vertical wells and drainage fans are shown in Figure 2.
