## Cornwall Coal

### Blackwood 6 Landslide Risk Assessment

Prepared for  
**Cornwall Coal**

Date  
**3 May 2021**

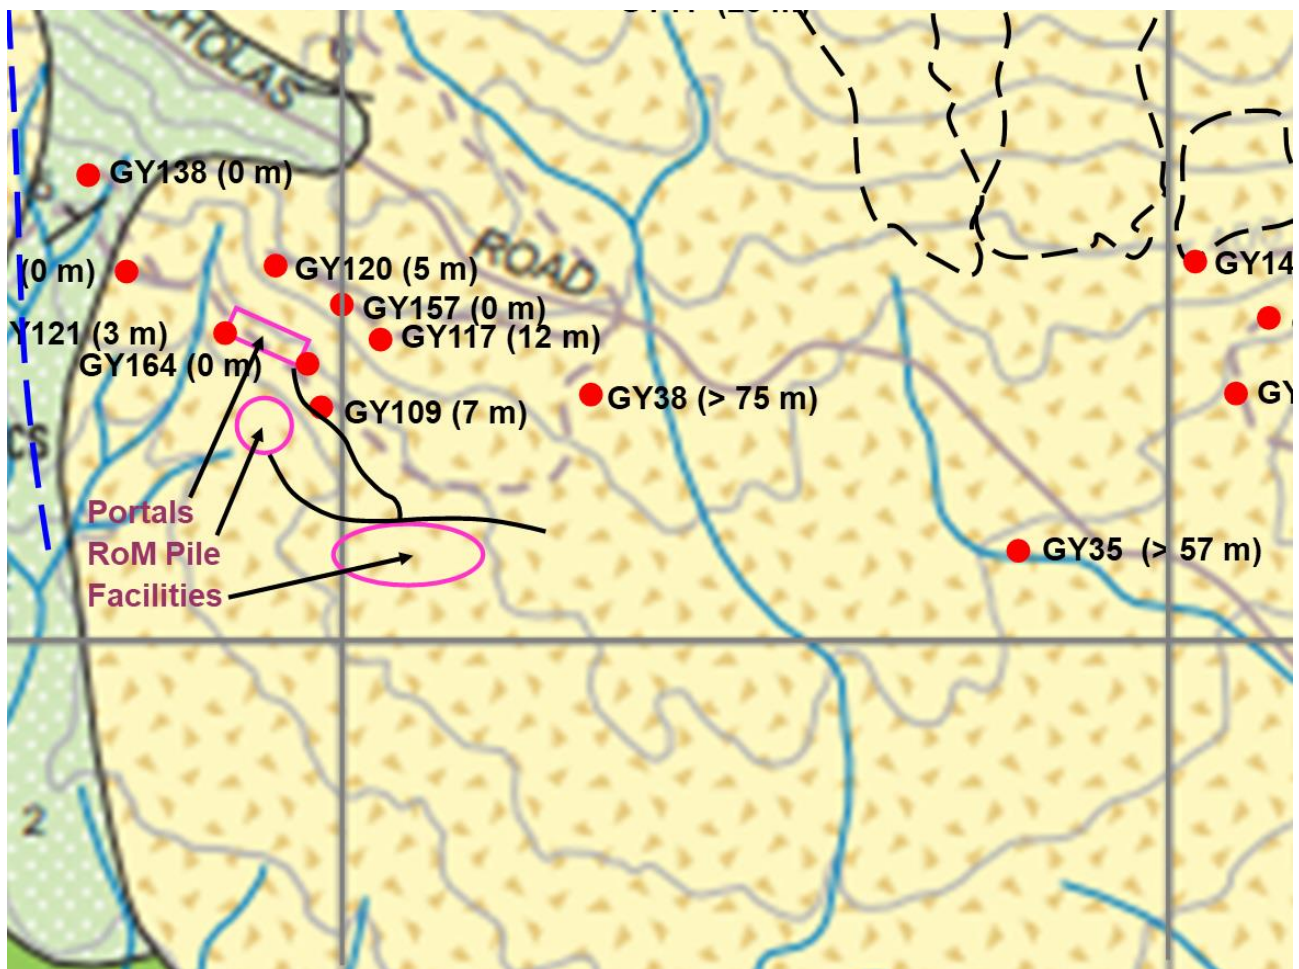
Figure 7: Detail of historical drill holes at the Blackwood 6 site.

- All intercept drains must be confirmed to have passed through the colluvium into the Triassic substrate and to maintain a constant negative gradient prior to placement of the lining material
- Colluvium should not remain on the cut slope above the portals if at all possible. Holes such as GY157 and GY164 suggest that this is possible although some is recorded in GY120 (Figure 7). pitt&sherry is not privy to recent site investigations and is unable to comment as to whether any further work is required
