Fig 3/2 GEOLOGICAL INTERPRETATION

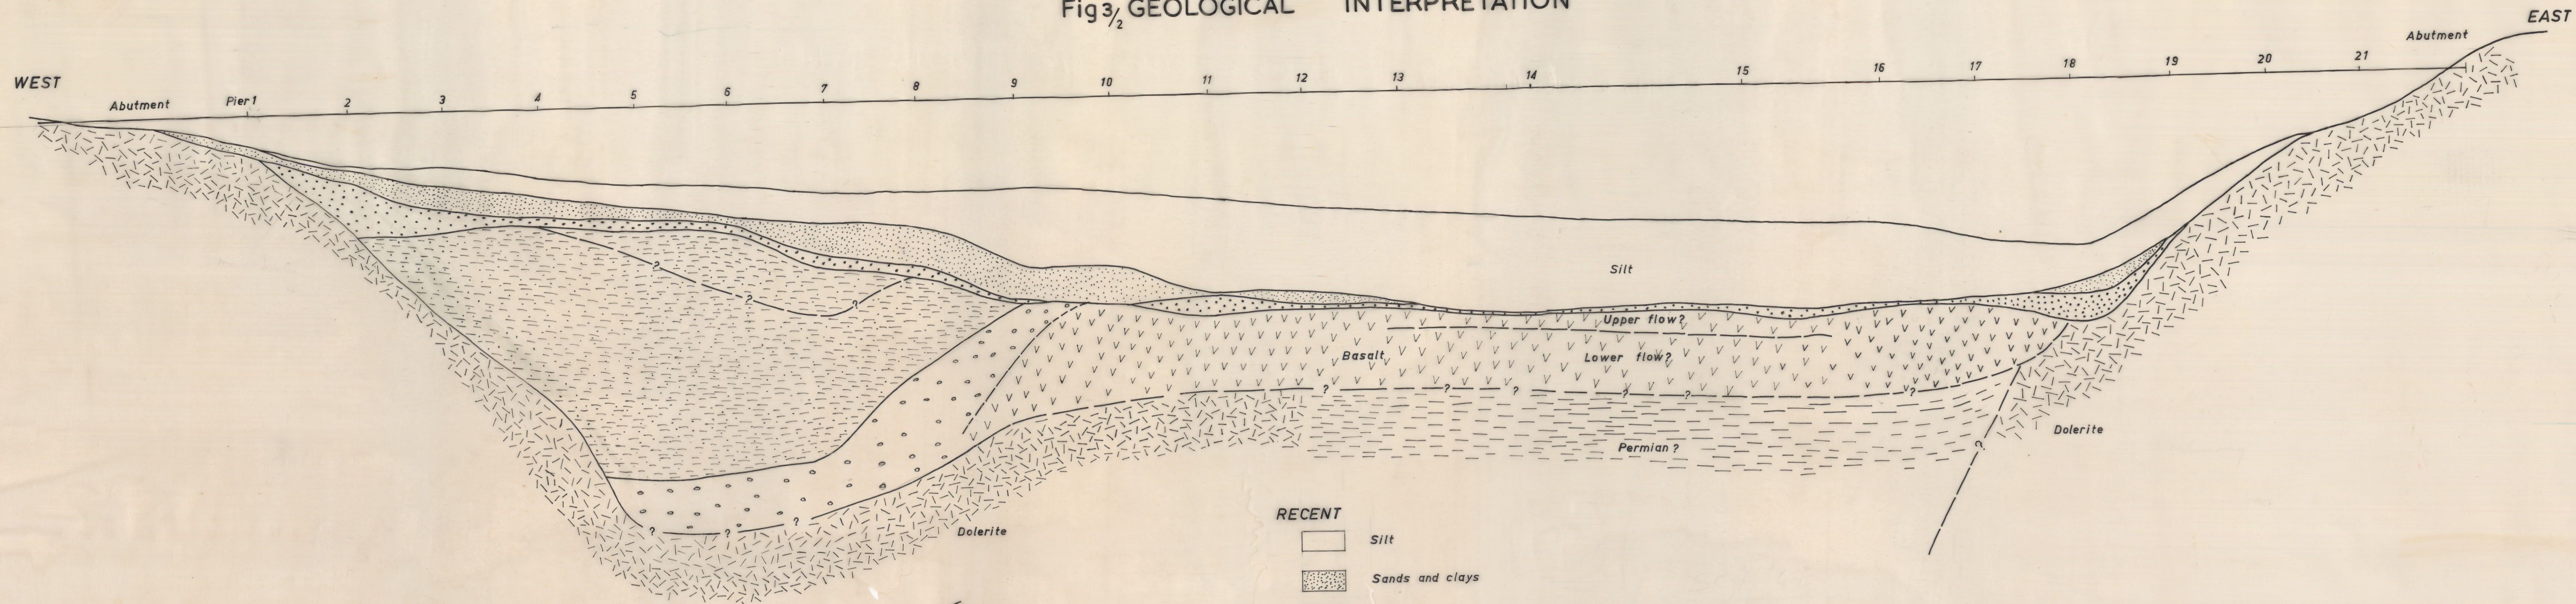
- RECENT**
- Silt
  - Sands and clays
  - Gravel
- TERTIARY ?**
- Clays sands etc.
  - Gravel
- BEDROCK**
- Tertiary basalt
  - Jurassic dolerite
  - Possible Permian sediments

**SCALE**  
HORIZONTAL 100' = 1"  
VERTICAL 50' = 1"

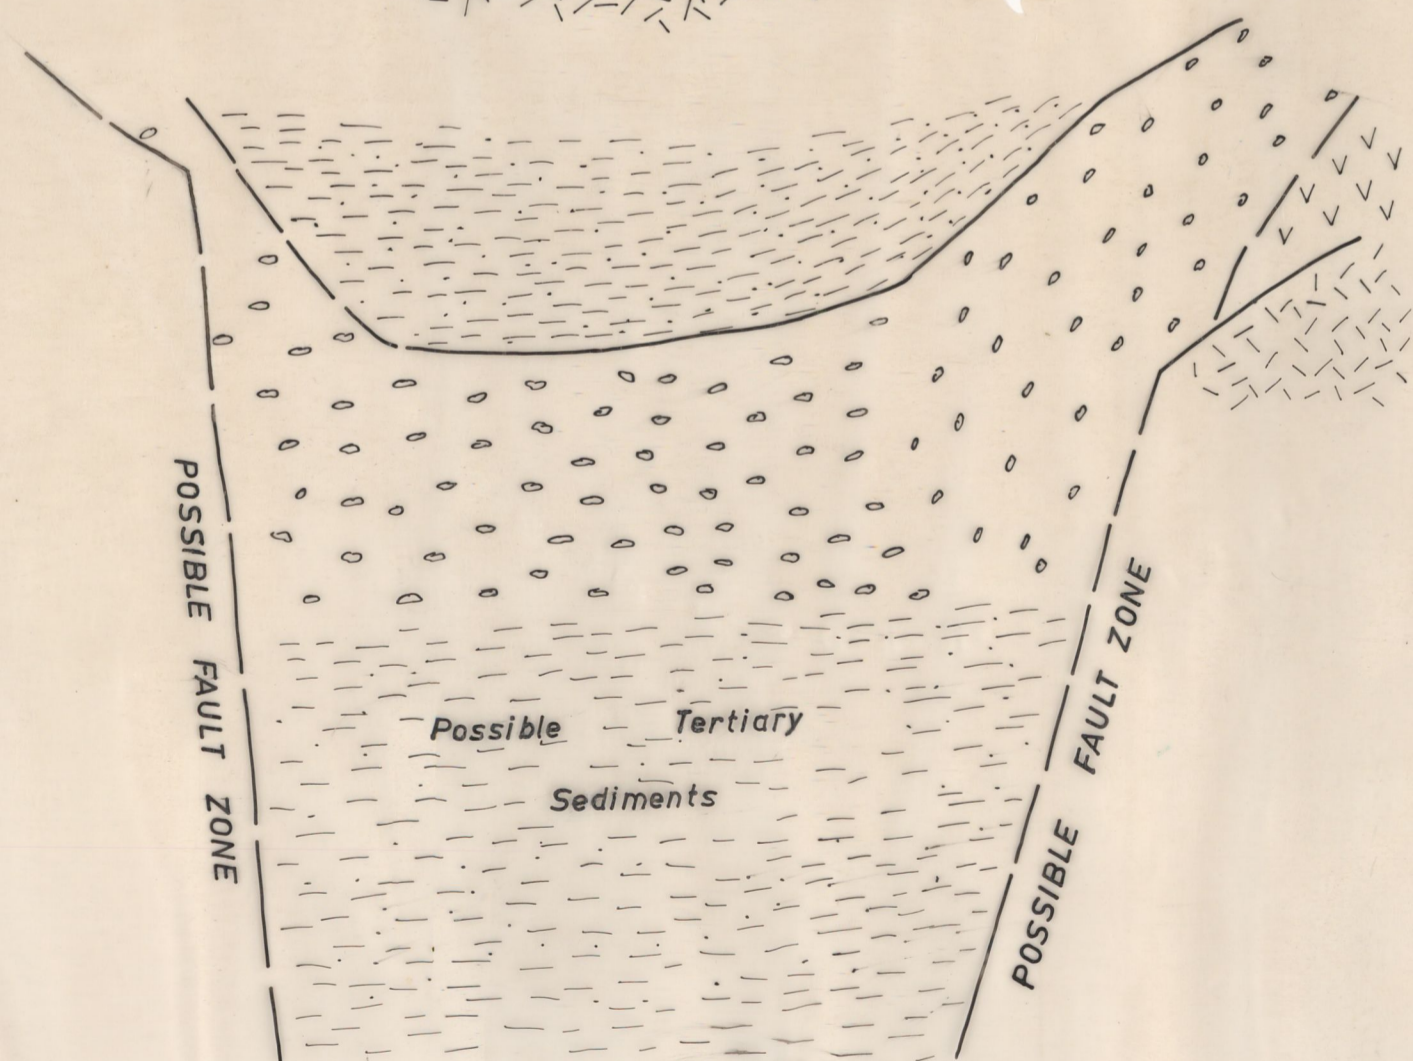
ALTERNATIVE  
STRUCTURE

A narrow fault graben is possible in this section. The bedrock may contain fault zones. Triassic sediments may be present.
