PROJECT										LOCATION										HOLE No									
MEANDER IRRIGATION SCHEME										MEANDER DAMSITE										1A									
METHOD					DATE DRILLED					LEVEL					COORDINATES					REFERENCE PLANS		SHEET							
DD					14-11-88					416.40					E 468 154					GEOLOGY		2 of 2							
VERT					15-11-88					COLLAR					N 6 284 332					SURVEY									
DRILLING INFORMATION										ROCK MASS DEFECTS										LOGGED BY		DATE							
DISTANCE DRILLED		S.L. LEVEL REL.		CORE SIZE		RECRY LIFT		PERMEABILITY		FLUID RET.		WATER PRESSURE TESTS		R.O.D. %		DEFECT SPACING		DISCONTINUITIES		GRAPHIC LOG		WITH INC.		STRENGTH		ROCK SUBSTANCE		ROCK DESCRIPTION	
26		390		NO						50% GREY		0.61 0.73 1.79		0.57 0.24 4.9		75		SEE GRAPHIC DEFECT LOG		SW						slightly weathered DOLERITE			
27																													
28																												HOLE COMPLETED 27.00m	
29																													
30

Project: MEANDER IRRIGATION SCHEME Location: MEANDER DAMSITE

Borehole No. 1A

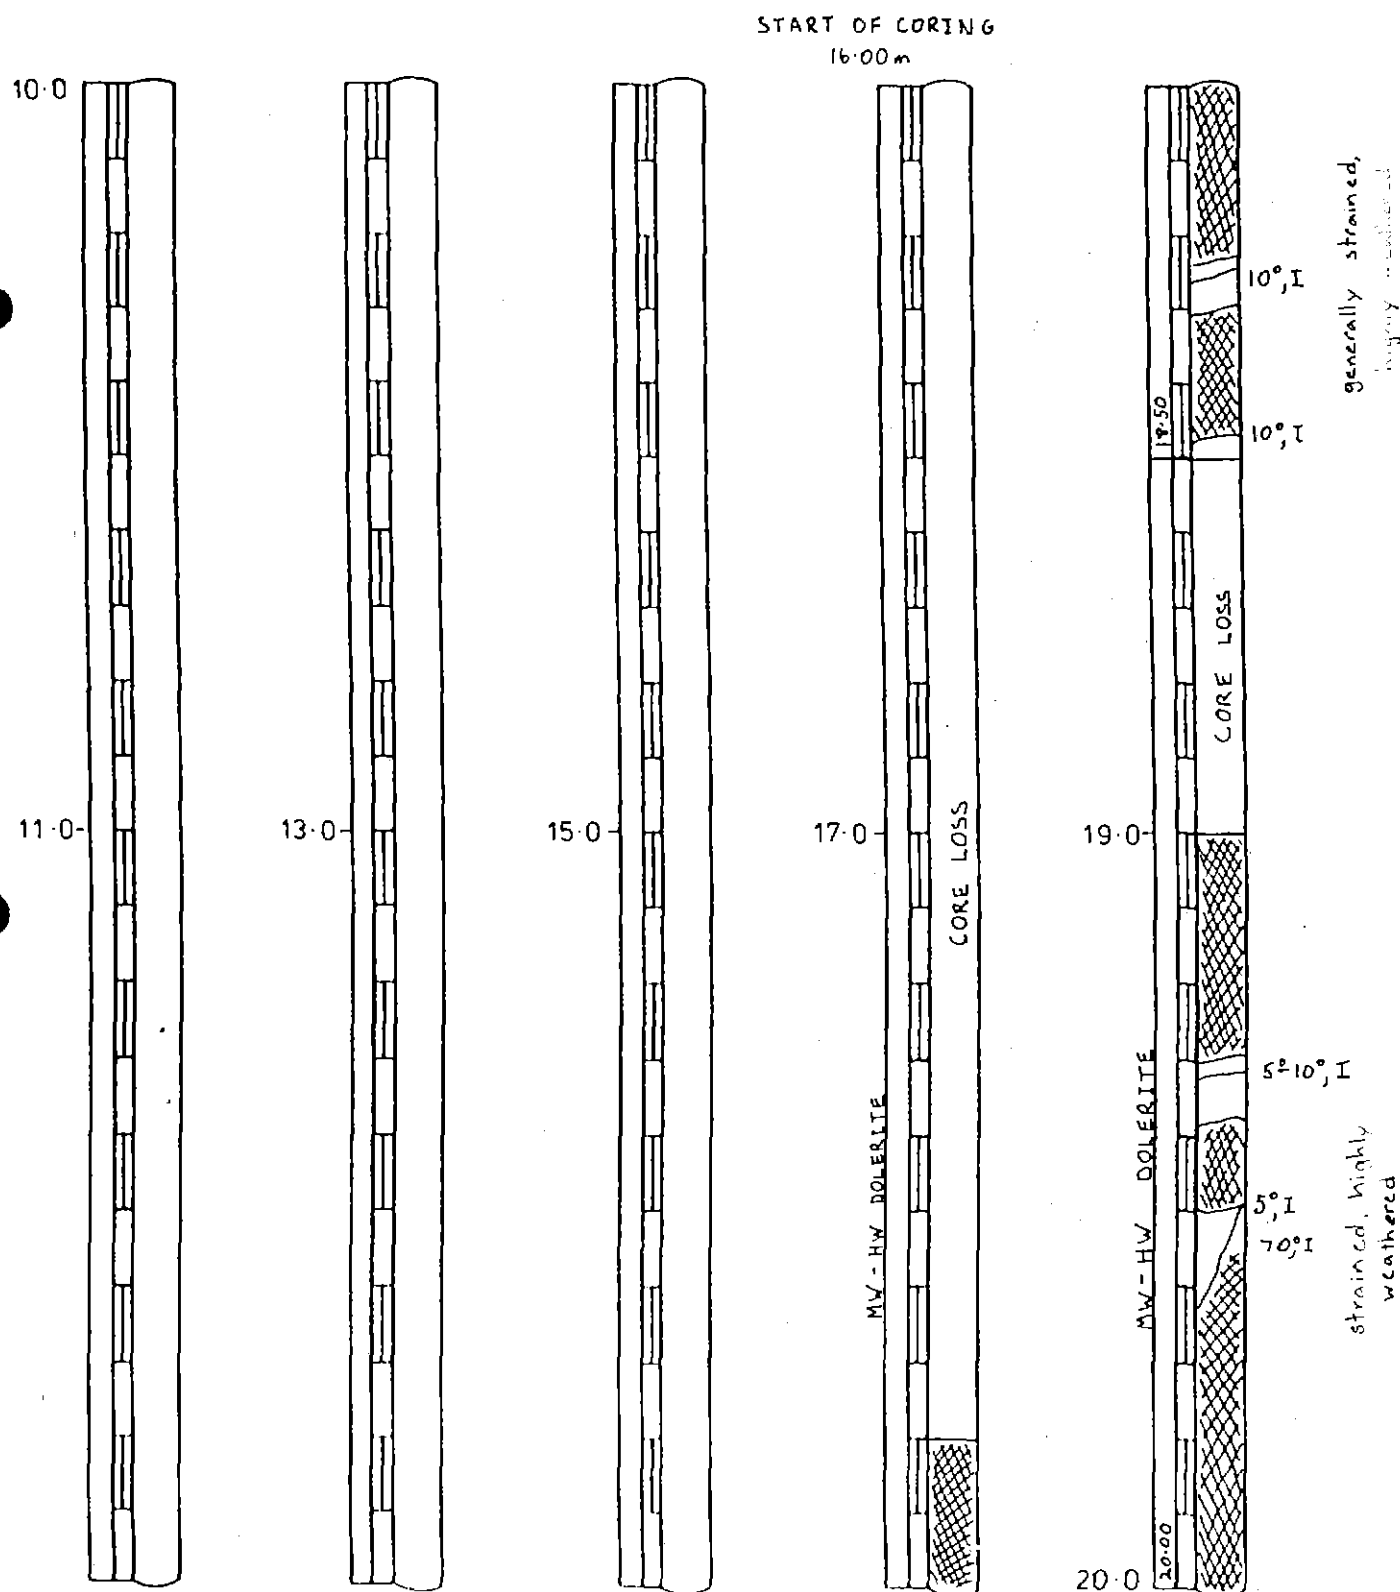
Sheet 1 of 2

graphic defect log

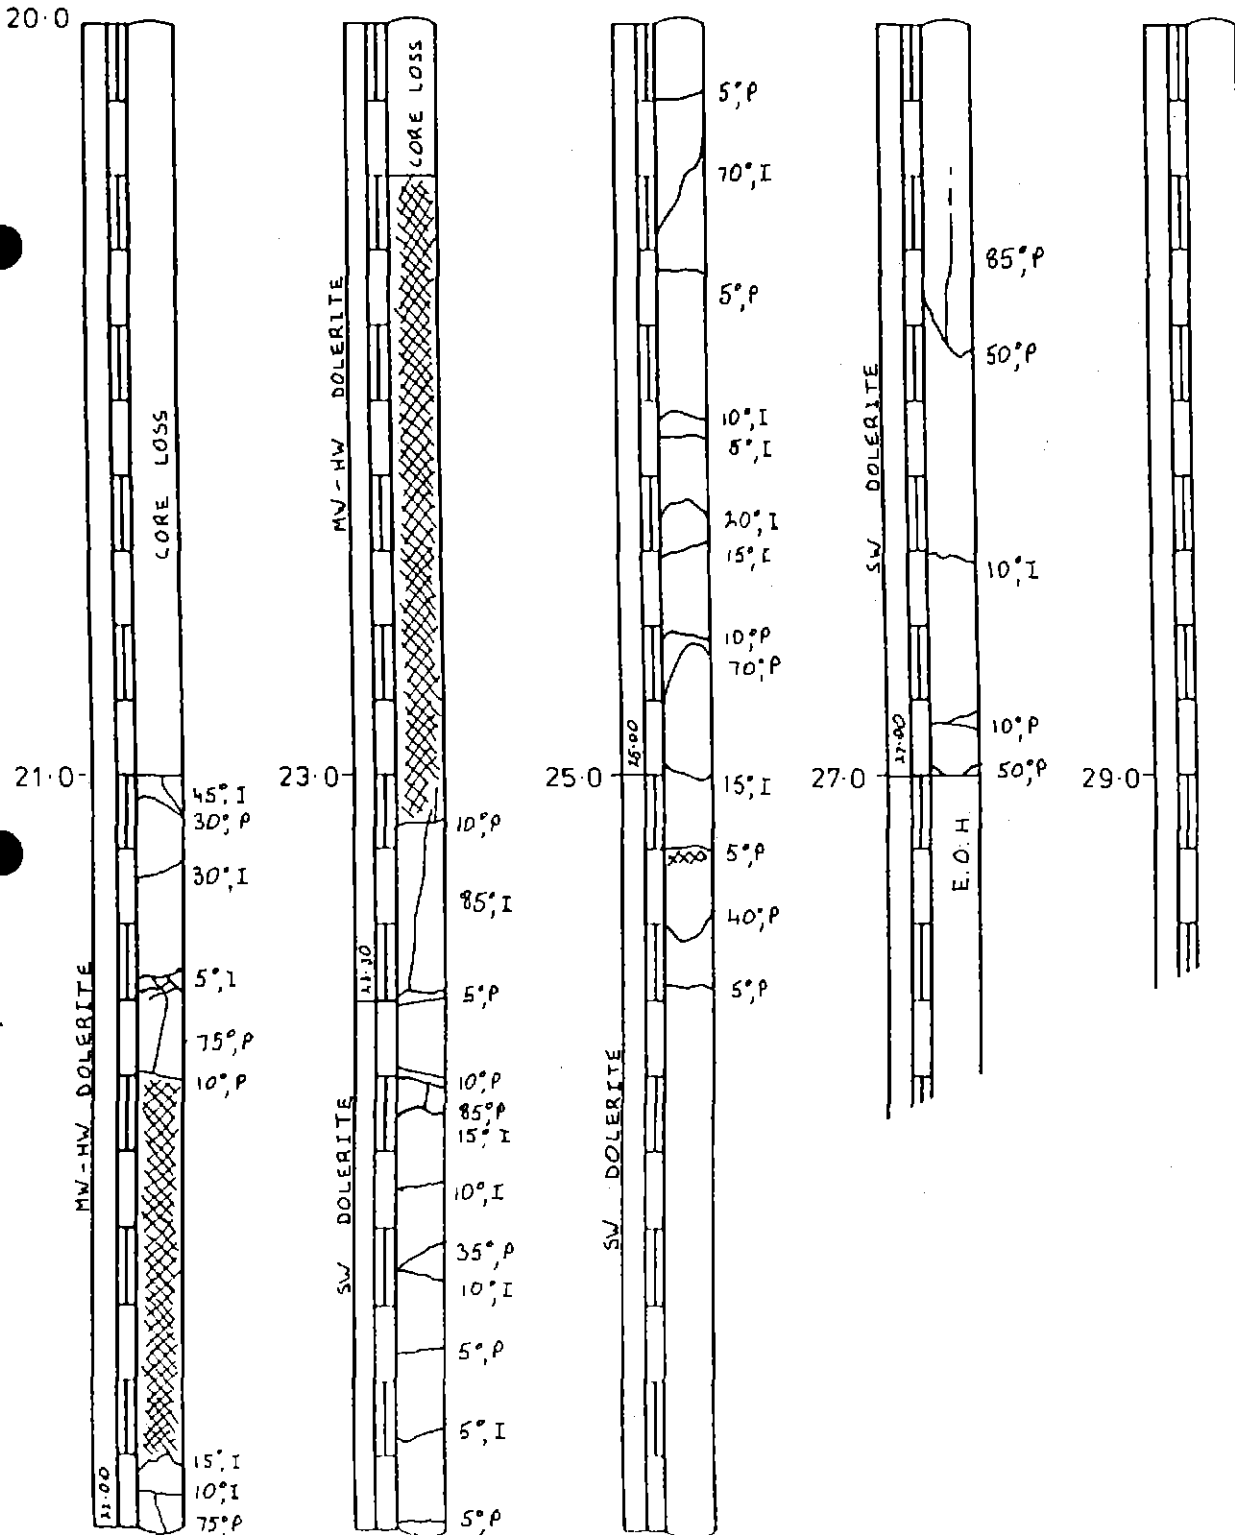
Sheet 2 of 2

graphic defect log

Project: MEANDER IRRIGATION SCHEME Location: MEANDER DAMSITE

Borehole No. 1A
