Thylacine-2

MWD – LWD End of Well Report

End of Well Report for Thylacine-2

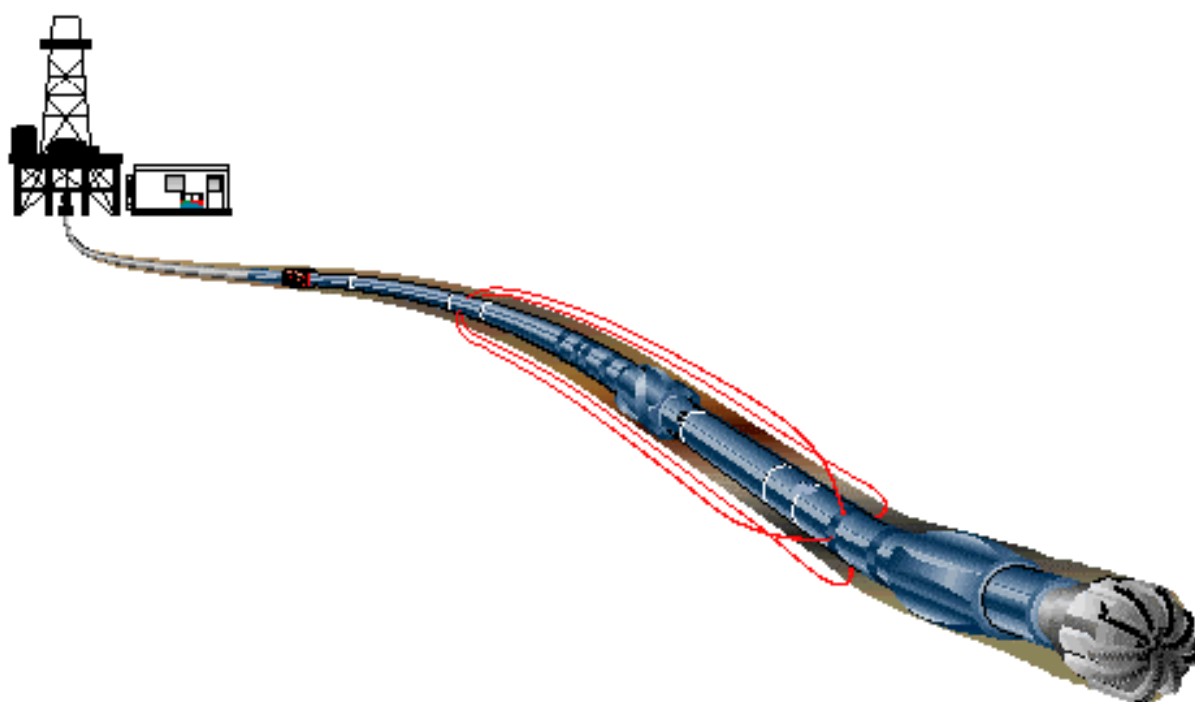
MVC data indicated a very smooth run through the section, with only occasional torsional vibrations and tool shocks.
