## Rehabilitation of Mines 2021 - 2022 Annual Review

Department of State Growth Mineral Resources Tasmania

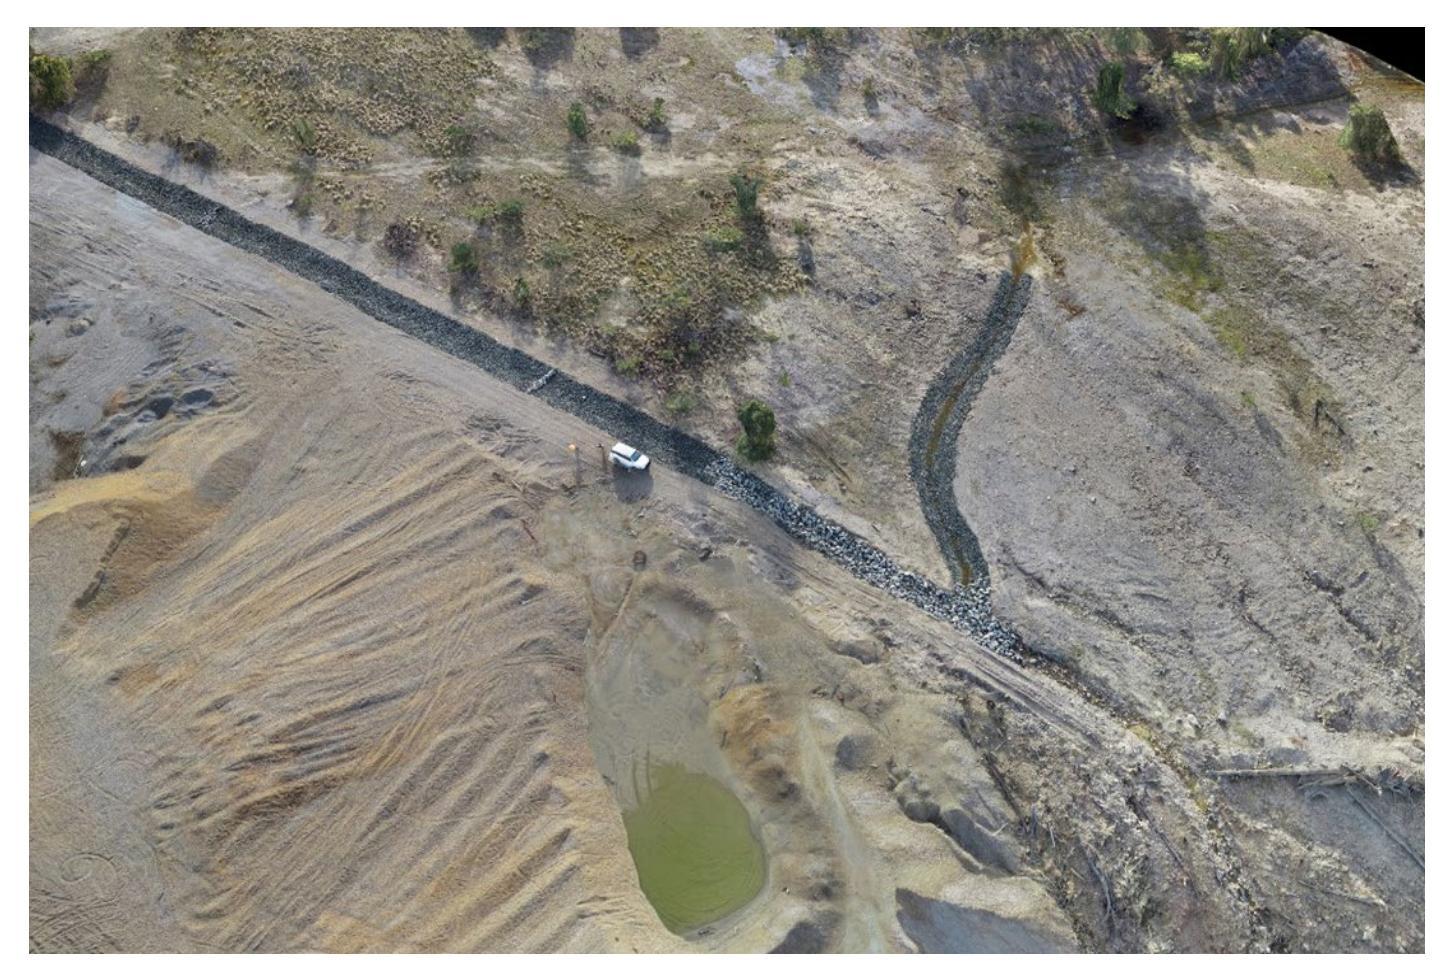
Smaller drain, north of the tailings, with constant flow (September 2021).

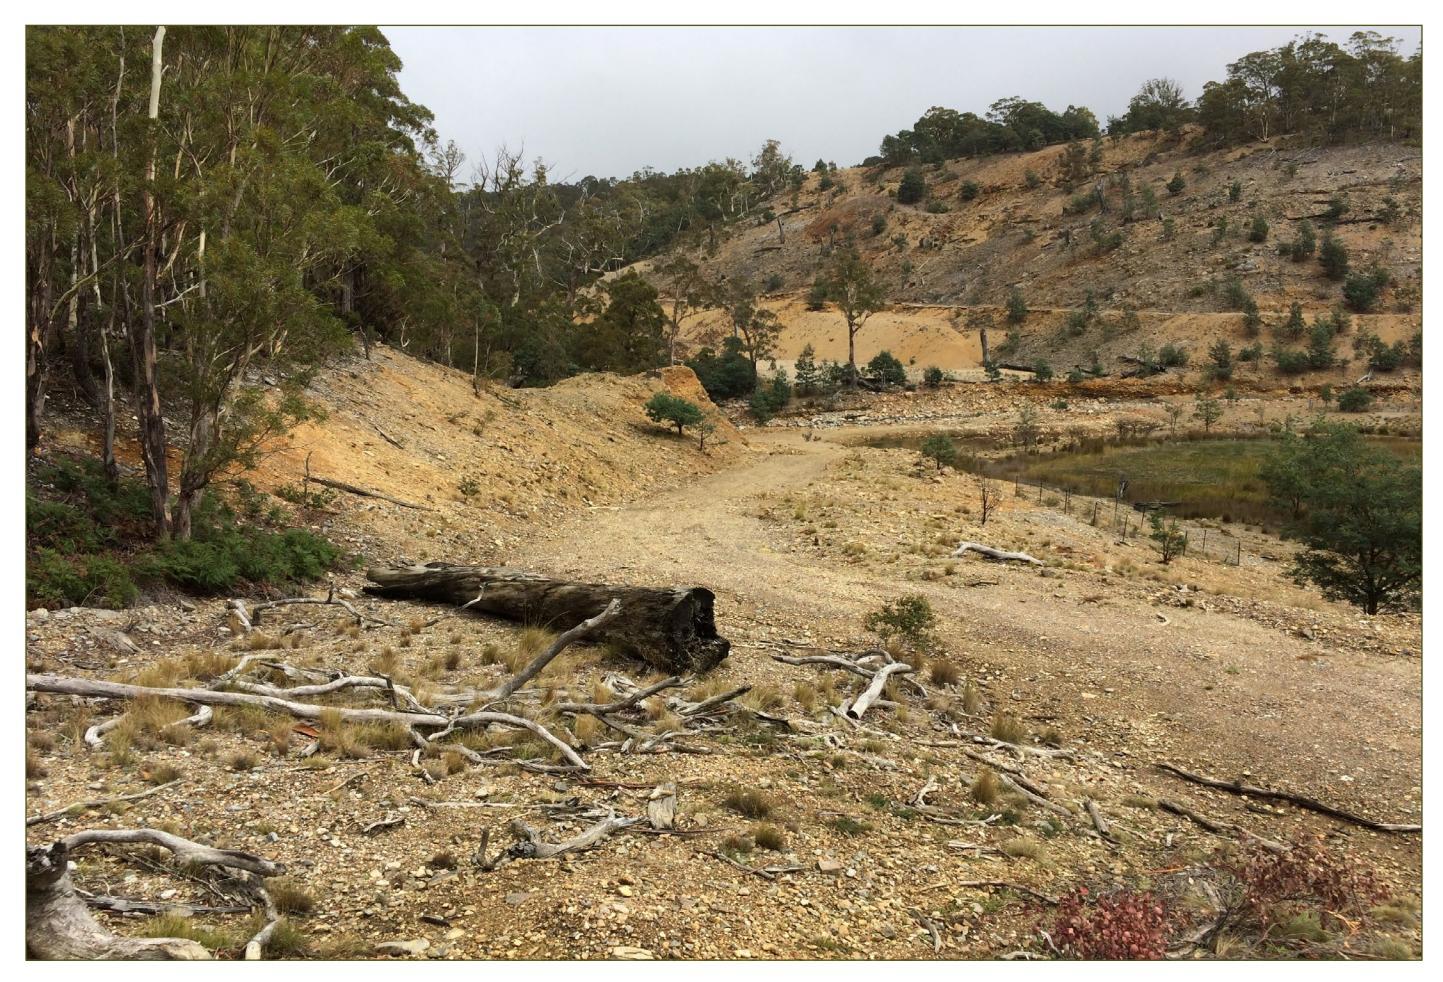
Storeys Creek mine site looking south from the repository dam.

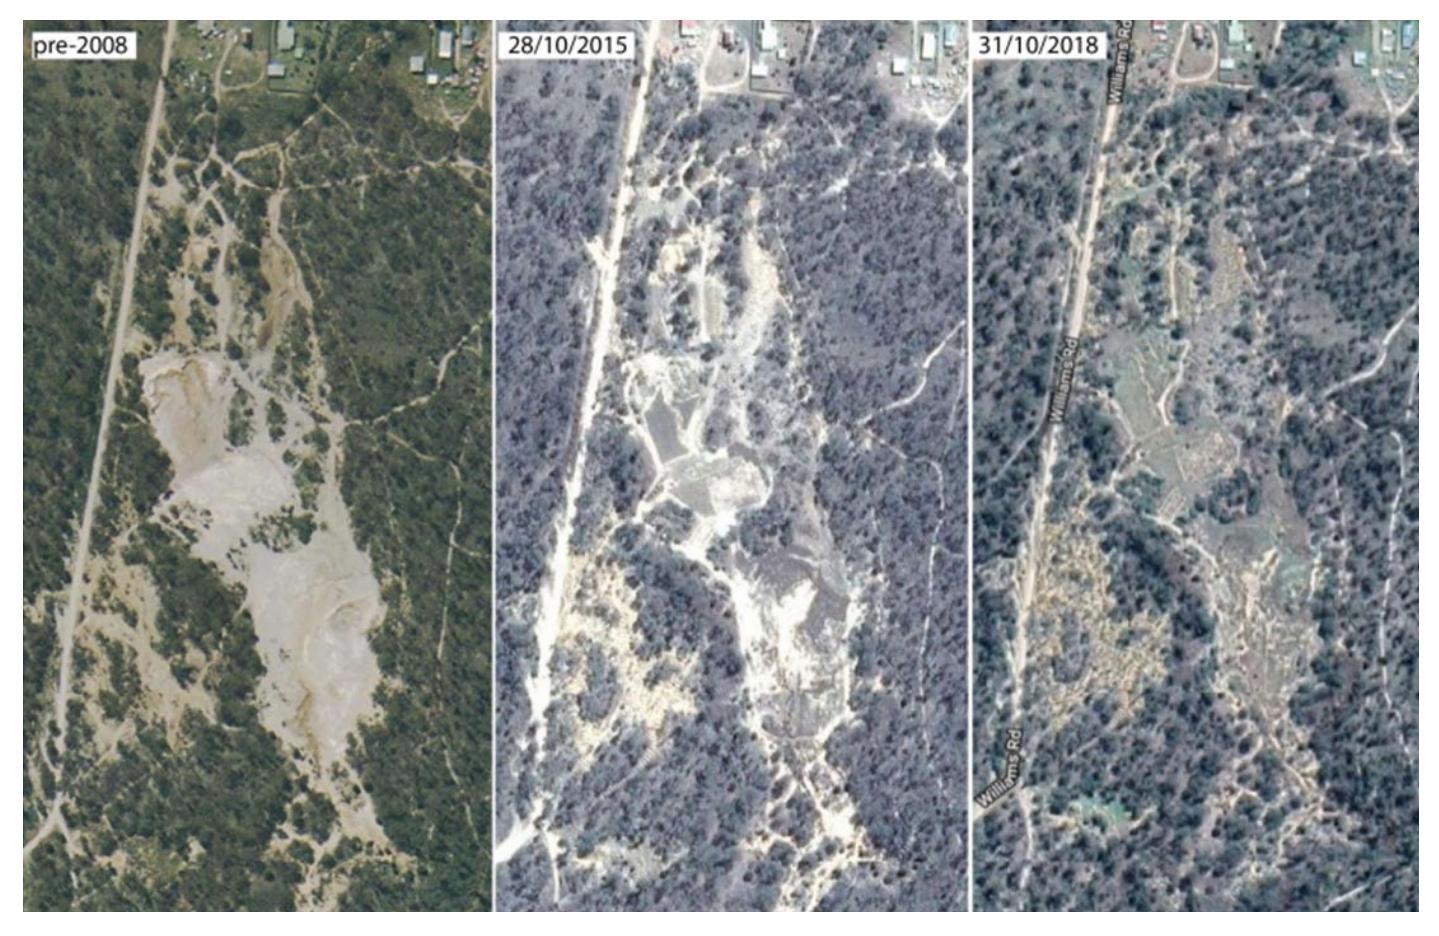
Aerial photography showing the revegetation success at the Royal George Mine.

During 2021-2022, the Environment Protection Agency (EPA) was asked to review the water quality data collected during MRT's management of the site. The EPA suggested that the works completed, including reshaping, revegetation, and fertiliser application have improved the overall site biodiversity and water quality. The EPA suggested that the lime addition in particular has assisted with improvements in water quality and dissolution of metal/oids into the environment. The RTF committee elected to continue lime addition on a biannual basis, most recently completed in May 2022.

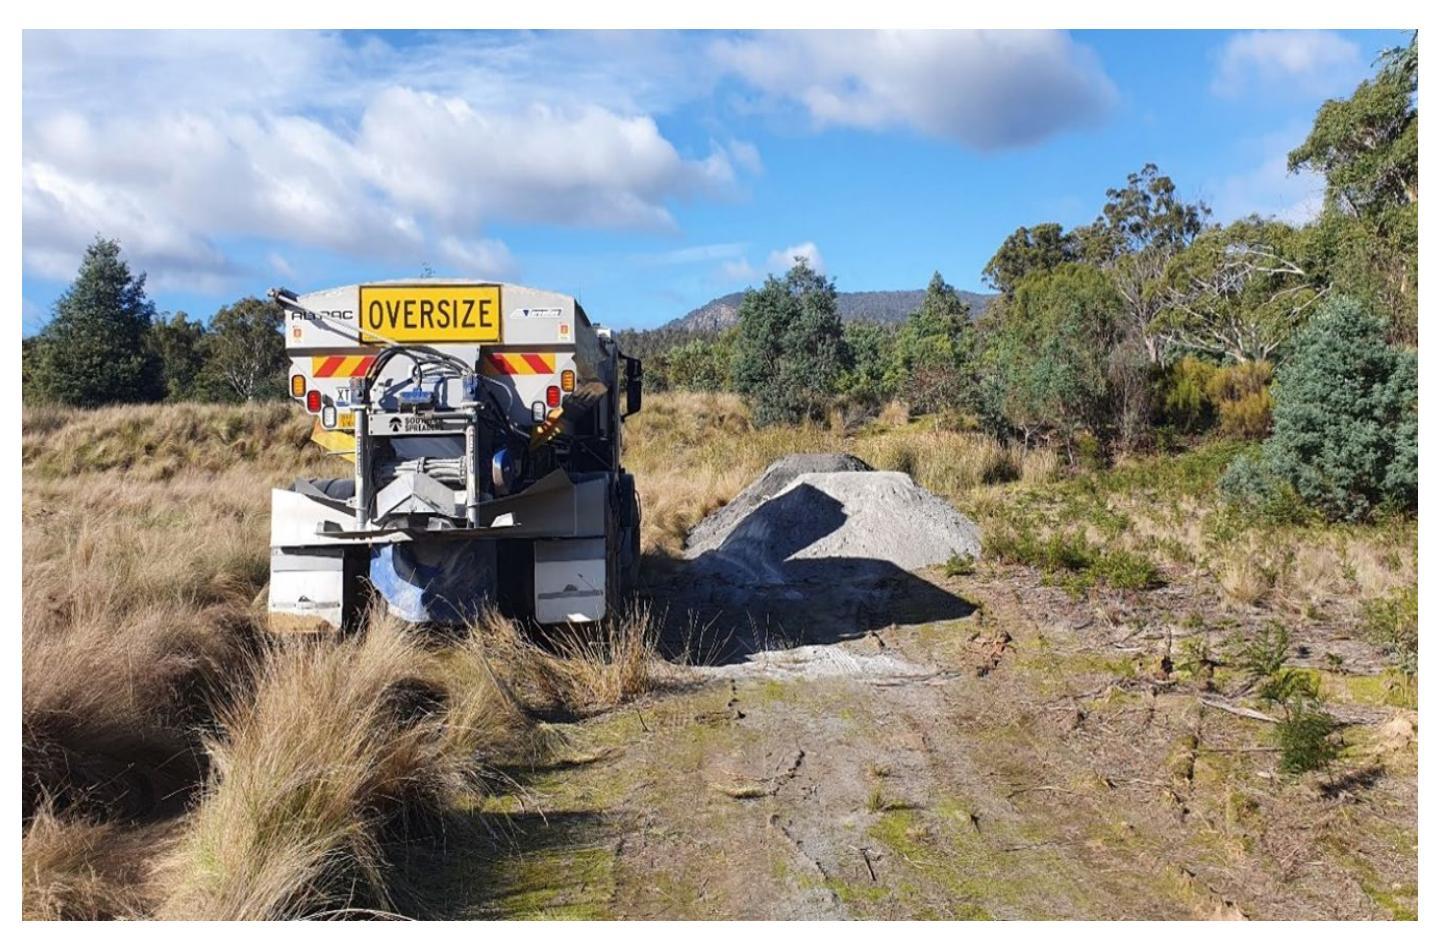
Lime addition occurring at the Royal George Mine.

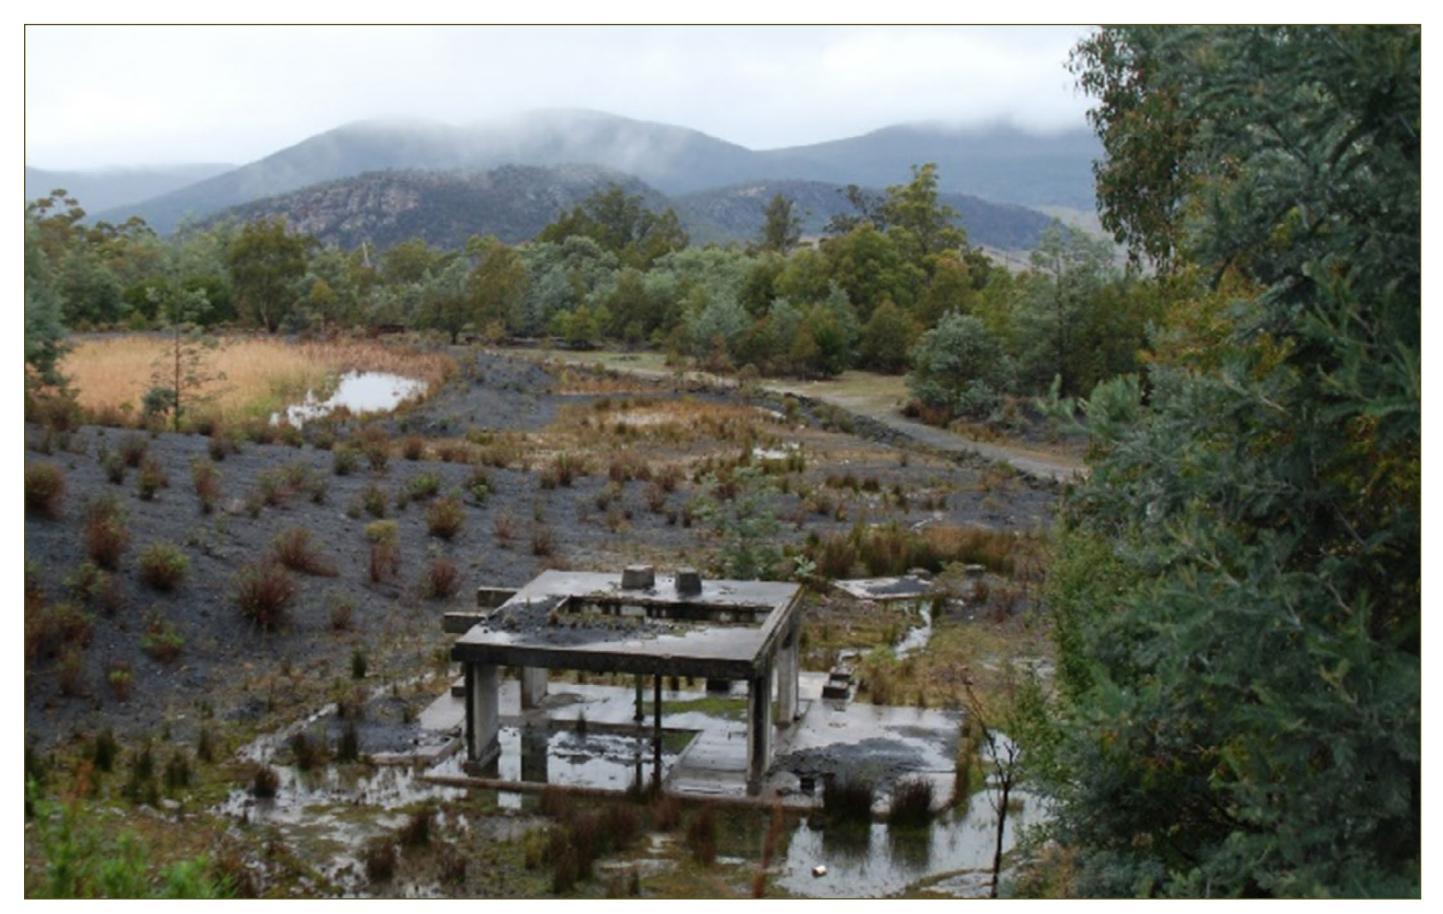
Remaining structures on the remediated Merrywood Mine Site.

Merrywood coal production stopped in 1996/1997. At this time, all plant was disposed of, and the company was expected to go into liquidation. In May 2000, the mining lease (31M/1992) was revoked, and the RTF remediated the site in the following years. The site has been stable and self-sustaining since the remediation.

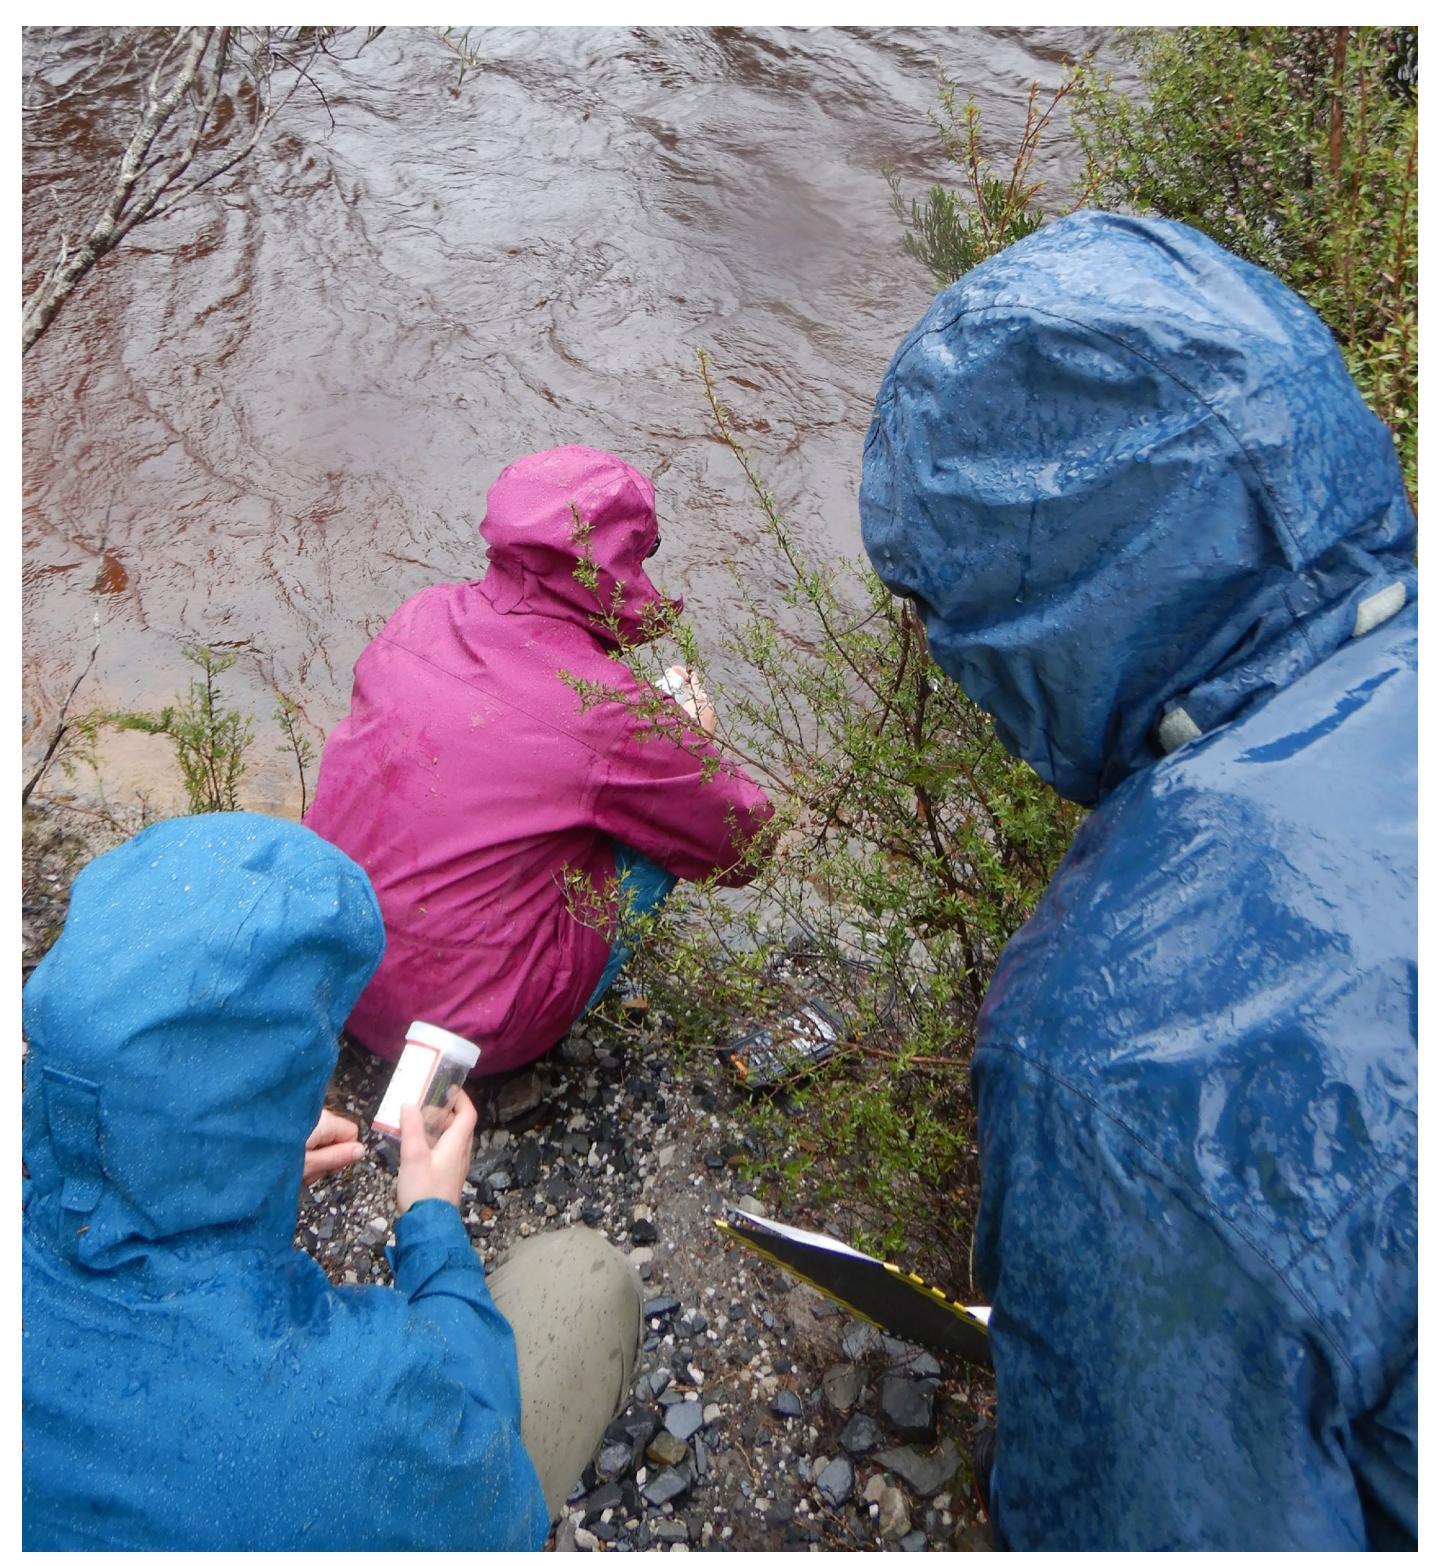
Water and sediment samples being collected in 2020 at the Frankland River downstream of the site.

The samples for the toxicology testing were collected on the 13th April 2022. Water samples were also collected to be analysed for physical properties, metals, and bulk properties. The samples collected in the Frankland River, downstream of the central Balfour shaft, did not exhibit any toxicity.

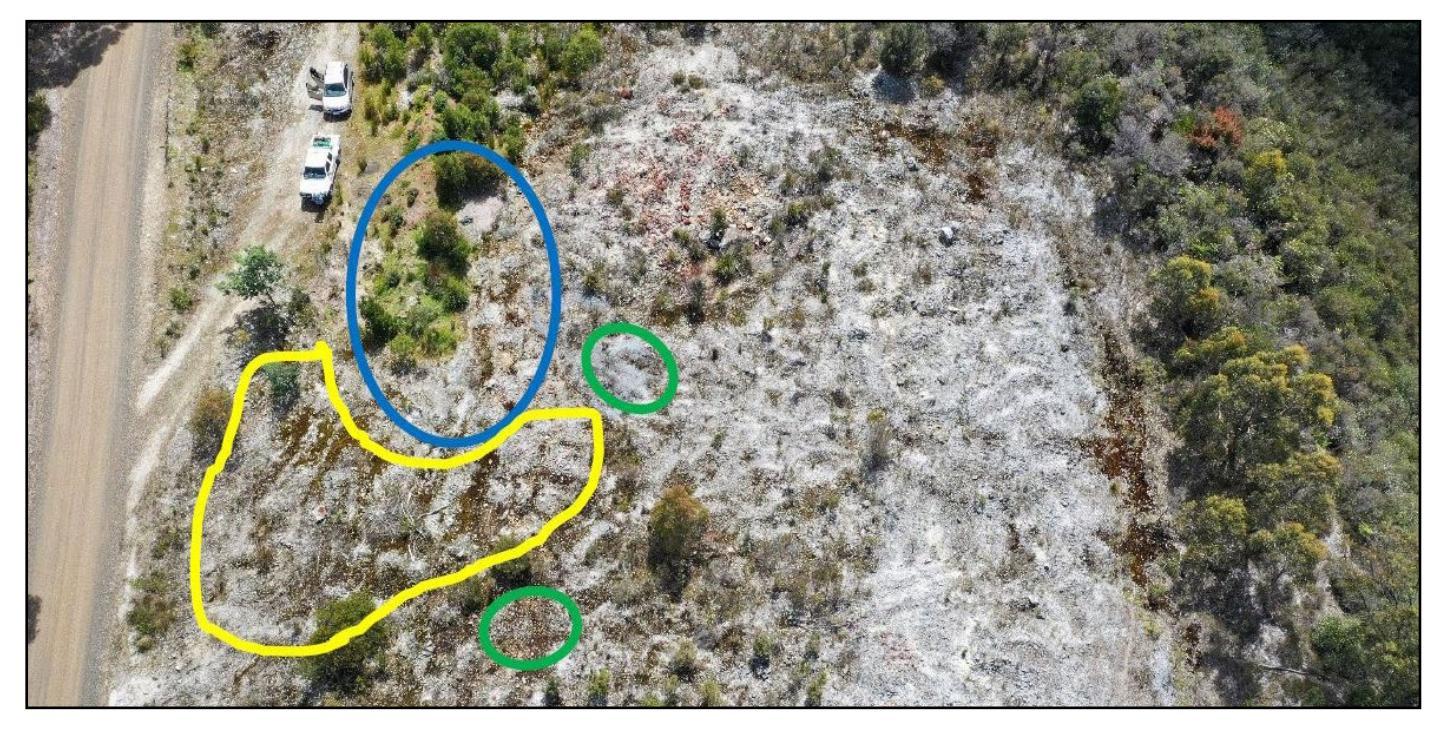
Locations of revegetation trials (Yellow - Hand Seeding, Blue - Translocation of Poa Grass, Green - Brush Matting).

Revegetation trials in June 2021 explored three different revegetation techniques: Hand seeding, translocation of Poa labillardierei (Silver Tussock Grass), and brush matting. A November 2021 inspection of the recent revegetation work determined that the hand seeding has germinated well in most of the pre-scraped areas and amongst some of the brush matting. Additionally, the planted Poa labillardierei appears to be growing well.

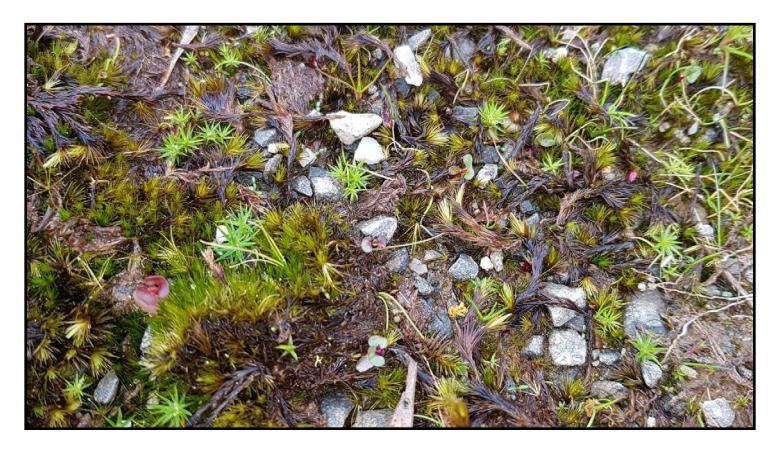
Germination evident in hand seeded areas.

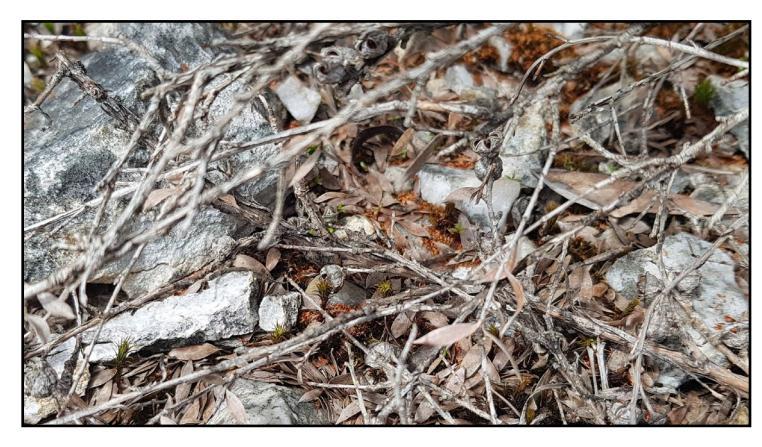
Some germination evident near brush matting.

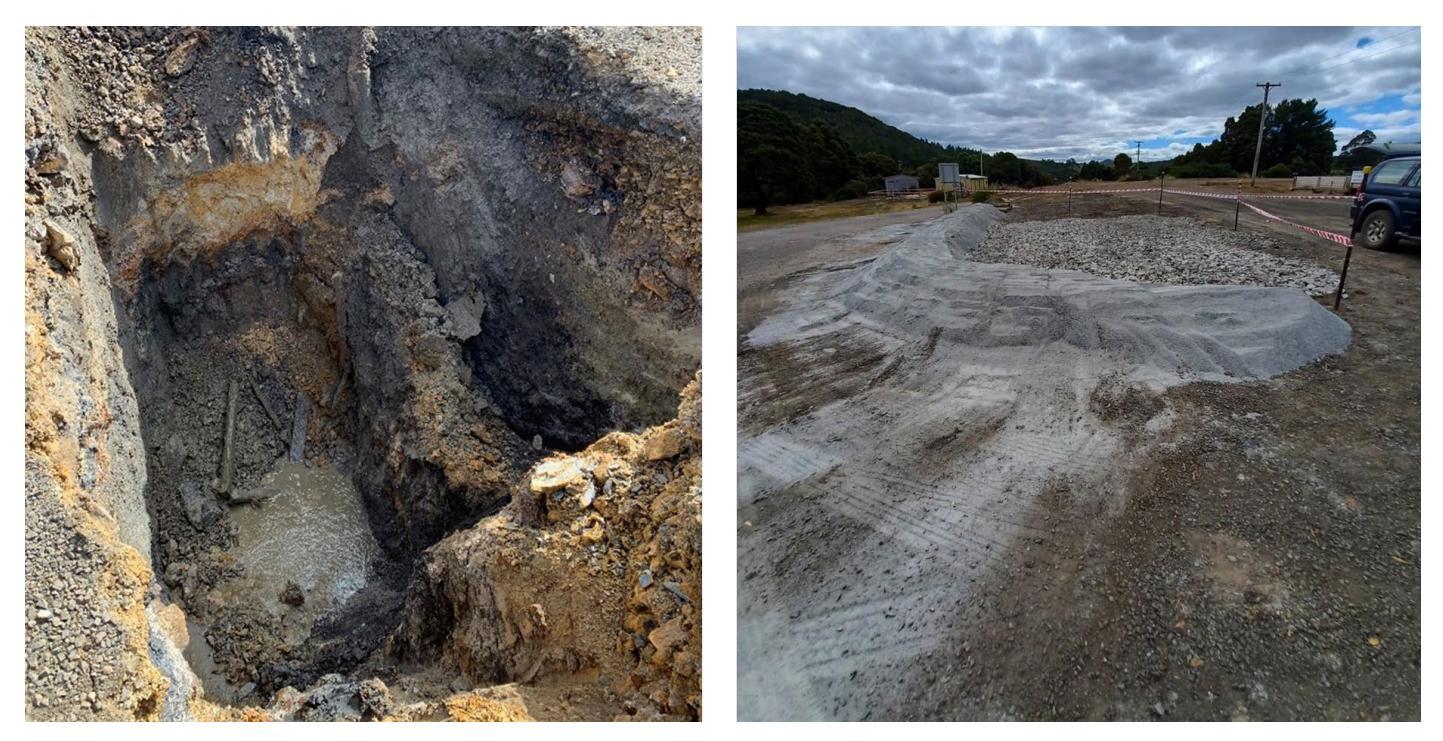
MRT identified that the areas of subsidence mapped at the Zeehan Golf Course correlated to old mine workings at the former Argent Mine. The areas of subsidence prioritised for repairs, as part of the 'shafts and adits' program, were determined to be a risk to public safety.

Trenching and repair of subsidence in the vicinity of the Zeehan Golf Course.

In March 2022, five sites were repaired at the Zeehan golf club, with each area excavated until hard material was encountered. The holes were backfilled, compacted, and levelled out. MRT staff were on-site, supervising, for the duration of the works.

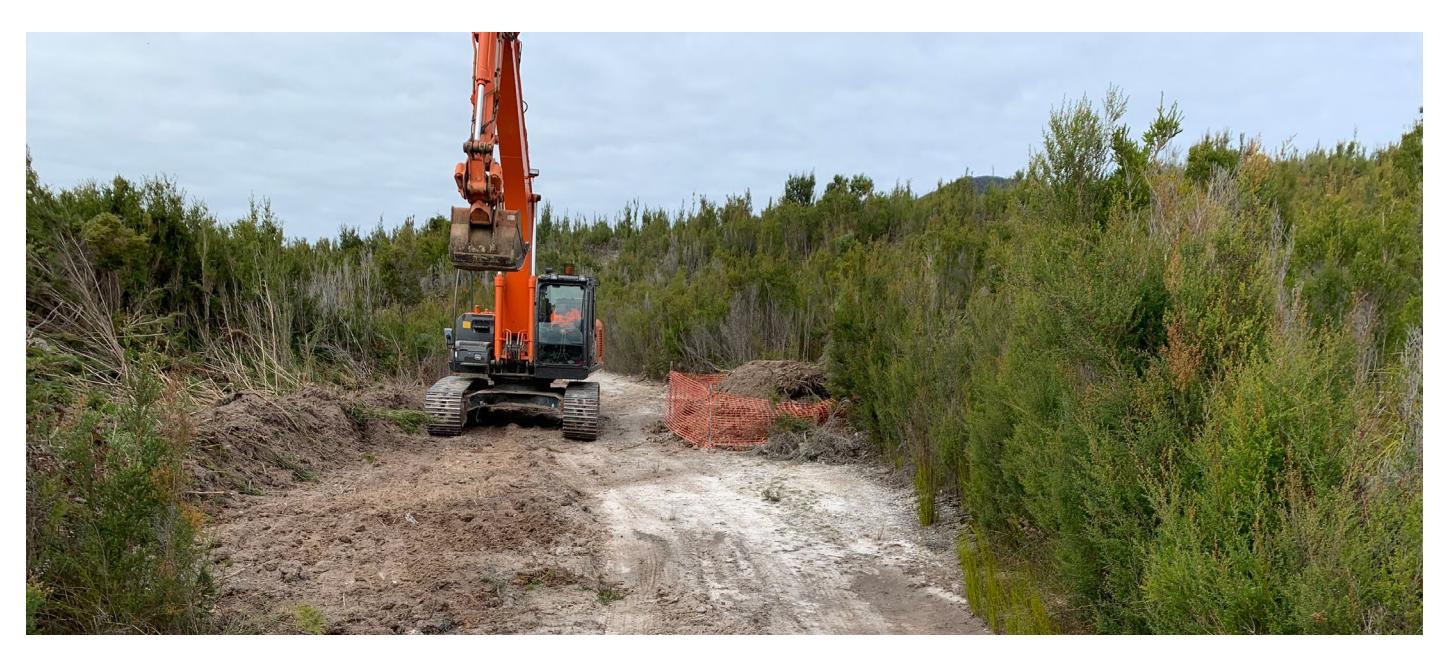
Parks and Wildlife Service (PWS) reported an area of subsidence on the Zeehan Fire trail, which is an important part of fire mitigation activities around the Zeehan township. A site visit, conducted by MRT, indicated that the subsidence was likely a result of historic mining activities. The area of subsidence was repaired in March 2022 and the fire trail was widened to ensure that any further subsidence does not impact future fire management activities.

Widening of the Zeehan Fire Trail and backfilling the area subsidence.

All works will be inspected regularly as part of ongoing rehabilitation management.

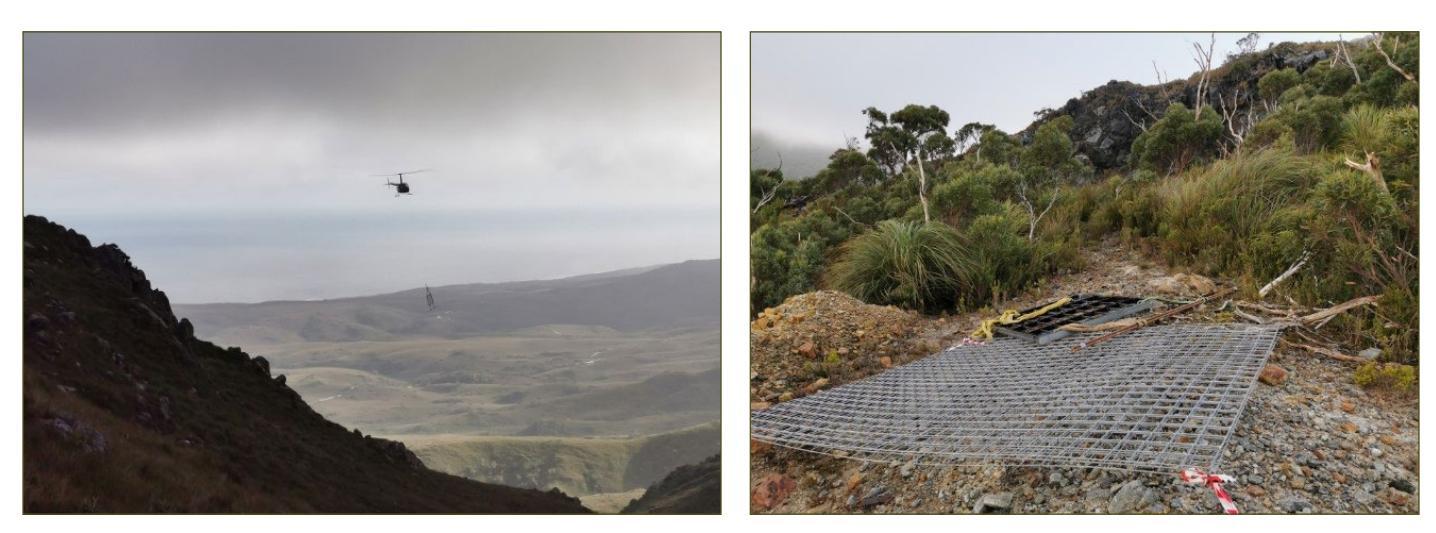
Air lifting equipment and materials to be stored on site.

The project has been contracted, with materials air lifted into the site and ropes laid for safety while installation of the shaft and air rise cover is installed, however, poor weather has delayed the completion of the project. The project will likely be completed in late 2022.
