PLATE: 2.

Geophysical Survey  
for  
Goliath Portland Cement Co.  
Railton, Tasmania.  
Resistivity Survey

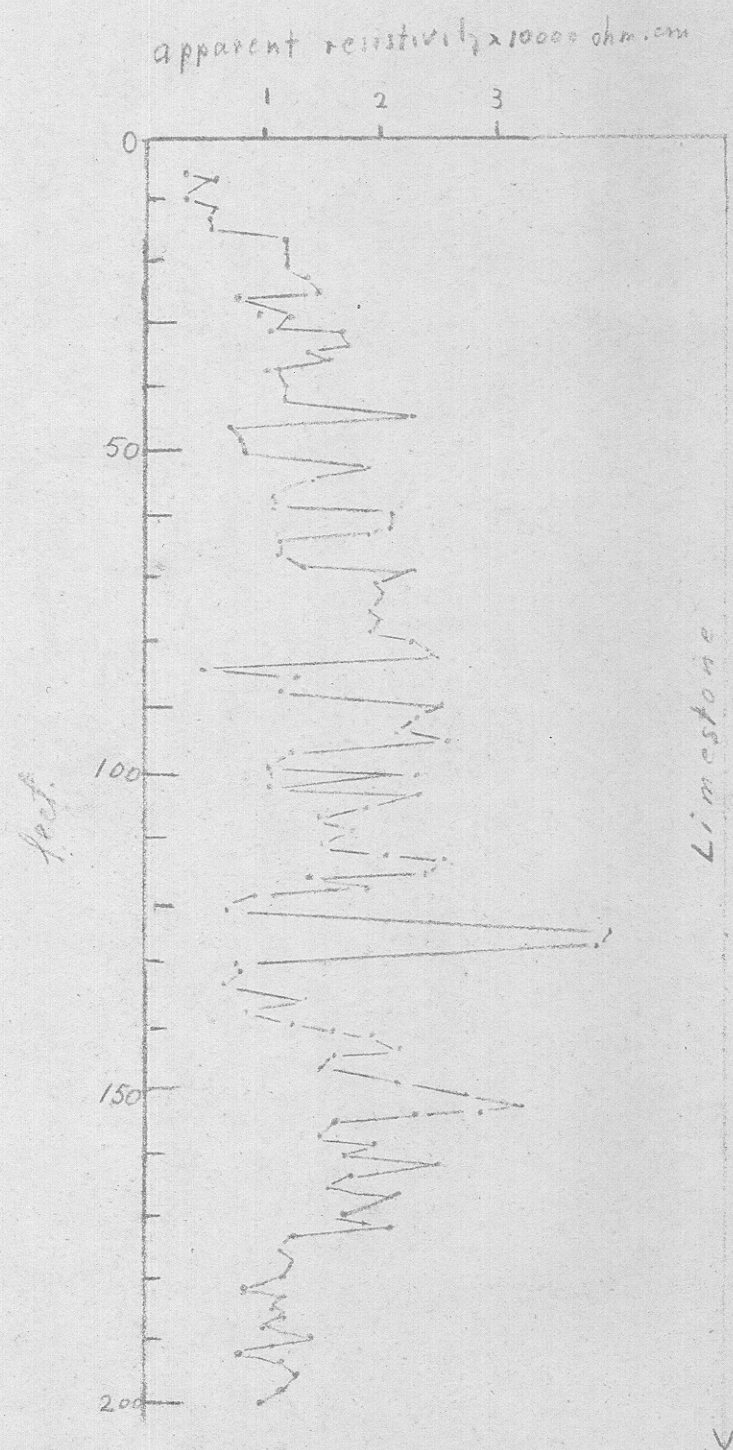
Fig. 2.

Three electrode Resistivity log  
Drill hole at bottom of quarry.

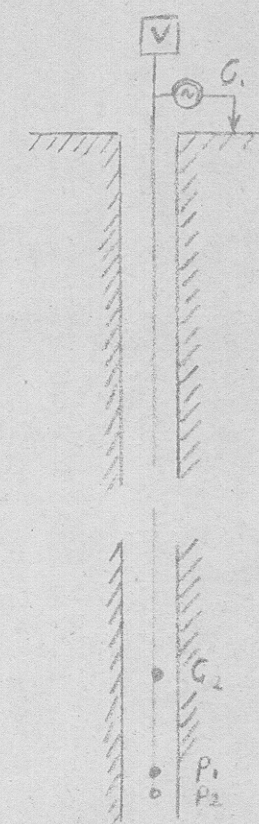
Fig. 3.

Electrode Arrangement.
