AMBLESIDE SUBDIVISION DEVONPORT TEST PITS

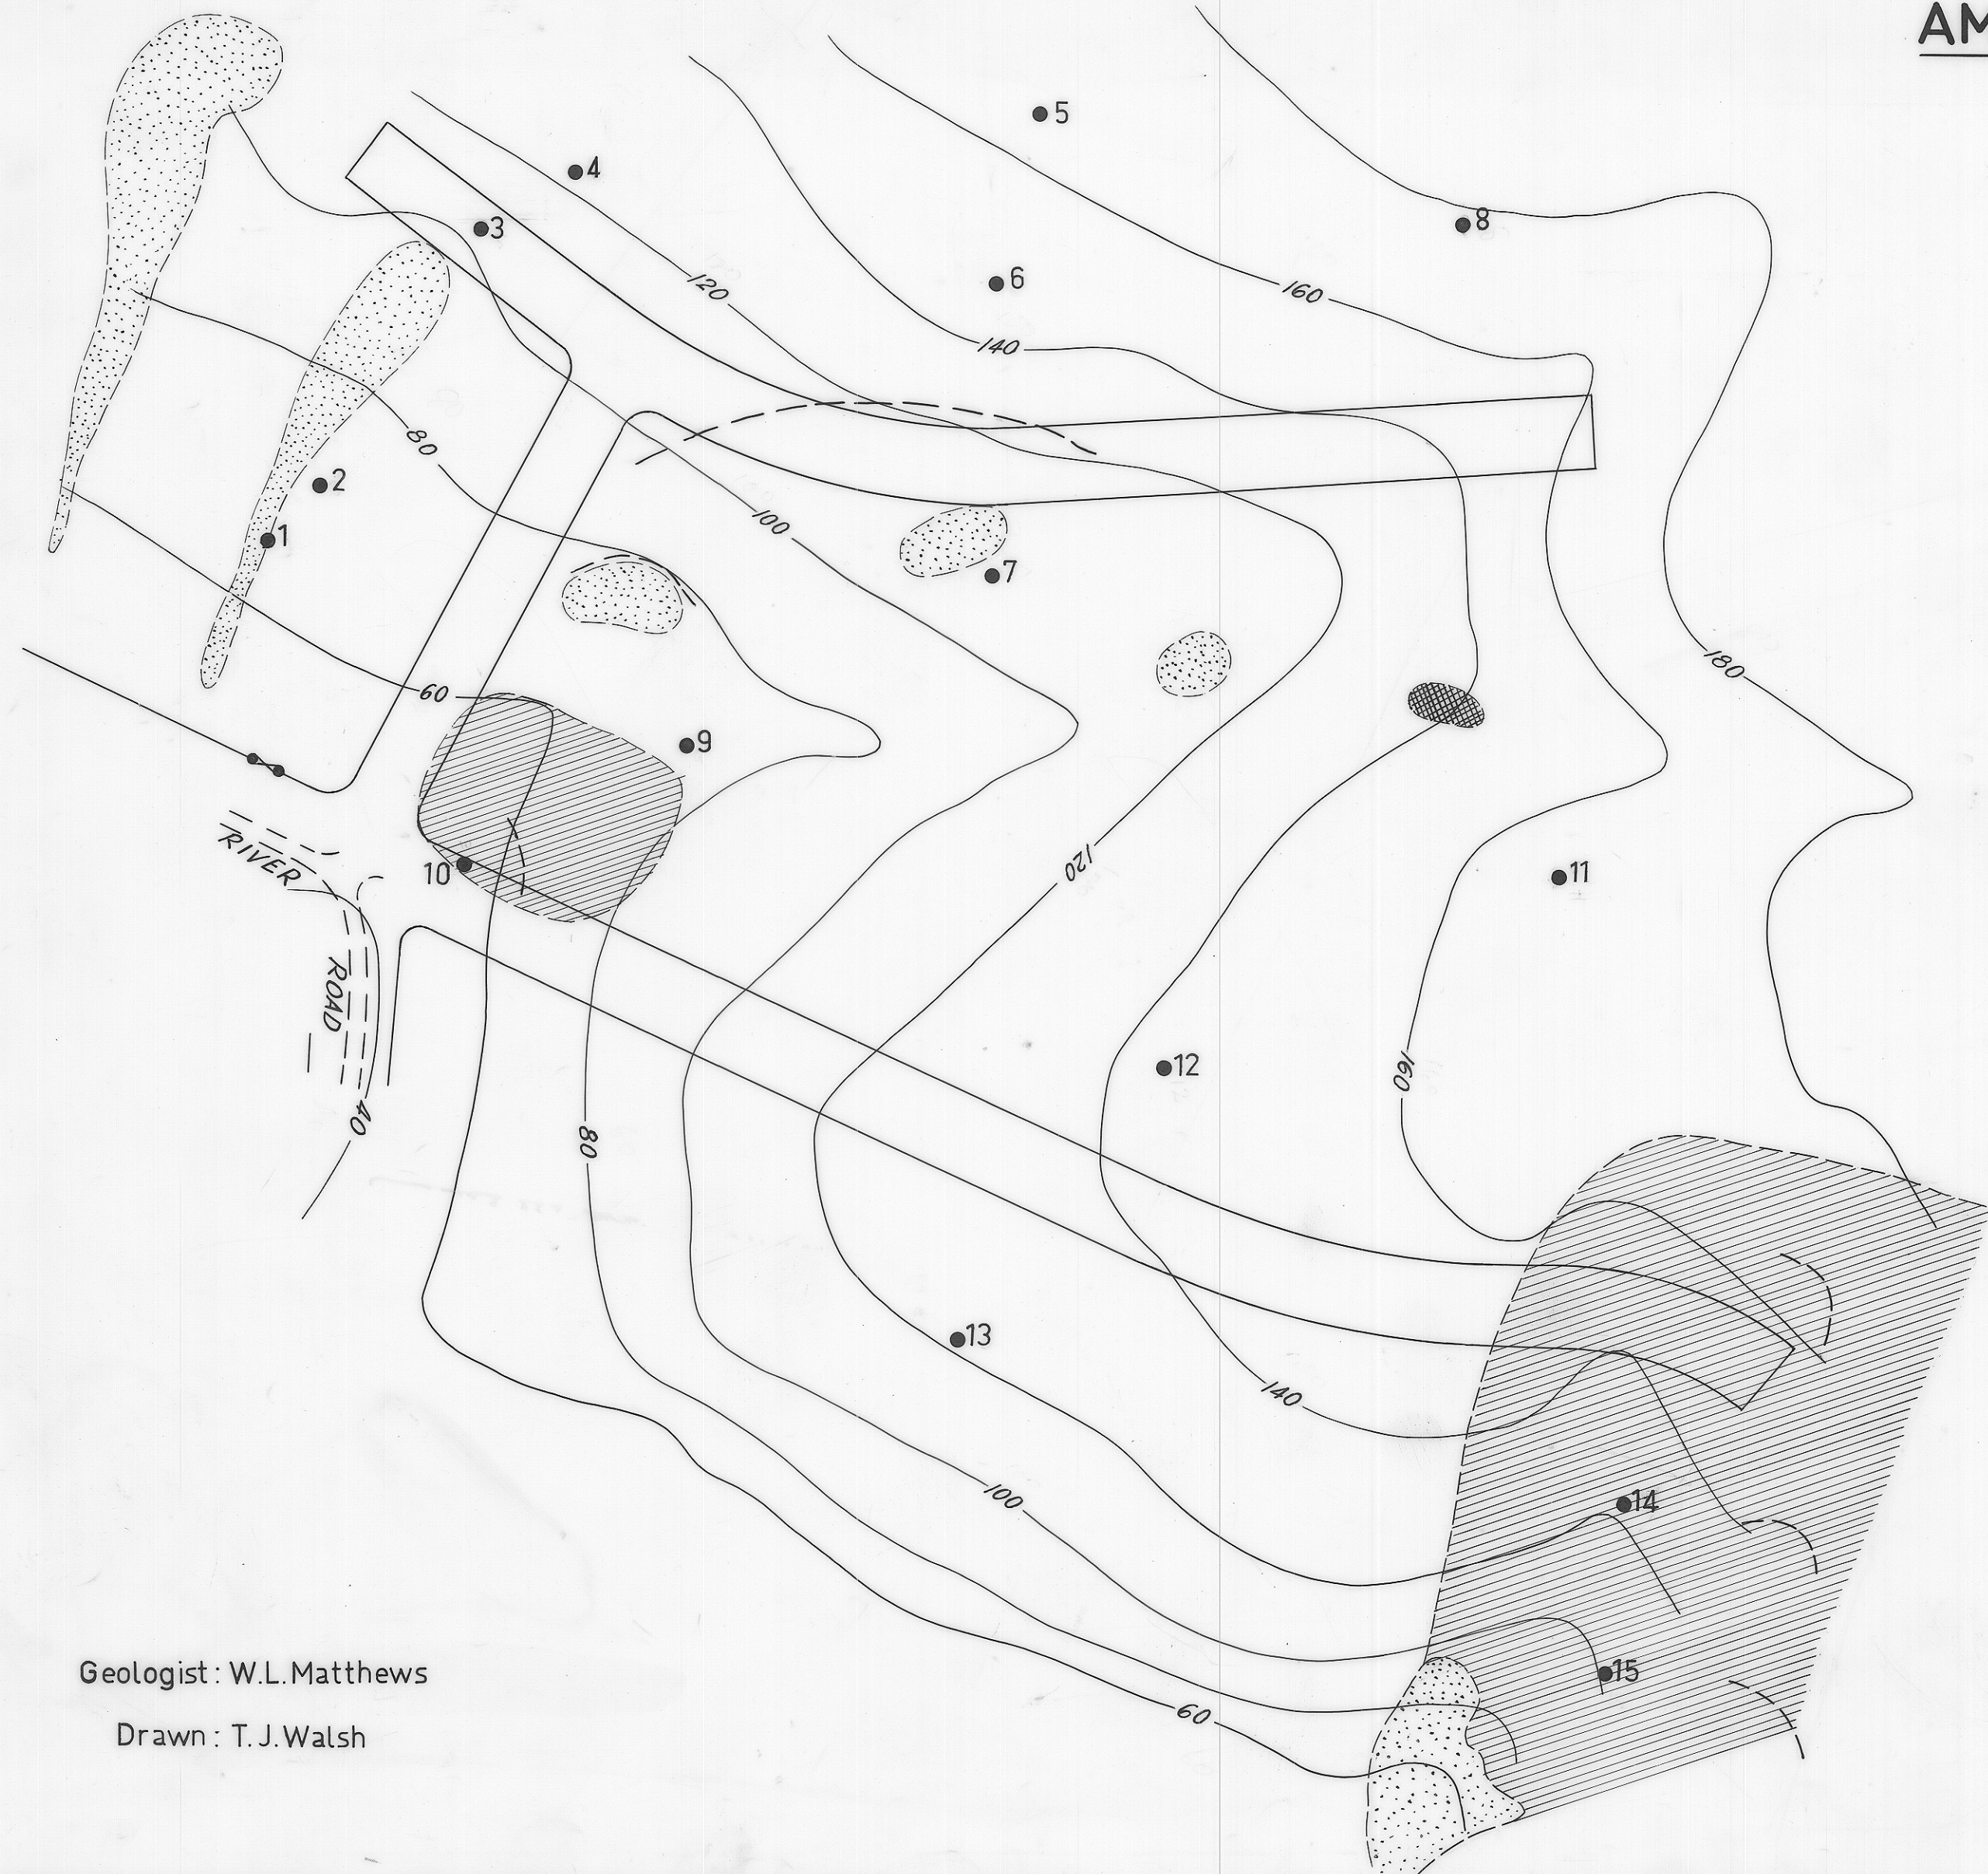
3367 B

- 2 Test pit position & No.
-

Seepages
-

Breaks in topography
-

Dolerite outcrop
-

Areas in which development is not recommended
- Contours in feet
