R548 — HOT WATER TANK & HEATING ELEMENT SHEATH — Figure 2

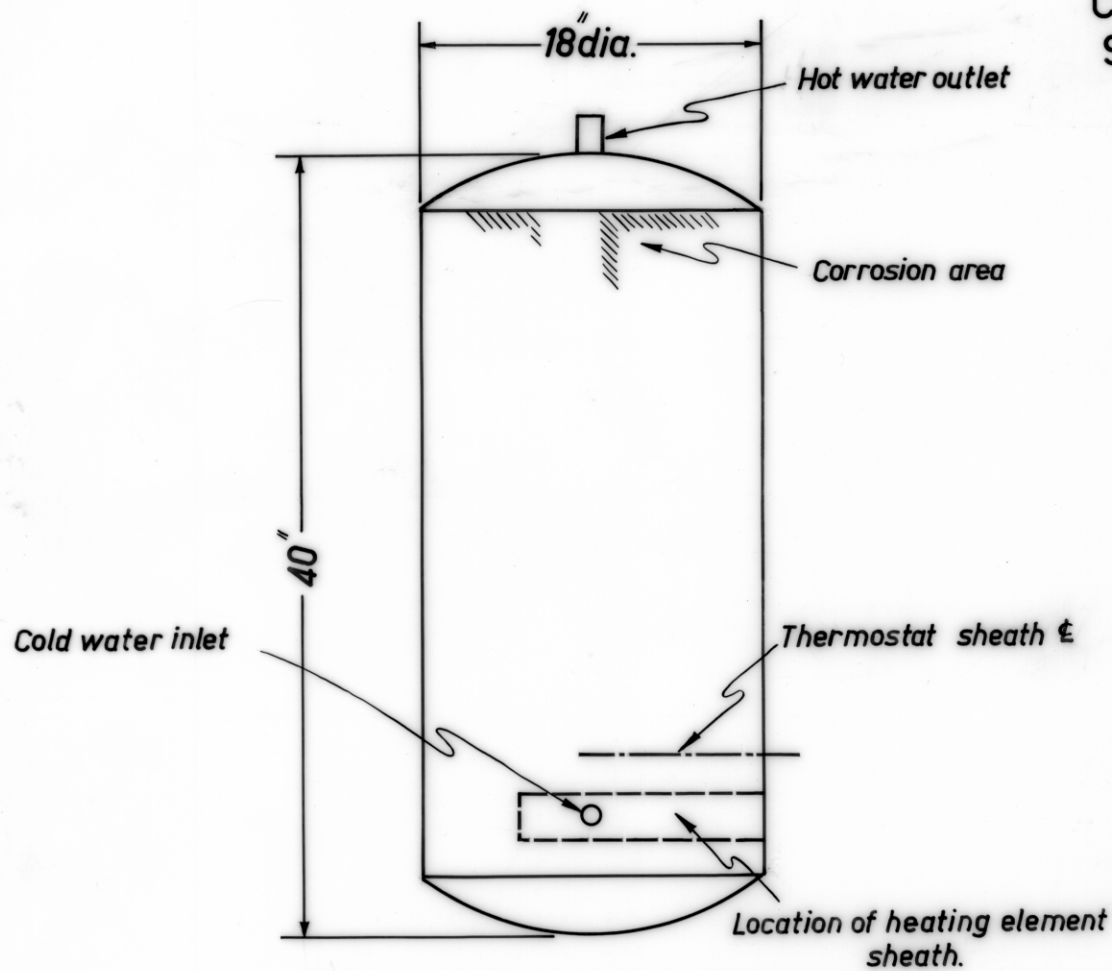
VIEW OF HOT WATER TANK SHOWING LOCATION OF PARTS & CORROSION AREAS ON TANK.

CROSS SECTION OF SHEATH SHOWING CORROSION ZONE.

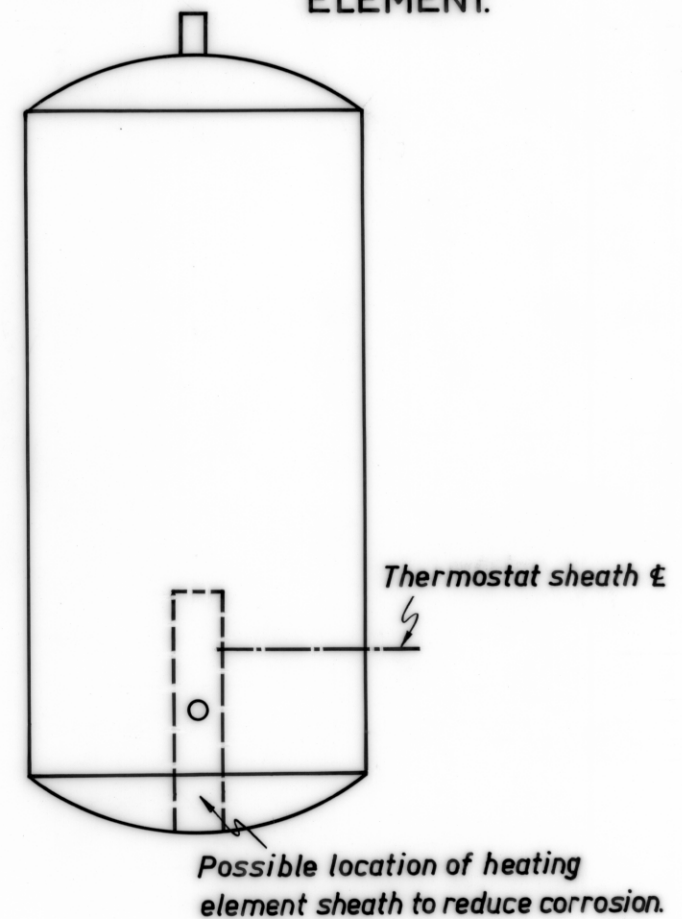
VIEW OF HOT WATER TANK SHOWING POSSIBLE LOCATION FOR HEATING ELEMENT.
