R710-MAGNET TAILING DAM

DEPARTMENT OF MINES - 4047

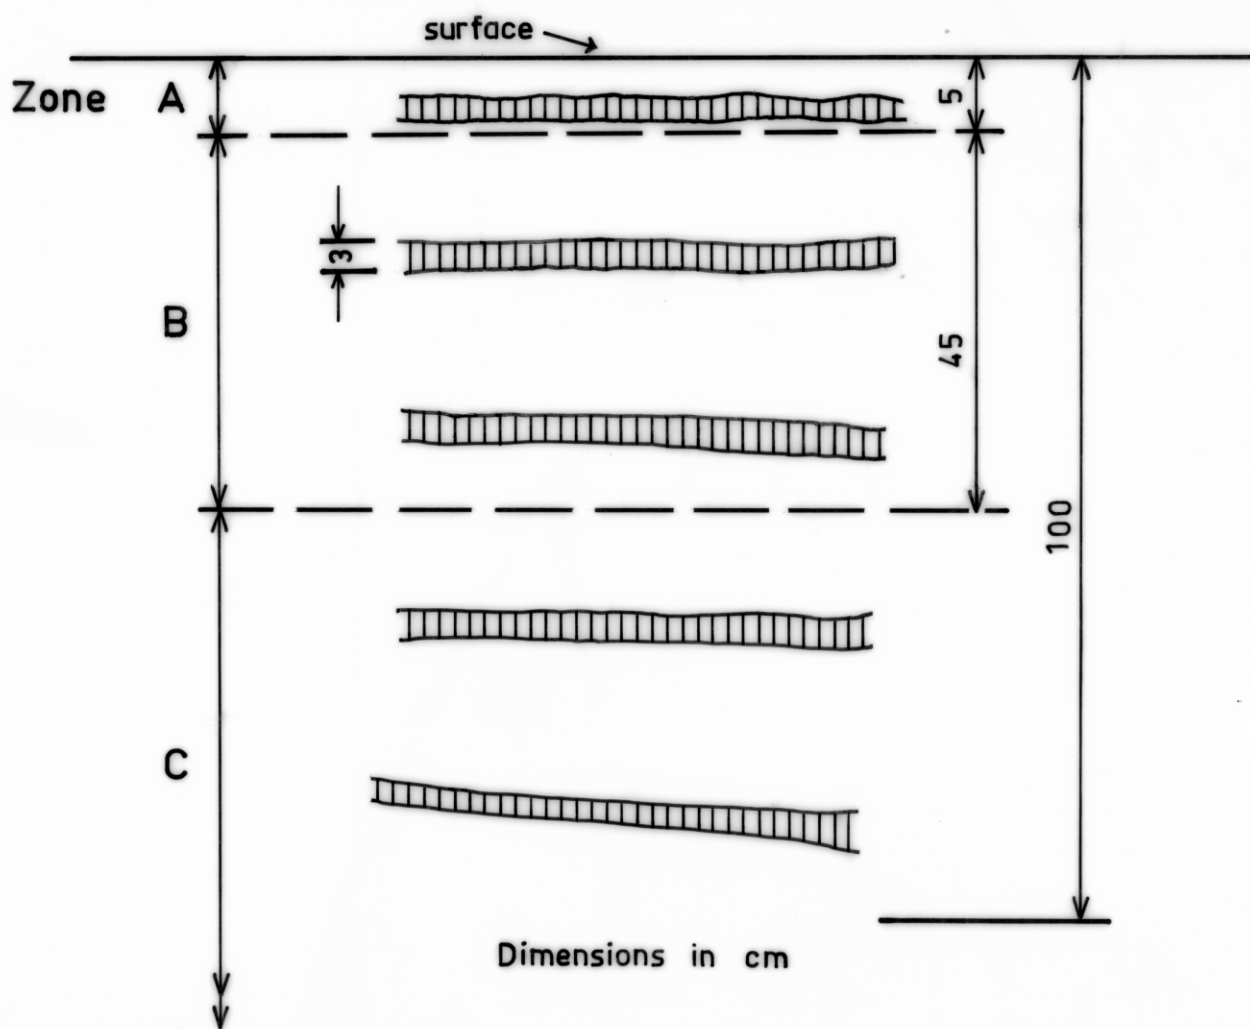
Cross-section through Magnet Tailing Dam showing:

Zone A - very dark weathered top (5 cm)

Zone B - brownish stained, not as weathered as 'A' down to 50 cm

Zone C - below 50 cm no brown staining which indicates weathering

▣▣▣▣ - bands of coarse stones relatively free of fine material.

These bands were spaced through the normal tailings which were much finer in size.
