GROUND MOVEMENT AT CASUARINA CRESCENT GLENORCHY

Geologist : P.C. Stevenson
March 1976

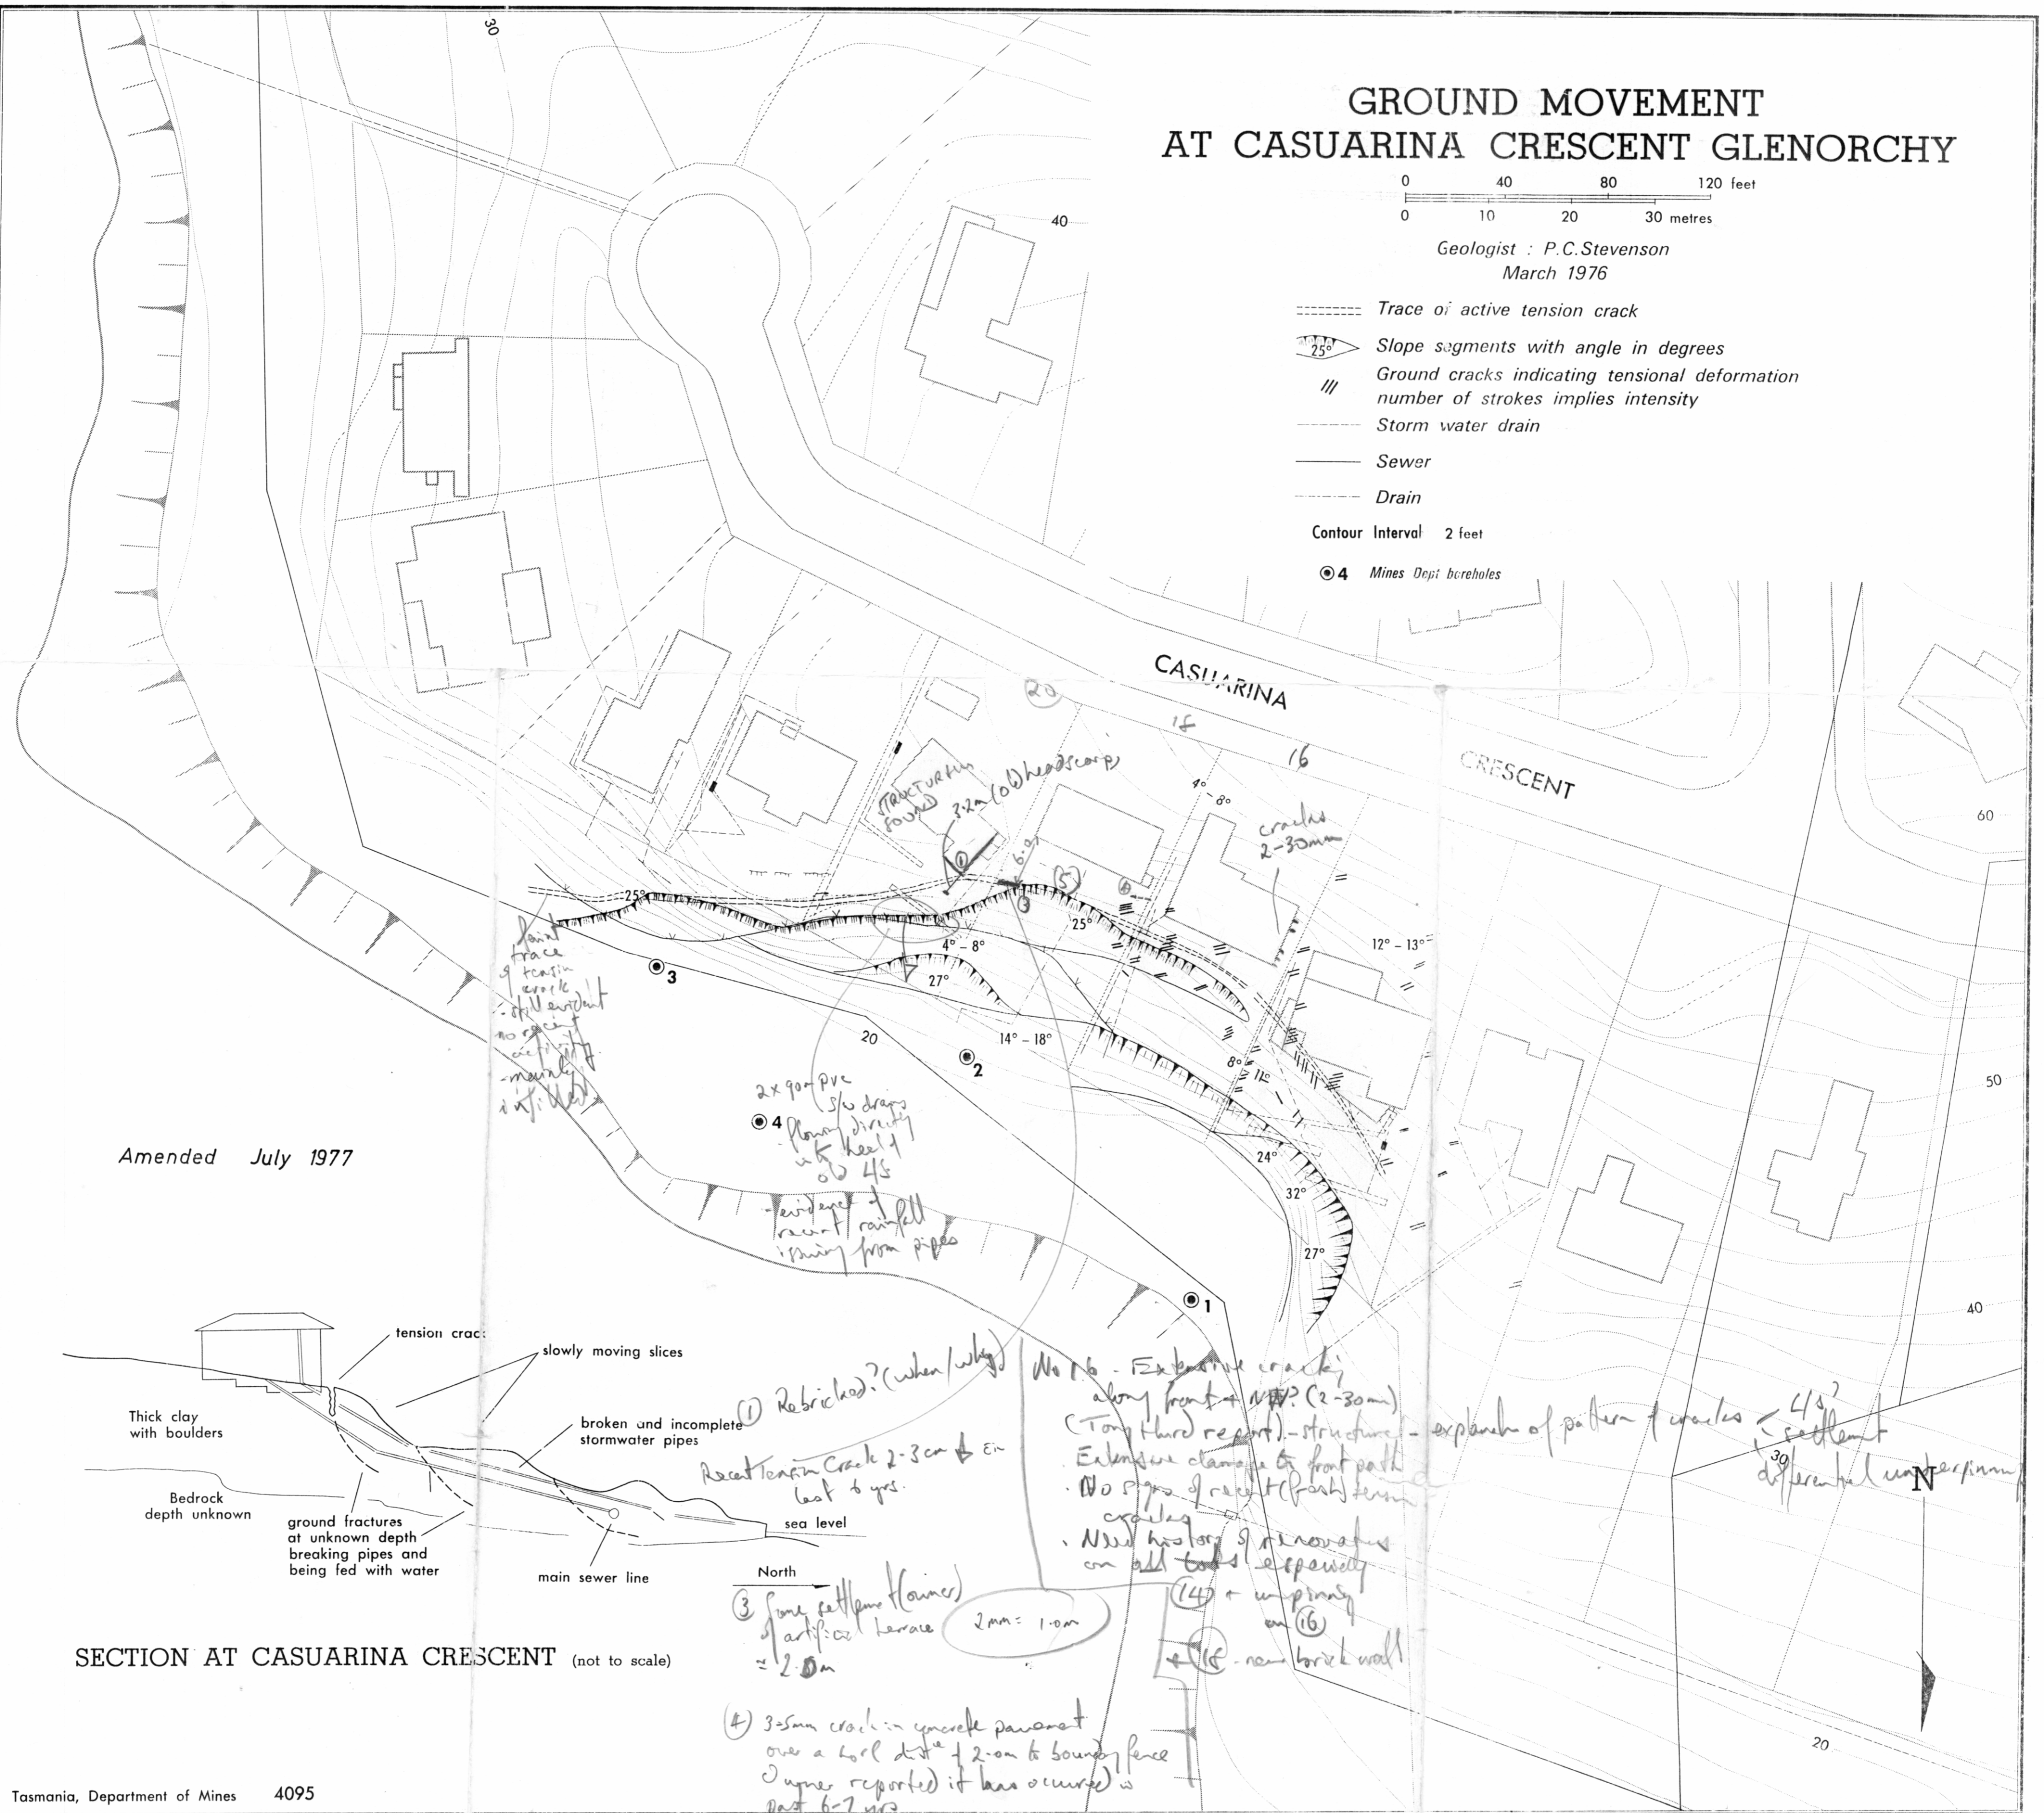
- Trace of active tension crack
- 25° Slope segments with angle in degrees
- /// Ground cracks indicating tensional deformation number of strokes implies intensity
- Storm water drain
- Sewer
- - - Drain
- Contour Interval 2 feet
- ⊙ 4 Mines Dept boreholes

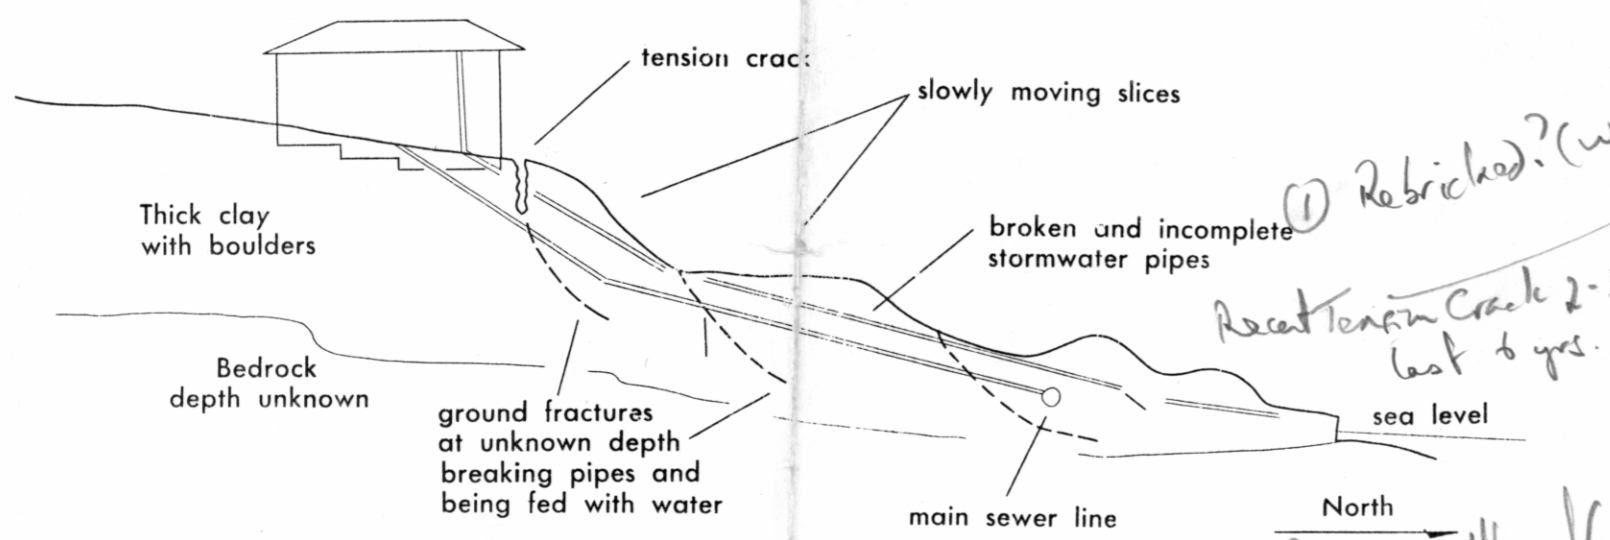
Figure 1

SECTION AT CASUARINA CRESCENT (not to scale)
