T. MCCARTHY - LOT 20 BRADDONS LOOKOUT ROAD, LEITH  
GEOLOGICAL INVESTIGATIONS

R.C. DONALDSON DECEMBER 1980

FIGURE 1

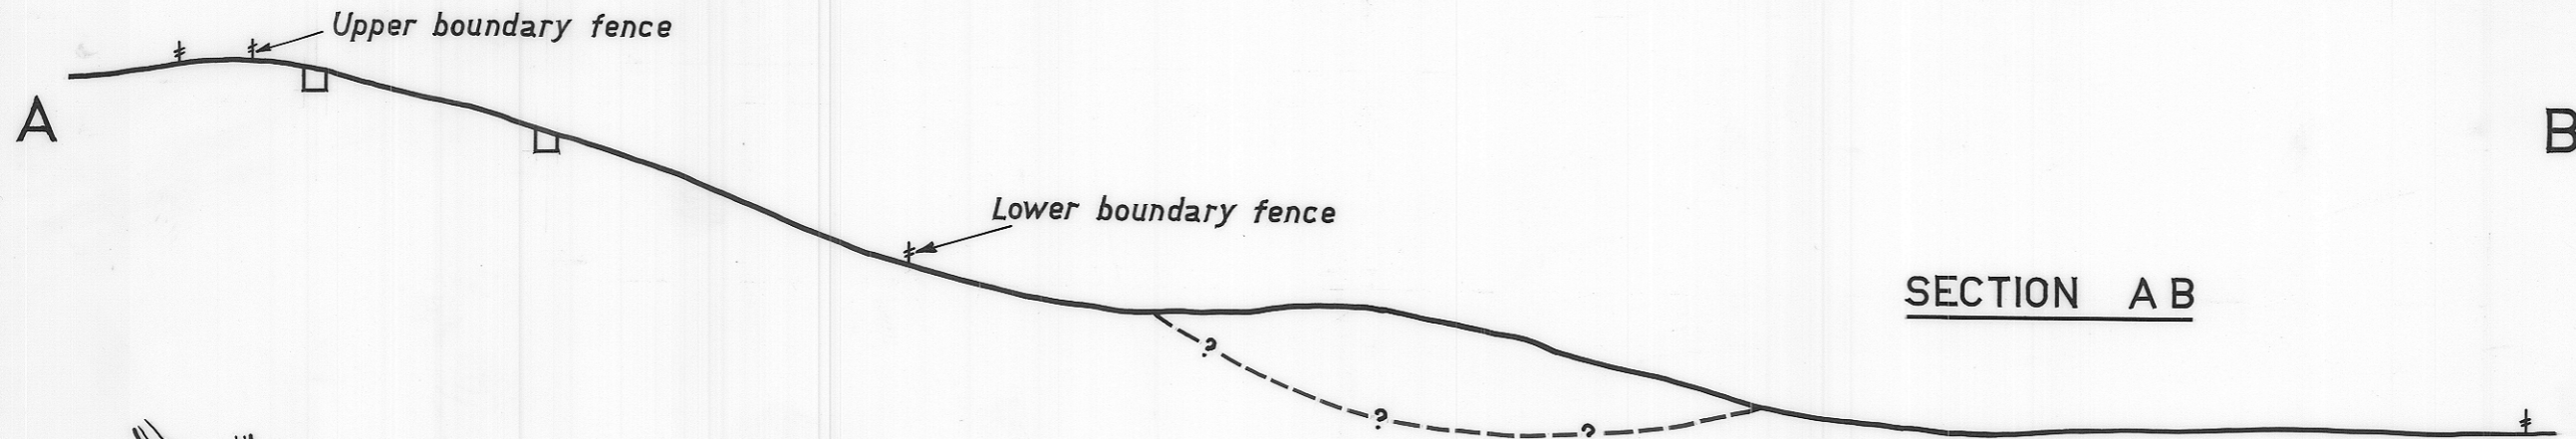
SECTION A B

Clay topsoil (CH).

Iron enriched clay (CH).

Extremely to highly weathered basaltic material.

Residual clay (CH).

Residual clay with pockets of extremely weathered basalt.

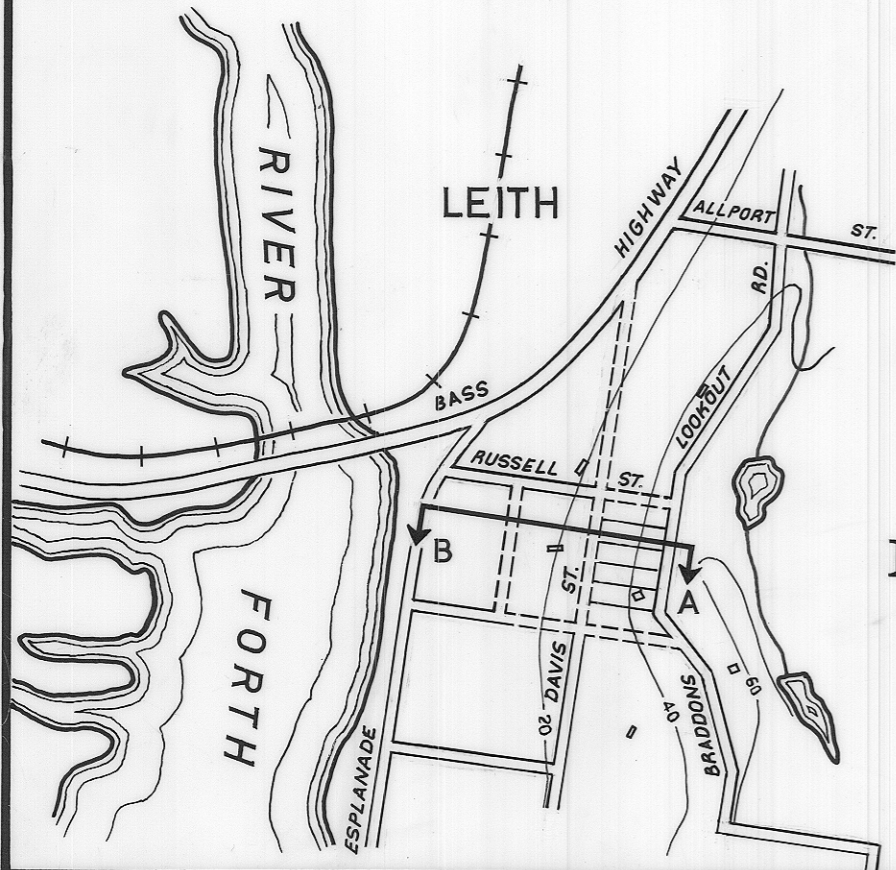
TP1 Test pit

⊥ Fence

---?--- Probable old landslide

— A — Line of section
