KING ISLAND SCHEELITE

No. KG2-01-001

DOLPHIN MINE
 GEOLOGICAL CROSS-SECTION
 220 000 E

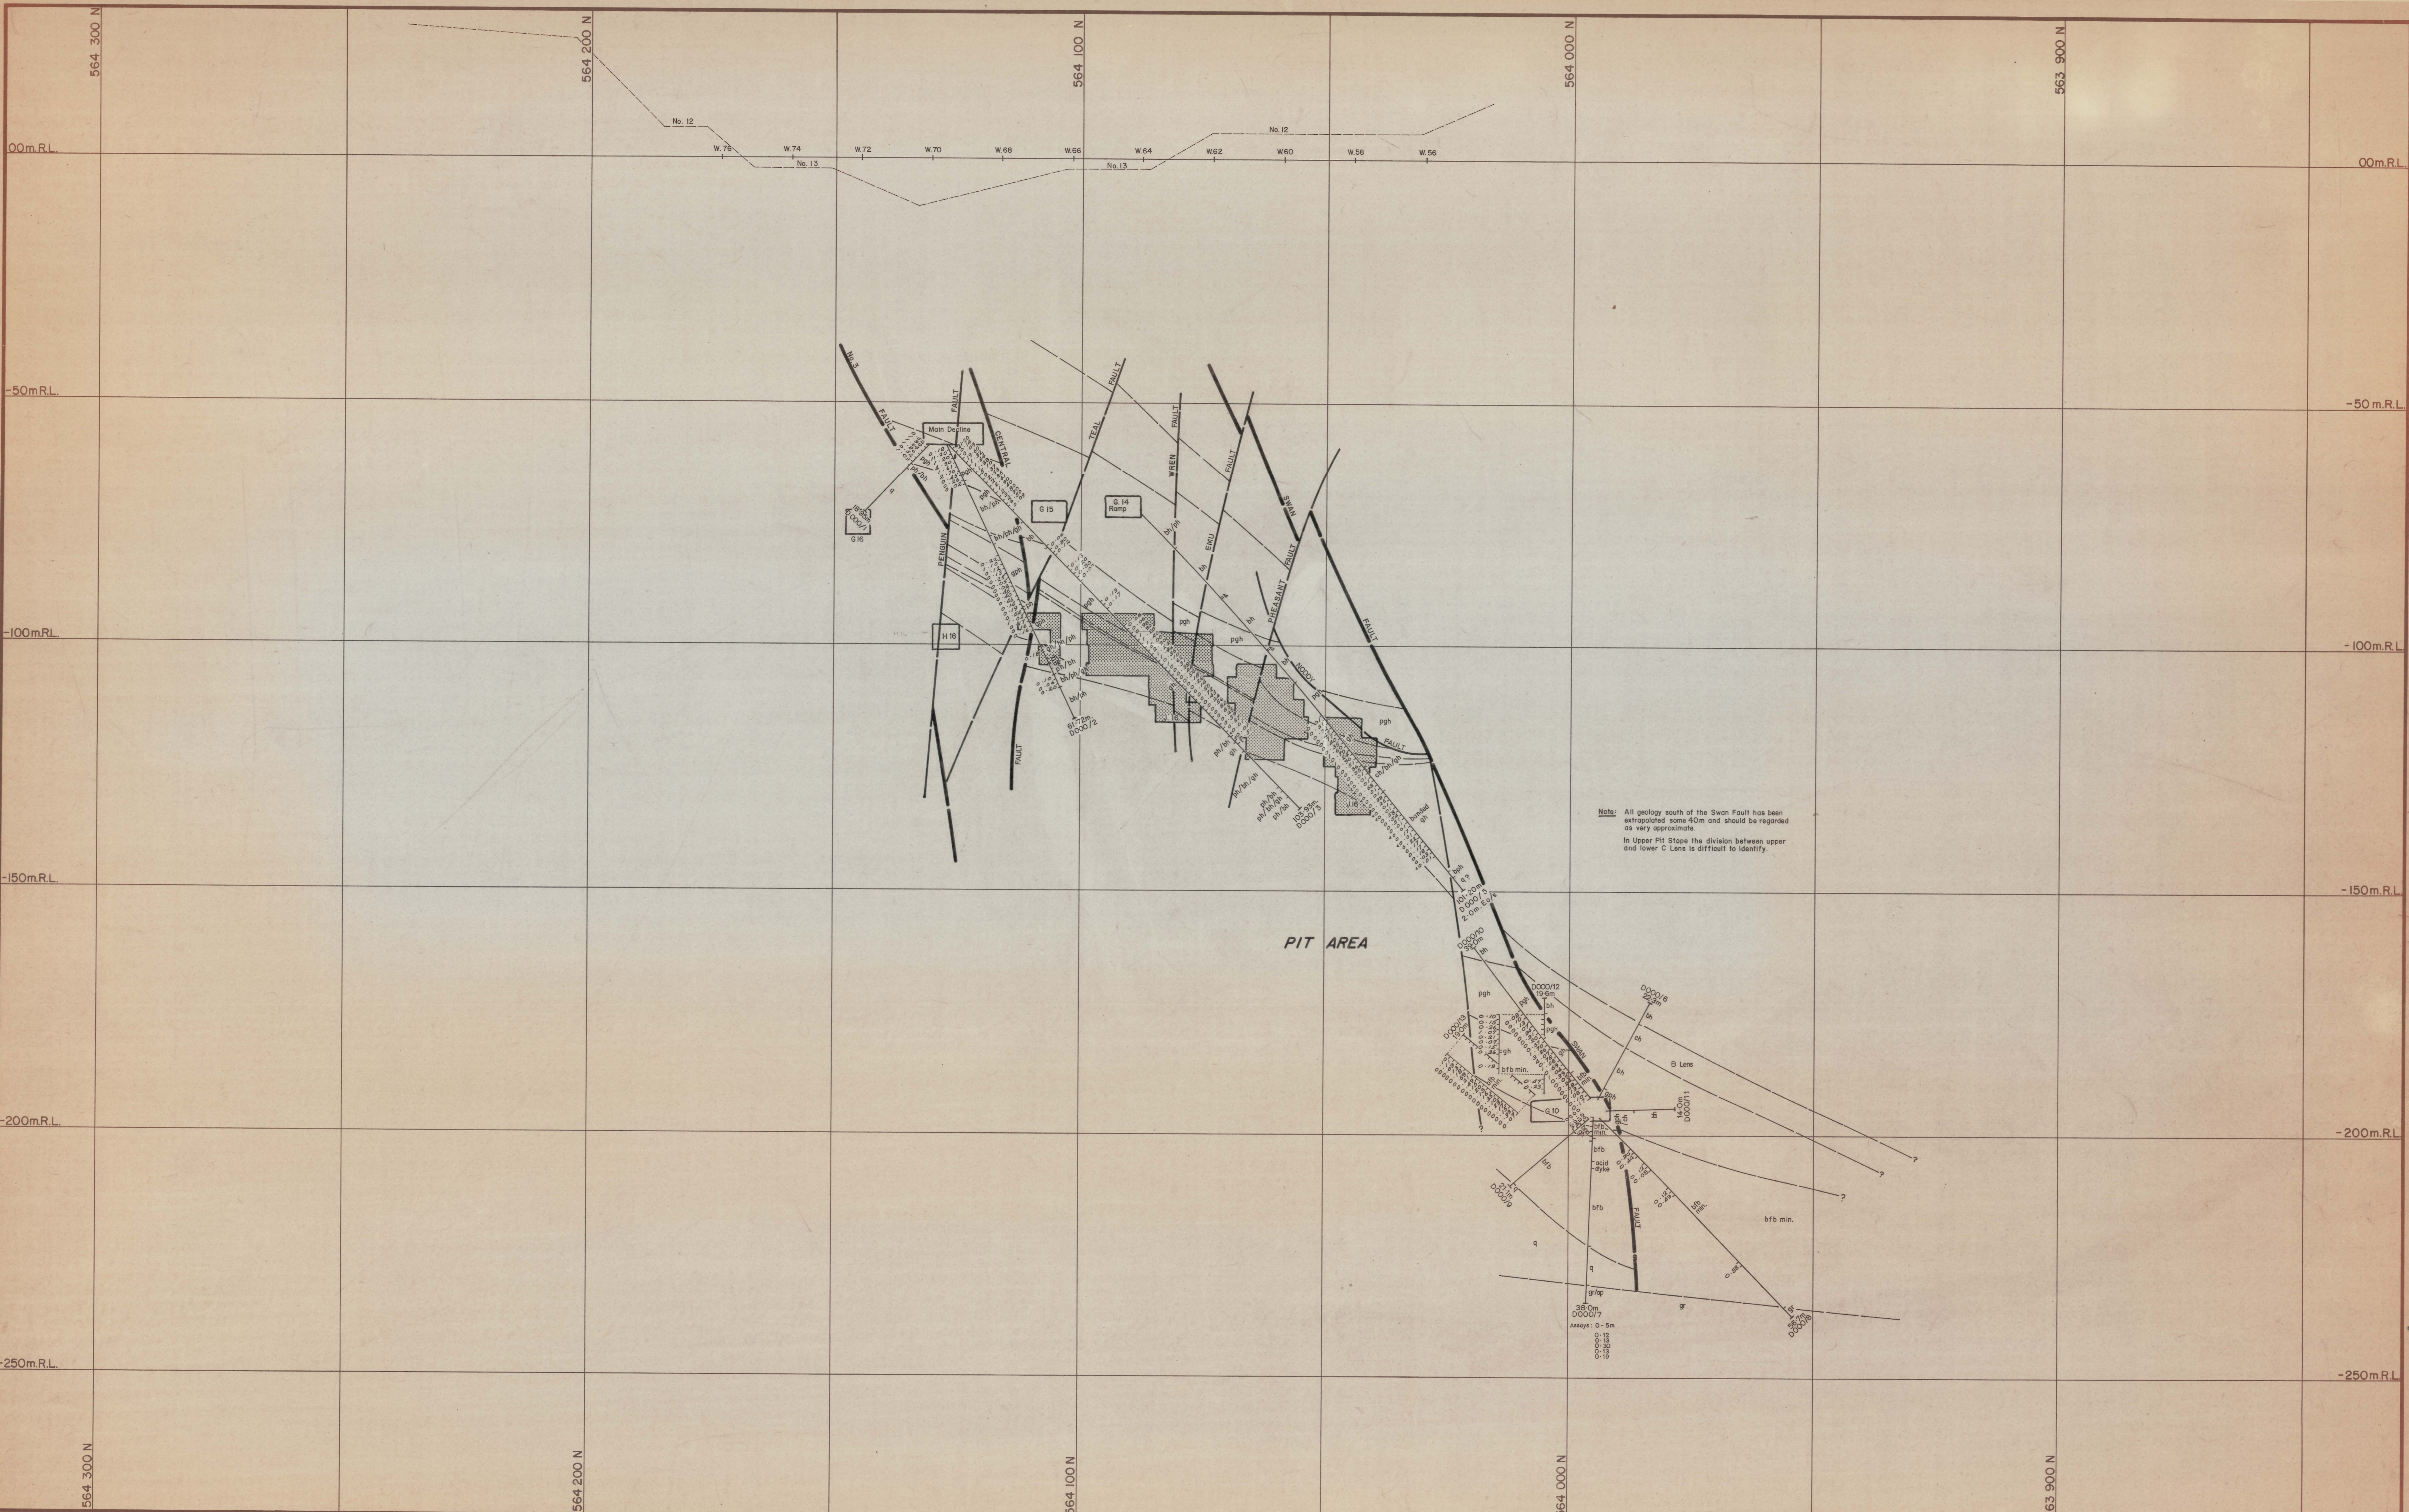
Notes: All geology south of the Swan Fault has been extrapolated some 40m and should be regarded as very approximate.
 In Upper Pit Slope the division between upper and lower C Lens is difficult to identify.

RQD %
 >90 Minimum or no support
 60-90 Intermediate support; rockbolts and one shotcrete application
 <60 Maximum support
 (after E. Miller; March, 1972)
