Borehole log

BH-015

Project	Macquarie Point GI	Location	Macquarie Point	Client	MPDC
Coordinates	527567.56mE; 5252514.03mN	Drill type	Sonic	Hole started	17/5/24
Datum	GDA2020	Drill rig	MRS XL Max	Hole finished	17/5/24
RL	4.30mAH	Drill fluid(s)	Water (where indicated)	Drilled by	SWD (G. Bourke)
Inclination	Vertical	Logged by	W. Cromer	Checked by	G. Bremner
Bearing

MAC POINT
 Macquarie Point
 Geotechnical Investigation

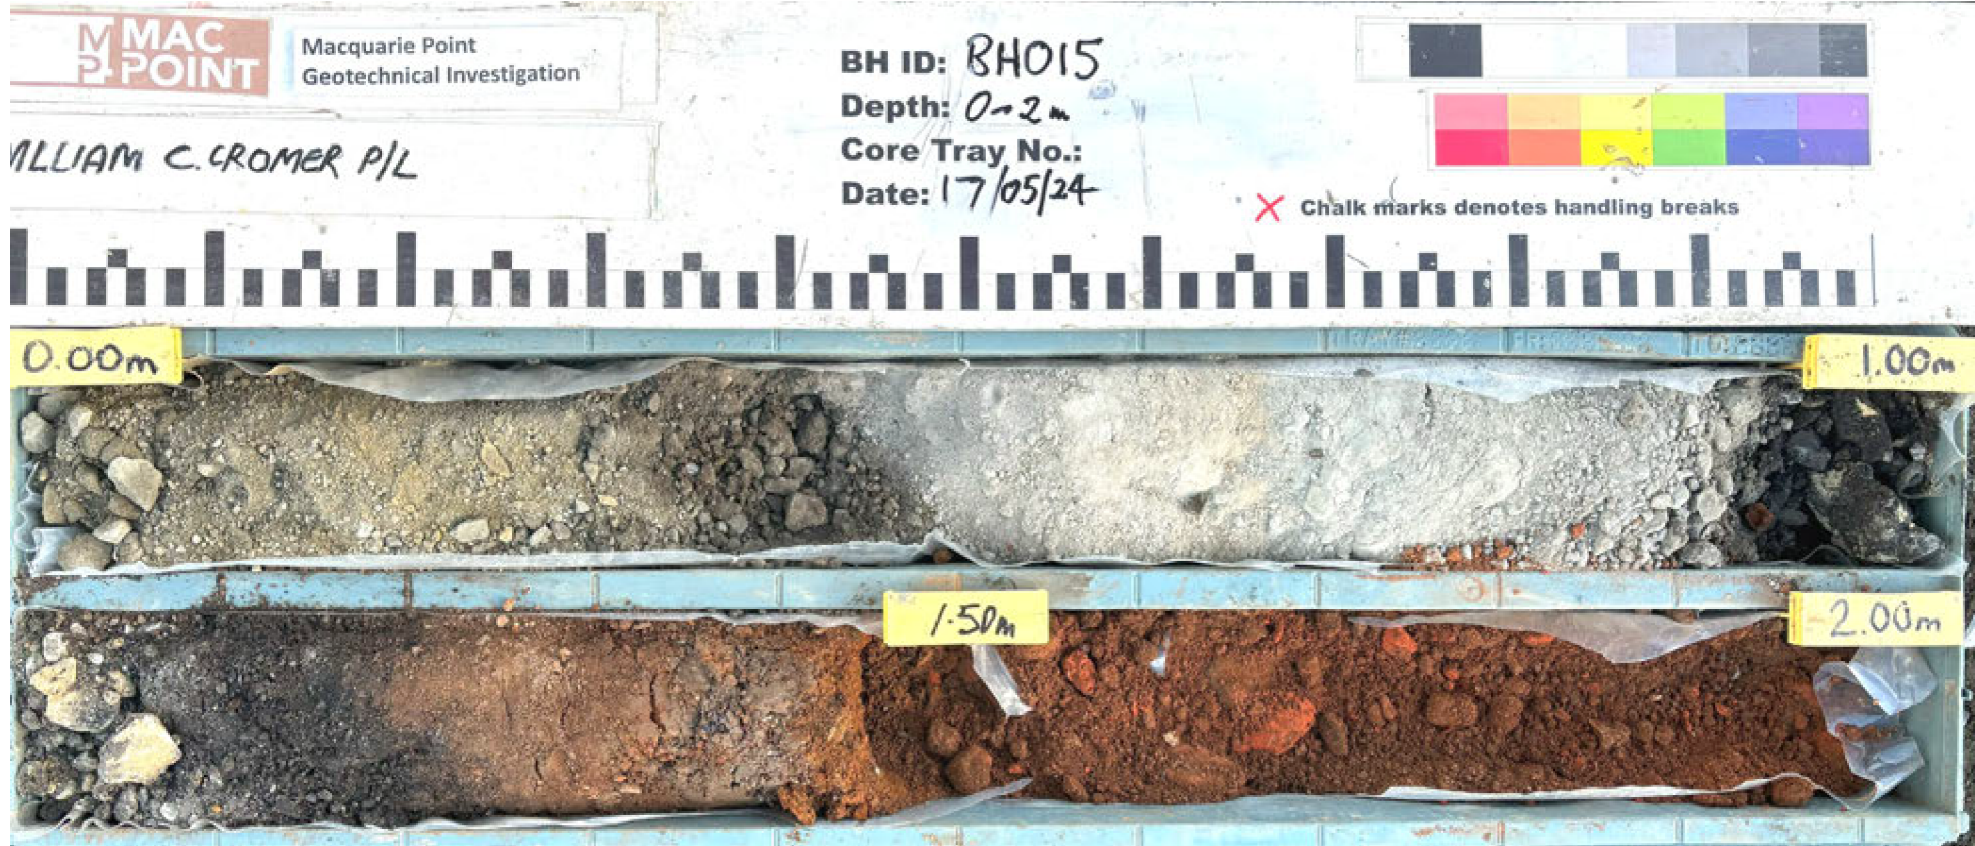
PointID: BH-015 Depth Range: 0.0 – 2.0 m

Method	Penet. resist	Water	Notes	metres	Recovery (%)	Graphic log	USCS	Materials	Moisture condition	Consistency	Structure, geology, interpretation, additional observations
			Samples and field tests	RLmAH	Depth			Soil type, colour, plasticity or particle characteristics, secondary and minor components		Density index	
Sonic				4	100		SP	Gravelly silty SAND: light greenish grey; 10% dolerite fragments to 20mm	D	MD	Fill
			ASS 0.4 - 0.5m	0.45m	100		GM	Sandy SILT - silty SAND: light grey; 20-30% angular dolerite clasts to 50mm			
			ASS 0.9 - 1.0m	0.9m	100		SM	Sandy gravelly SILT: black; occasional cream siltstone clasts to 30mm		L, VS	
			ASS 1.4 - 1.5m	1.9m	100		SP	Silty SAND: reddish orange; 5% well graded brick fragments mostly to 10mm, occasionally to 50mm; some low plasticity clayey sand near base		L	
			SPT 6, 4, 3 N=7 Recovery: 350/450	1.9m							
			ASS 2.0 - 2.1m	2.2m	100		SM	Sandy gravelly SILT: black; occasional orange-red brick fragments to 50mm	D-M	VS	(Ash and cinders)

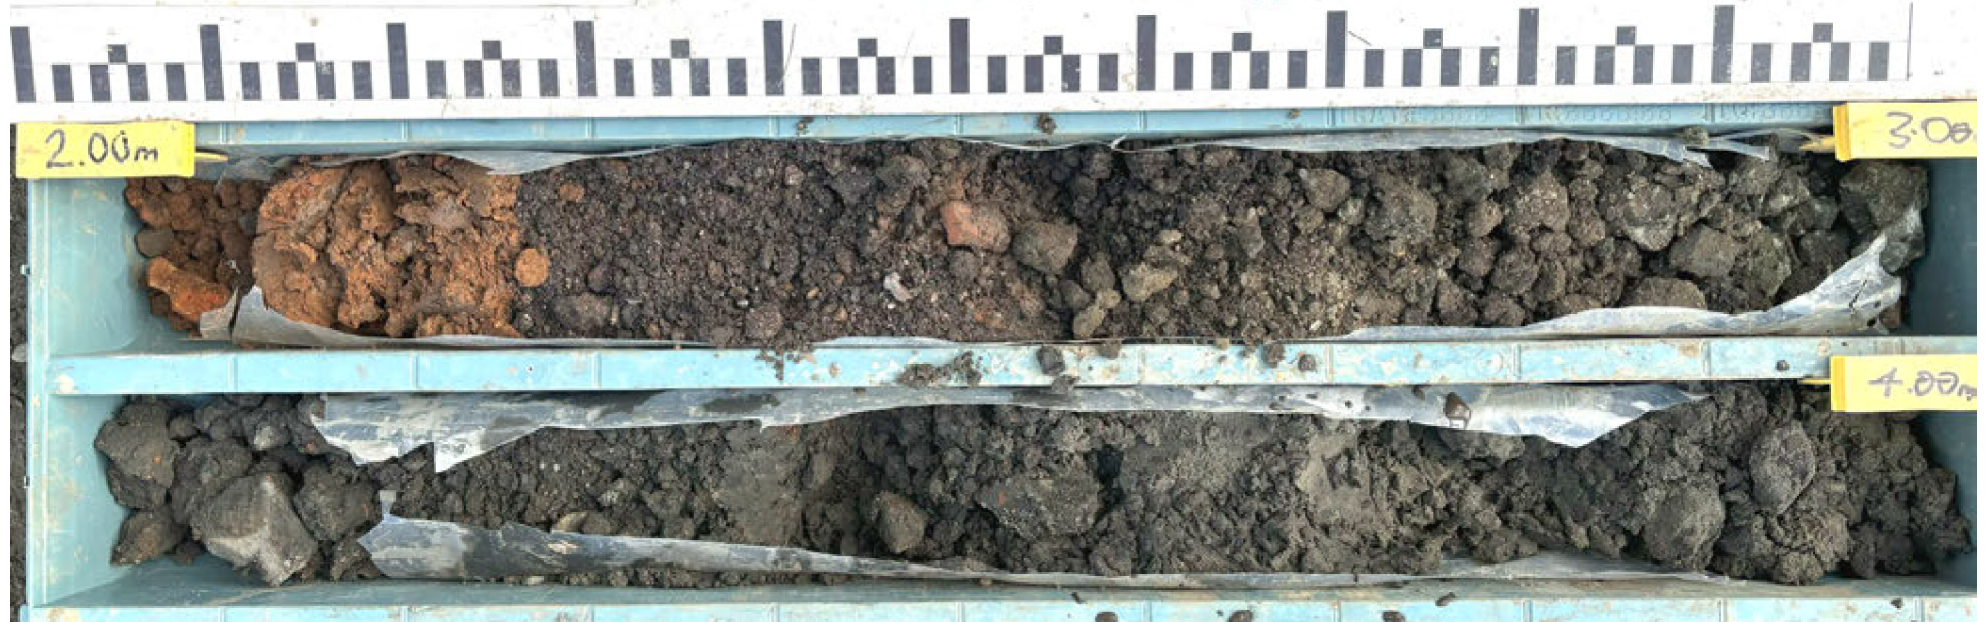
PointID: BH-015 Depth Range: 2.0 – 4.0 m

ASS 2.5 - 2.6m	2.65m	100		SP, loc.	Gravelly SAND: dark grey; some silt; trace clay; locally with 20 - 30% well graded subrounded dolerite clasts to 75mm	M	MD	
			SPT 6, 16, 21 N=37 Recovery: 340/450	3.0m							
			ASS 3.4 - 3.5m	3.5m	100		SP	SAND: dark grey - black; fine-med, grained; some silt			
			Aggress 3.7- 3.8m	3.7m							
			ASS 4.0 - 4.1m	4.0m							
			ASS 4.5 - 4.6m	4.5m	100		SP	AS ABOVE: trace silt and fine red brick fragments, 1 piece leather, 1 piece porcelain, 1 piece wood (10cms); occasional rounded white quartzite pebbles to 10mm			
			ASS 5.0 - 5.1m	5.0m	100		SP	SAND: black grading to dark olive grey; med grained; occasional rounded white quartzite pebbles to 10mm; some fine white shell at base			Estuarine sediments
			ASS 5.5 - 5.6m	5.5m	100		SP	SAND: black grading to dark olive grey; med grained; occasional rounded white quartzite pebbles to 10mm; some fine white shell at base			Estuarine sediments

BH ID: BH015
 Depth: 2-4m
 Core Tray No.:
 Date: 17/05/24

X Chalk marks denotes handling breaks

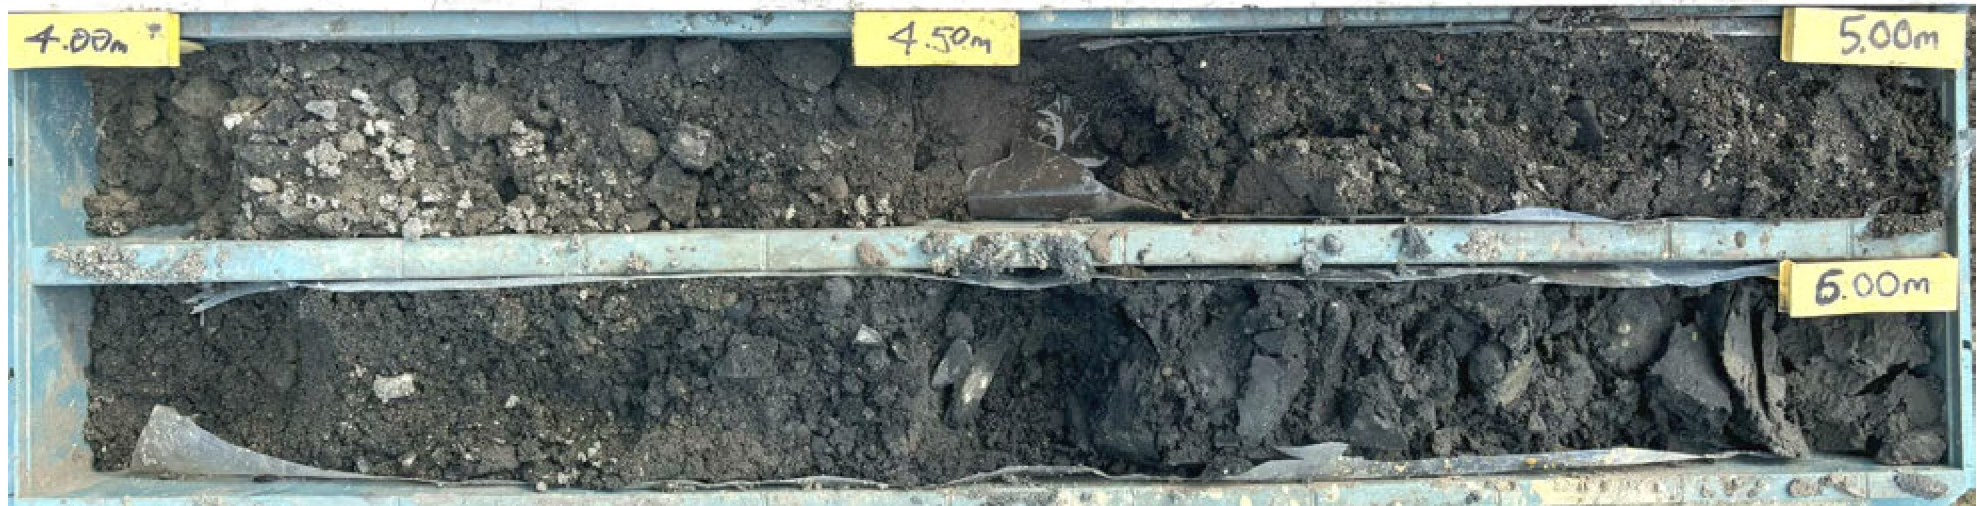
PointID: BH-015 Depth Range: 4.0 – 6.0 m

BH ID: BH015
 Depth: 4 - 6m
 Core Tray No.:
 Date: 17/05/24

X Chalk marks denotes handling breaks

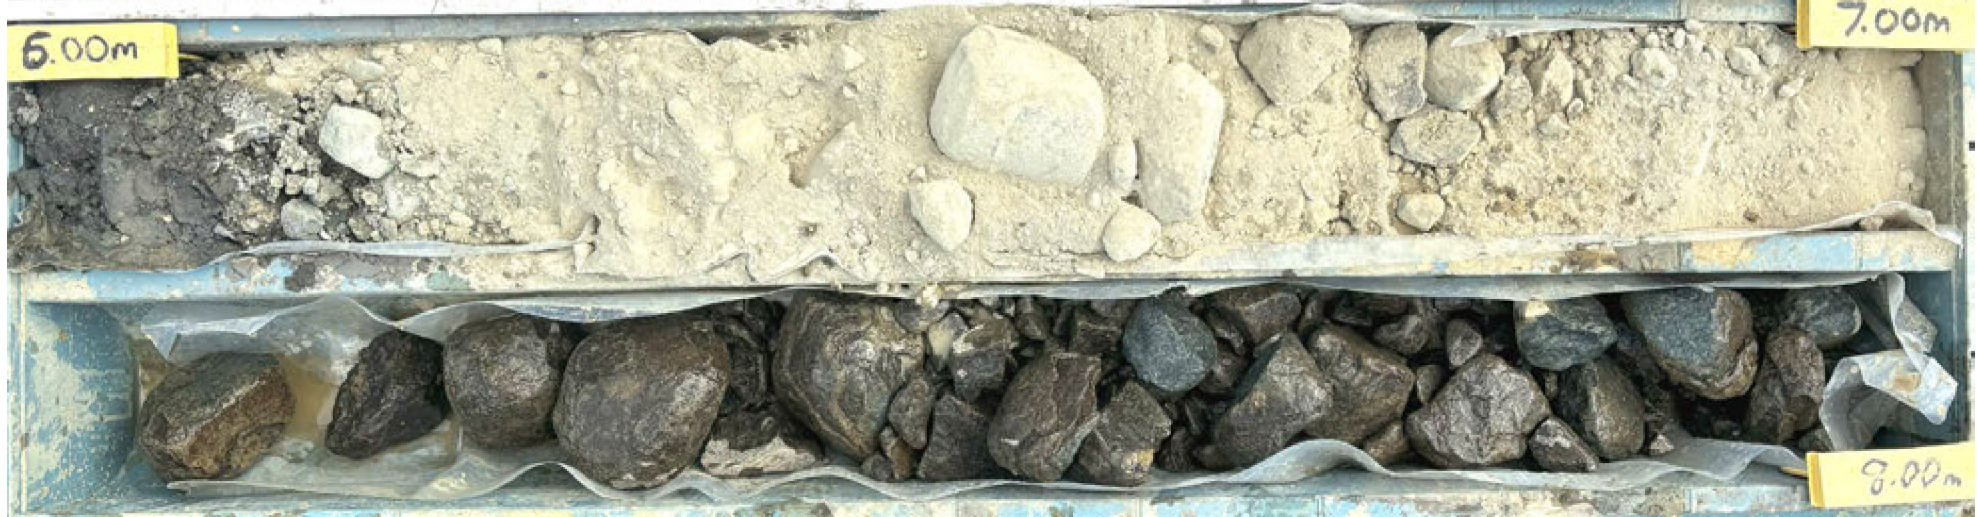
PointID: BH-015 Depth Range: 6.0 – 8.0 m

PSD 5.8 - 5.9m	5.8m							
		SPT R @ 6.3m on rock	6.3m								
		6 - 7m: hard sonic drilling; material mostly pulverised	6.3m								
		7 - 8.2m: water used; matrix flushed out	7.0m	75		GP	COBBLES: grey blue; well-mod. graded, subrounded, mod. weathered (some spheroidally) dolerite clasts to 100mm		W

BH ID: BH015
 Depth: 6-8m
 Core Tray No.:
 Date: 17/05/24

X Chalk marks denotes handling breaks

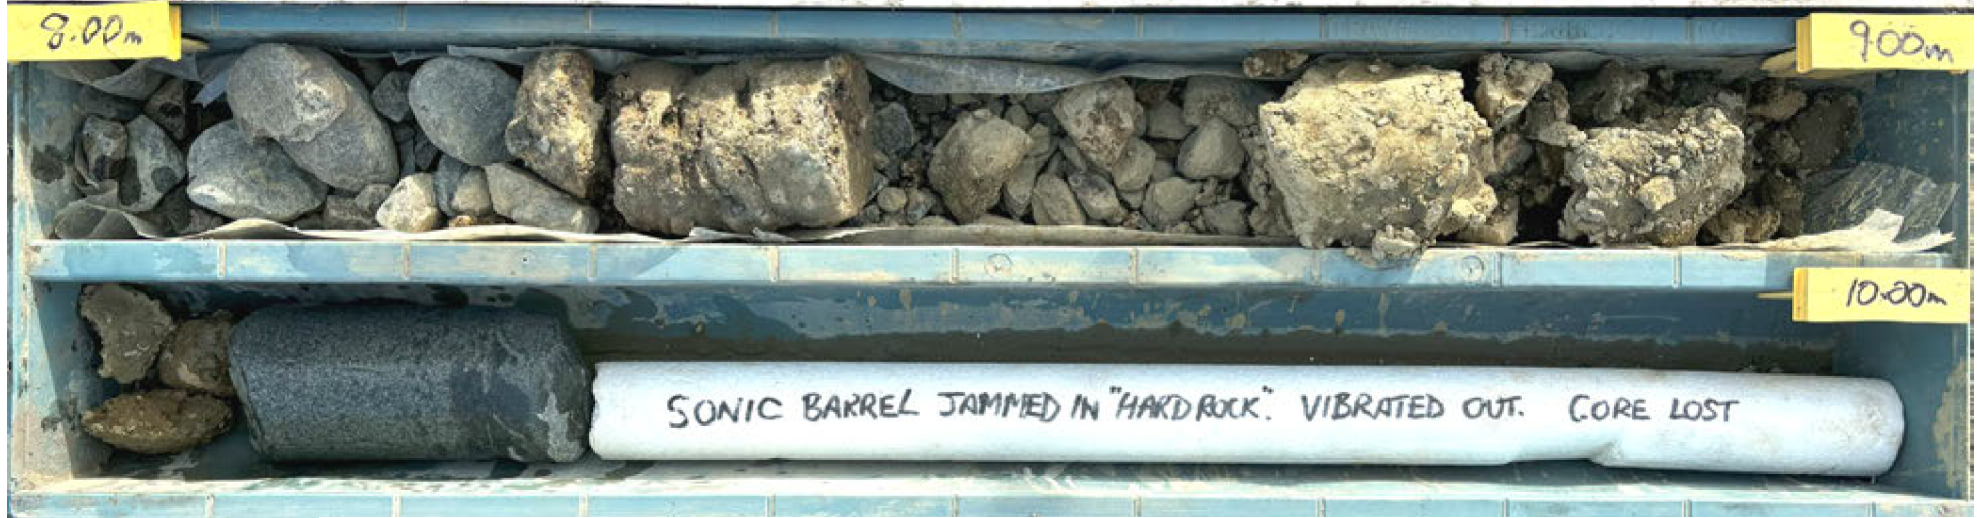
PointID: BH-015 Depth Range: 8.0 – 10.1 m EOH

8.0m								
			8.2m	75		GP	Sandy silty GRAVEL: light yellowish brown; matrix is doleritic sand and fine gravel flecked with white/cream; 30% mod. graded, subrounded, mod. weathered dolerite clasts to 30mm		D

9.0m								
		10.1m: sonic barrel jammed in "hard rock"; vibrated out; core lost.	9.1m								
			9.25m								
			10

BH ID: BH015
Depth: 8-10.1m
Core Tray No.:
Date: 17/05/24

✗ Chalk marks denotes handling breaks
