Table 3 Drilling log from the drilled off Haines Road on the Sutton property

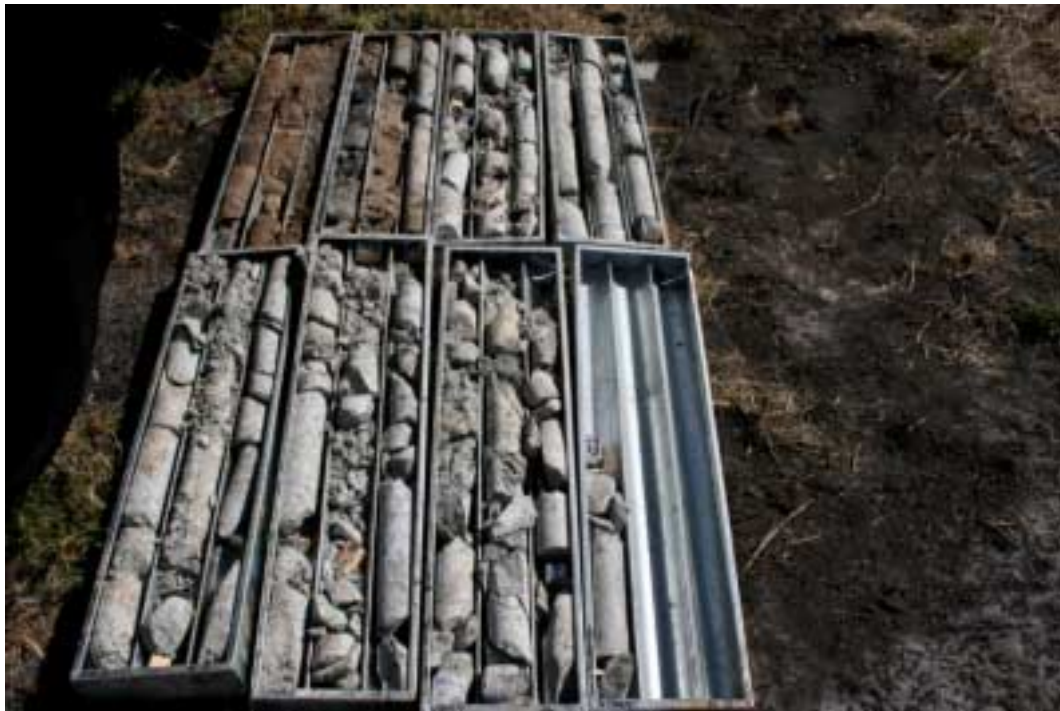
King Island Drilling - Salinity Investigation	
Geological log – Site: Sutton 1 Southwest	
Depth (m)	Description of strata
0 – 14	Brown and grey fine sand
14 – 30	Very coarse grained granite – possibly pegmatite, very large feldspar crystals at 1 – 2 cm in width and slightly longer
Notes:	Lack of saprolite (decayed rock mass) Fractured rock aquifer
