Table 6 Drilling log from the bore drilled on the Stellmaker property

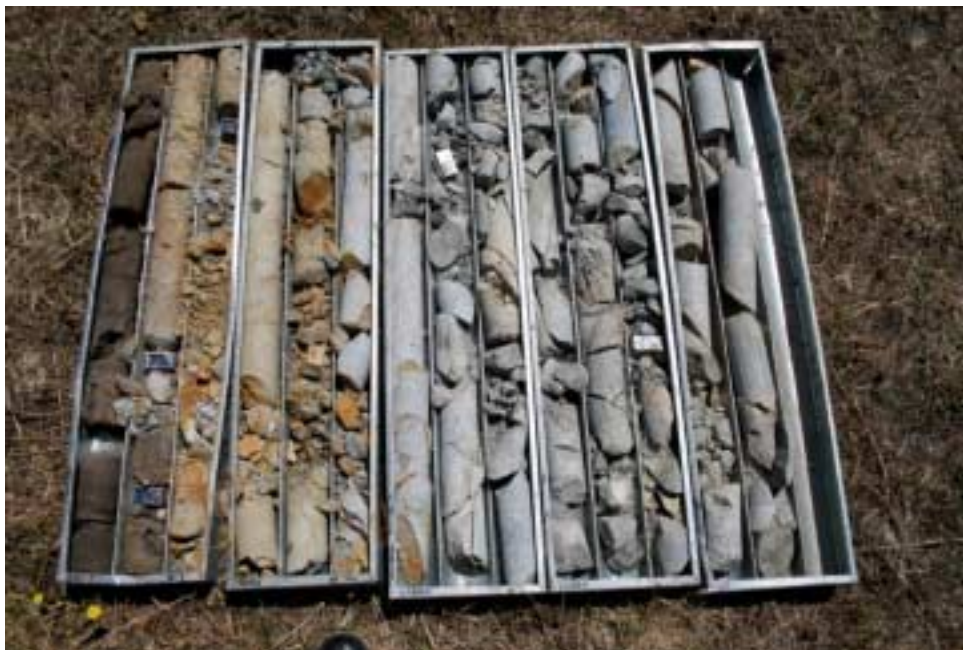
King Island Drilling - Salinity Investigation	
Geological log – Site: Stellmaker	
Depth (m)	Description of strata
0 – 1,0	Organic rich sand with lignite like material
1 – 2	Dark gray silty clay
2.0 – 3.9	Dark organic rich sandy clay
3.9 - 7.0	Grey granite, not weathered (fresh)
7.0 - 8.9	Grey fractured with weathering along fractures
8.9 – 10	Sold granite (fresh)
Notes:	Complete lack of saprolite (decayed rock mass) Fractured rock aquifer
